**ADDITIONAL PHASE II
ENVIRONMENTAL SITE ASSESSMENT
FOR ASSESSOR'S PARCEL NUMBERS
401-031-038, -044, -046, -055, -059, AND -060
SAMOA PENINSULA BROWNFIELD SITE
SAMOA, HUMBOLDT COUNTY, CALIFORNIA**

April 2007

Winzler & Kelly Consulting Engineers
633 Third Street
Eureka, California 95501
707-443-8326

Project No. 016670-5001-11110

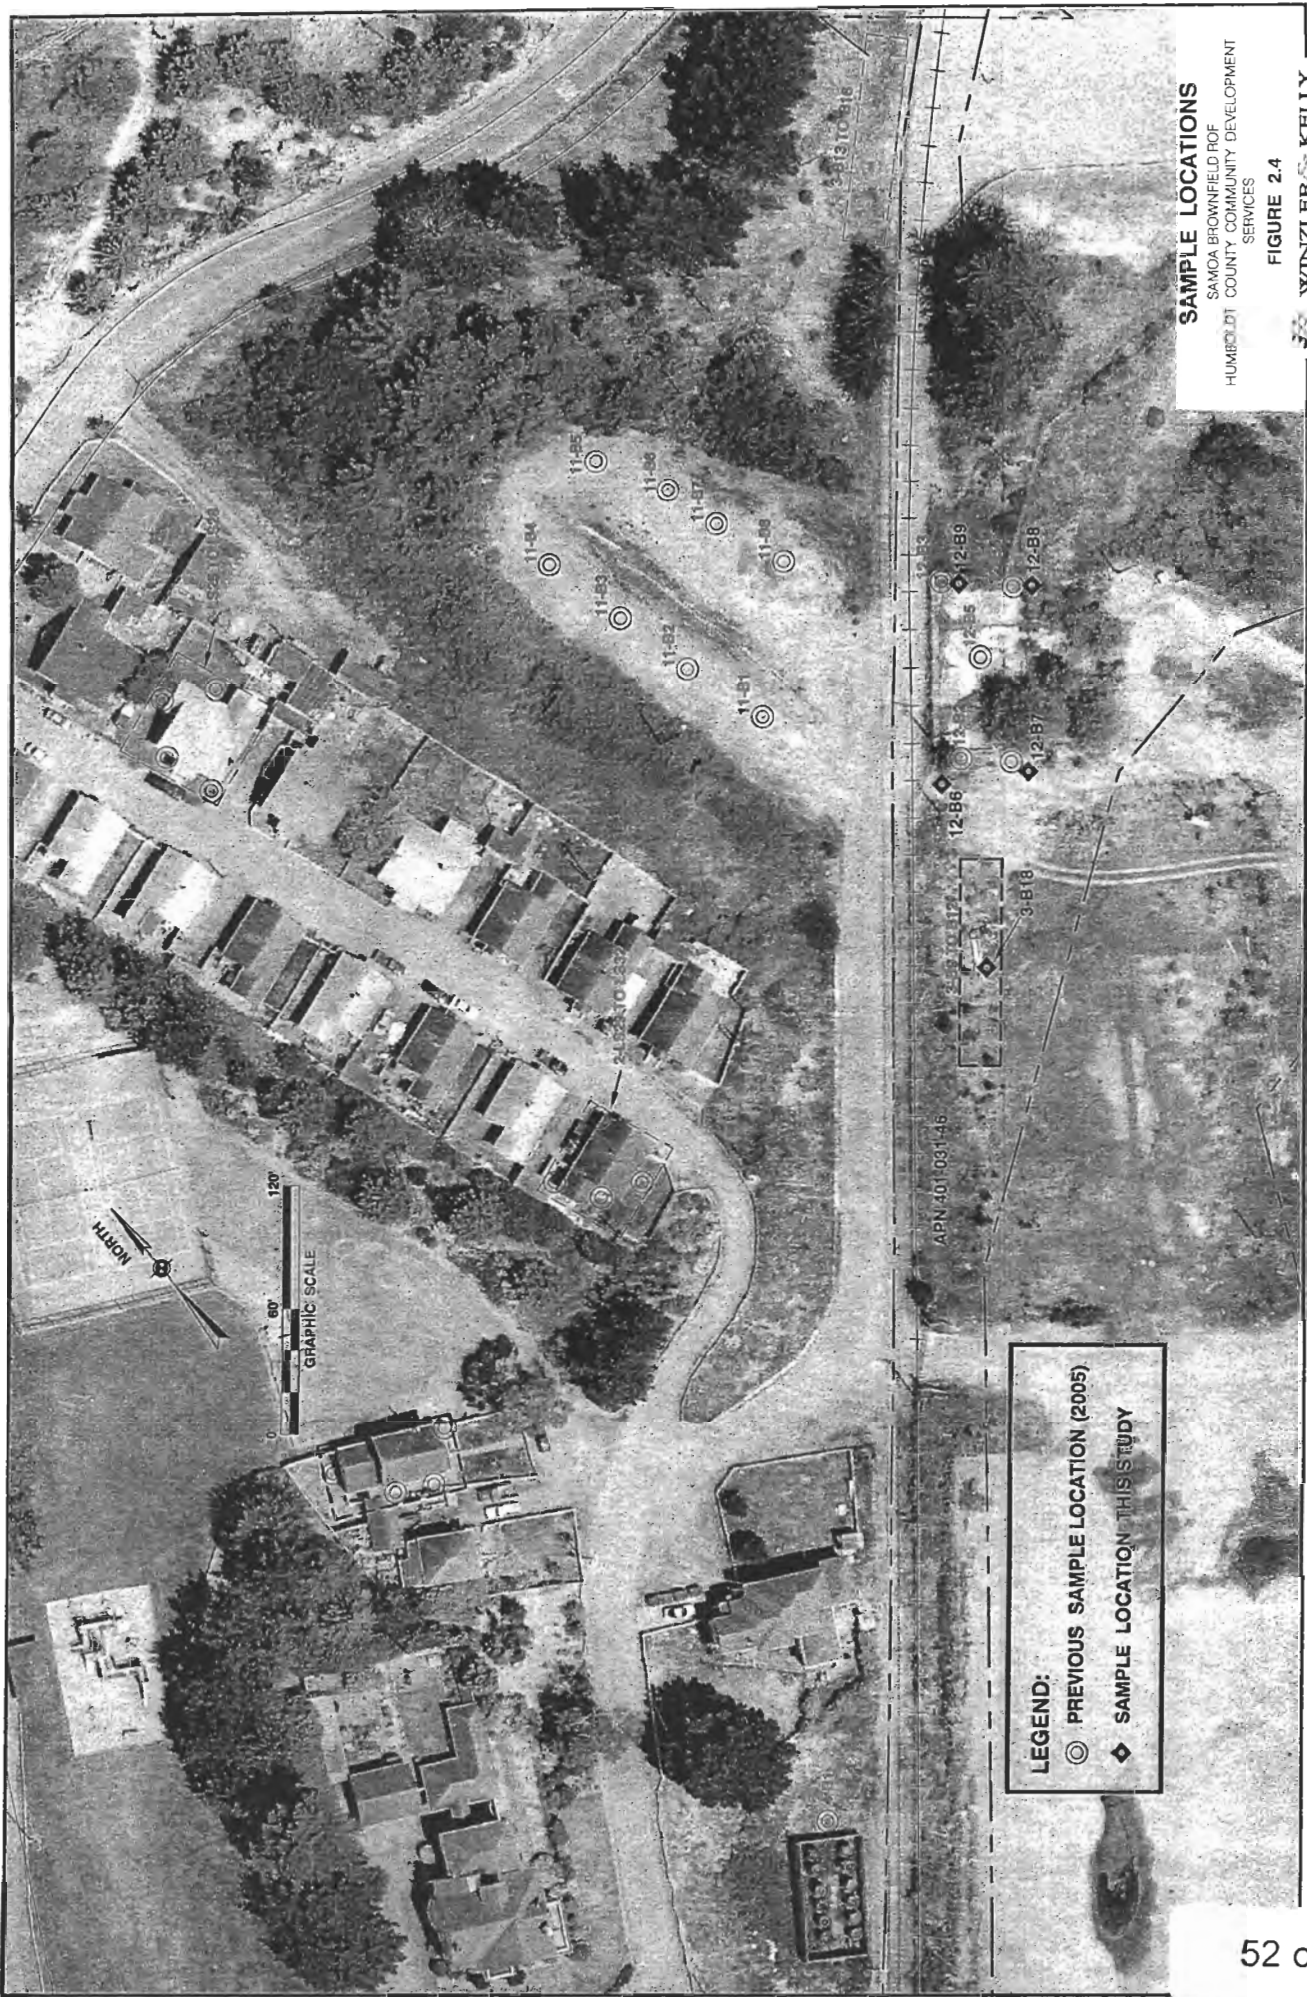
SAMPLE LOCATIONS
 SAMOA BROWNFIELD ROF
 HUMBLET COUNTY COMMUNITY DEVELOPMENT SERVICES
FIGURE 2.4
 WINZLER & KELLY

Boring 3-B18, located within the Phase II ESA area "3-B9 to 3-B12" (see Figure 2.4 for the sample locations), reported low levels of TPH-D/MO in the surface sample (3.1 ppm/46 ppm) and at 5-feet below ground surface (bgs) (25 ppm/150 ppm). TPH-D/MO were below detection limits in the 10-foot bgs sample. The groundwater sample from boring 3-B18 reported 570 ppb TPH-D and 4,600 ppb TPH-MO.

These results indicate that the area around boring 3-B17 has only minor petroleum impacts near the surface that do not extend to depth and do not appear to be impacting groundwater. The soil impacts in that area around boring 3-B18 appear to be more extensive, and there are significant hydrocarbon impacts to the groundwater in this area. The extent of the soil and groundwater impacts in this area is yet to be defined.

The impacts in this area appear to be to the southwest, toward, and possibly related to the impacts reported at boring 3-B18. The extent of the impacts in this direction has not been defined.

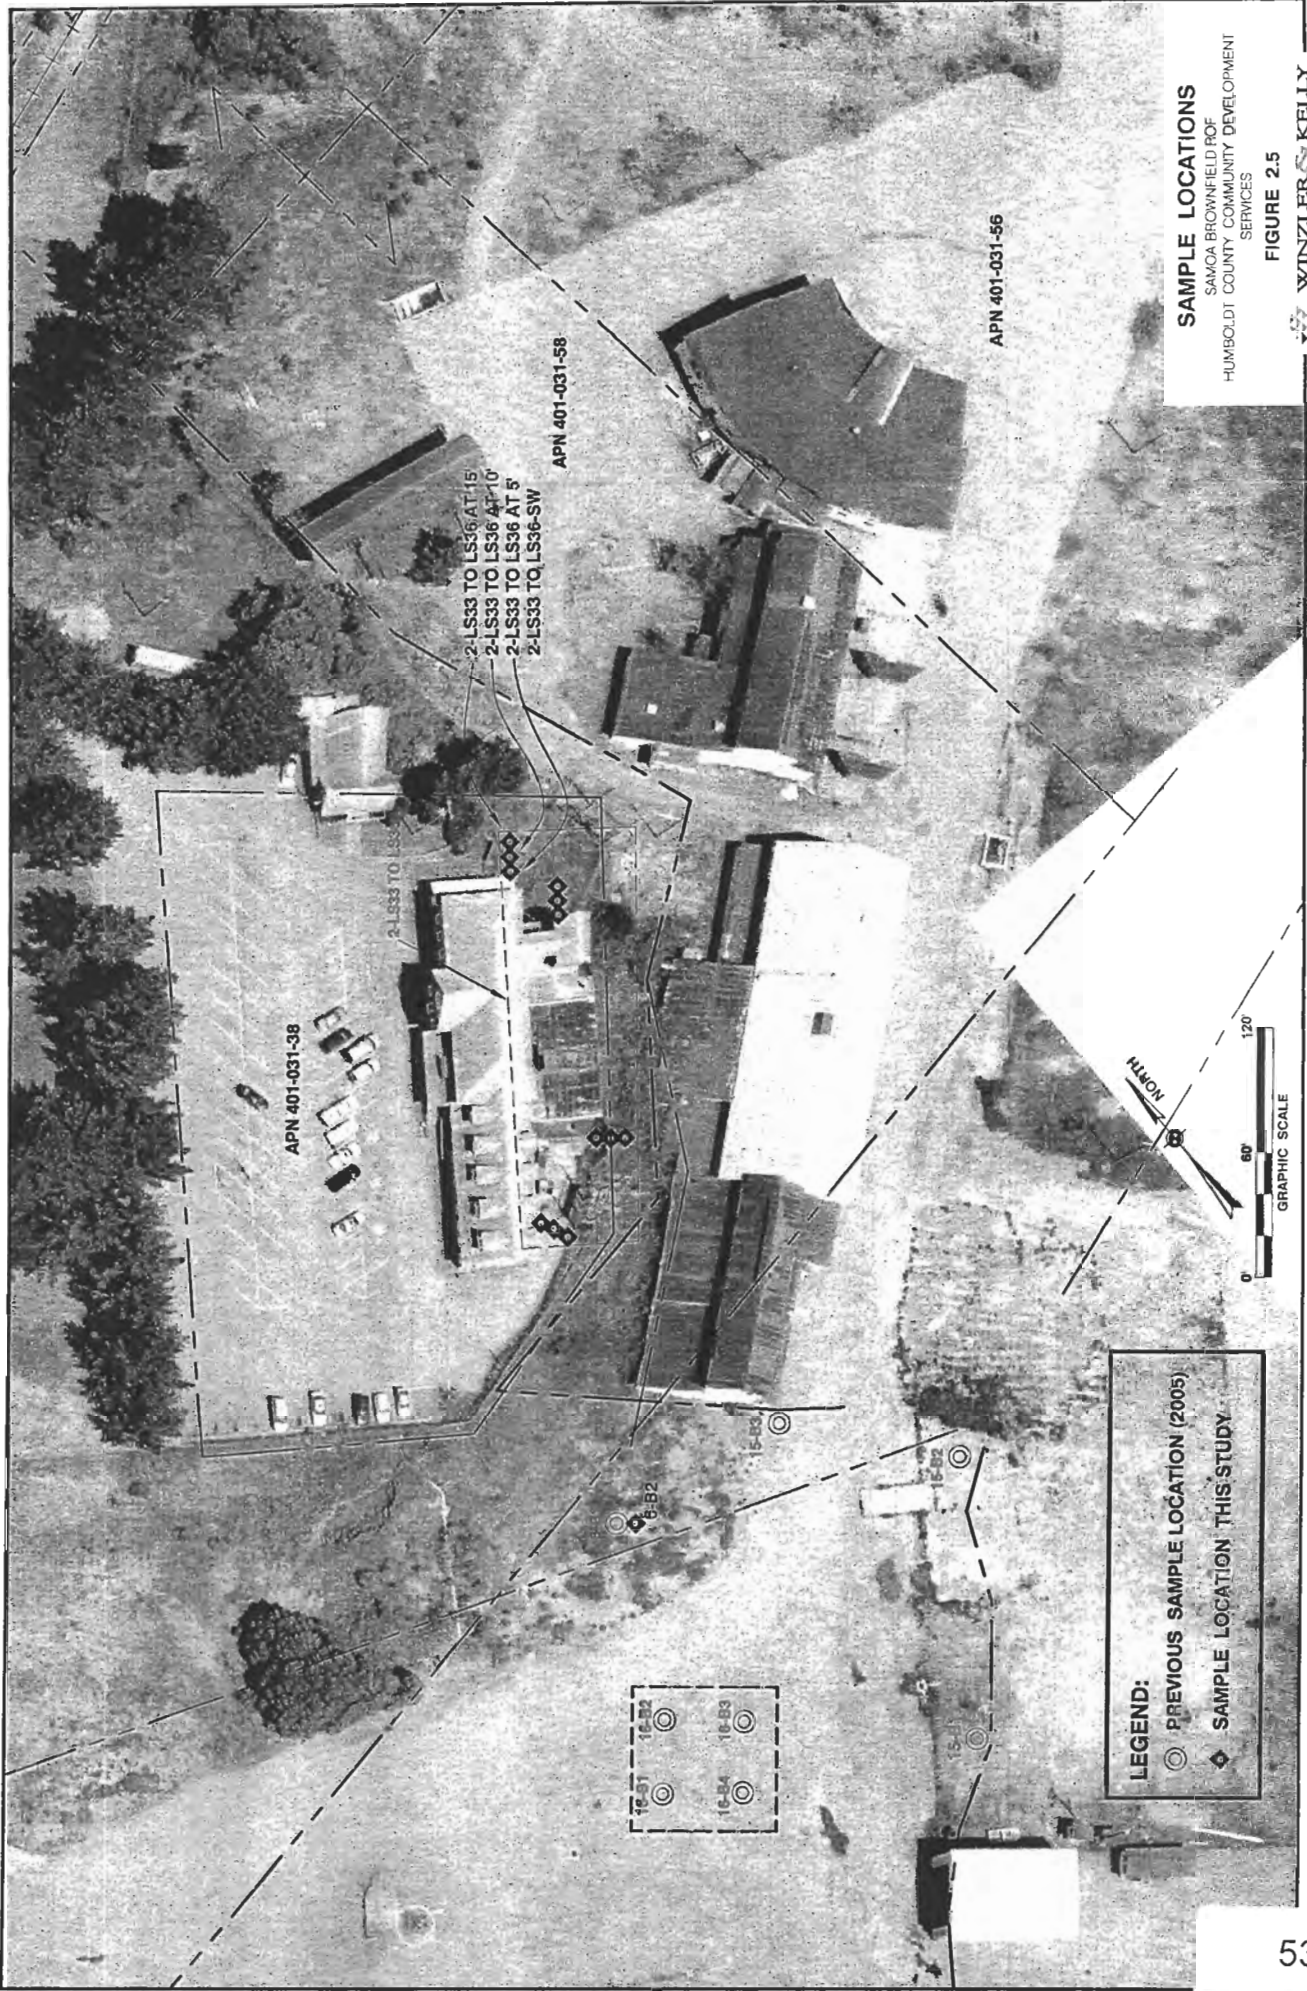
FIGURE 2.5

Lead was detected at levels that would classify the soil as a hazardous waste around all of the five buildings that were retested during this investigation (See Figures 2.2, 2.3, and 2.5 for sample locations). The impacts extended out fifteen feet from the structures, which in most cases was approximately to the property lines. The extent of the impacts at other structures not tested is unknown at this time. The depth of the impacted soil is also not known, as all samples collected were from the surface.
