“Maunawili”

Underwater Propeller Inspection

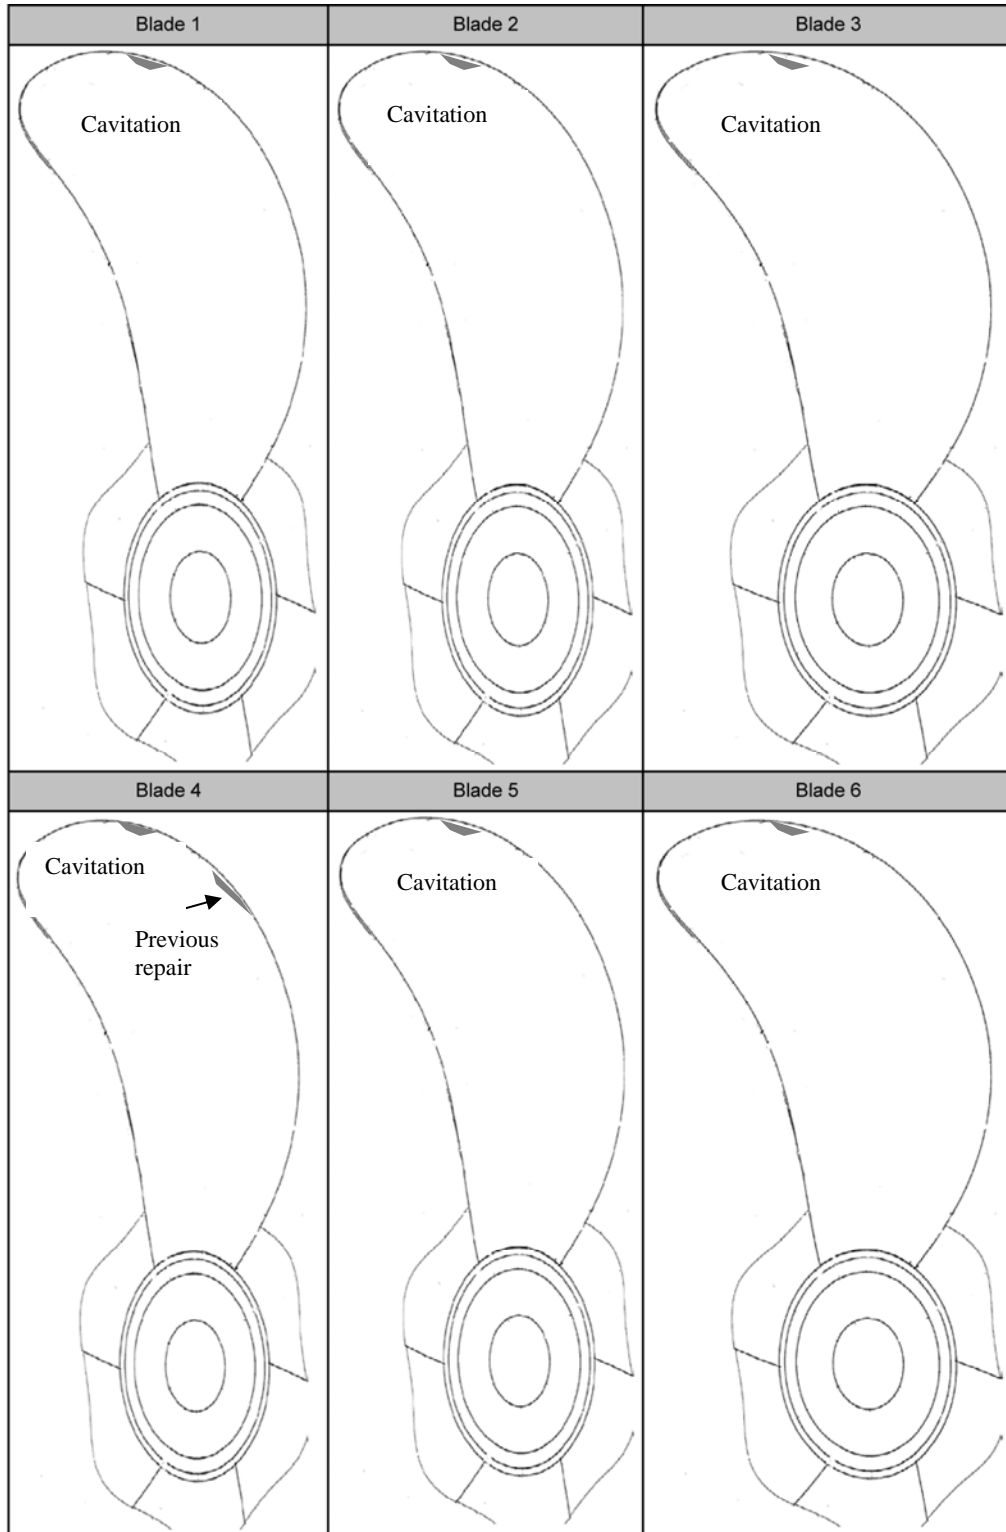
PROPELLER DIAGRAM SHEET

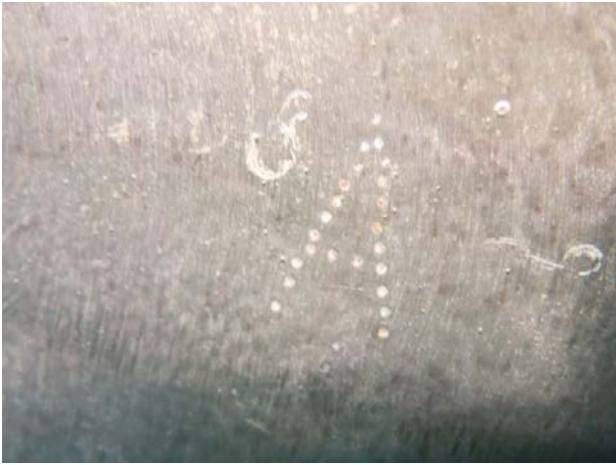
Blade A: fouled with light slime on leading and trailing edge. Tube worms were observed on the pressure face and suction back. Coating in good condition overall.

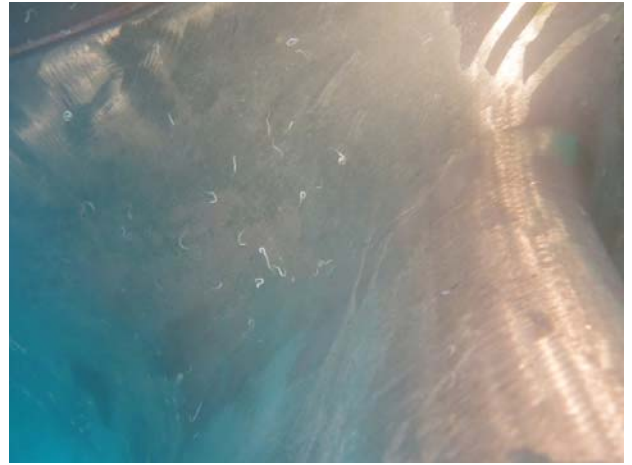
Blade A: fouled with light slime on leading and trailing edge. Tube worms were observed on the pressure face and suction back. Coating in good condition overall.

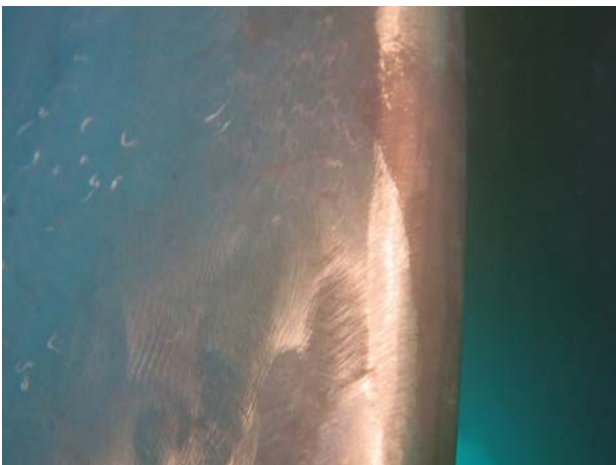
Blade A: fouled with light slime on leading and trailing edge. Tube worms were observed on the pressure face and suction back. Coating in good condition overall.

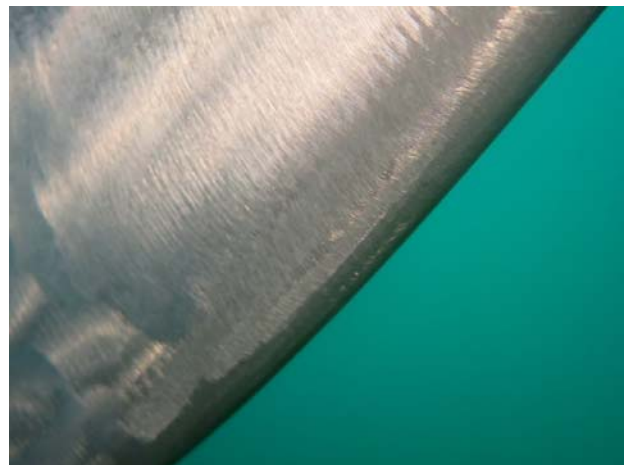
Blade A: fouled with light slime on leading and trailing edge. Tube worms were observed on the pressure face and suction back. Coating in good condition overall.

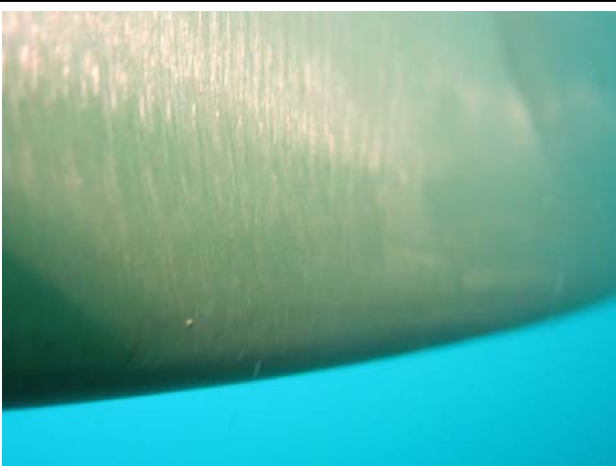
Blade A: fouled with light slime on leading and trailing edge. Tube worms were observed on the pressure face and suction back. Coating in good condition overall.

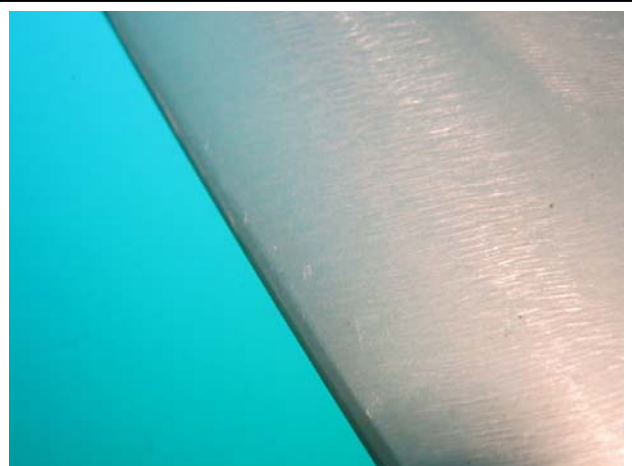
Blade A: fouled with light slime on leading and trailing edge. Tube worms were observed on the pressure face and suction back. Coating in good condition overall.

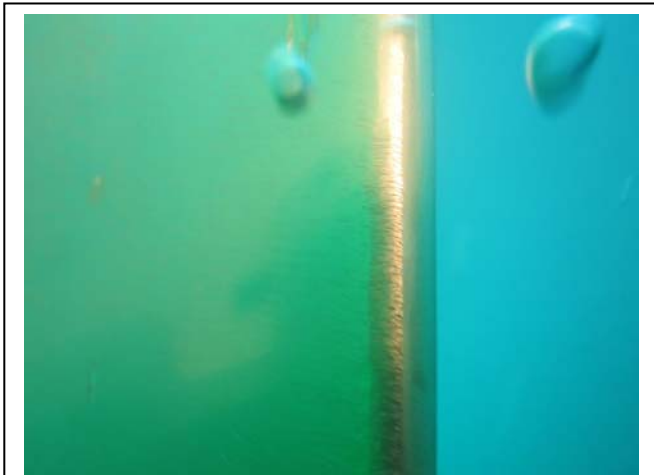
Blade A: fouled with light slime on leading and trailing edge. Tube worms were observed on the pressure face and suction back. Coating in good condition overall.

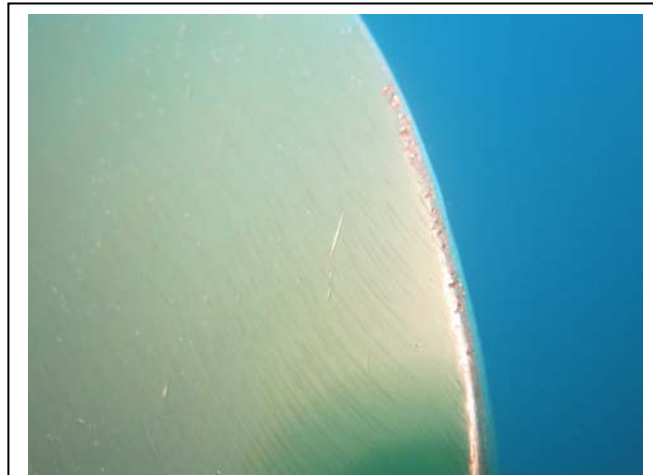
Blade A: fouled with light slime on leading and trailing edge. Tube worms were observed on the pressure face and suction back. Coating in good condition overall.

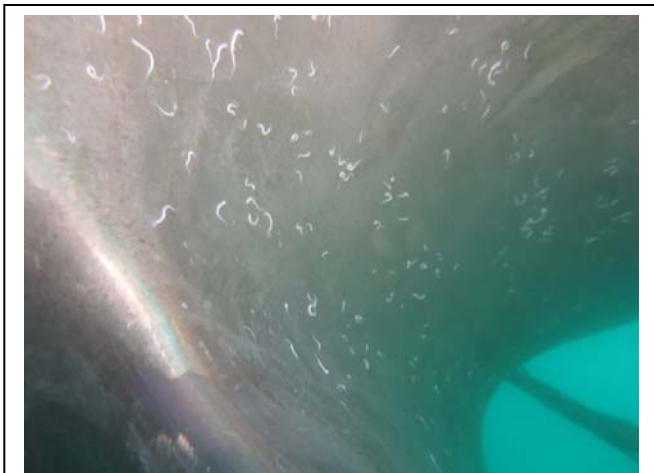
Blade A: fouled with light slime on leading and trailing edge. Tube worms were observed on the pressure face and suction back. Coating in good condition overall.

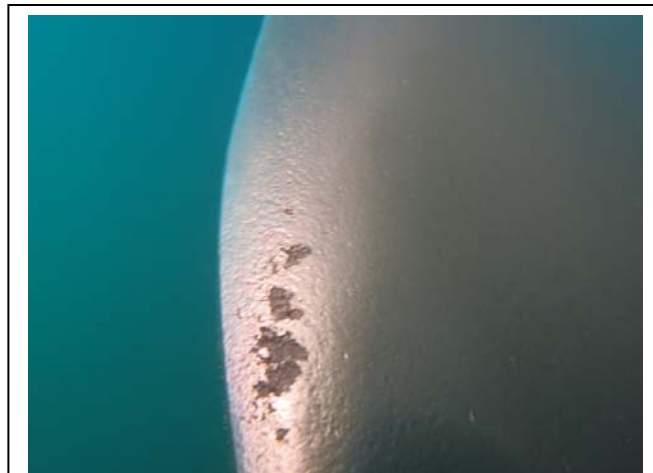
Blade A: Cavitation on .9 radius 2.5 inches in length. Surfaces around the cavitation damage appeared to still have intact coating.

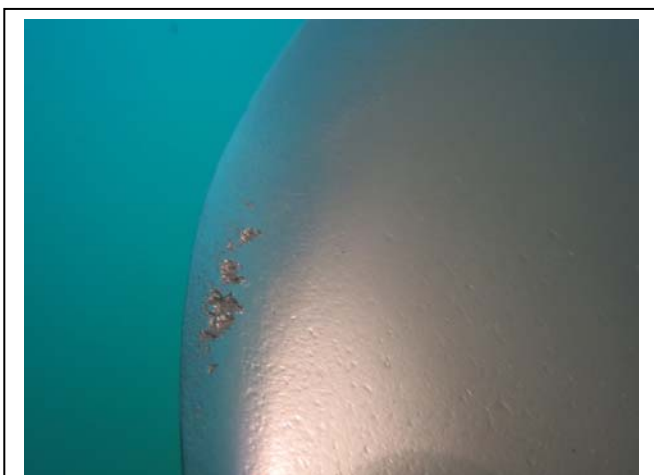
Blade A: Cavitation on .9 radius 2.5 inches in length. Surfaces around the cavitation damage appeared to still have intact coating.

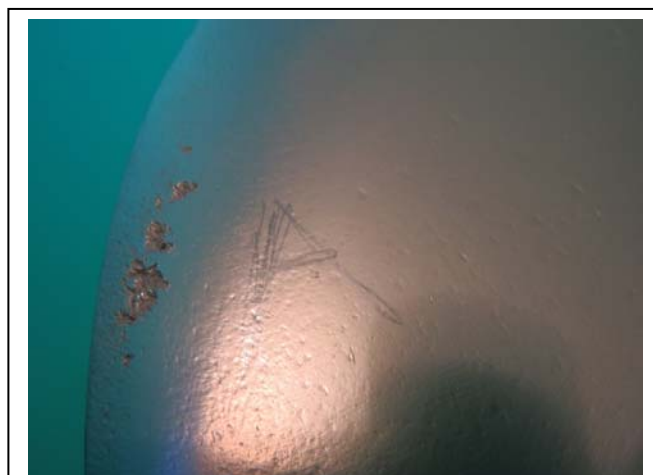
Blade A: Cavitation on .9 radius 2.5 inches in length. Surfaces around the cavitation damage appeared to still have intact coating.

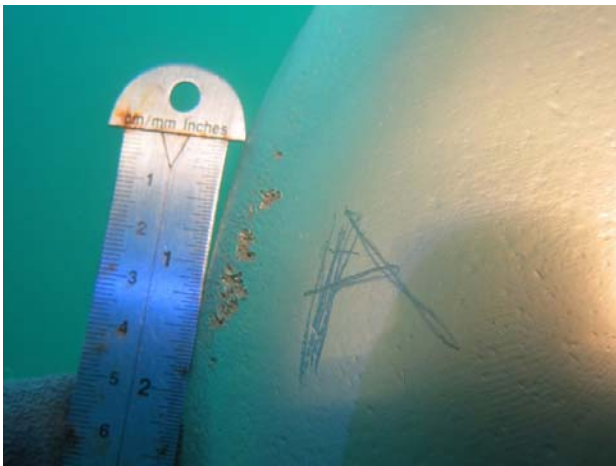
Blade A: Cavitation on .9 radius 2.5 inches in length. Surfaces around the cavitation damage appeared to still have intact coating.

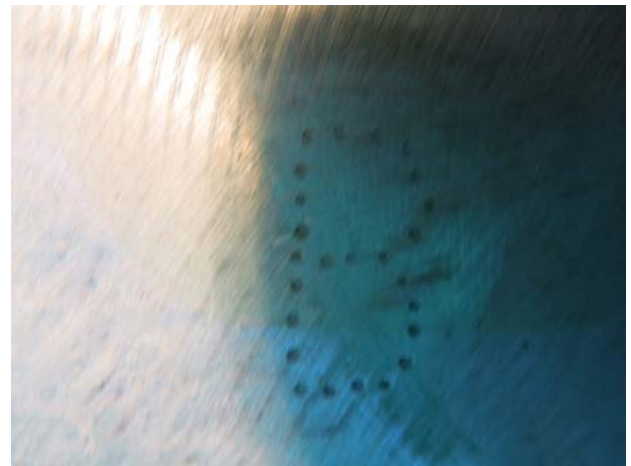
Blade B: fouled with light slime on leading and trailing edge. Tube worms were observed on the pressure face and suction back. Coating in good condition overall.

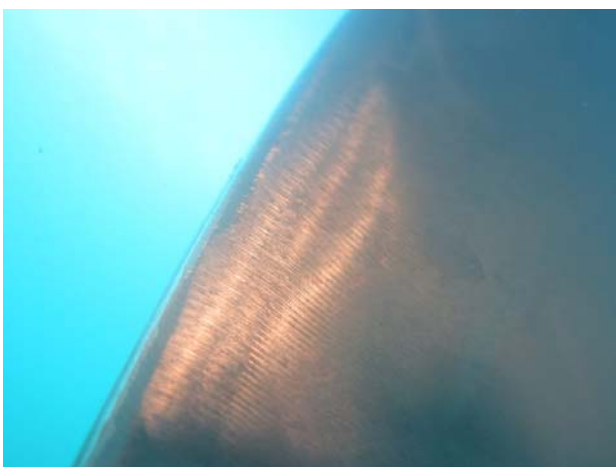
Blade B: fouled with light slime on leading and trailing edge. Tube worms were observed on the pressure face and suction back. Coating in good condition overall.

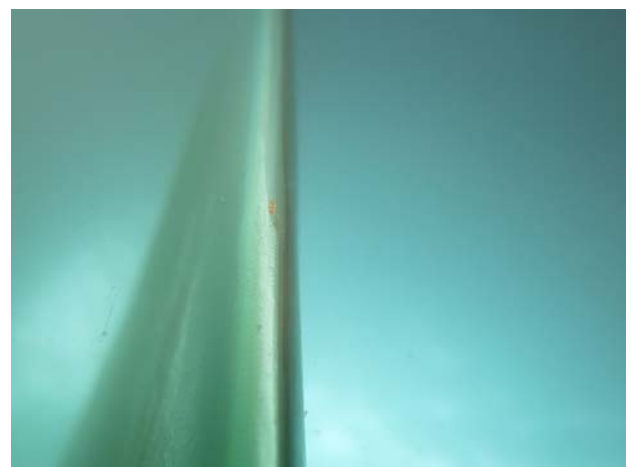
Blade B: fouled with light slime on leading and trailing edge. Tube worms were observed on the pressure face and suction back. Coating in good condition overall.

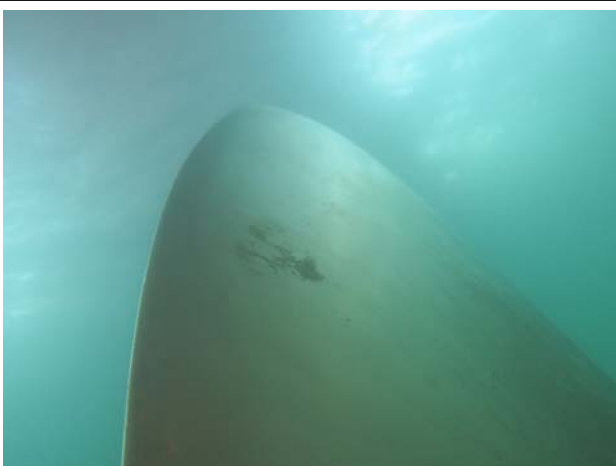
Blade B: fouled with light slime on leading and trailing edge. Tube worms were observed on the pressure face and suction back. Coating in good condition overall.

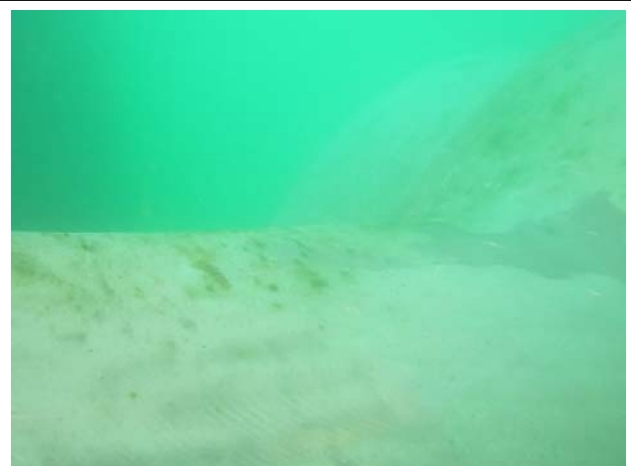
Blade B: fouled with light slime on leading and trailing edge. Tube worms were observed on the pressure face and suction back. Coating in good condition overall.

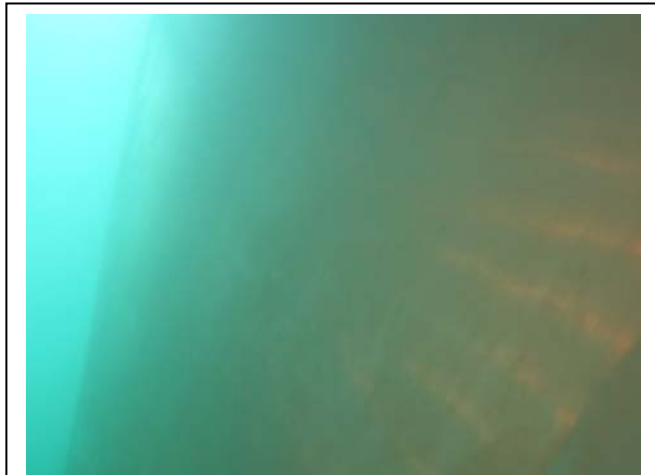
Blade B: fouled with light slime on leading and trailing edge. Tube worms were observed on the pressure face and suction back. Coating in good condition overall.

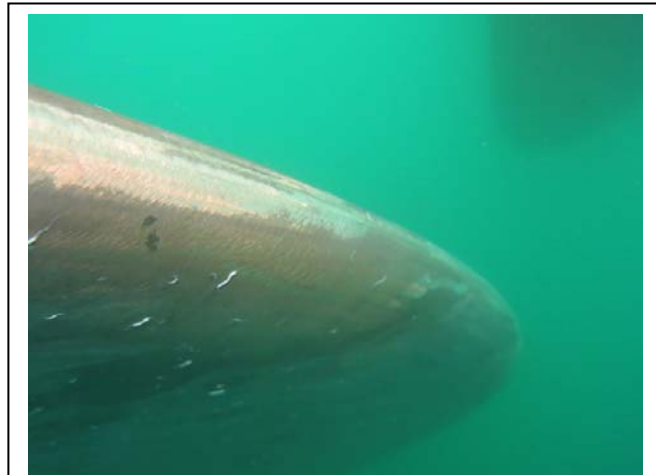
Blade B: fouled with light slime on leading and trailing edge. Tube worms were observed on the pressure face and suction back. Coating in good condition overall.

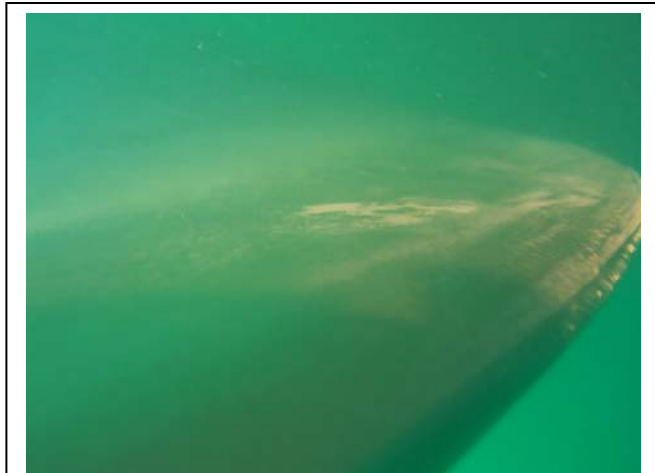
Blade B: fouled with light slime on leading and trailing edge. Tube worms were observed on the pressure face and suction back. Coating in good condition overall.

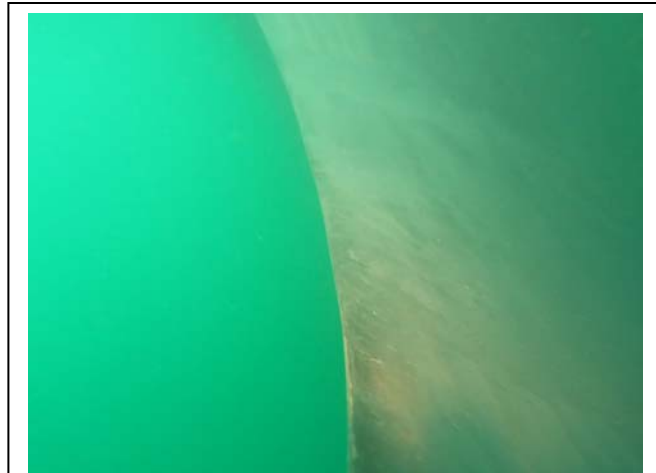
Blade B: fouled with light slime on leading and trailing edge. Tube worms were observed on the pressure face and suction back. Coating in good condition overall.

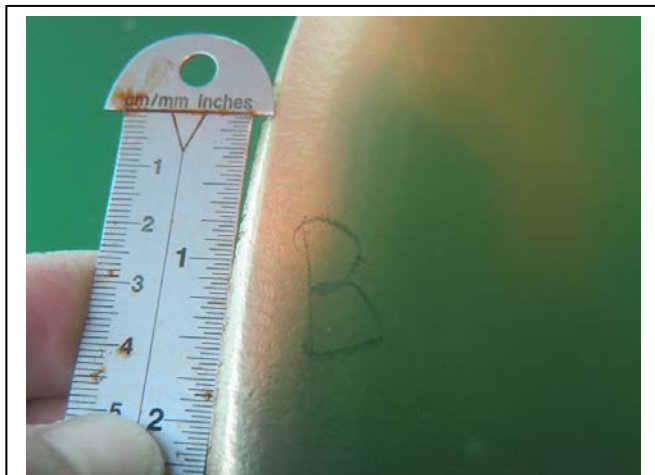
Blade B: Cavitation at the .9 radius, 2 inches in length. Surfaces around the cavitation damage appeared to still have intact coating.

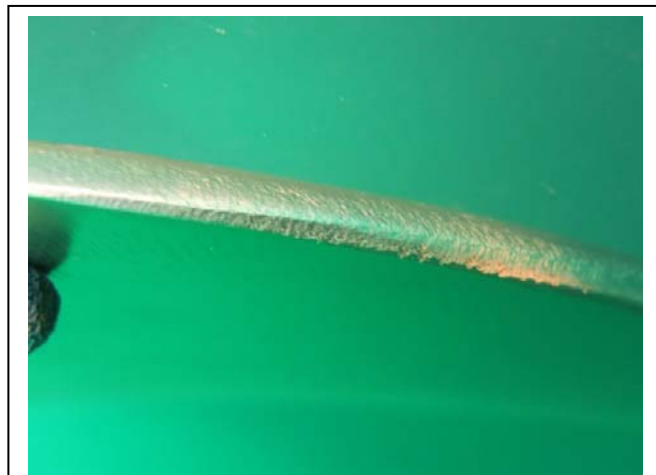
Blade B: Cavitation at the .9 radius, 2 inches in length. Surfaces around the cavitation damage appeared to still have intact coating.

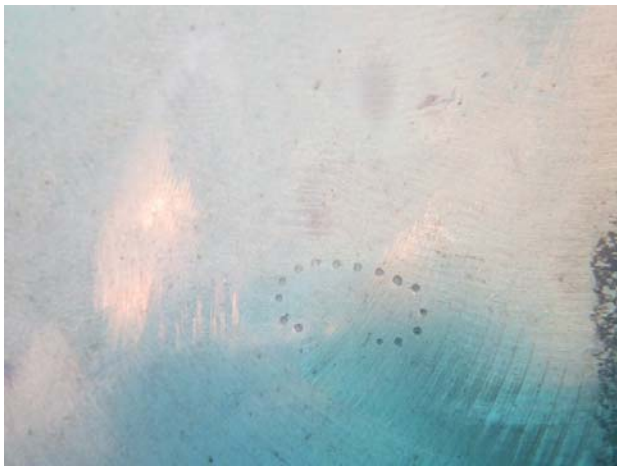
Blade C: fouled with light slime on leading and trailing edge. Tube worms were observed on the pressure face and suction back. Coating in good condition overall.

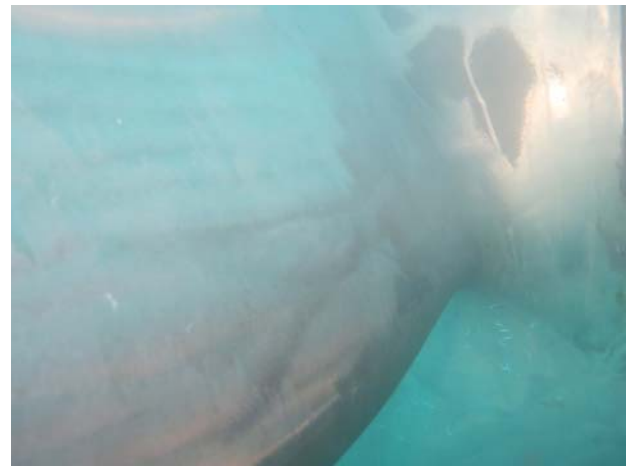
Blade C: fouled with light slime on leading and trailing edge. Tube worms were observed on the pressure face and suction back. Coating in good condition overall.

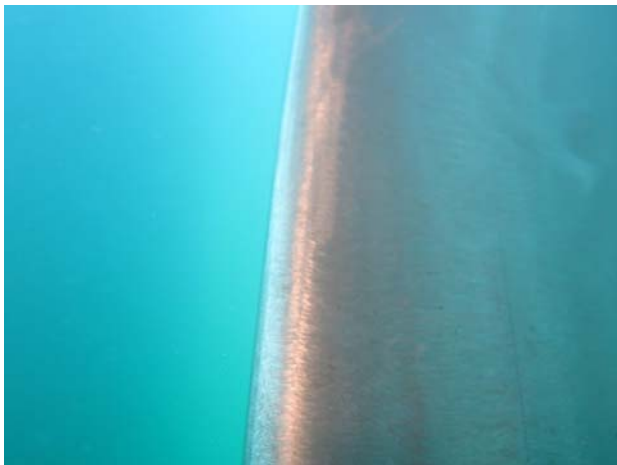
Blade C: fouled with light slime on leading and trailing edge. Tube worms were observed on the pressure face and suction back. Coating in good condition overall.

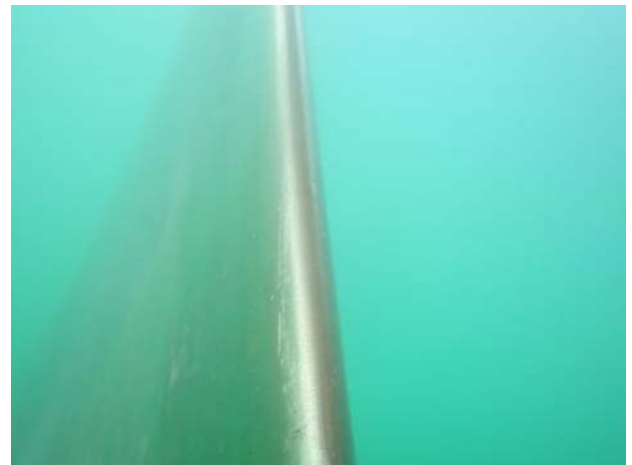
Blade C: fouled with light slime on leading and trailing edge. Tube worms were observed on the pressure face and suction back. Coating in good condition overall.

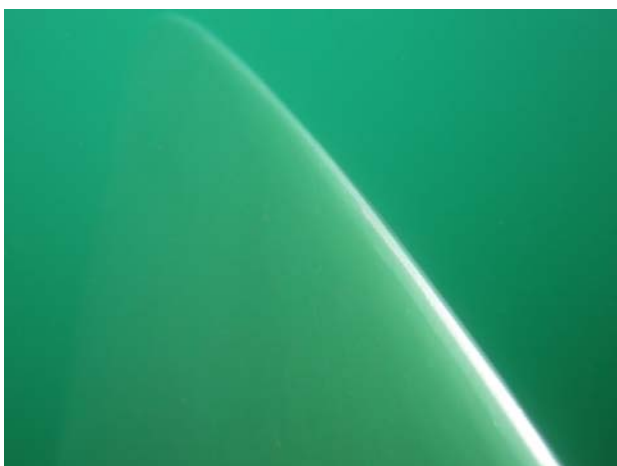
Blade C: fouled with light slime on leading and trailing edge. Tube worms were observed on the pressure face and suction back. Coating in good condition overall.

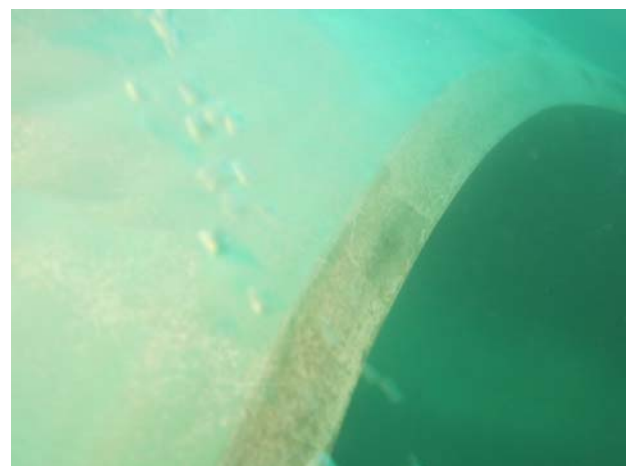
Blade C: fouled with light slime on leading and trailing edge. Tube worms were observed on the pressure face and suction back. Coating in good condition overall.

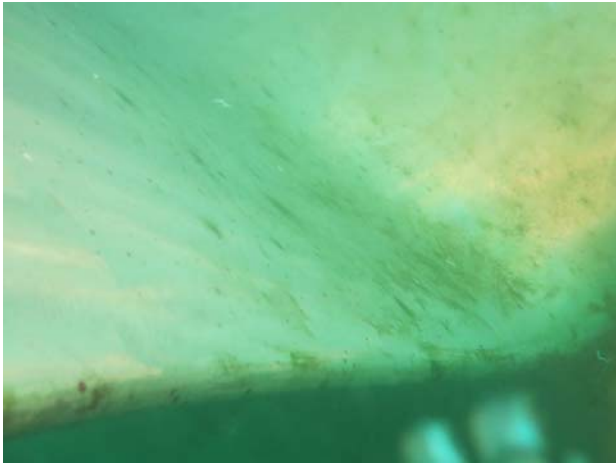
Blade C: fouled with light slime on leading and trailing edge. Tube worms were observed on the pressure face and suction back. Coating in good condition overall.

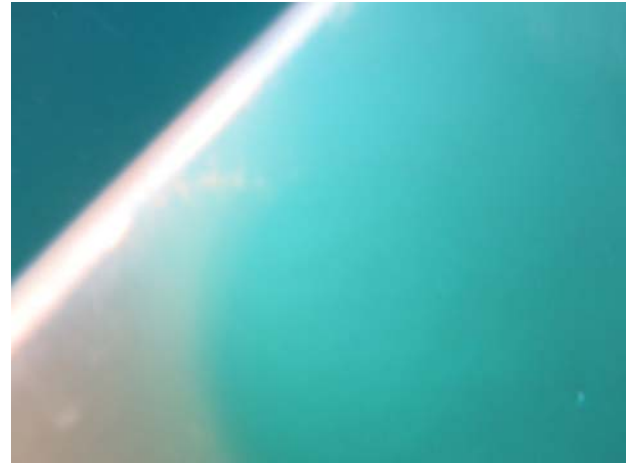
Blade C: fouled with light slime on leading and trailing edge. Tube worms were observed on the pressure face and suction back. Coating in good condition overall.

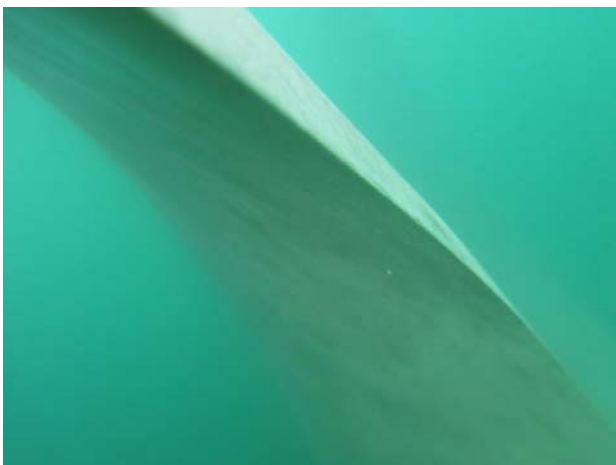
Blade C: fouled with light slime on leading and trailing edge. Tube worms were observed on the pressure face and suction back. Coating in good condition overall.

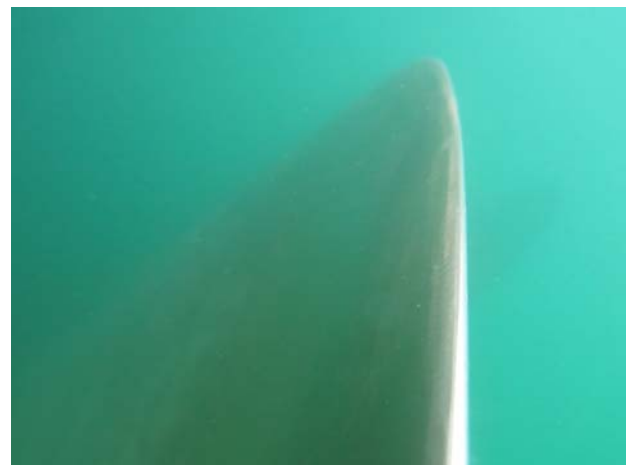
Blade C: fouled with light slime on leading and trailing edge. Tube worms were observed on the pressure face and suction back. Coating in good condition overall.

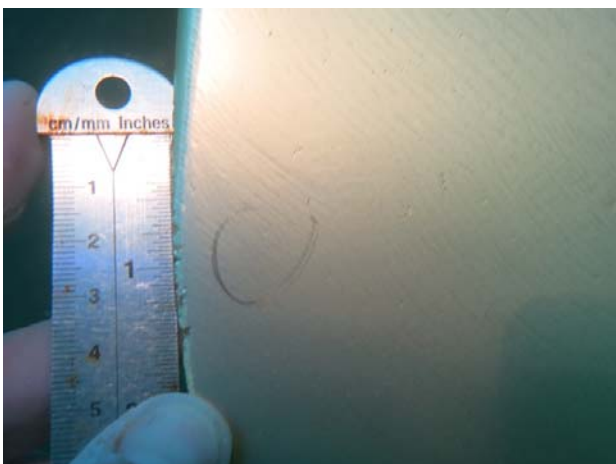
Blade C: Cavitation at the .9 radius, 1.5 inches in length. Surfaces around the cavitation damage appeared to still have intact coating.

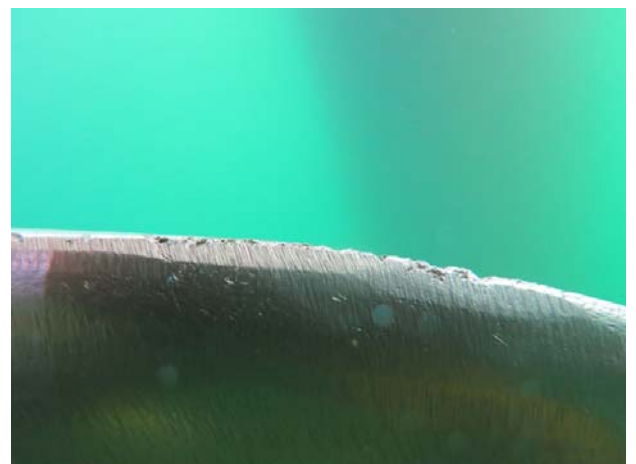
Blade C: Cavitation at the .9 radius, 1.5 inches in length. Surfaces around the cavitation damage appeared to still have intact coating.

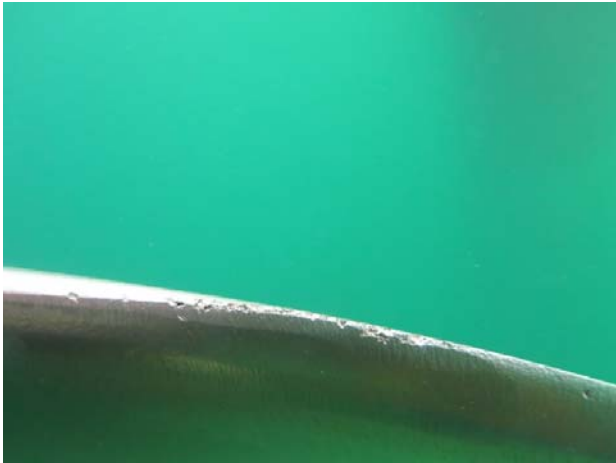
Blade C: Cavitation at the .9 radius, 1.5 inches in length. Surfaces around the cavitation damage appeared to still have intact coating.

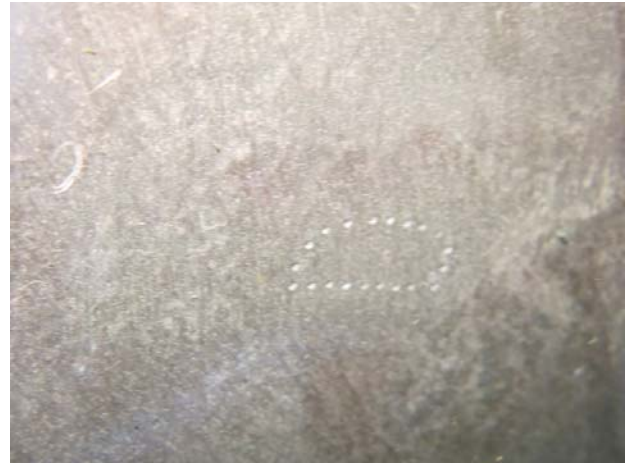
Blade D: fouled with light slime on leading and trailing edge. Tube worms were observed on the pressure face and suction back. Coating in good condition overall.

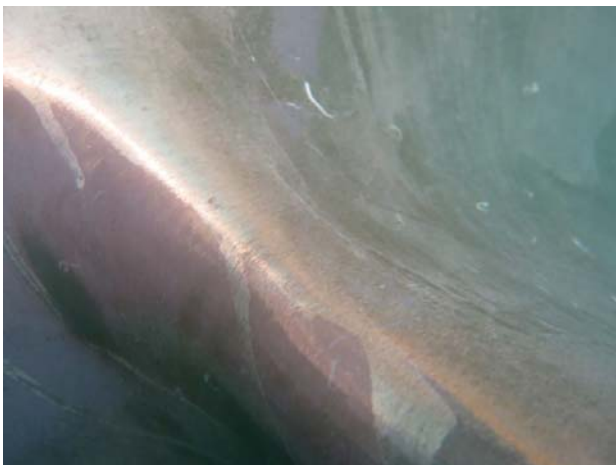
Blade D: fouled with light slime on leading and trailing edge. Tube worms were observed on the pressure face and suction back. Coating in good condition overall.

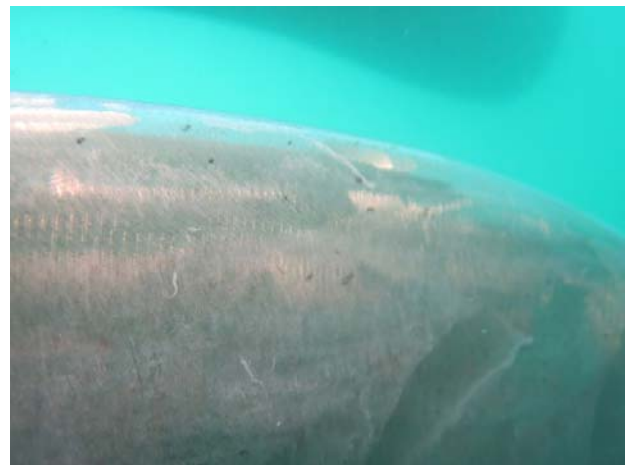
Blade D: fouled with light slime on leading and trailing edge. Tube worms were observed on the pressure face and suction back. Coating in good condition overall.

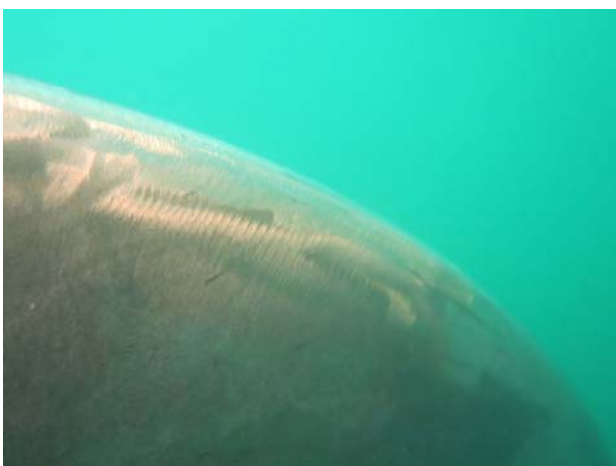
Blade D: fouled with light slime on leading and trailing edge. Tube worms were observed on the pressure face and suction back. Coating in good condition overall.

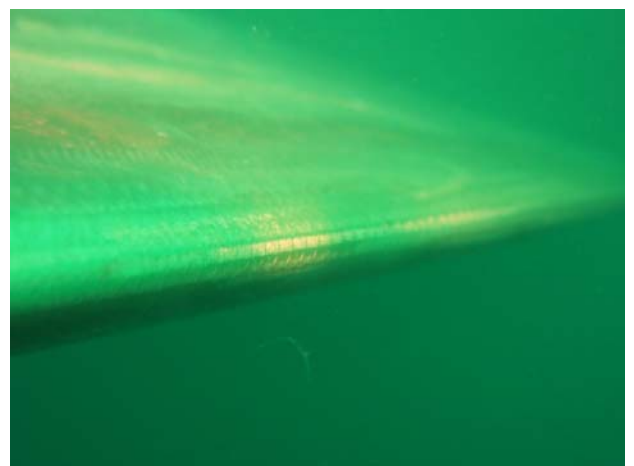
Blade D: fouled with light slime on leading and trailing edge. Tube worms were observed on the pressure face and suction back. Coating in good condition overall.

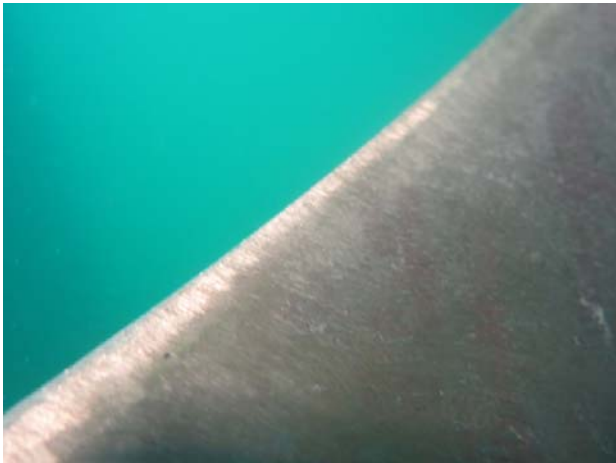
Blade D: fouled with light slime on leading and trailing edge. Tube worms were observed on the pressure face and suction back. Coating in good condition overall.

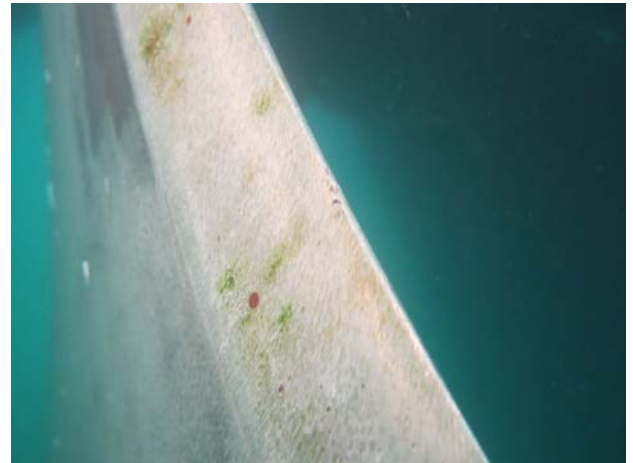
Blade D: fouled with light slime on leading and trailing edge. Tube worms were observed on the pressure face and suction back. Coating in good condition overall.

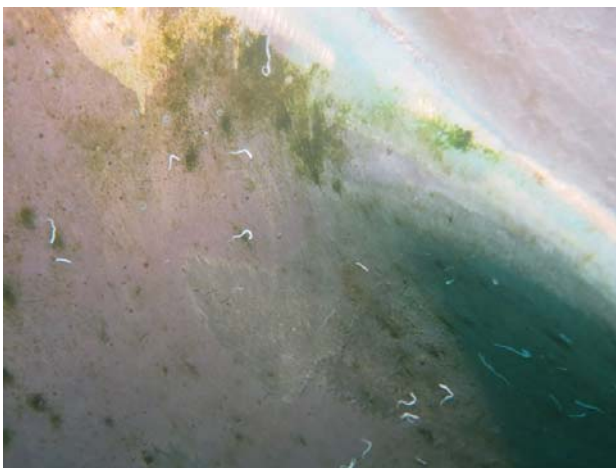
Blade D: fouled with light slime on leading and trailing edge. Tube worms were observed on the pressure face and suction back. Coating in good condition overall.

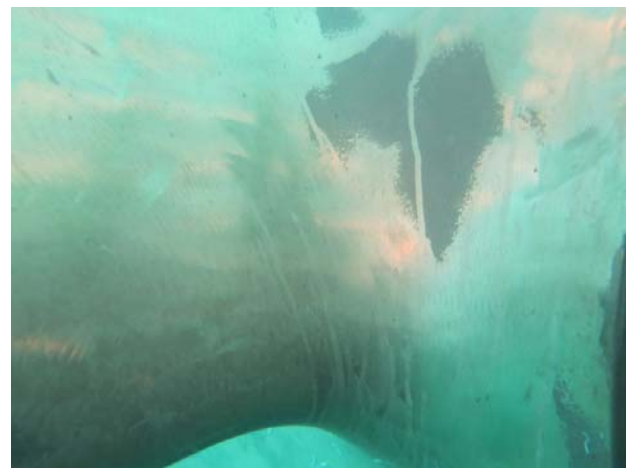
Blade D: fouled with light slime on leading and trailing edge. Tube worms were observed on the pressure face and suction back. Coating in good condition overall.

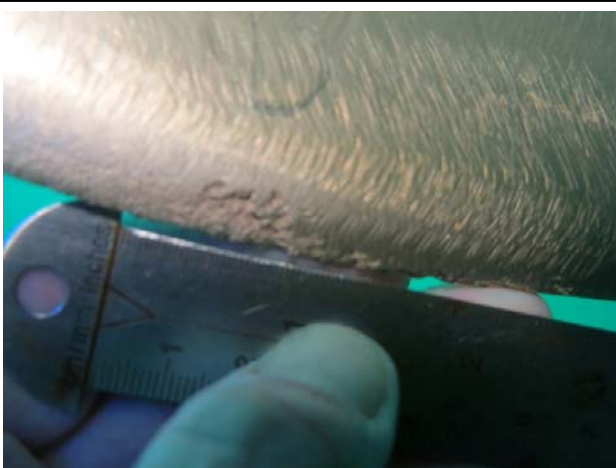
Blade D: Cavitation at the .9 radius, 2 inches in length. Surfaces around the cavitation damage appeared to still have intact coating.

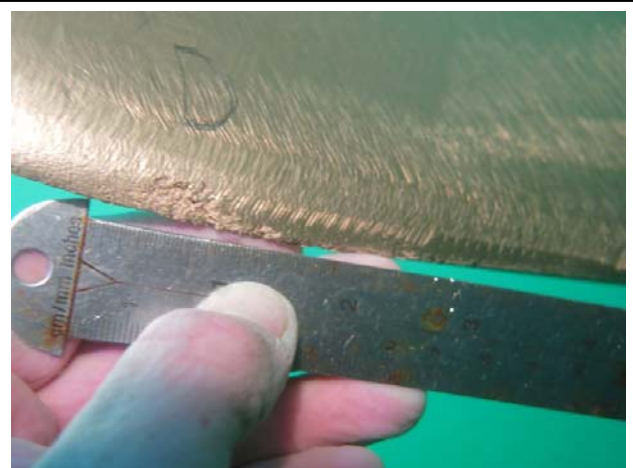
Blade D: Cavitation at the .9 radius, 2 inches in length. Surfaces around the cavitation damage appeared to still have intact coating.

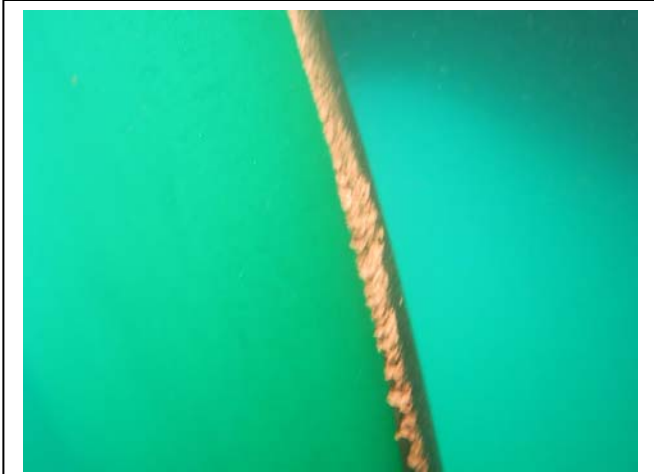
Blade D: Cavitation at the .9 radius, 2 inches in length. Surfaces around the cavitation damage appeared to still have intact coating.

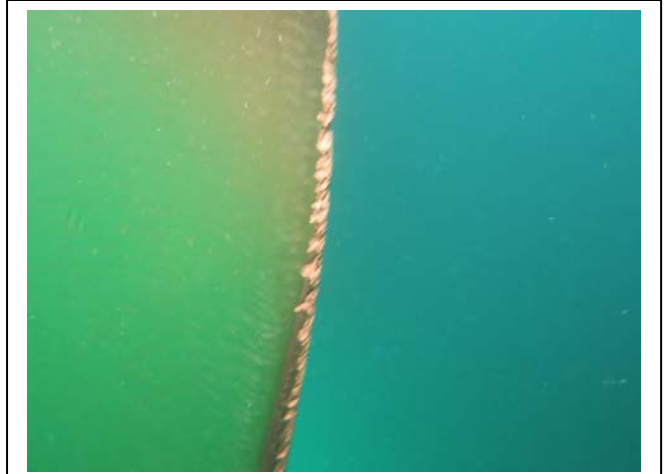
Blade D: Cavitation at the .9 radius, 2 inches in length. Surfaces around the cavitation damage appeared to still have intact coating.

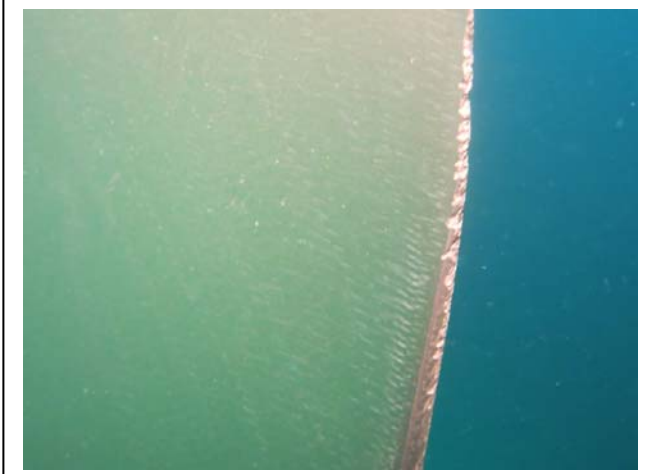
Blade D: Cavitation at the .9 radius, 2 inches in length. Surfaces around the cavitation damage appeared to still have intact coating.

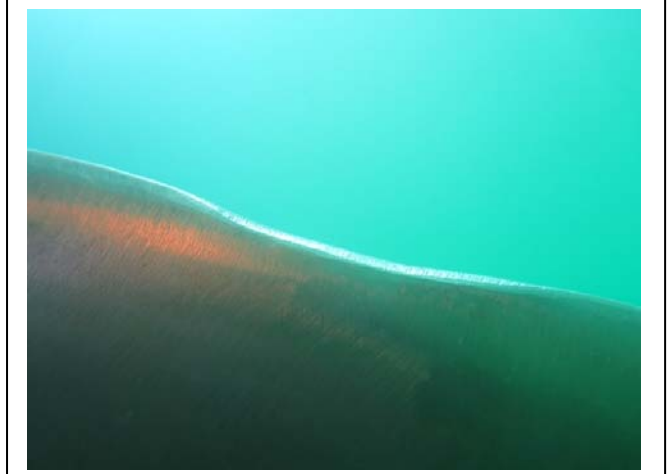
Blade D: A previous grinding repair was observed was still holding.

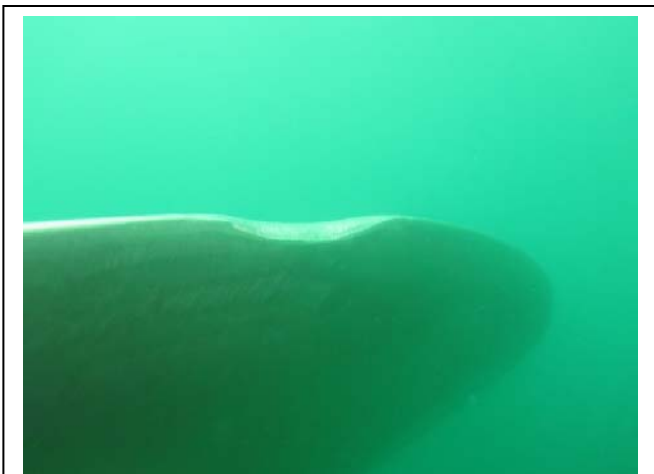
Blade D: A previous grinding repair was observed was still holding.

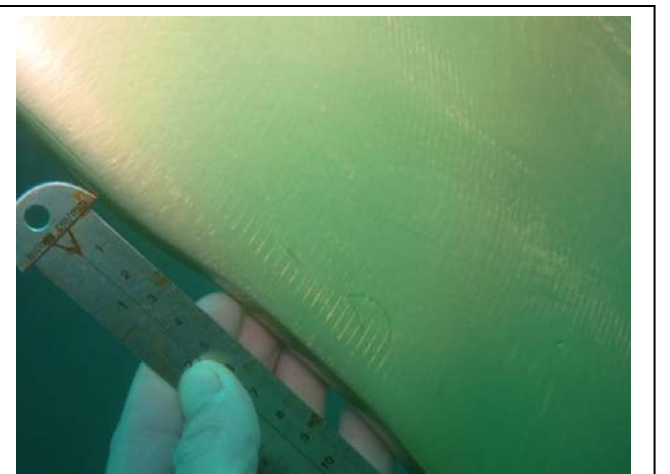
Blade D: A previous grinding repair was observed was still holding.

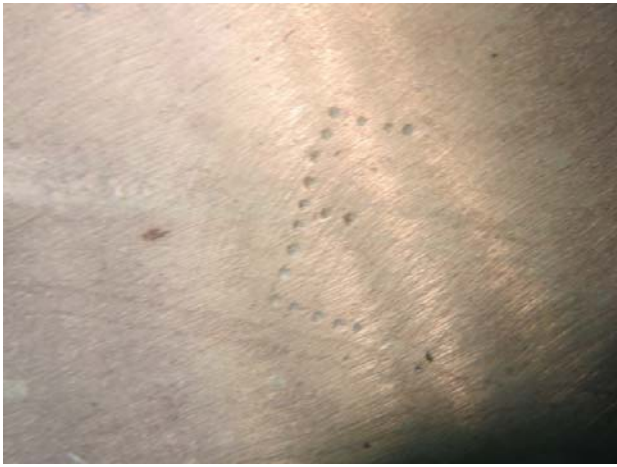
Blade E: fouled with light slime on leading and trailing edge. Tube worms were observed on the pressure face and suction back. Coating in good condition overall.

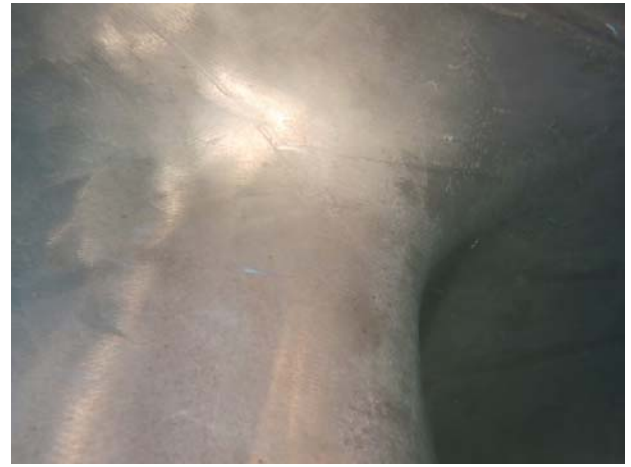
Blade E: fouled with light slime on leading and trailing edge. Tube worms were observed on the pressure face and suction back. Coating in good condition overall.

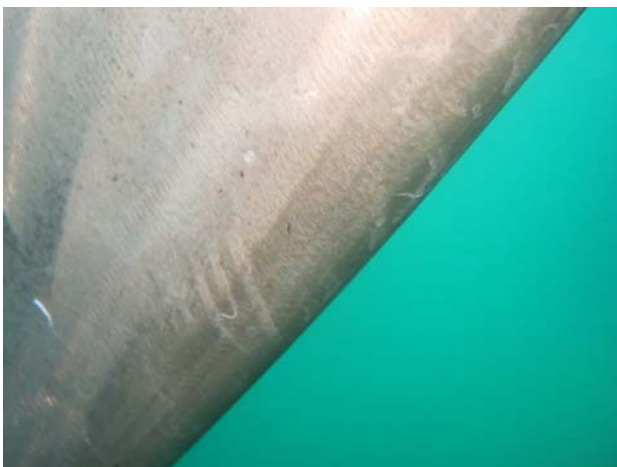
Blade E: fouled with light slime on leading and trailing edge. Tube worms were observed on the pressure face and suction back. Coating in good condition overall.

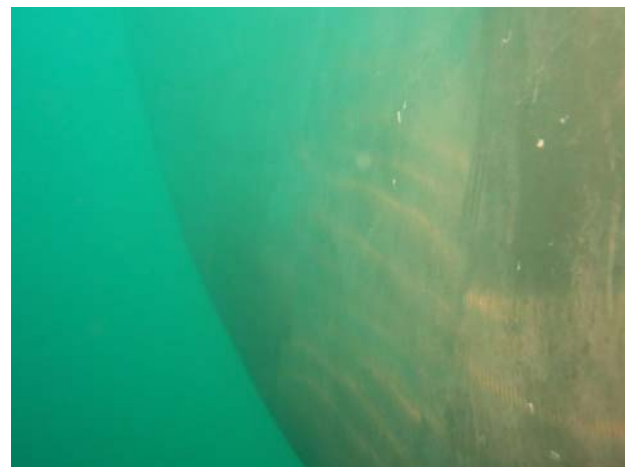
Blade E: fouled with light slime on leading and trailing edge. Tube worms were observed on the pressure face and suction back. Coating in good condition overall.

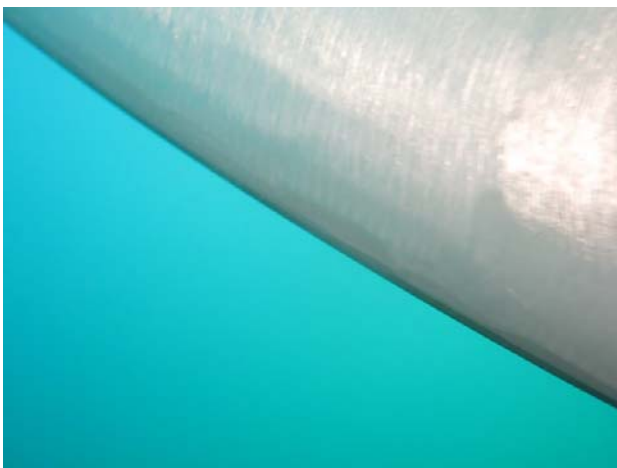
Blade E: fouled with light slime on leading and trailing edge. Tube worms were observed on the pressure face and suction back. Coating in good condition overall.

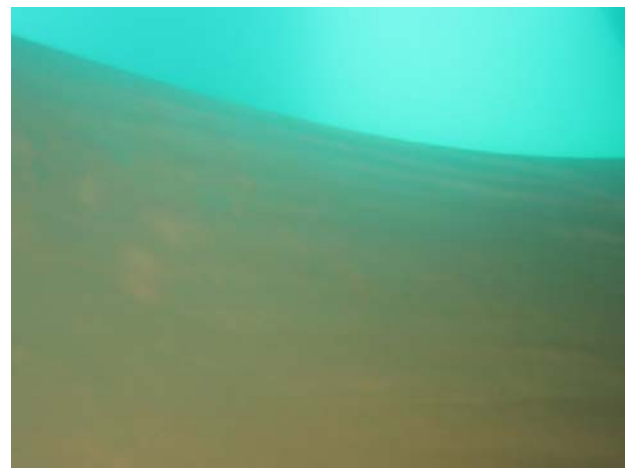
Blade E: fouled with light slime on leading and trailing edge. Tube worms were observed on the pressure face and suction back. Coating in good condition overall.

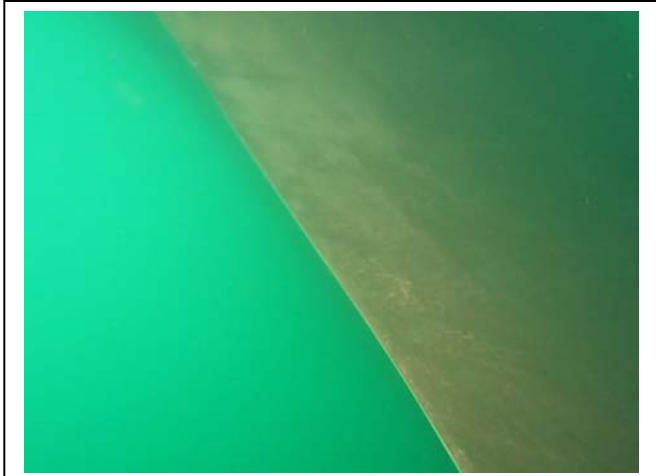
Blade E: fouled with light slime on leading and trailing edge. Tube worms were observed on the pressure face and suction back. Coating in good condition overall.

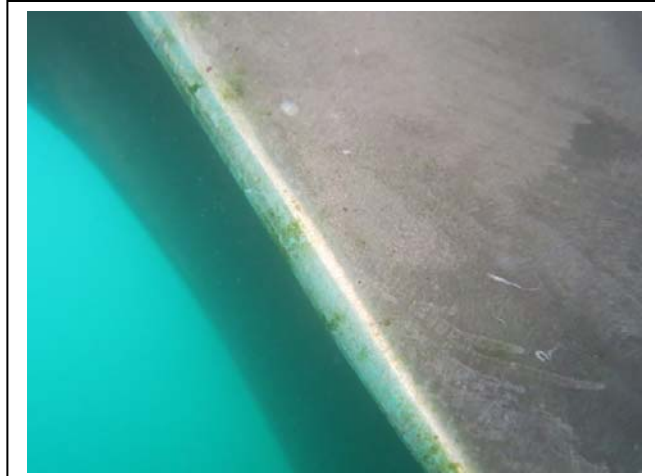
Blade E: fouled with light slime on leading and trailing edge. Tube worms were observed on the pressure face and suction back. Coating in good condition overall.

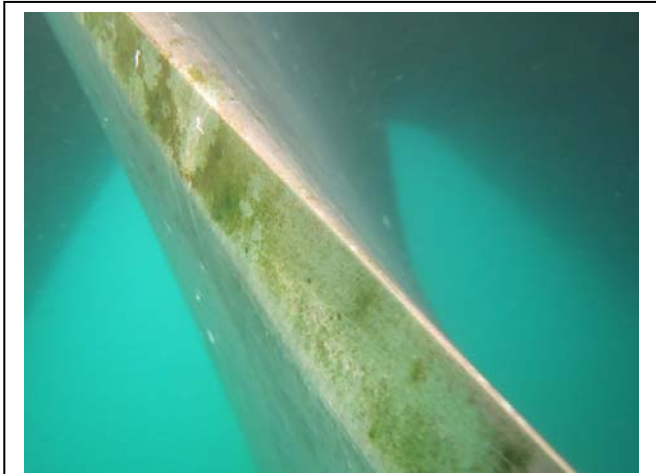
Blade E: fouled with light slime on leading and trailing edge. Tube worms were observed on the pressure face and suction back. Coating in good condition overall.
