“Maunawili”

Underwater Propeller Inspection

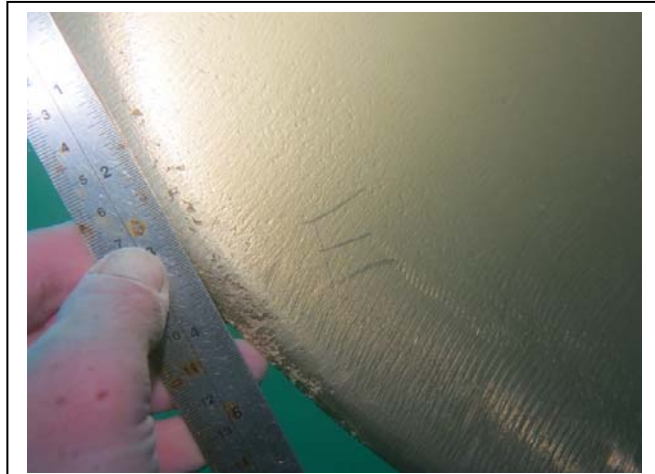
Blade E: Cavitation at the .9 radius, 4 inches in length. Surfaces around the cavitation damage appeared to still have intact coating.

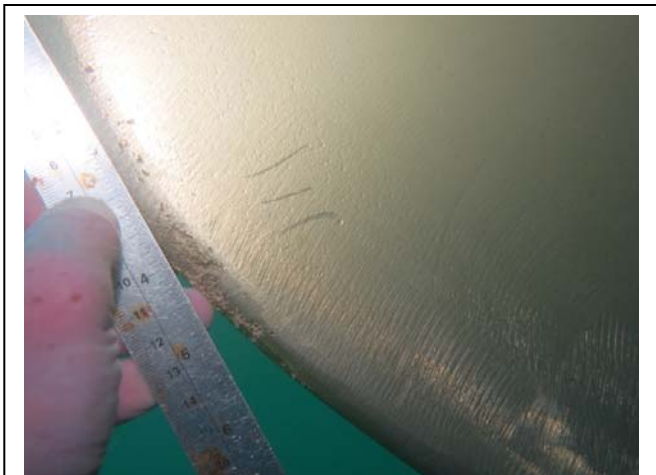
Blade E: Cavitation at the .9 radius, 4 inches in length. Surfaces around the cavitation damage appeared to still have intact coating.

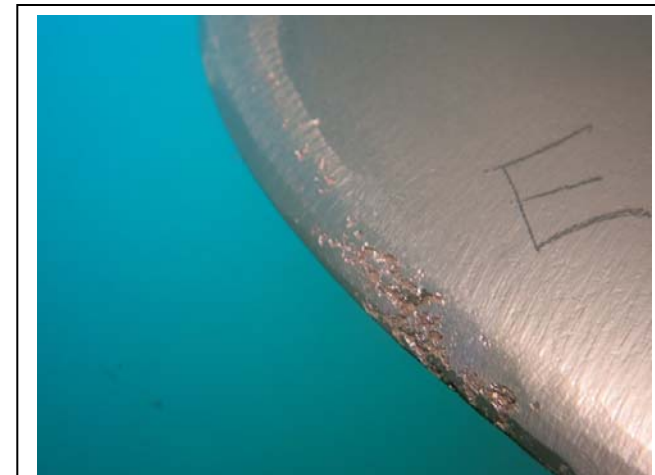
Blade E: Cavitation at the .9 radius, 4 inches in length. Surfaces around the cavitation damage appeared to still have intact coating.

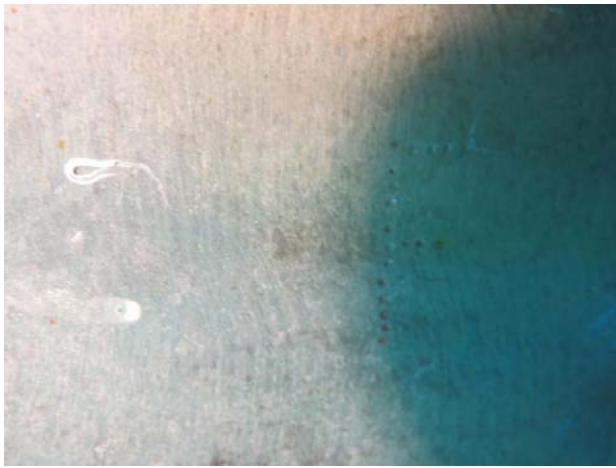
Blade F: fouled with light slime on leading and trailing edge. Tube worms were observed on the pressure face and suction back. Coating in good condition overall.

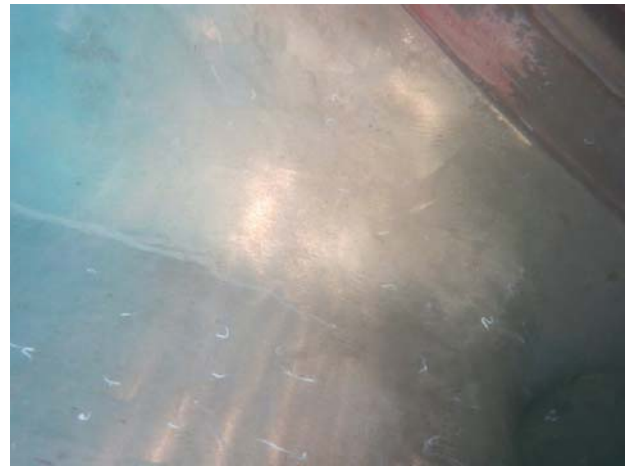
Blade F: fouled with light slime on leading and trailing edge. Tube worms were observed on the pressure face and suction back. Coating in good condition overall.

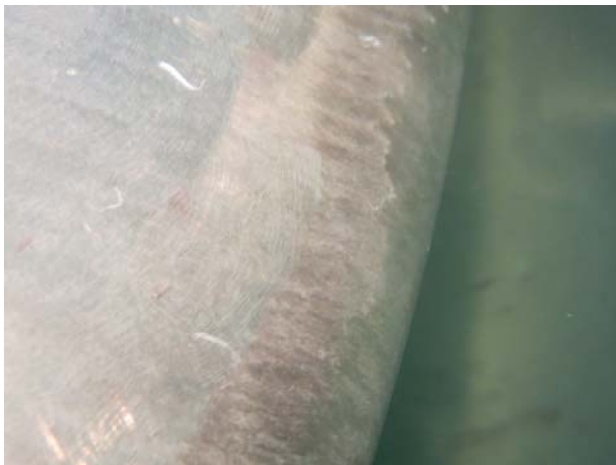
Blade F: fouled with light slime on leading and trailing edge. Tube worms were observed on the pressure face and suction back. Coating in good condition overall.

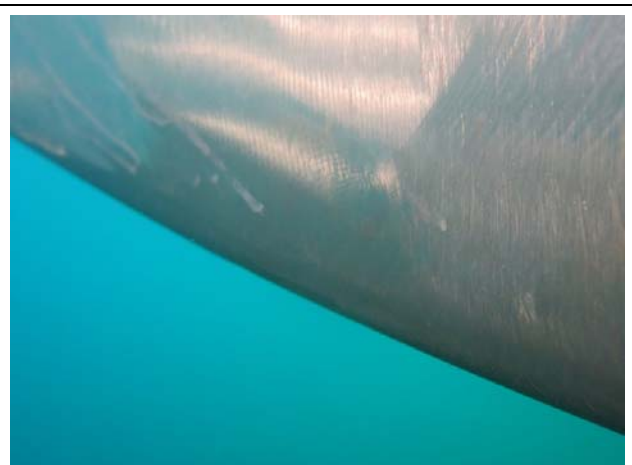
Blade F: fouled with light slime on leading and trailing edge. Tube worms were observed on the pressure face and suction back. Coating in good condition overall.

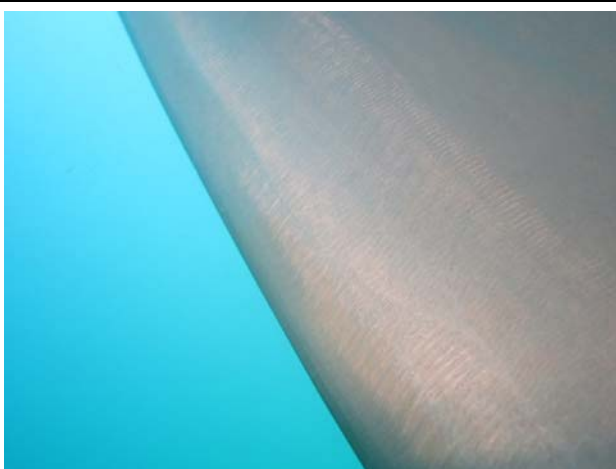
Blade F: fouled with light slime on leading and trailing edge. Tube worms were observed on the pressure face and suction back. Coating in good condition overall.

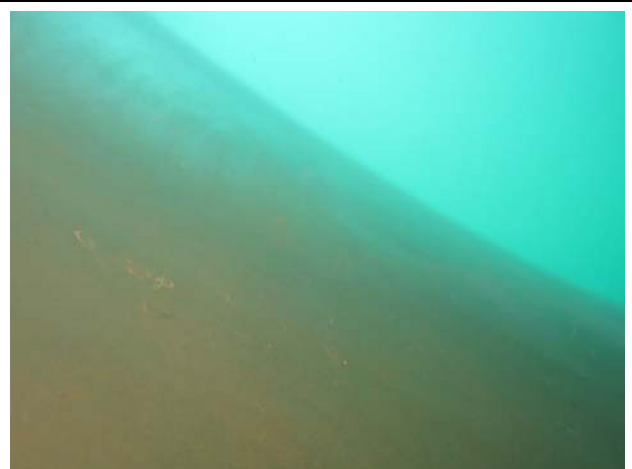
Blade F: fouled with light slime on leading and trailing edge. Tube worms were observed on the pressure face and suction back. Coating in good condition overall.

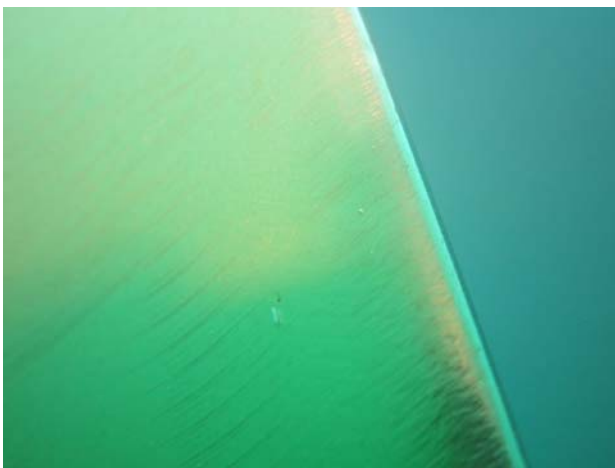
Blade F: fouled with light slime on leading and trailing edge. Tube worms were observed on the pressure face and suction back. Coating in good condition overall.

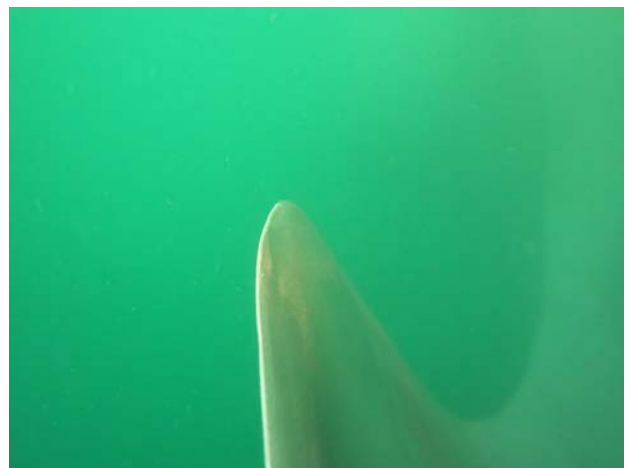
Blade F: fouled with light slime on leading and trailing edge. Tube worms were observed on the pressure face and suction back. Coating in good condition overall.

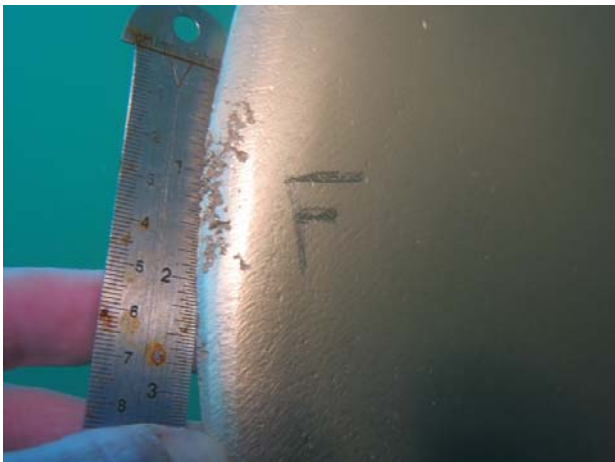
Blade F: Cavitation at the .9 radius, 3.5 inches in length.
