**Photos from the Santa Cruz Harbor Field Tour for the MIACC Meeting on May 30, 2019:
Treated Wood and Alternative Materials Used in Overwater and Waterfront Structures**

Michael Sandecki, Coastal Water Quality Program, California Coastal Commission

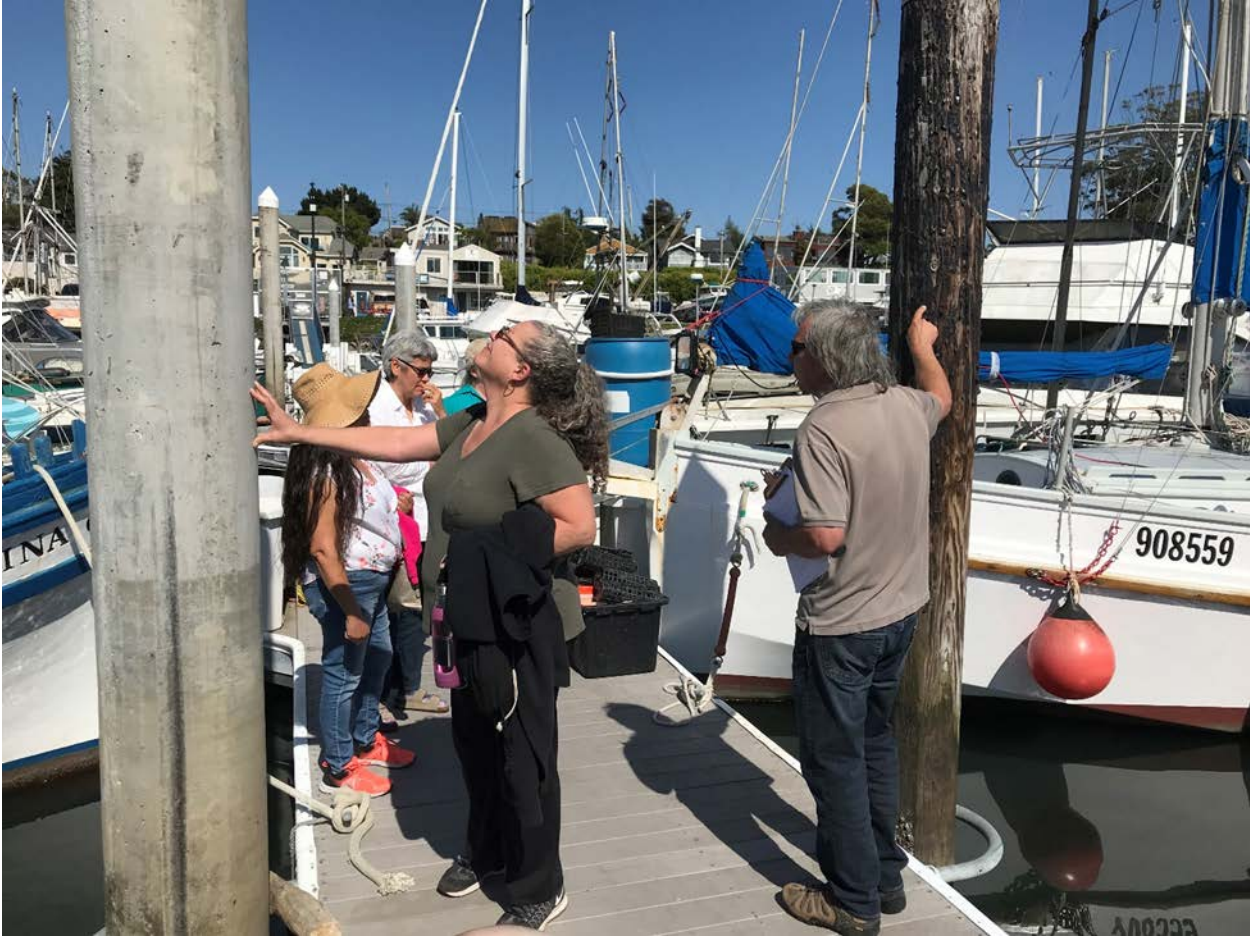
Photo 3: Several generations of piles are apparent in the harbor. The piles associated with the floating docks and other over-water structures were initially creosote-treated Douglas fir, seen on the right.

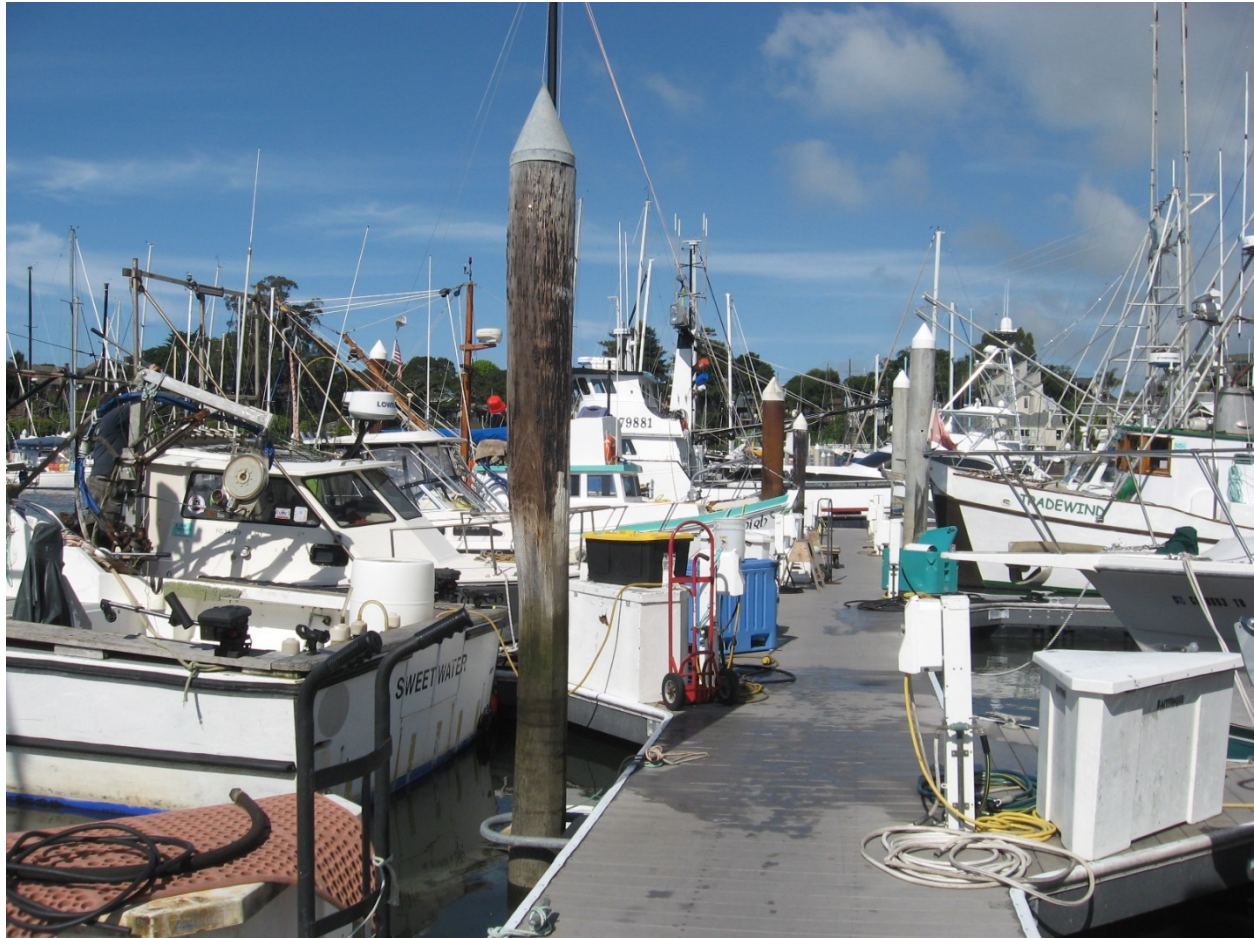
Photo 4: In the late 1980s and early 1990s, steel piles were used to replace many deteriorated wood piles. In 2011, a tsunami occurred that caused a great deal of damage; 205 spun-concrete piles were used to replace tsunami-damaged piles throughout the harbor. Most recently, 65 solid pre-cast concrete piles were used to replace damaged or deteriorated piles in 2016. Finally, 80 steel piles with HDPE sleeves are planned to be installed in 2019. These will replace additional damaged or deteriorated piles.

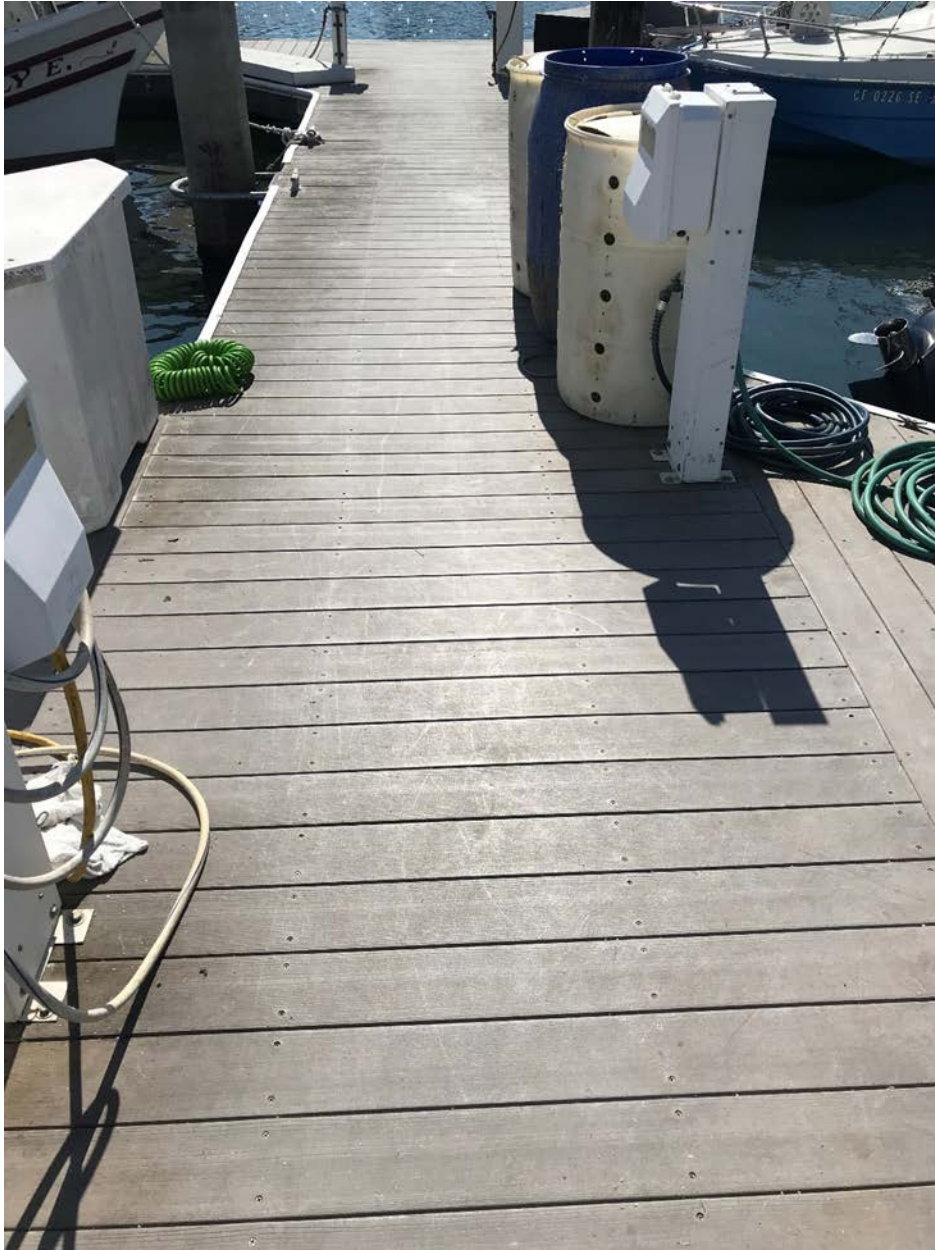
Photo 5: The deck material now used for the floating docks in both the upper and lower harbor is mostly a composite of wood and plastic material that was developed in the early 1990s. This material was originally susceptible to rot and UV-exposure, but has been improved over time.

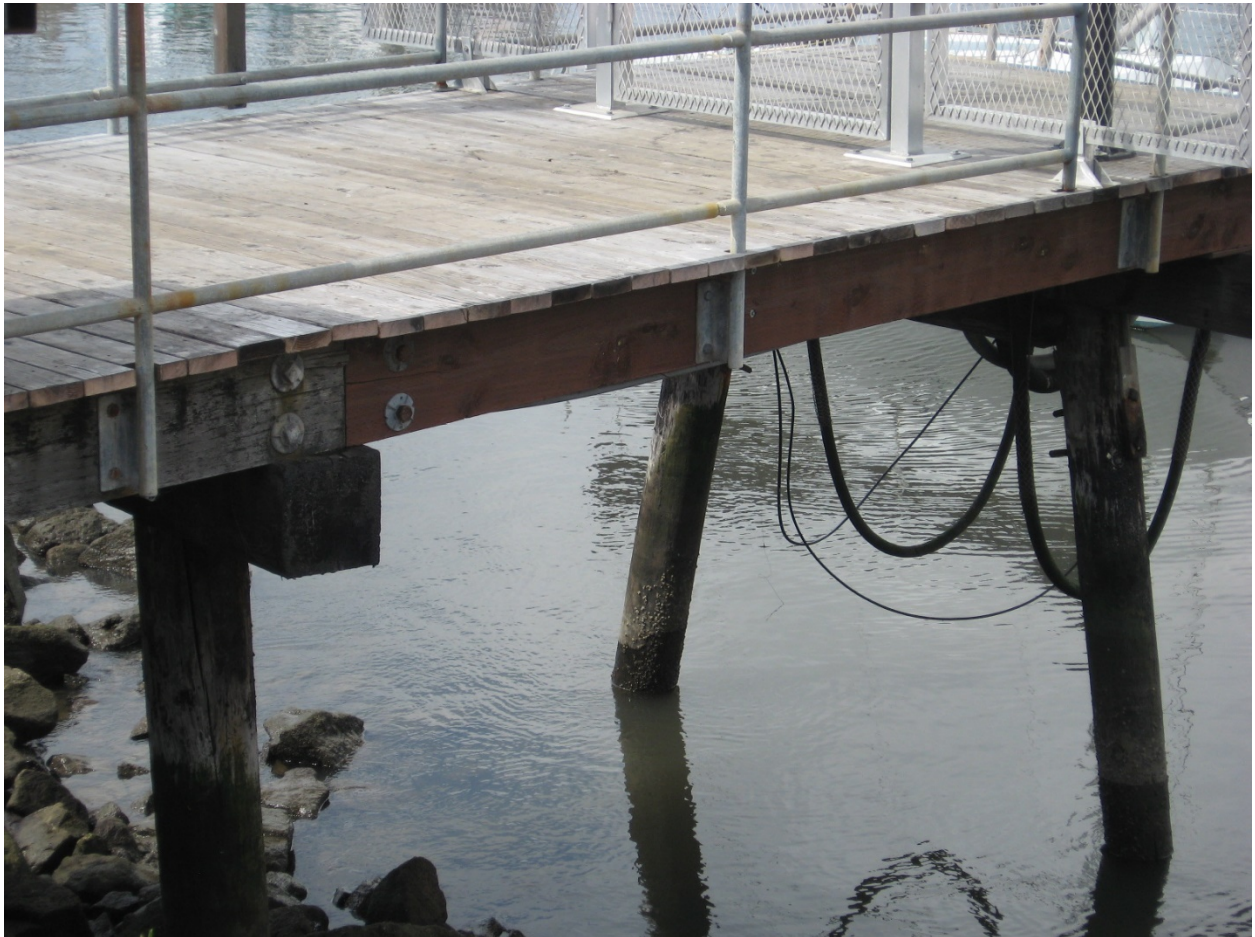
Photo 6: Decking and structural timber used for overwater structures other than the floating docks are still comprised of wood, and wood is also used to replace deteriorated materials. ACQ-treated lumber was used to rebuild this dock's structural members. Piles are creosote-treated lumber from 1963.

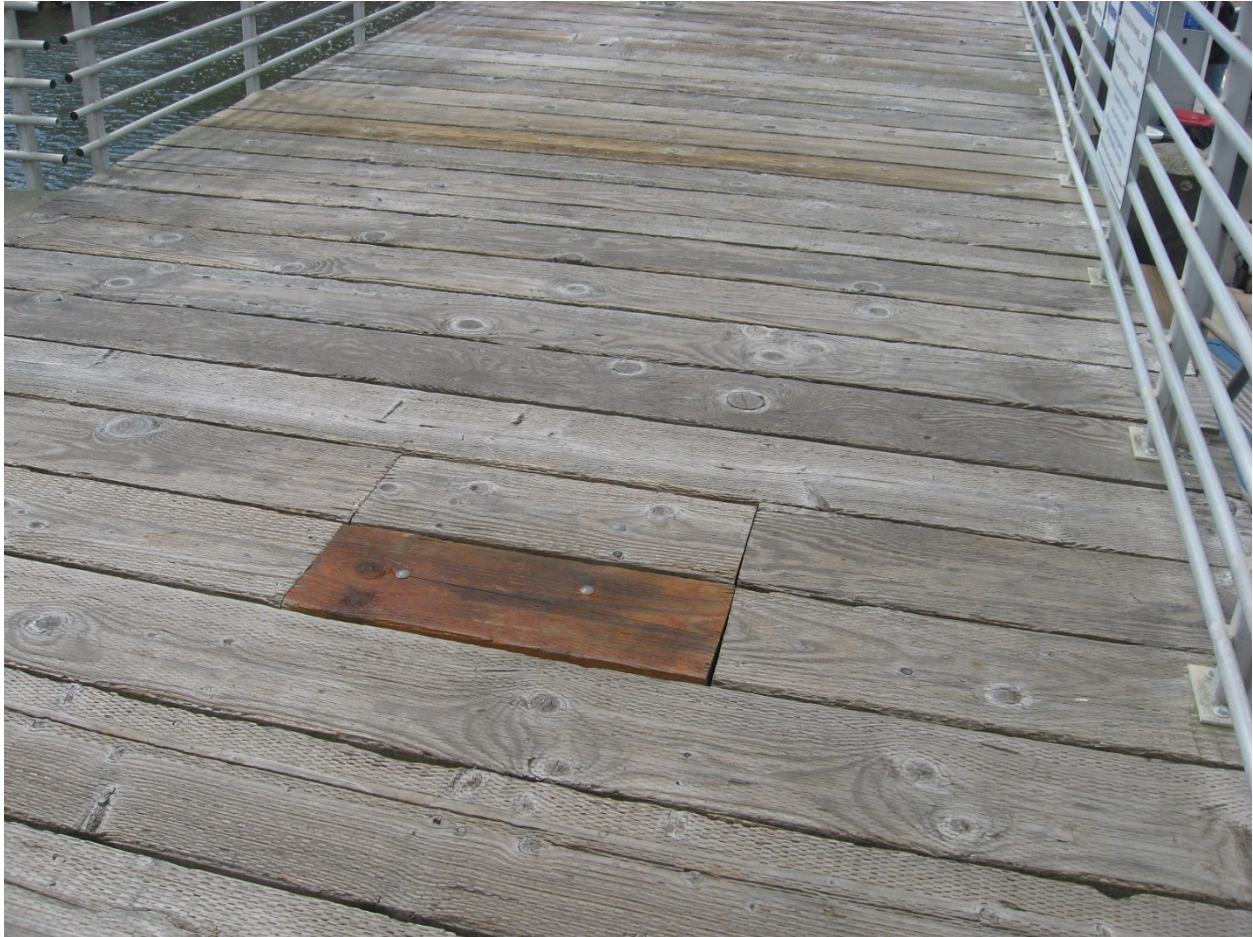
Photo 7: A variety of copper-treated Douglas fir boards were used to patch this deck. Also, non-treated Douglas fir is currently used for patching decking at the harbor. Treated wood is recognizable by the incisions made in the board's surfaces, which allows greater penetration of the preservatives, and greater protection of the wood. Preservative-treated wood may also have a greenish hue owing to the oxidation of the copper.
