**STAFF REPORT: REGULAR CALENDAR**

**APPLICATION NUMBER:** 5-00-316

**PROJECT LOCATION:** Immediately seaward of the Hyperion Treatment Plant,  
12000 Vista del Mar, Playa del Rey, Los Angeles County

**PROJECT DESCRIPTION:** Repair two existing sewage outfalls: (1) re-ballast (replace anchoring stone under) approximate 2,200 lineal feet of existing five-mile outfall; (2) fill voids caused by undercutting and scouring of concrete-encased nearshore pipe section of the existing one-mile outfall, (3) inspect chip on offshore bell of five-mile outfall; repair if necessary 4) repair spalls on nearshore bells of five-mile outfall (use epoxy and grout to fill holes left by chips). Total fill: 1,400 cubic yards of 16-inch rock, 9,180 cubic yards of 12-inch rock and 450 cubic yards of 2-inch rock (replacing rock fill cover on approximately 126,000 sq. feet or 2.9 acres of ocean bottom.)

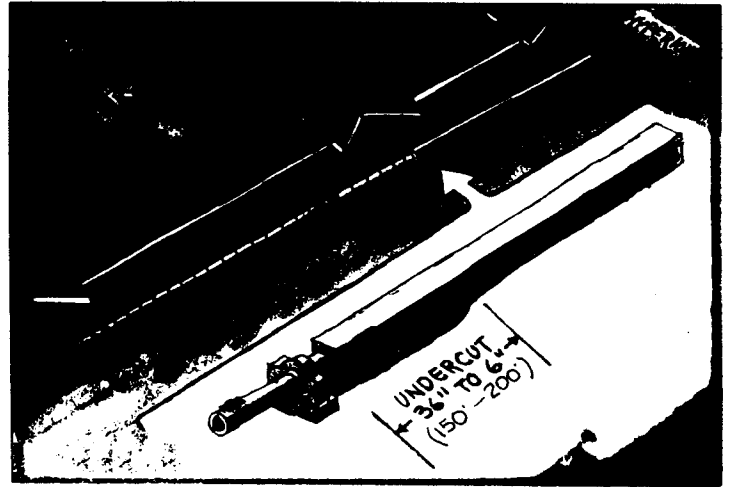
Addendum Figure 2

The scour under the encasement potentially reduces the vertical stability of the pipeline by encasement scour in the following ways:

- Loss of soil as a "reserve support system" in the event of pile failure.
- Reduction of vertical pile capacity as the effective embedded length of a pile, and the corresponding pile/soil friction area is reduced.
- Reduction in vertical pile capacity as a result of increased pile corrosion, possibly caused by exposure to marine growth or increased water velocities.

The piles have proven sufficient to support the structure weight and to resist wave loading in the scoured area during typical sea conditions. However, although waves can and do cause significant lateral forces on the encasement, the most critical lateral loads that the encasement may have to resist might be associated with seismic events. Should large lateral forces occur transverse to the encased pipe axis, the piles will be subjected to bending moments in the direction of their least strength, because of their orientation. Therefore, the scouring and potential reduction in lateral stability of the encasement may be critical during a severe seismic event.

The City of Los Angeles will fill the scour void beneath the encasement and protect the affected area to prevent further scouring. The void beneath the 20-ft encasement of the One-mile Outfall will be filled with 2-inch rock. The rock will be applied to the sides and under the encasement commencing from Station 20 + 86.5 (30ft depth) towards the shore until the void is packed solid with rock as shown in Drawing C-4. This will provide for solid contact to the encasement and piles.

The City of Los Angeles will place <sup>16</sup>/<sub>2</sub>-inch rock on the ocean floor along both sides of the rock-filled void and 20-ft. encasement of the One-mile outfall from Station 20 + 86.5 (30ft depth) towards the shore and fifty (50) feet beyond the nearshore end of the void as shown in Drawing C-4.

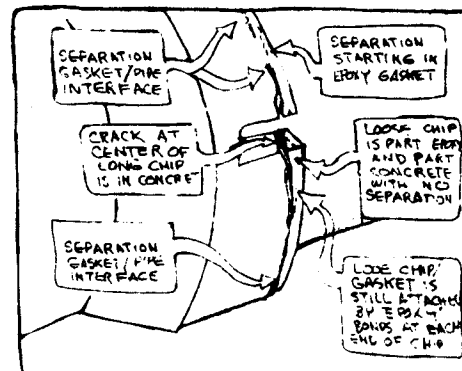
Addendum Figure 3

The inspection of one bell joint, at the 159-foot water depth, shows a small section of concrete pulled away from the bell face and adhering to the separated epoxy cushion. The separation of the epoxy cushioning material from the bell face presents no loss in pipe functional or structural integrity (see Addendum Figure 3). The small spall in the concrete may have resulted from an installation bump of the 8 segment assemblage in excess of what the bumper could cushion. Possibly no reinforcing bar has been exposed and the corner spall does not constitute a problem.

Inspection of the bell could not examine the depth or the width of the small concrete spall. Determination if reinforcing steel was exposed has not been possible. However, there is no evidence of additional spalling or other sign of concrete degradation. In the region of the bell where steel might be exposed, there are no structural stresses associated with internal pressure so that limited degradation would not impair the functionality of the pipe.

The City of Los Angeles will inspect the condition of the concrete at the bell by removing the epoxy rubber bumper and inspecting for exposed reinforcement and concrete deterioration. Based on the above, we estimate that the bell could potentially require repair. Various remedial options are available if bell concrete has been damaged, and the appropriate repair method depends on the extent of damage incurred and on the potential for further deterioration. In the worst case, repair would require preparation of the damaged area and patching with epoxy, epoxy grout, or a combination thereof. Although the primary objective of the repair method is to restore the integrity of the bell to a level consistent with the outfall as a whole, other factors will be considered when evaluating the most appropriate alternative. The following factors will be considered, not necessarily in order of importance:

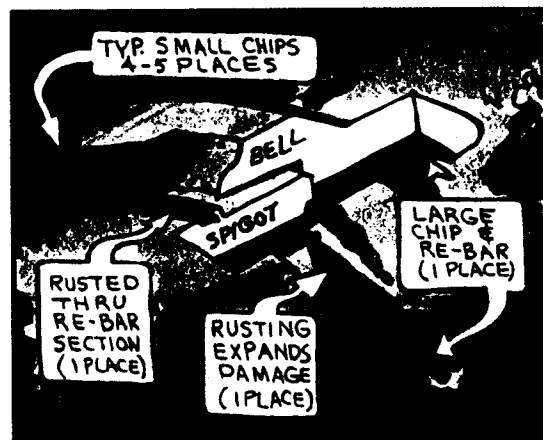
Addendum Figure 4

Seven (7) bells are potentially damaged in a 300-foot length of pipeline and all damage occurs on the top of the bells. Damage appears to be the result of anchor impacts and chain drags associated with vessel and fishing activity (see Addendum Figure 4).

The City of Los Angeles will repair the seven spalls/chips on nearshore bells shown on C-1 between Station 67+48 (61 feet depth) and Station 69+40 (61 feet depth). The repair will proceed by preparing the damaged area, including exposed

reinforcing steel, and patching the damaged area with epoxy, epoxy grout, or a combination thereof. Concerning the repair, the same factors described previously under repair #3 will be considered.
