**ADDITIONAL PHASE II
ENVIRONMENTAL SITE ASSESSMENT
FOR ASSESSOR'S PARCEL NUMBERS
401-031-038, -044, -046, -055, -059, AND -060
SAMOA PENINSULA BROWNFIELD SITE
SAMOA, HUMBOLDT COUNTY, CALIFORNIA**

Project No. 016670-5001-11110

April 2007

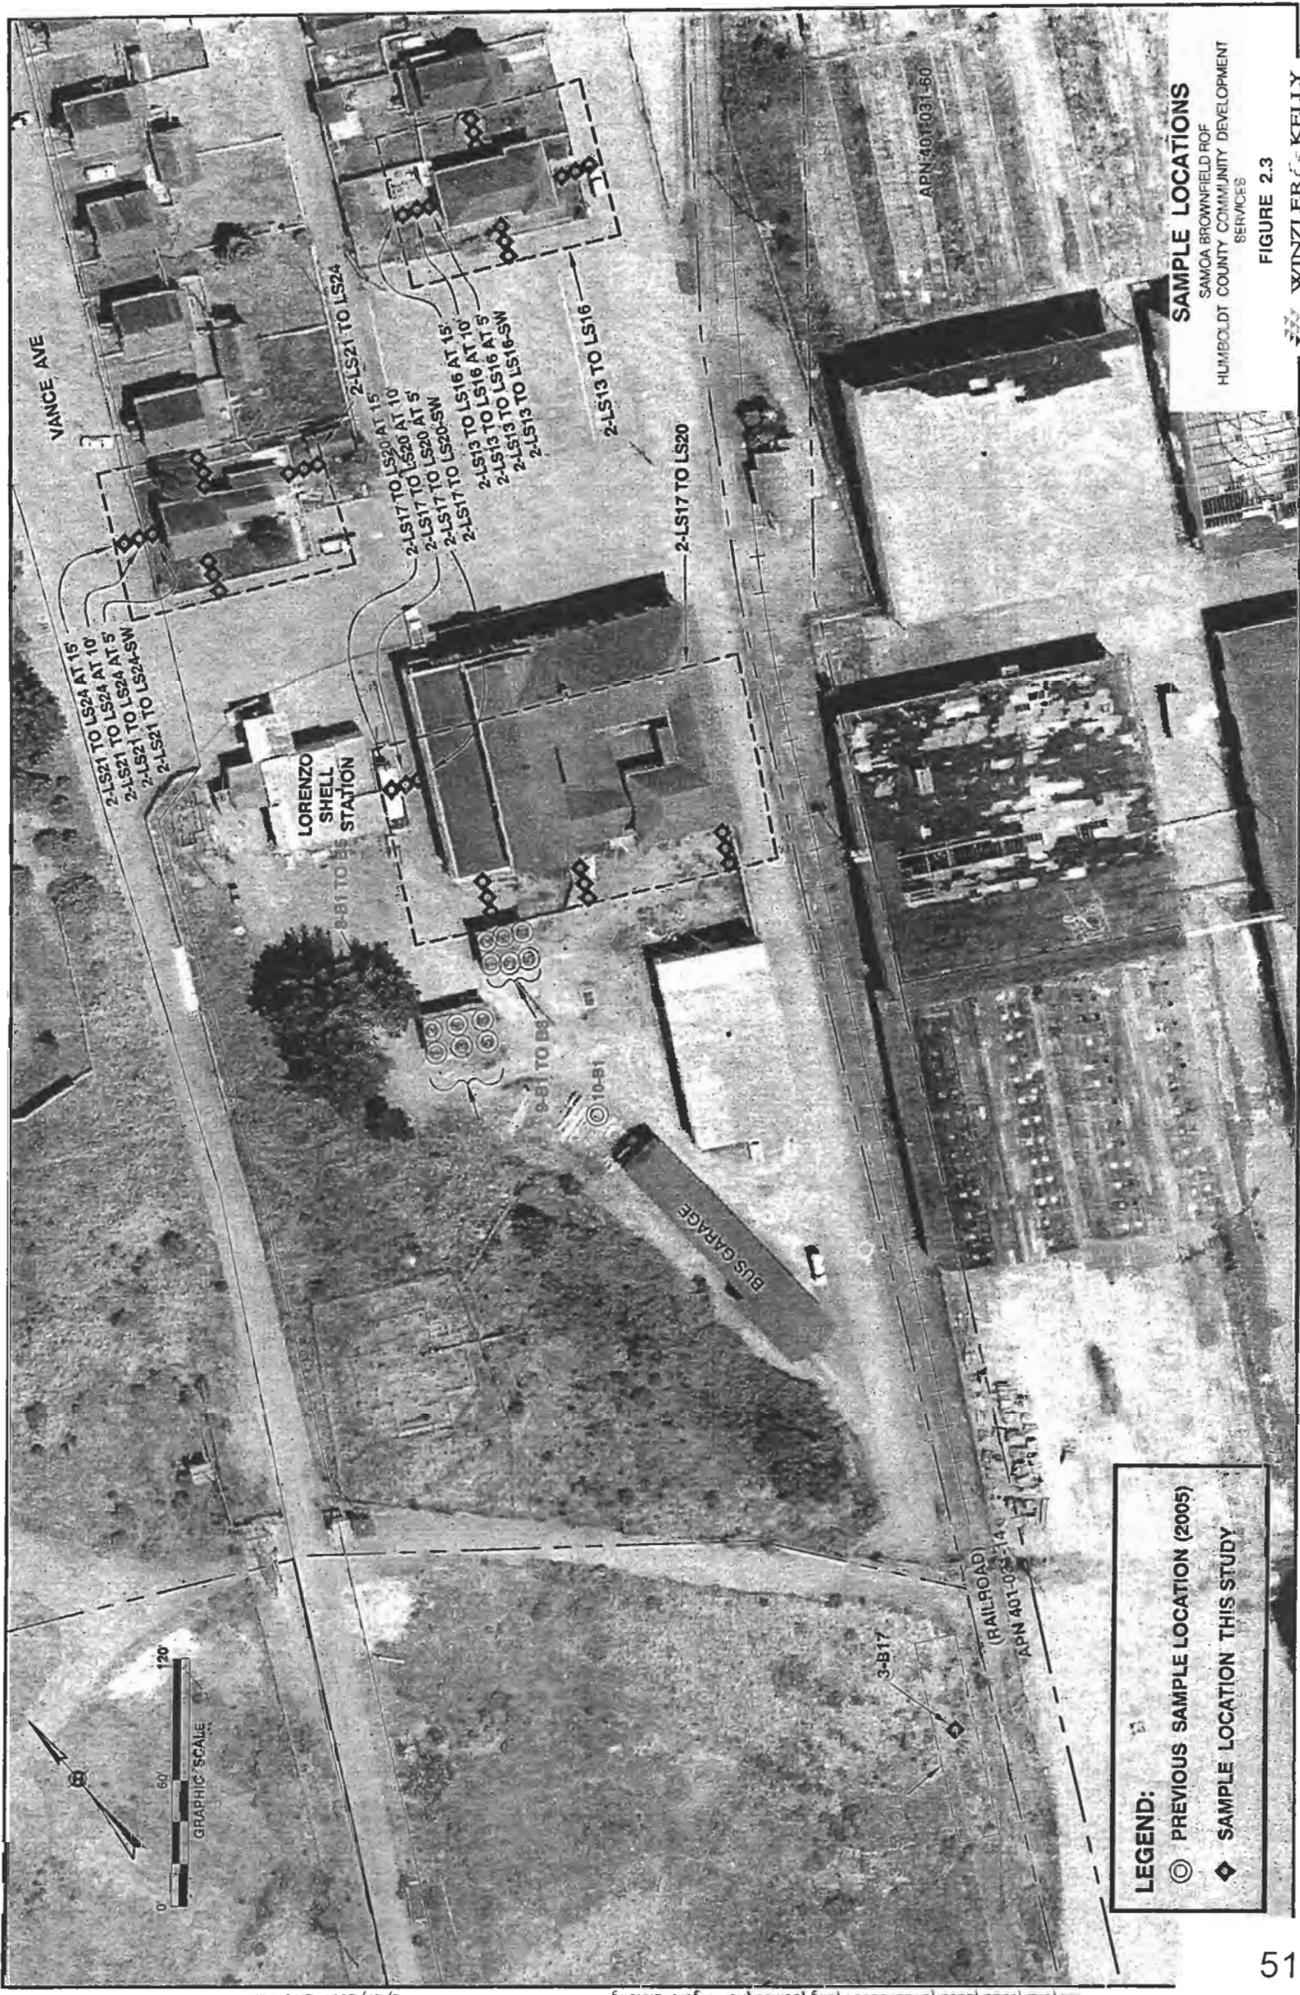
FIGURE 2.3

Site 2LS-13 to 16 (See Figure 2.3) is also a residence that had lead levels during the previous Phase II investigation of 407 ppm under the drip line of the house (see Table 4, Appendix C). The TTLC levels during this investigation were reported as 240, 200, 140 $\mu\text{g/g}$ at 5-, 10- and 15-foot respectively. The STLC levels were 14, 10, 7.8 mg/L at 5-, 10- and 15-feet respectively (See Table 1, Appendix C). These levels are all above the 5 mg/L threshold level that classify the soils as hazardous waste. Arsenic levels were also analyzed for in the soil samples, and the results reported were 3.846, 4.793, and 4.92 $\mu\text{g/g}$ in the 5-, 10-, and 15-foot samples. These results are all similar to the background arsenic results from boring B18. Stormwater runoff samples were also collected at this site and analyzed for dissolved lead. The stormwater sample did not contain any lead at levels above the 5 $\mu\text{g/L}$ method detection limit (See Table 2, Appendix C).

Site 2LS-17 to 20 (See Figure 2.3) is the Post Office that had lead levels during the previous Phase II investigation of 684 ppm under the drip line of the building (see Table 4, Appendix C). The TTLC levels during this investigation were reported as 426.3/340.5, 167.4, 163.9 $\mu\text{g/g}$ at 5/5-foot split-, 10- and 15-feet respectively. The STLC levels were 14, 7.8, and 5.9 mg/L at 5-, 10- and 15-feet respectively (See Table 1, Appendix C). These levels are all above the 5 mg/L threshold level that classify the soils as hazardous waste. Arsenic levels were also analyzed for in the soil samples, and the results reported were 15.03/15.15, 13.66, and 14.39 $\mu\text{g/g}$ in the 5/5-foot split, 10-, and 15-foot samples. These results are all higher than the background arsenic results from boring B18. Stormwater runoff samples were also collected at this site and analyzed for dissolved lead. The stormwater sample did not contain any lead at levels above the 5 $\mu\text{g/L}$ method detection limit (See Table 2, Appendix C).

Site 2LS-21 to 24 (See Figure 2.3) is a private residence that had lead levels during the previous Phase II investigation of 2,350 ppm under the drip line of the house (see Table 4, Appendix C). The TTLC levels during this investigation were reported as 170, 132.5, 143.6 $\mu\text{g/g}$ at 5-, 10- and 15-feet respectively. The STLC levels were 6, 6.4, and 16 mg/L at 5-, 10- and 15-feet respectively (See Table 1, Appendix C). These levels are all above the 5 mg/L threshold level that classify the soils as hazardous waste. It is also interesting to note that at all other houses, the further away from the house the sample was taken, the lower the lead results were, for this house, the STLC levels increased further away from the house. Arsenic levels were also analyzed for in the soil samples, and the results reported were 4.888, 4.988, and 5.715 $\mu\text{g/g}$ in the 5-, 10-, and 15-foot samples. These results are all similar to the background arsenic results from boring B18. Stormwater runoff samples were also collected at this site and analyzed for dissolved lead. The stormwater sample did not contain any lead at levels above the 5 $\mu\text{g/L}$ method detection limit.
