EXHIBIT NO. 8
APPEAL NO.
A-1-HUM-12-006
SMITH, BRIAN
GEOLOGY REPORT (EXCERPT) PLUS 3/19/12 ADDENDUM (1 of 11)

Subject: Geologic Hazard and Engineering-Soils Report for a Proposed New Residence, 183 Westgate Drive, Trinidad, California

Smith Residence
183 Westgate Drive
Trinidad, California

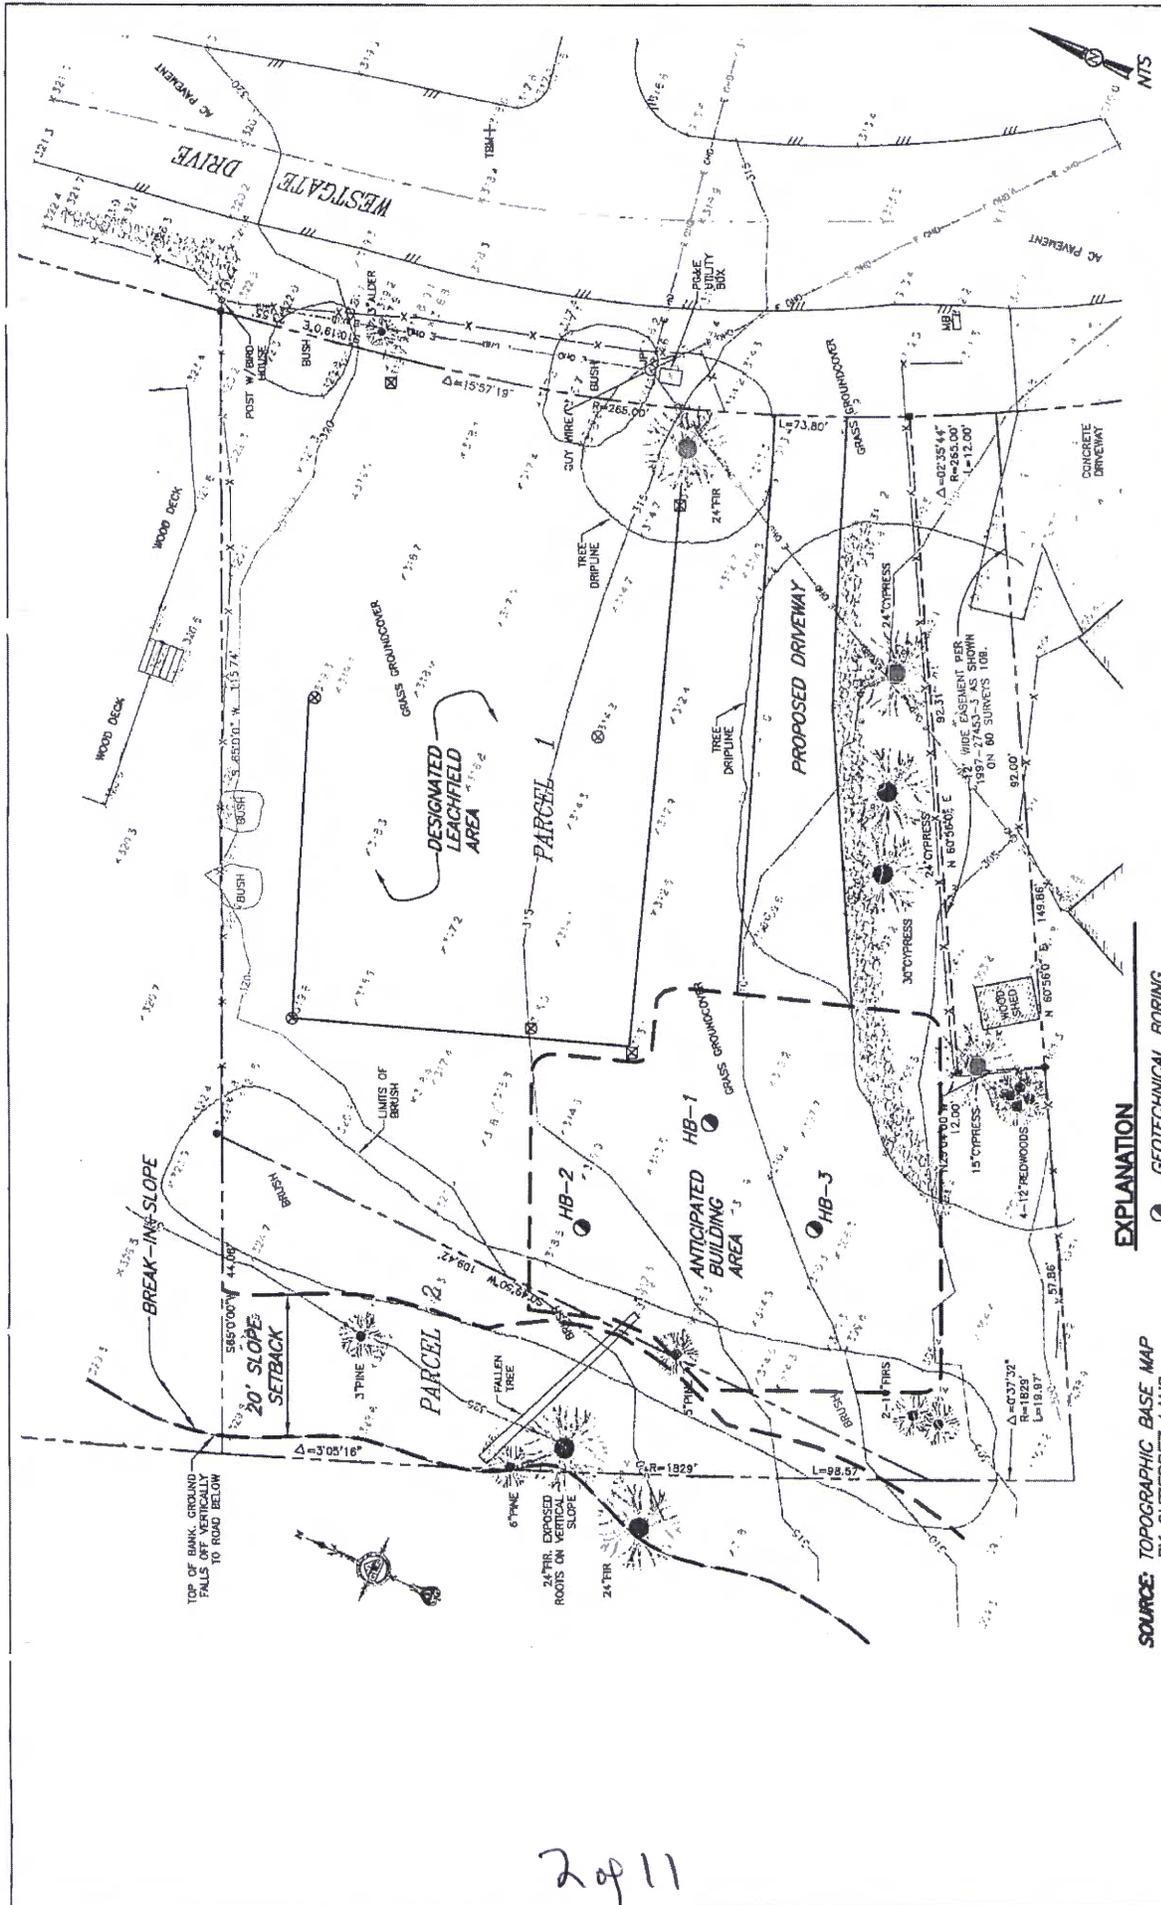
Site Map with Boring Locations
SFN 010166
Figure 2

On January 6, 2011, a geologist from SHN conducted a subsurface investigation at the project site. Three hand augered borings, shown as HB-1, HB-2, and HB-3 on Figure 2, were advanced to 6, 3.5, and 5 feet below grade, respectively. Soils observed in cuttings and samples were logged in general accordance with the Unified Soil Classification System. A description of the soil profile is

The slope on the west side of the property is approximately 60 to 70 feet high, and near vertical in places. The break-in-slope is abrupt and is situated at the crest of a topographic high. The proposed building area as indicated on Figure 2 is generally 5 to 10 feet below the elevation of the break-in-slope. The slope face is part of a remnant cutslope on the east side of Patrick's Point Drive. It is our understanding that some historic rock quarrying may have taken place as well. The rock consists of bedrock of the Franciscan Formation. The bedrock within the lower two-thirds of the slope is highly indurated and generally massive with some thin zones of shear that primarily dips toward the east (into the slope). The upper one third of the slope consists of moderately weathered rock, capped by a thin veneer of Pleistocene-aged alluvial gravels. Two trees are rooted within the alluvial gravels directly on the break-in-slope. The rock appears to be an isolated erosional remnant (low sea stack) with shallow marine alluvium draping the rock on the north, east, and south sides. Very little rocky debris was noted at the base of the slope. The primary mechanism of erosion of the slope face is shallow rock falls. We observed freshly exposed rock in some areas, but none represented significant volumes. Periodic sloughing of small pockets of fractured rock is expected within the economic lifespan of the residence. The upper 8 to 10 feet are considered susceptible to erosion, as it is comprised of sheared bedrock and a thin veneer of alluvial gravels. Deep-seated slides or other types of large failures are not considered likely due to the competency of the bedrock.

Our assessment of the stability conditions of the slope on the west end of the property is discussed above in Section 3.2. We consider the areas within 10 feet of the break-in-slope to have a high slope stability hazard, within 10 to 20 feet from the break-in-slope to have a moderate slope stability hazard, and the areas beyond 20 feet from the slope break to have a low slope stability hazard. The 20 foot setback line is shown on Figure 2. We recommend all structures maintain a minimum setback of 20 feet from the break in slope.
