3-17-0335 (PACIFIC GROVE SEAWALL REPAIRS)

TITLE SHEET
 PACIFIC GROVE COASTAL BLUFF PROTECTION REPAIR
 OVERLOOK ALONG RECREATIONAL TRAIL
 SEAWARD OF 701 OCEAN VIEW BLVD.
 3-6-2017

Reference: Pacific Grove Coastal Bluff Protection Repair
Coastal Overlook Along Recreational Trail
Seaward of 701 Ocean View Boulevard
Pacific Grove, CA

Subject: Emergency Coastal Bluff Protection

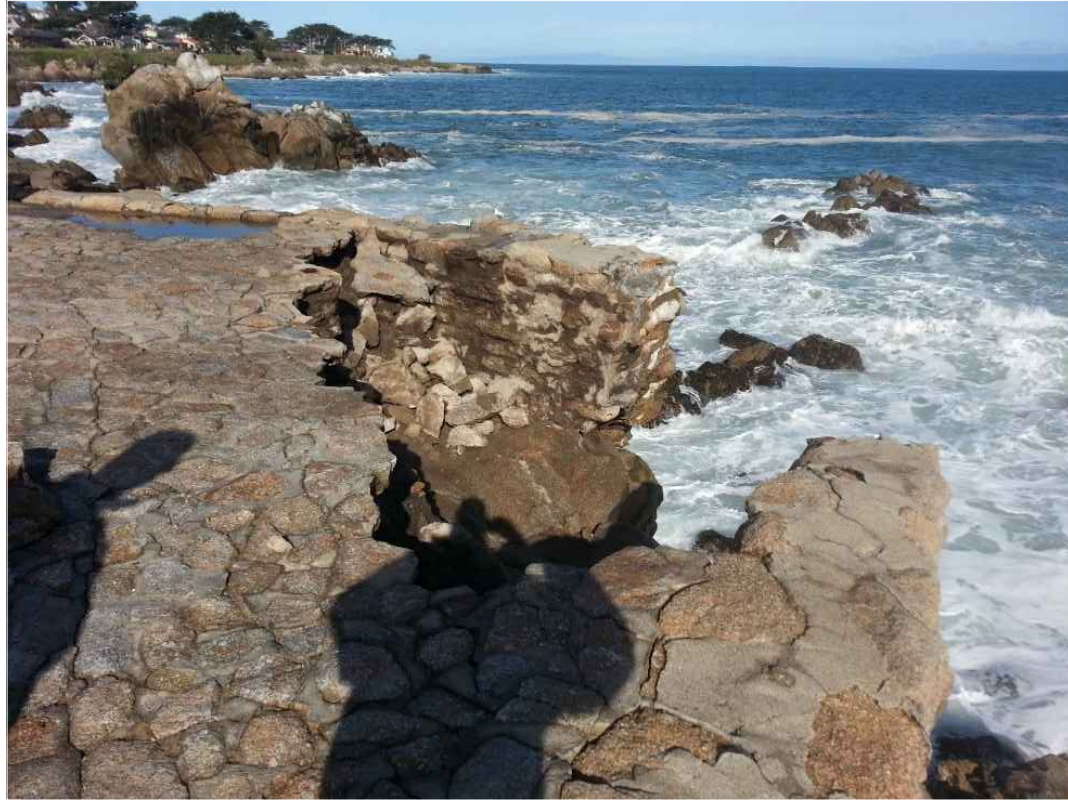
PHOTOGRAPH OF DAMAGED OVERLOOK

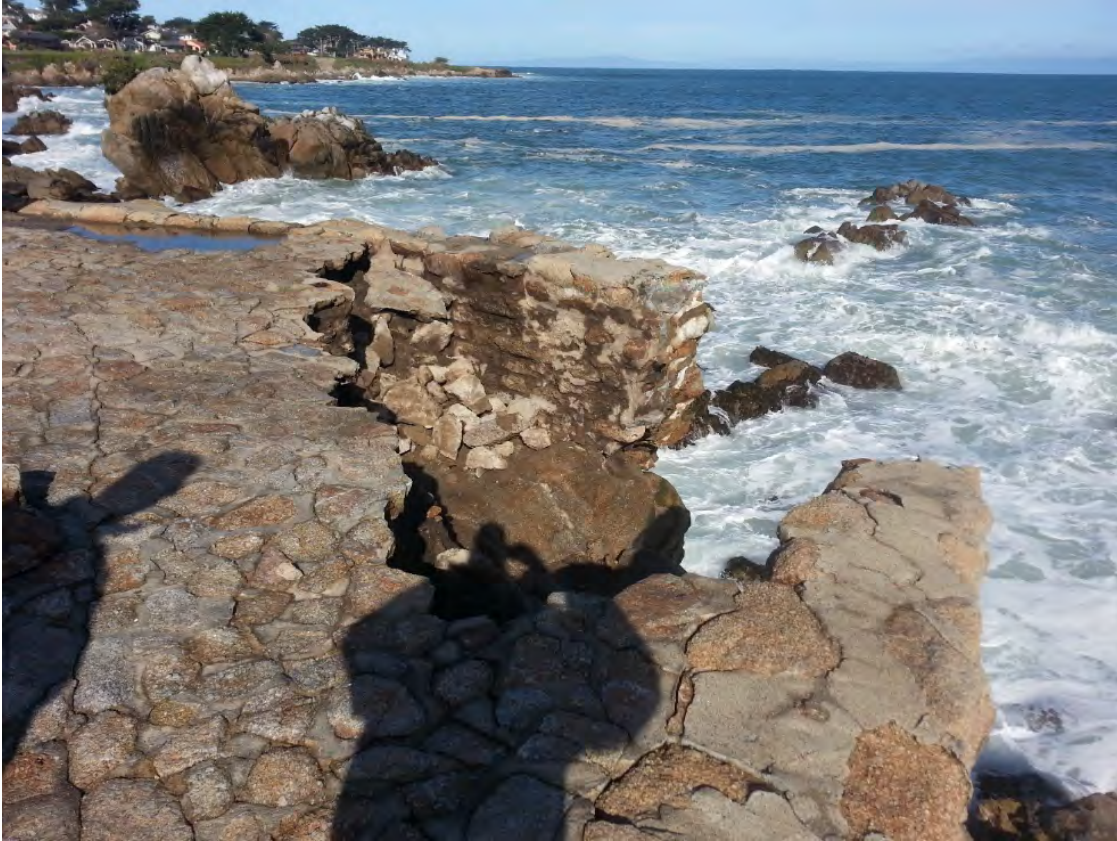
Photograph 1: Area of Damage to Coastal Trail Overlook

The existing rock and mortar wall at the bluff edge of this popular ocean overlook collapsed and fell into the ocean during strong wave impact on January 21, 2017. That day offshore significant wave heights exceeded 34 feet (10.4 meters) and damage to improvements occurred in many areas of the coastline.

The purpose of our study was to analyze the site conditions and develop plans for emergency repair of the existing coastal protection for the public access trail overlook pictured above. We recommend construction of a gravity type retaining structure surfaced to resemble the adjacent rock and mortar retaining wall; this will minimize visual impacts associated with bluff protection. The repaired area of the wall will be subject to wave overtopping and wave impact forces. The wall repair will be located a short distance landward of the location of the wall segment that failed in order to minimize wall height and take advantage of better foundation conditions.

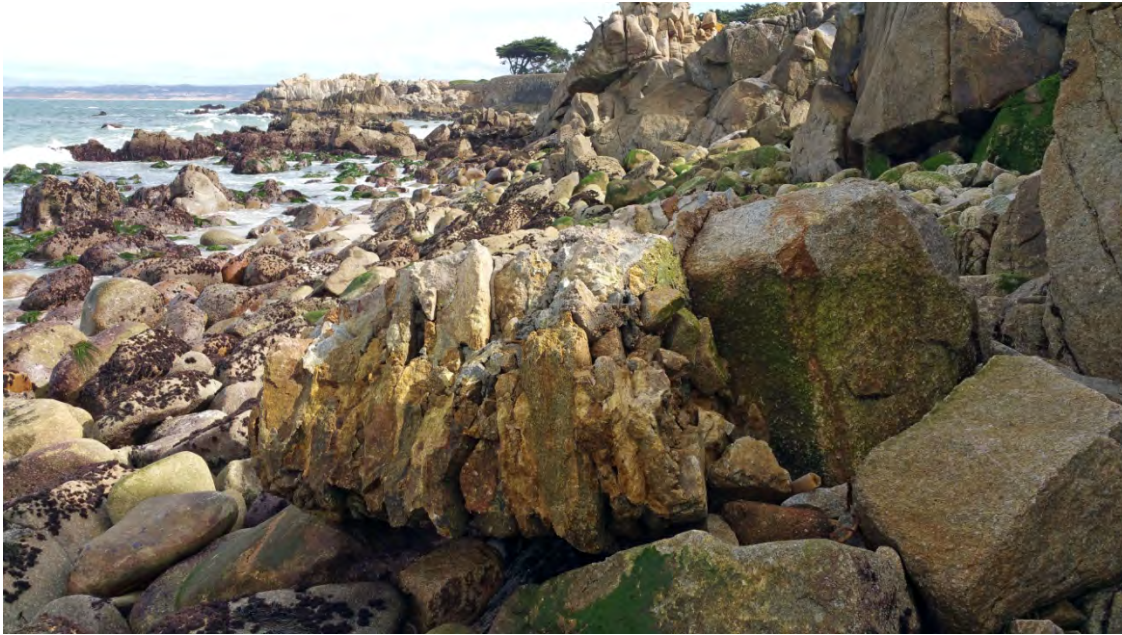
Our site inspection revealed that the segment of wall that failed lost foundation support when the bedrock below the wall cracked along pre-existing natural jointed surfaces within the rock. A large piece of granite bedrock slid downslope along with the wall segment and is now at rest on the beach below the overlook. The portions of this wall that consist of concrete or mortar should be removed from the beach during repair of the wall.

Photograph 2: Coastal Trail Overlook Wall Segment on Beach

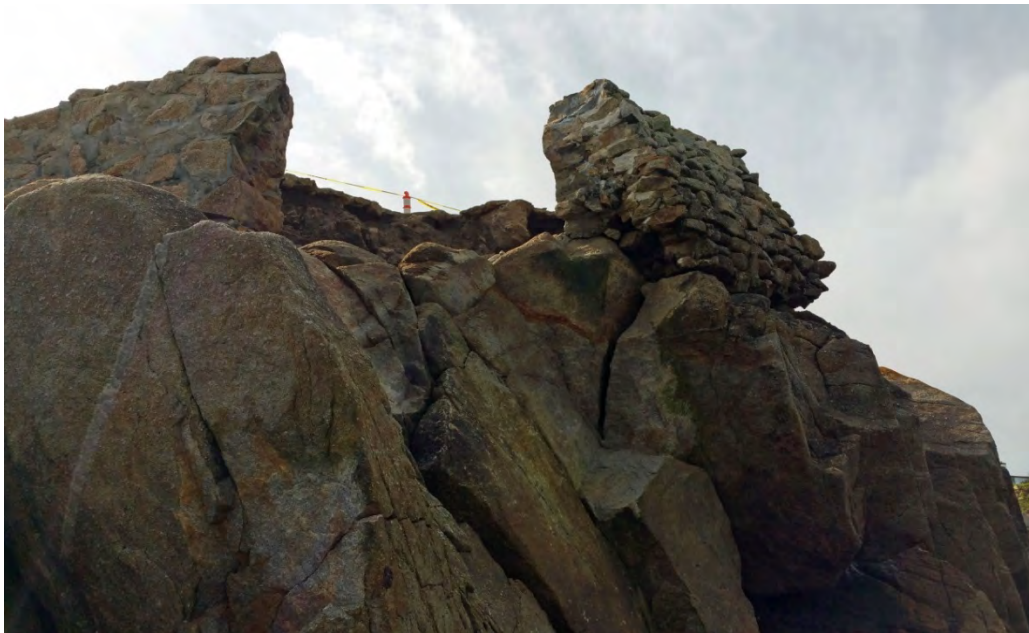
Examination of the face of the coastal bluff at the downcoast end of the failure revealed that an additional area of precarious existing wall is cracked, is undermined and is at risk of failure in the near future.

Photograph 3: Showing Failed Area of Existing Coastal Protection and Precarious Wall Segment at Top of Bluff

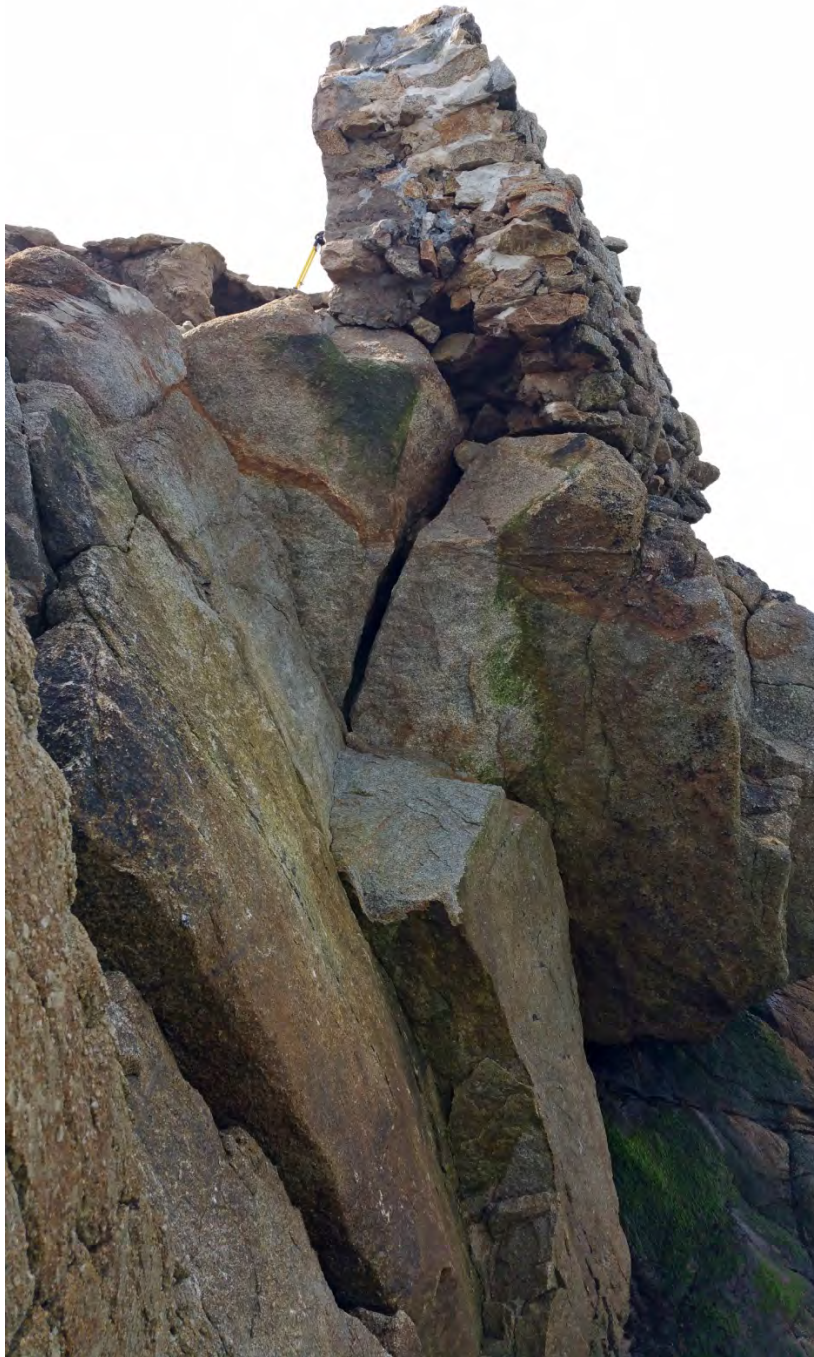
**Photograph 4: Showing Cracked Bedrock Below Wall
And Recent Bedrock Failure Area That Damaged Wall**

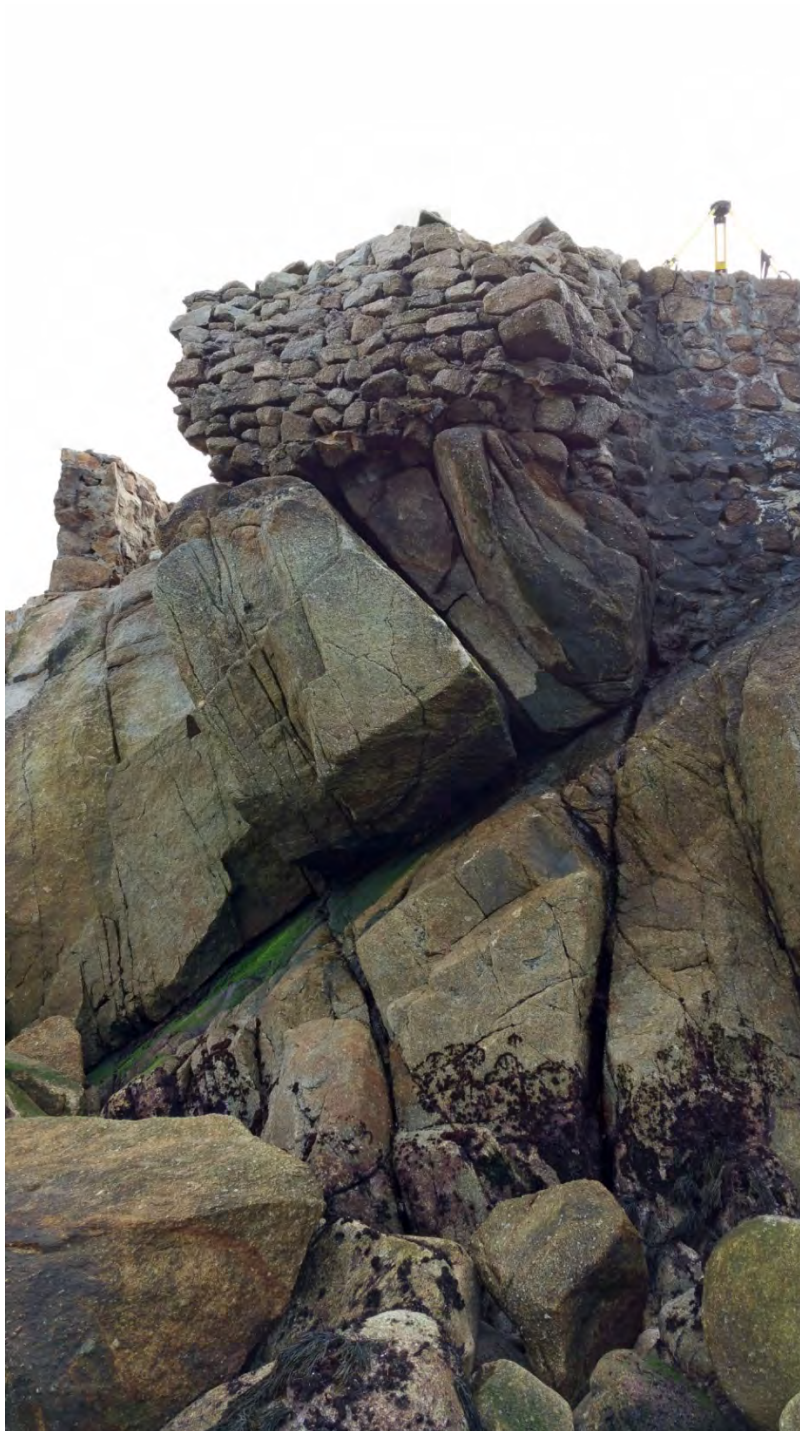
Photograph 5: Showing Bedrock Jointing and Fracturing

Bedrock has Moved Along Inclined Joint Plane Surface

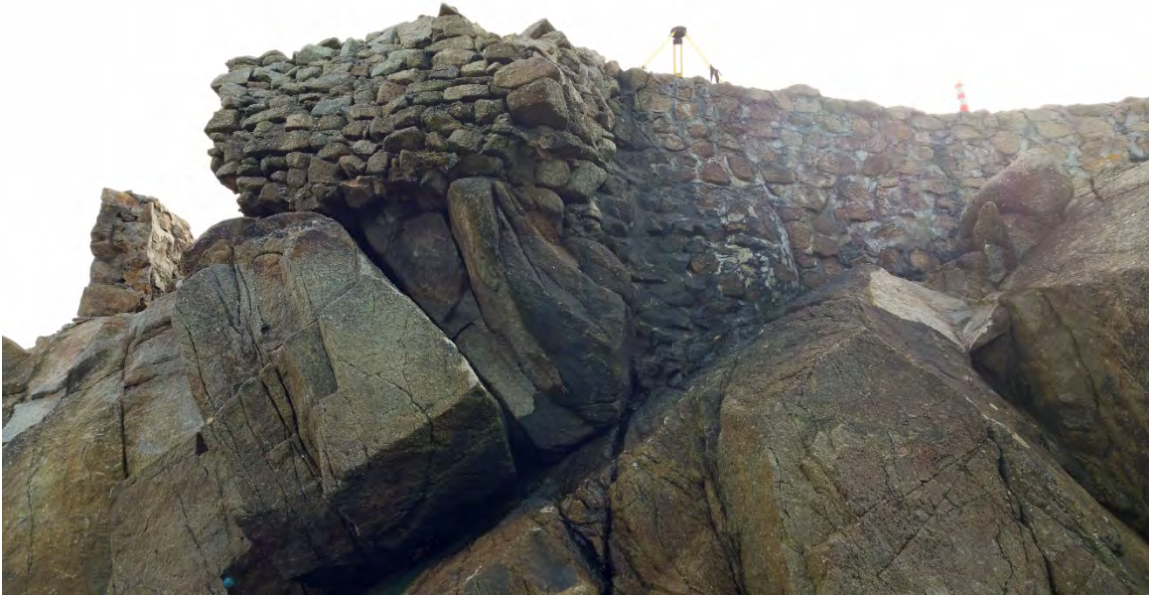
**Photograph 6: Showing Precarious Portion of Wall
in Relation to Stable Part of Wall at Downcoast Area of Overlook
Bedrock in Left Half of Photo is Unstable**

to be attached to the existing rock and mortar work that extends to a lower elevation (visible in right half of Photograph 6 above). Use of a rock breaking demolition agent (like Ecobust or Dexpan) will be required to break the rock in a controlled manner. Approximately 25 cubic yards of soil removal and demolition will be required. Portions of the soils can be used as backfill for the repaired wall segment. Compaction of those soils should be done with good workmanship. The top surface of the repaired wall should be shaped to achieve positive drainage. Any repaired area of the surface of the overlook should be surface top match the existing overlook. Our intent is to have the top of the repaired wall overlook surfaced to prevent pedestrians from standing on it, so that it forms a safety zone between the overlook area and the drop-off to the beach. These details need to be discussed with the selected contractor prior to commencement of construction to insure they are implemented.
