CALIFORNIA COASTAL COMMISSION

F11a

CC-0004-18 (SANDAG)

June 18, 2020

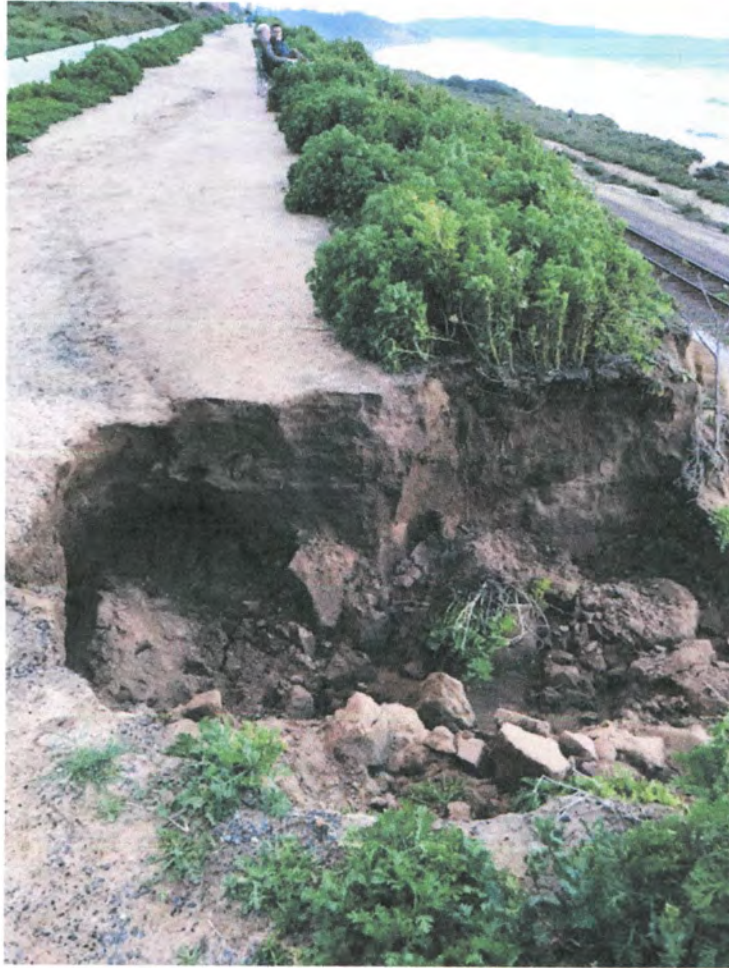
Storm water runoff has caused localized erosion and failures of the upper bluff just north of 7th Street. Two sections of the upper bluff measuring approximately 20 feet in width each have slid, resulting in soil and vegetation moved onto the track bed. One of the sections is shown in Figure 4 below. The upper edge of slope has cut father into the existing path that parallels the existing concrete drainage channel. The existing path has narrowed to less than 5 feet in width. Additional stabilization improvements will be required in this location to protect the track bed from debris and support the upper bluff channel and path.

Figure 4: Upper Bluff Slope Failure Below 7th Street
