## **CALIFORNIA COASTAL COMMISSION**

**3-83-172-A9 (Viewpointe Armoring)  
November 18, 2022**

**SUBJECT:** Response to California Coastal Commission (CCC) Staff Questions in an August 18, 2022 Email Regarding Shore Protection Maintenance at 1300 Palmetto Avenue, Cottages at Seaside, Pacifica, California.

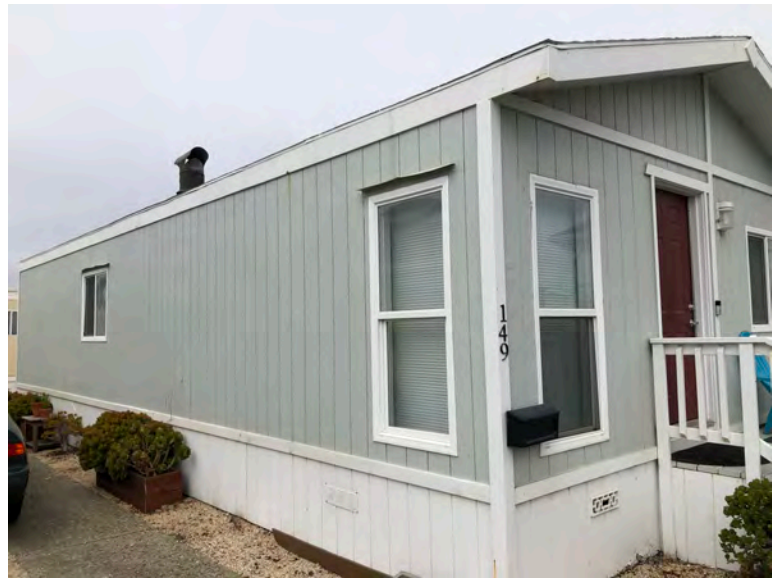
**149 First Ave - Left side elevation. Gable roof, no overhang. Roof replacement likely would have included overhang. T1-11 siding typical of original construction. No indication that removal or replacement of structural wall framing has occurred.**

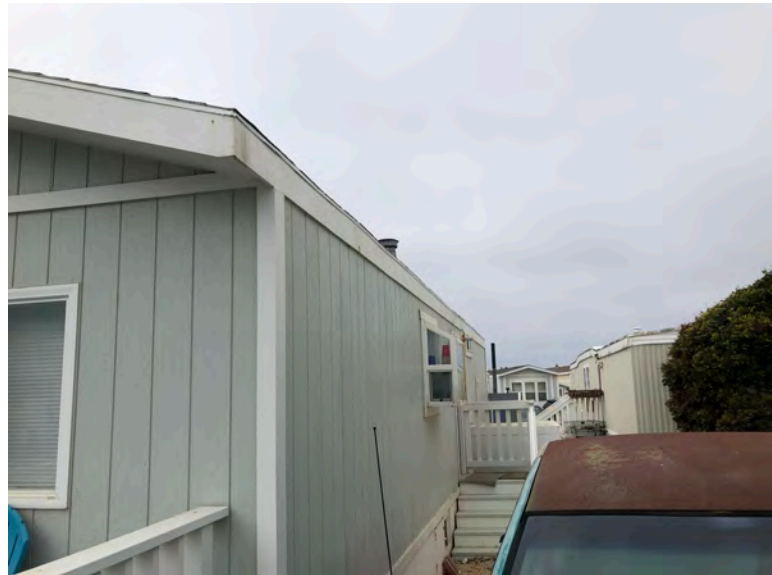
**149 First Ave - Right side elevation. T1-11 wall covering with gable roof and no overhang. No indication of modifications to structural roof or wall elements.**

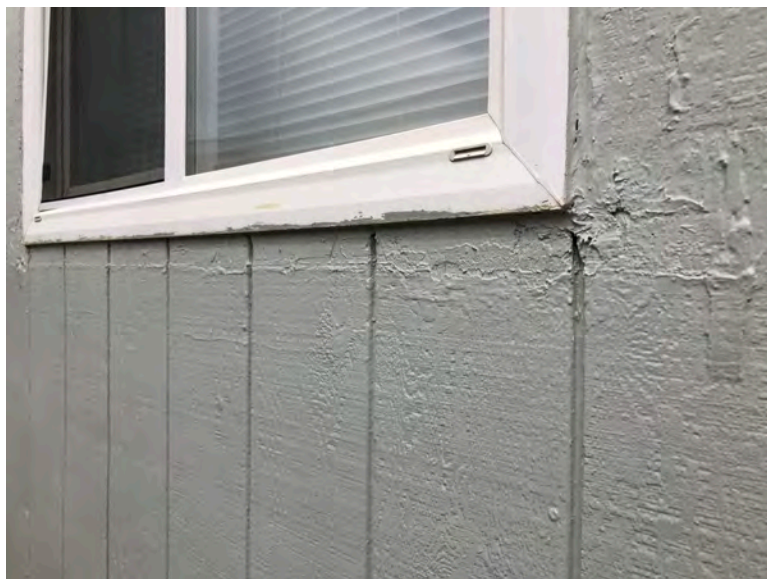
**149 First Ave - Evidence of prior window replacement without modification of structural wall elements. Evidence of repair and maintenance to T1-11 wall surfacing without modification to existing structural wall framing elements. T1-11 wall covering typical of original construction.**

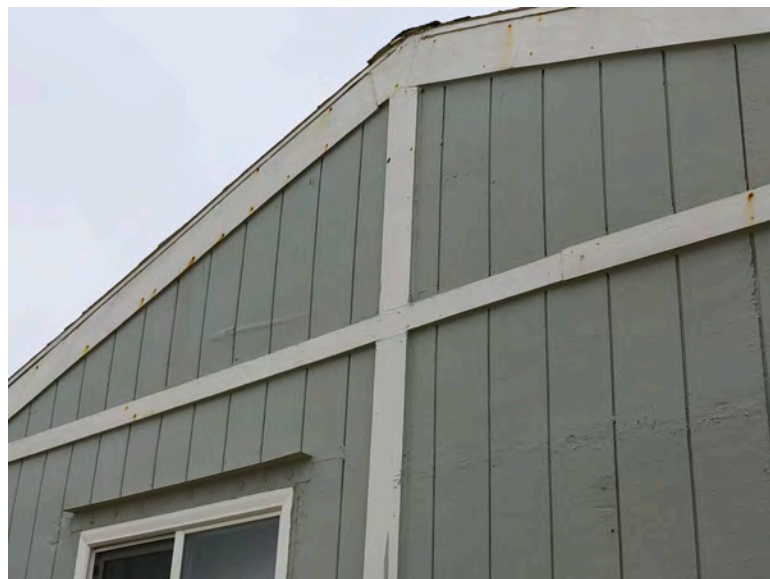
**149 First Ave - Gable end of structure. Evidence of repair and maintenance of existing T1-11 wall covering without structural replacement. No evidence of any removal or replacement of structural roof framing system or wall elements.**

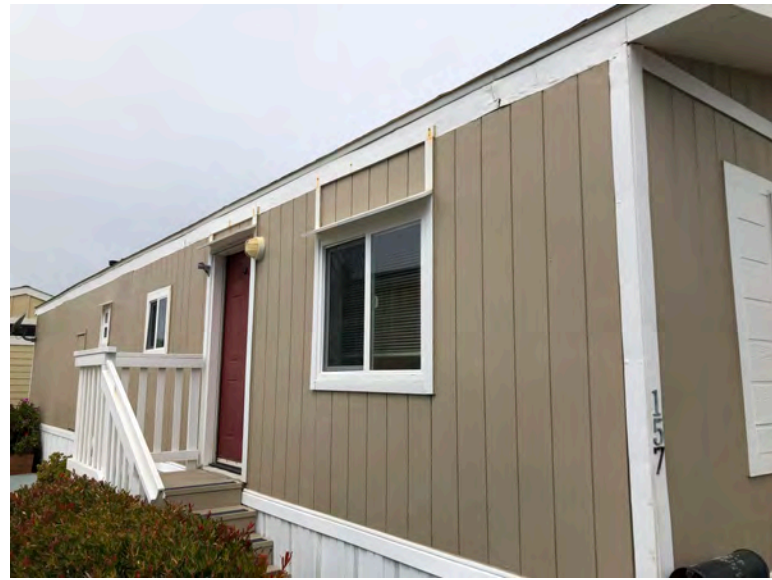
**157 First Ave - Entry stairs. Evidence of prior window replacement without modification of structural wall elements. Gable roof with no overhang. T1-11 wall covering typical of original construction.**

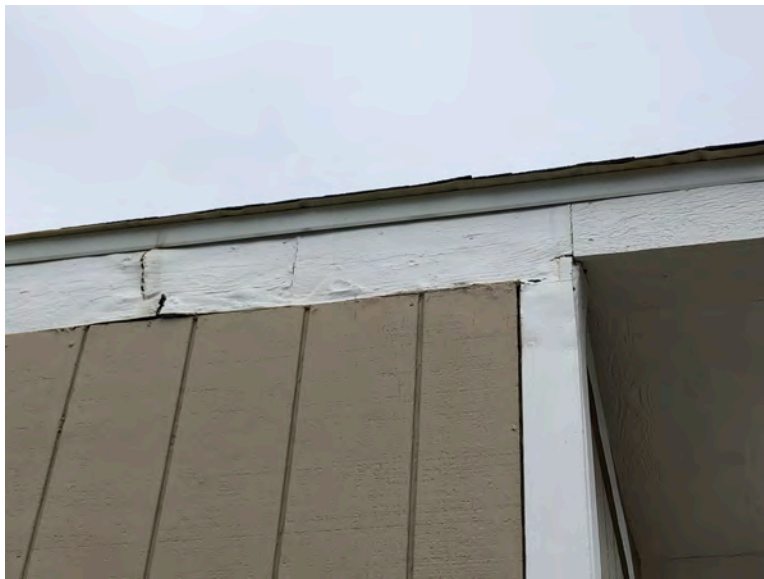
**157 First Ave - Fascia typical of original construction. Evidence of fascia wear and indications of maintenance, including caulking and re-painting. No evidence of any modifications to structural roof or wall elements. Roof replacement likely would have included overhang.**

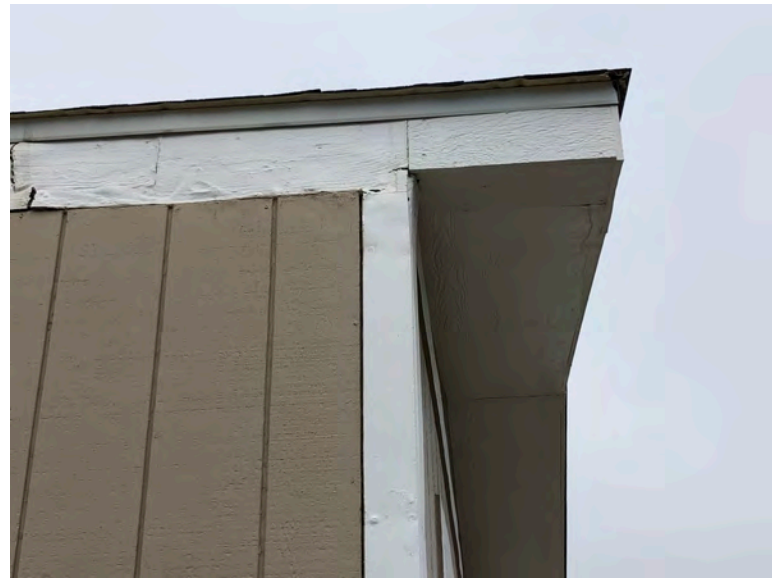
**157 First Ave - No roof overhang. Typical of original construction method for older units. Evidence of fascia wear and indications of maintenance. No evidence of any modification of structural roof or wall elements.**

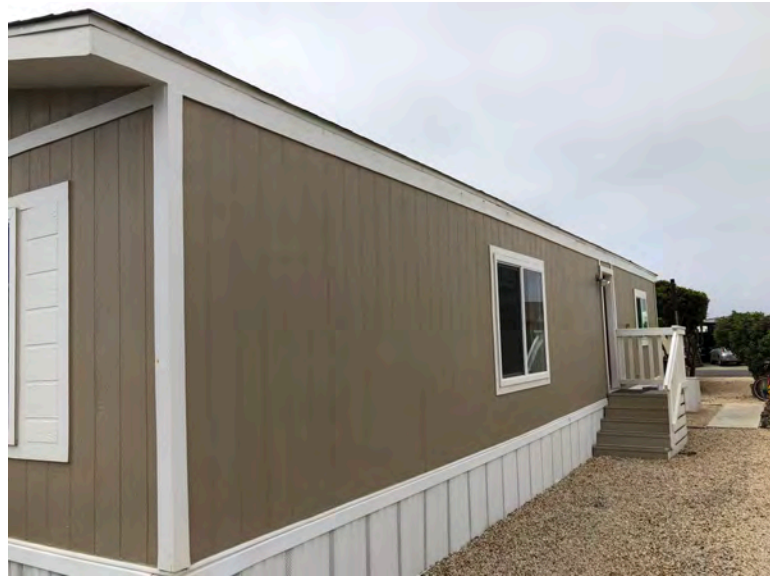
**157 First Ave - Right side elevation. T1-11 siding typical of original wall covering. Gable roof construction, no overhang. Typical of original unit.**

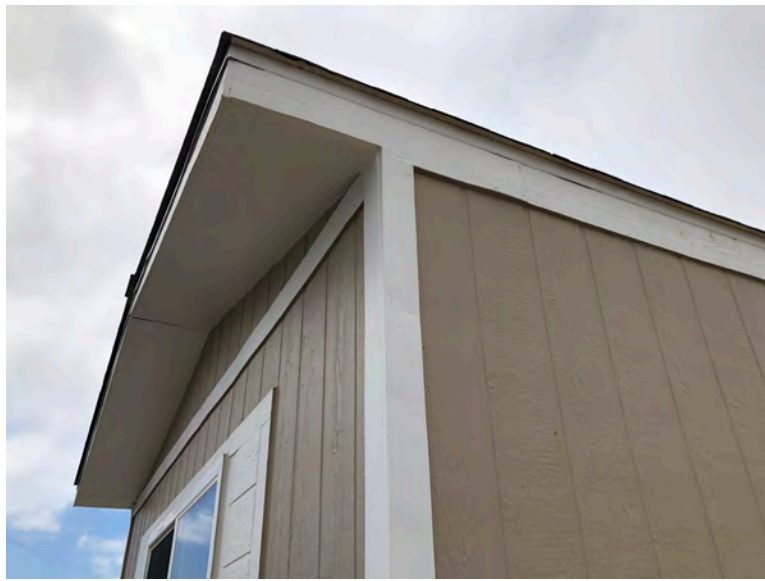
**157 First Ave - Front elevation with boxed overhang at front gable. Typical of original construction. No evidence of removal or replacement of structural roof framing system or wall elements.**

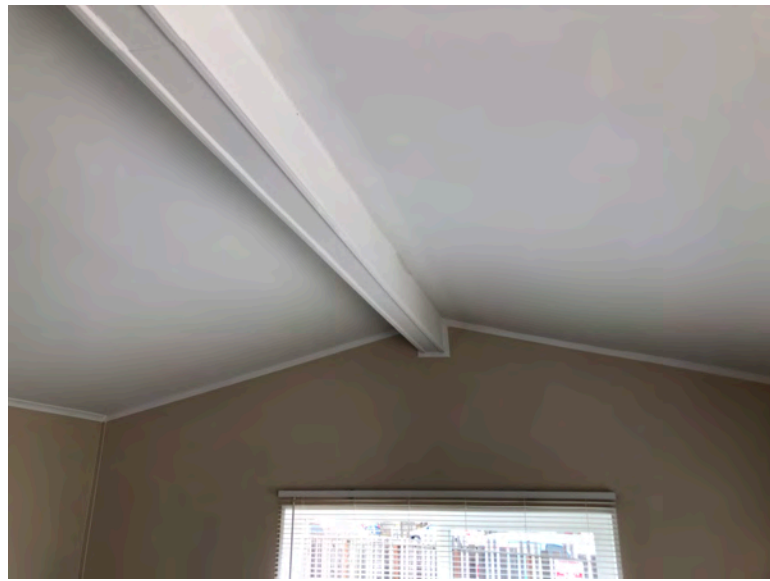
**157 First Ave - Interior elevation of open ceiling with boxed beam. Indicative of original gable construction. Interior finish of ceiling typical of original construction.**

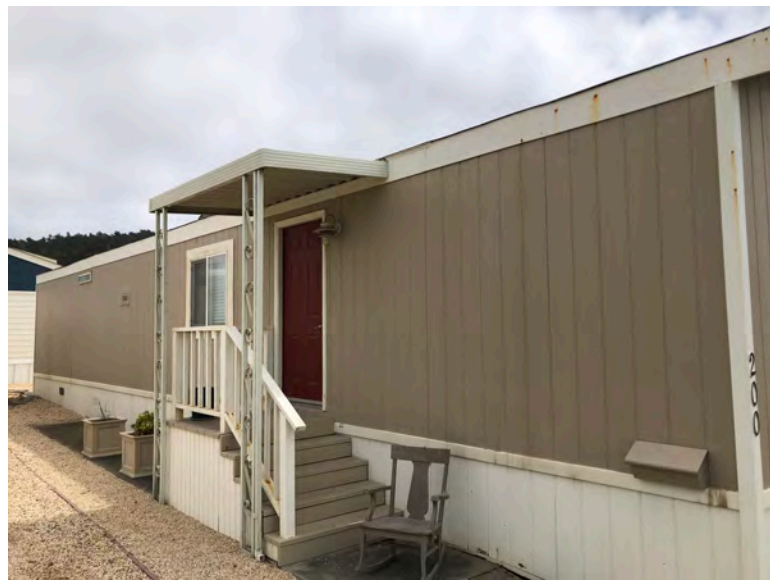
**200 Second Ave - Side view with T1-11 siding. T1-11 siding typical of original construction. Evidence of repair and maintenance (e.g., caulking, sealing) of T1-11 wall covering. No indication that any removal or replacement of structural wall framing has occurred.**

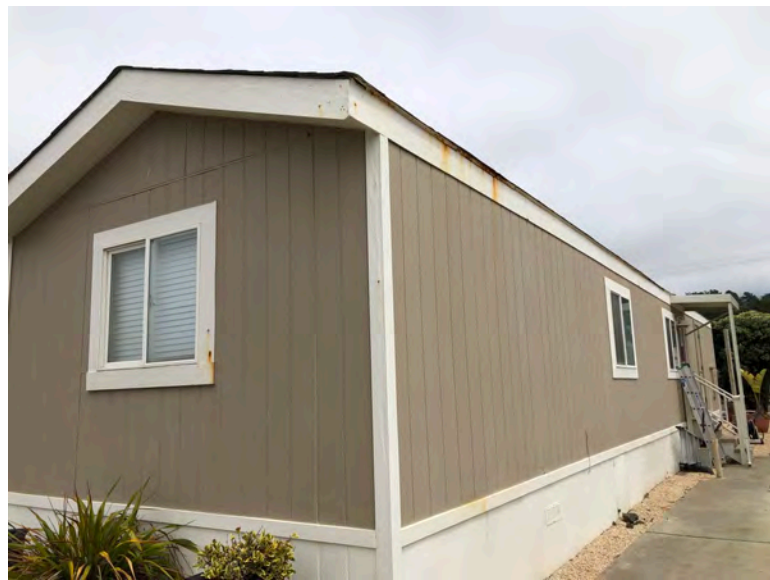
**200 Second Ave - Side view with T1-11 siding. Evidence of repair and maintenance (e.g., caulking, sealing) of T1-11 wall-covering. No indication that removal or replacement of structural wall framing has occurred.**

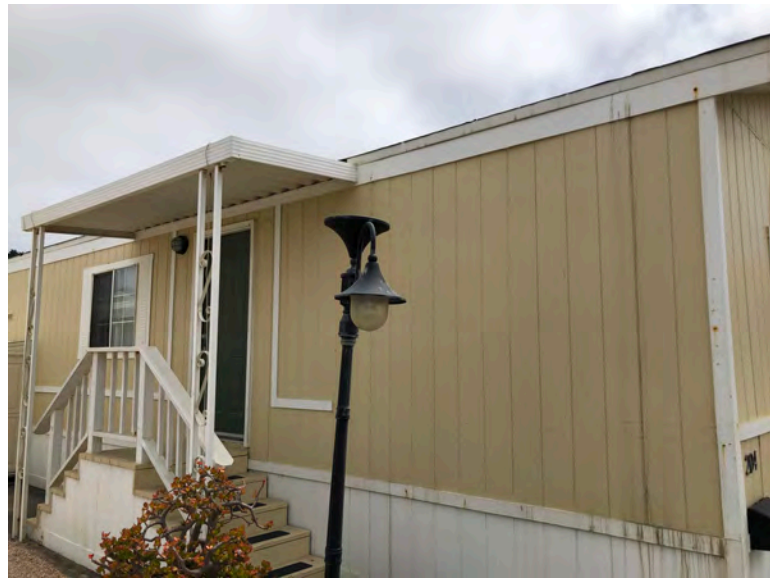
**204 Second Ave - Side view with T1-11 siding. Evidence of non-structural repair and maintenance (e.g., caulking, sealing) of T1-11 wall covering. No indication that removal or replacement of structural wall framing has occurred.**

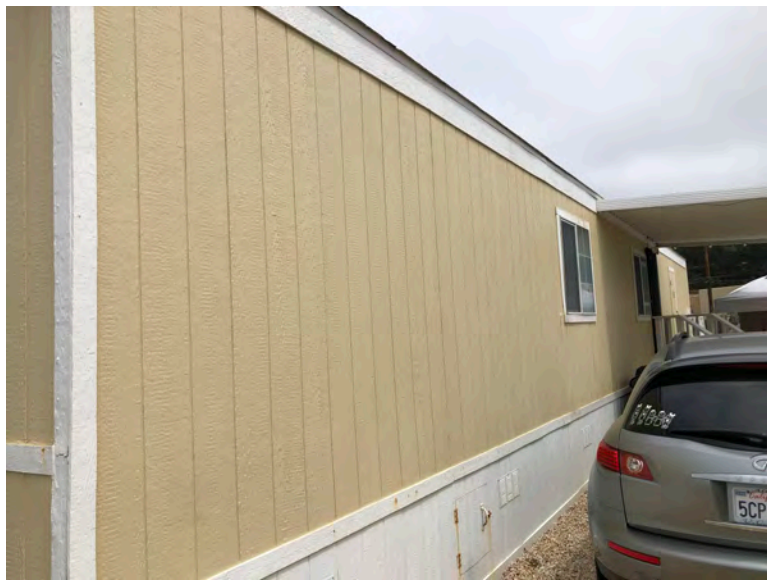
**204 Second Ave - Side view with T1-11 siding. Evidence of non-structural repair and maintenance (e.g., caulking, sealing) of T1-11 wall covering. T1-11 siding typical of original construction. No indication that any removal or replacement of structural wall framing has occurred.**

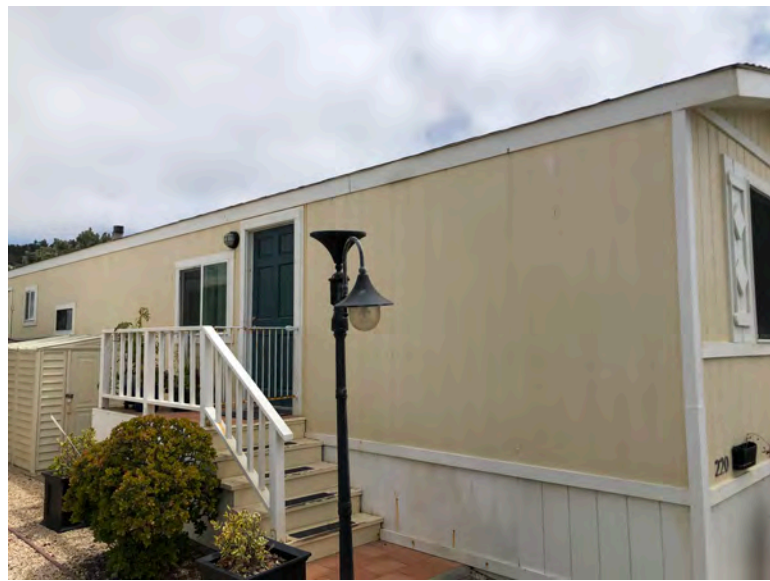
**220 Second Ave - Side view with T1-11 siding. Evidence of non-structural repair and maintenance (e.g. caulking, sealing) of T1-11 wall covering. T1-11 siding typical of original construction. No indication that any removal or replacement of structural wall framing has occurred.**

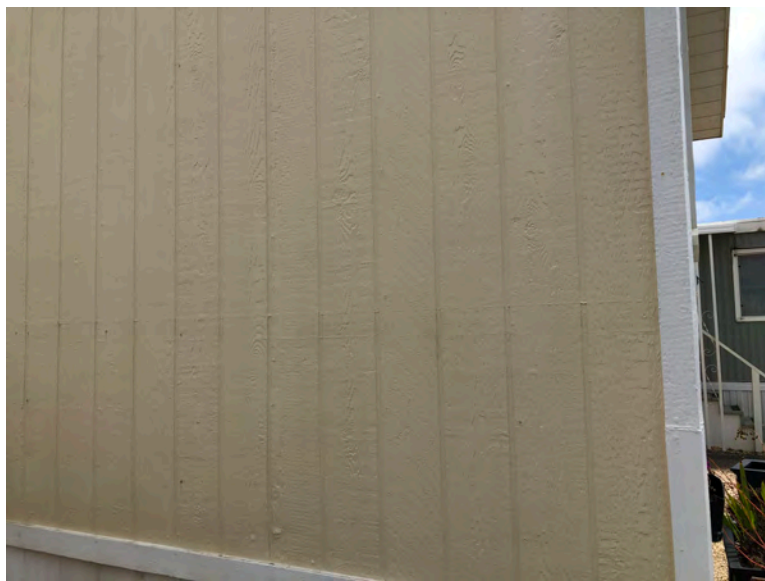
**220 Second Ave - Evidence of non-structural repair and maintenance (e.g., caulking, sealing) of T1-11 wall covering. No indication that any removal or replacement of structural wall framing has occurred.**

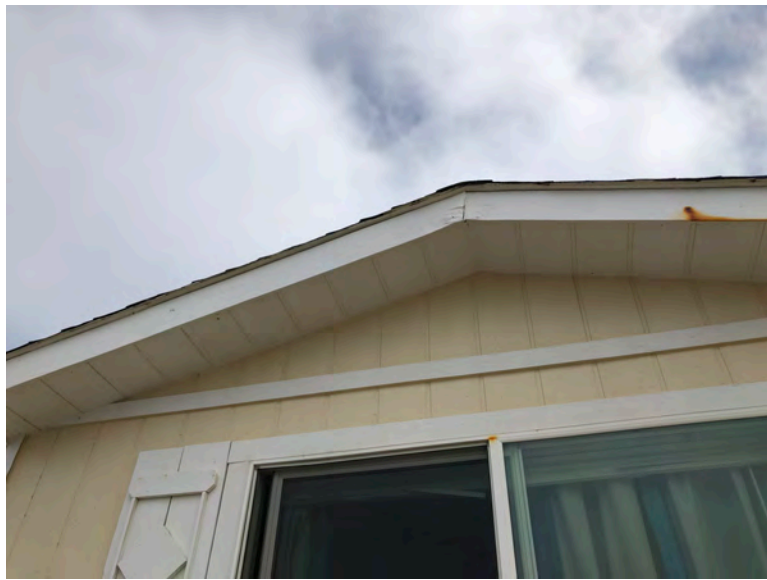
**220 Second Ave - Fascia detail at roof. Fascia typical of original construction. Evidence of fascia wear and indications of maintenance, including re-painting. No evidence of any modifications to structural roof or wall elements. If roof structural framing had been replaced, boxed eave and fascia would not show similar wear. Replacement of roof elements likely would have included overhang.**

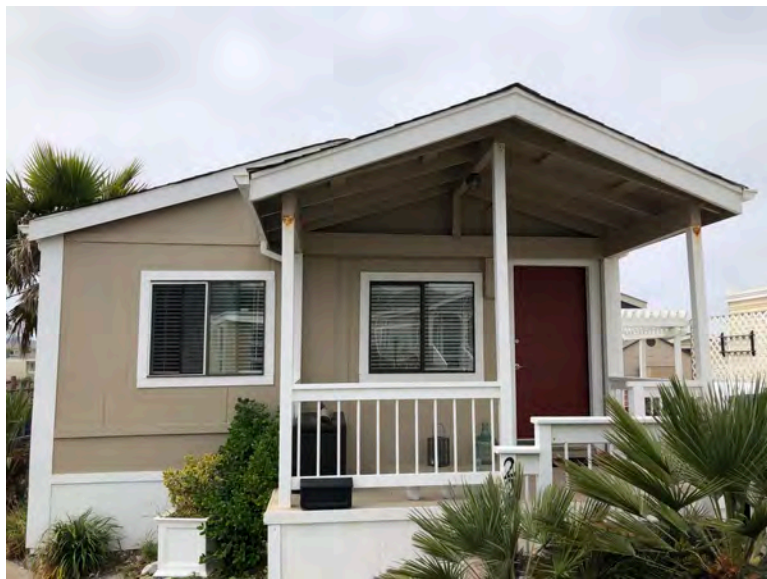
**229 Second Ave - Front view, gable construction with small overhang at eaves. No indication that removal or replacement of structural wall framing or siding elements has occurred.**

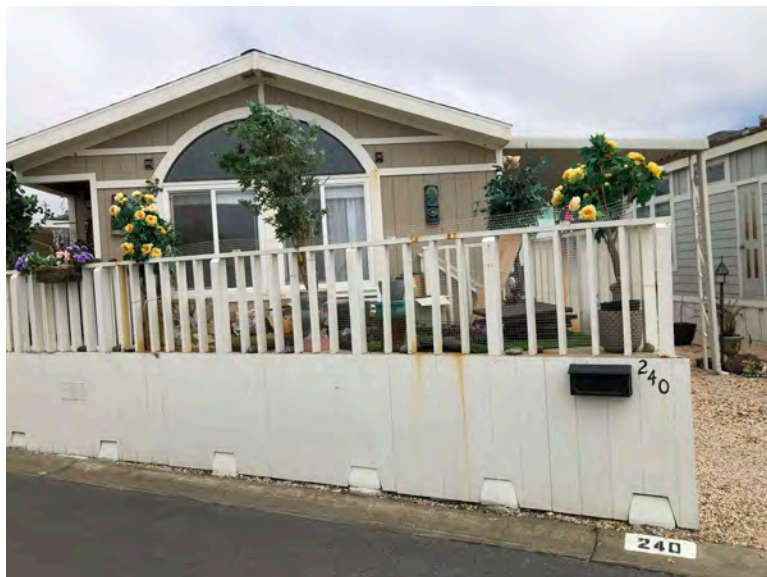
**240 Second Ave - Front view. Materials and gable roof with little or no overhang typical of original construction. No indication that removal or replacement of structural roof framing has occurred. Replacement would have had significant impact on wall framing and interiors and likely would have been constructed with an overhang.**

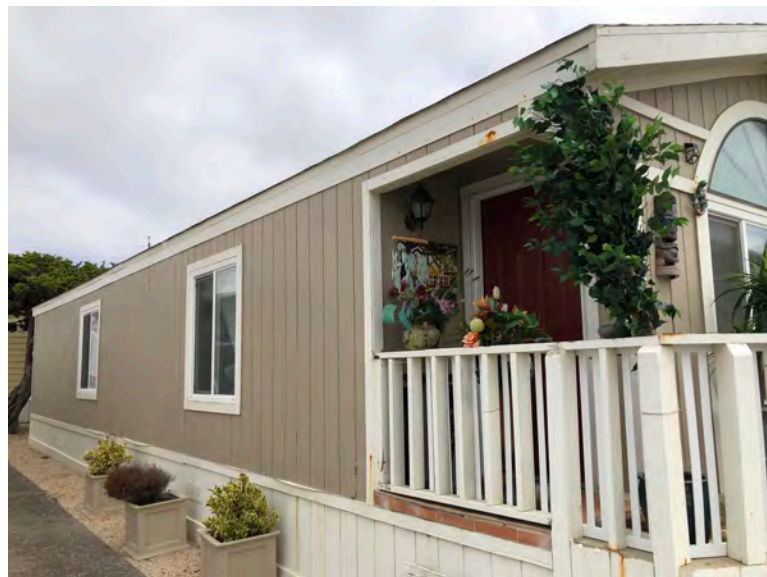
**240 Second Ave - Side view with T1-11 siding. T1-11 siding typical of original construction. No indication that any removal or replacement of structural wall framing has occurred.**

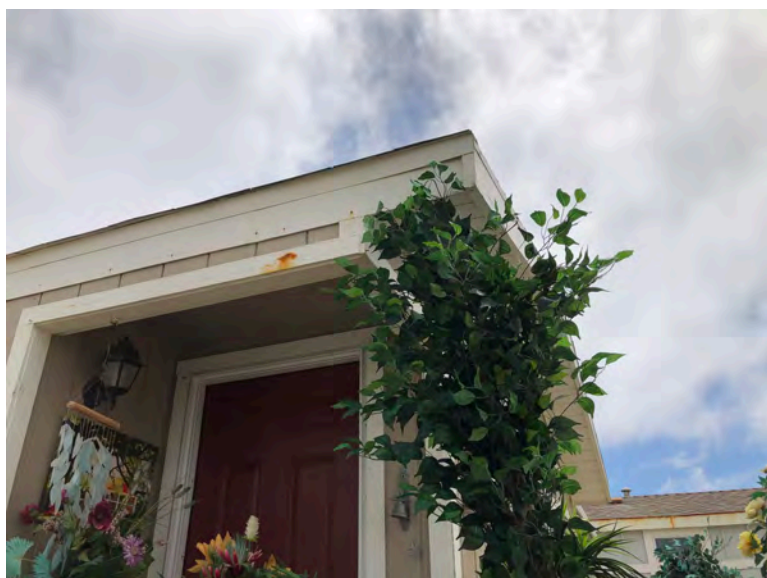
**240 Second Ave - Side view of roof over front porch area, typical of original construction. No roof overhang.**

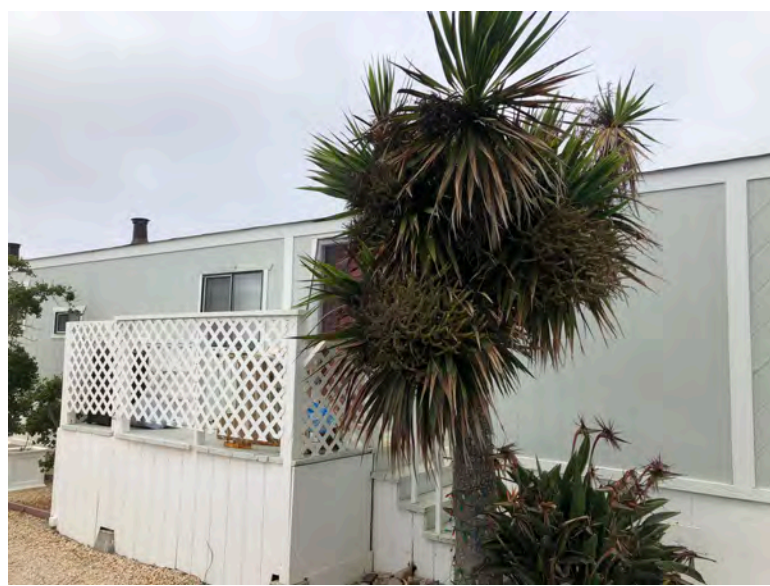
**245 Second Ave - Side view with T1-11 siding. Evidence of non-structural repair and maintenance (e.g. caulking, sealing) of T1-11 wall covering. T1-11 siding typical of original construction. No indication that any removal or replacement of structural wall framing has occurred.**

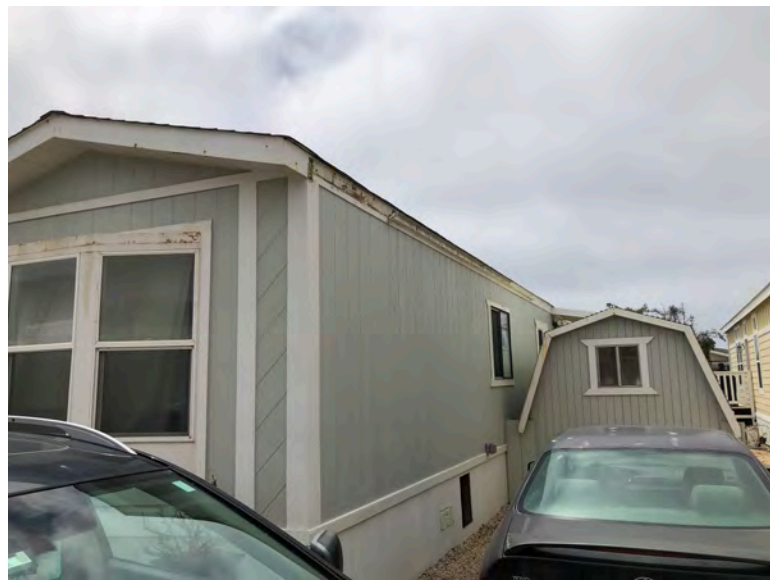
**245 Second Ave - Side View with T1-11 siding. Evidence of non-structural repair and maintenance (e.g. caulking, sealing) of T1-11 covering. No indication that any removal or replacement of structural wall framing has occurred.**

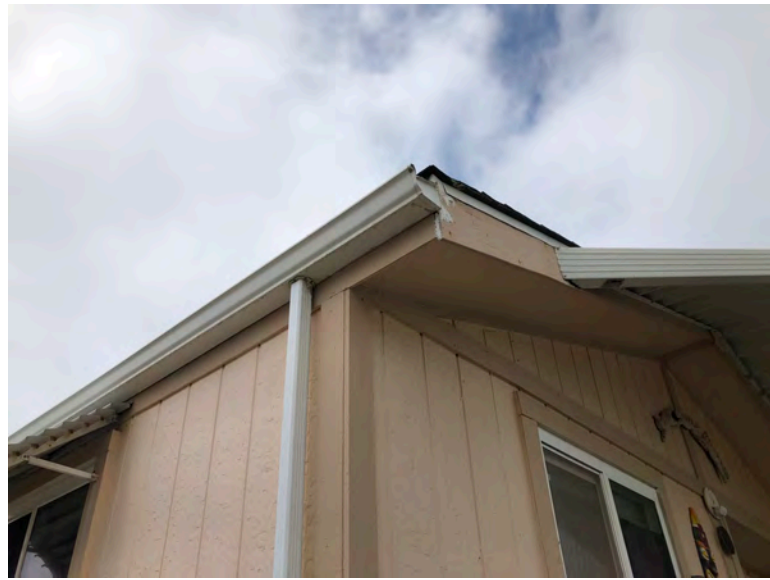
**249 Second Ave - Fascia detail at roof. Fascia typical of original construction. Evidence of fascia wear and indications of maintenance, including re-painting. No evidence of any modifications to structural roof or wall elements. If roof structural framing had been replaced, boxed eave and fascia would not show similar wear.**

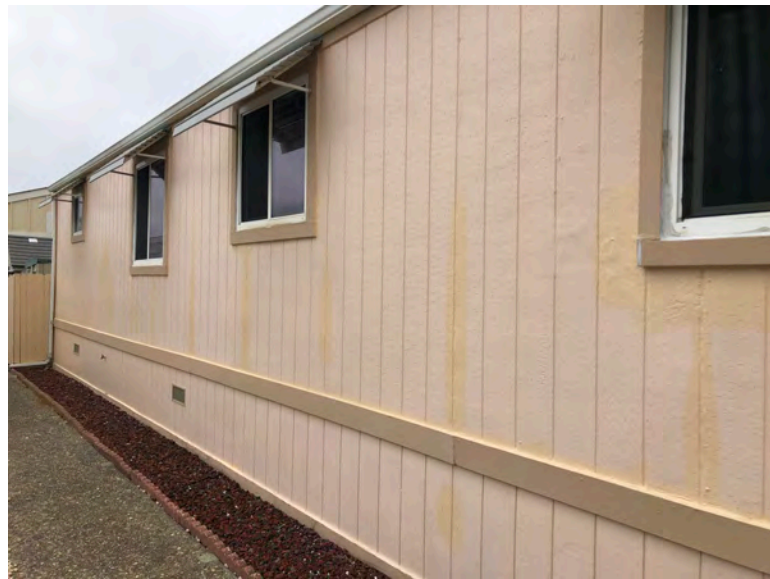
**249 Second Ave - Evidence of non-structural repair and maintenance (e.g., caulking, sealing) of T1-11 wall covering. No indication that any removal or replacement of structural wall framing has occurred. If wall framing had been replaced, siding would not show similar wear.**

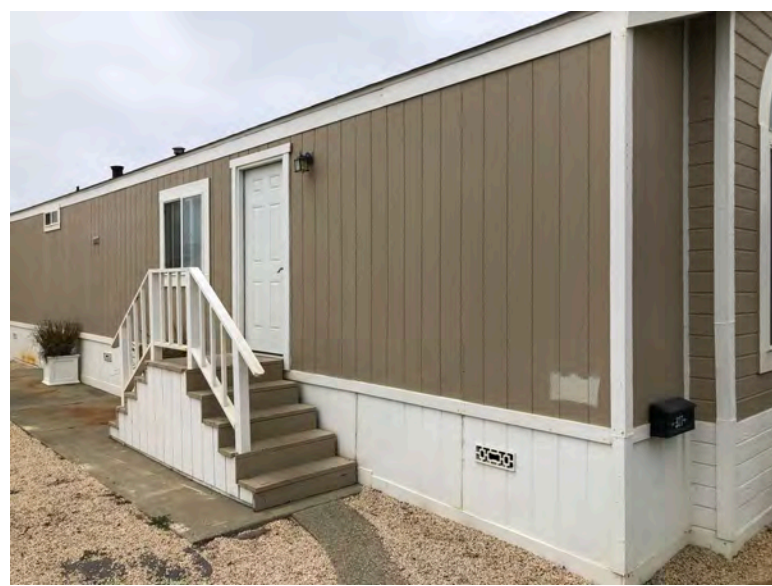
**317 Third Ave - Side view with T1-11 siding. Evidence of non-structural repair and maintenance (e.g., caulking, sealing) of T1-11 wall covering. T1-11 siding typical of original construction. No indication that removal or replacement of structural wall framing has occurred.**

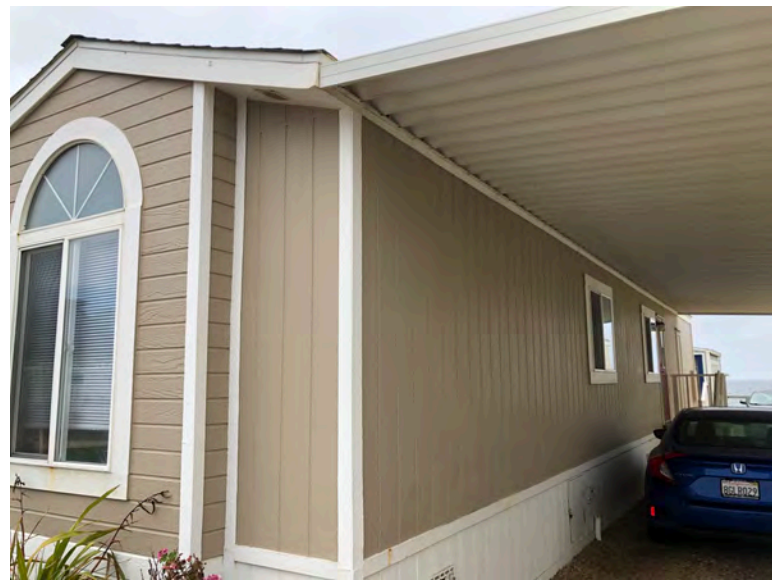
**317 Third Ave - Side view with T1-11 siding. Evidence of non-structural repair and maintenance (e.g., caulking, sealing) of T1-11 wall covering. No indication that any removal or replacement of structural wall framing has occurred.**

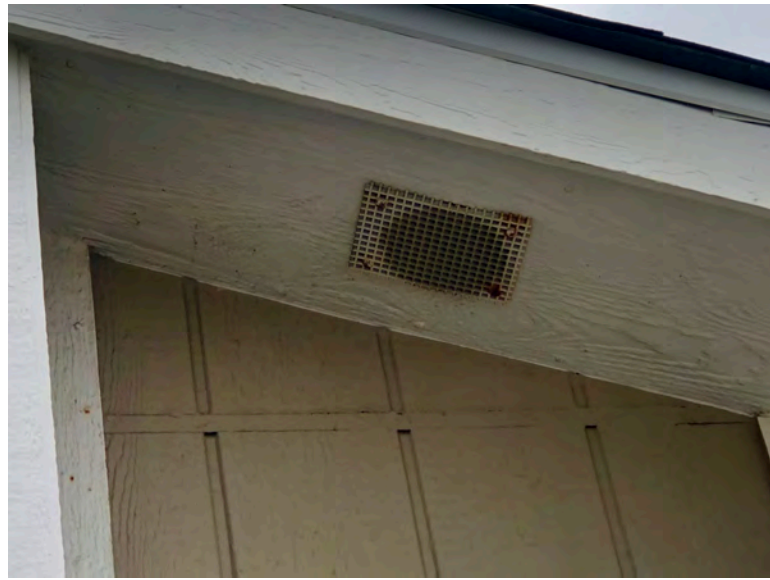
**317 Third Ave - Fascia detail at roof with boxed eave, no overhang. Note old style vent at boxed eave, typical of original construction.**

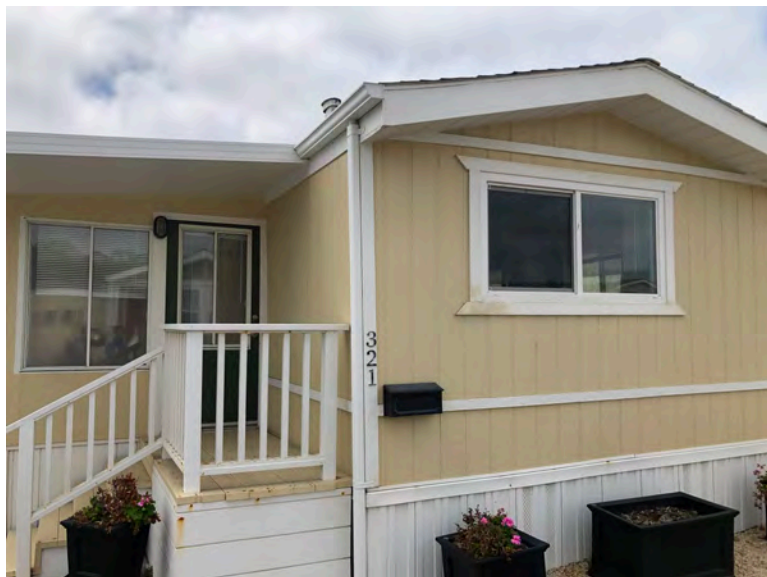
**321 Third Ave - Front elevation. Gable roof with no overhang, typical of original construction. Replacement would have had significant impact on framing and interiors and likely would have been constructed with an overhang.**

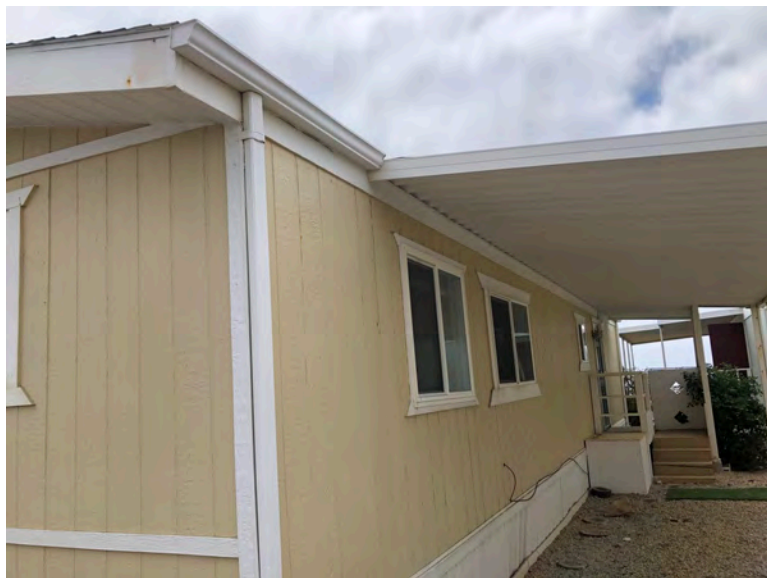
**321 Third Ave - Side view with T1-11 siding. Evidence of non-structural repair and maintenance (e.g., caulking, sealing) of T1-11 wall covering. T1-11 siding typical of original construction. No indication that any removal or replacement of structural wall framing has occurred.**

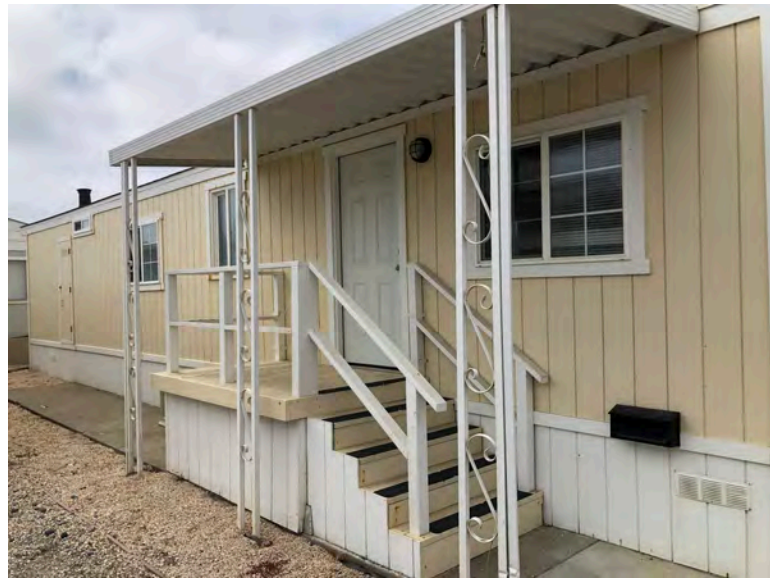
**325 Third Ave - Entrance at side elevation. No roof overhang, typical of original construction. No indication that any removal or replacement of structural roof framing has occurred. Replacement would have had significant impact on wall framing and interiors.**

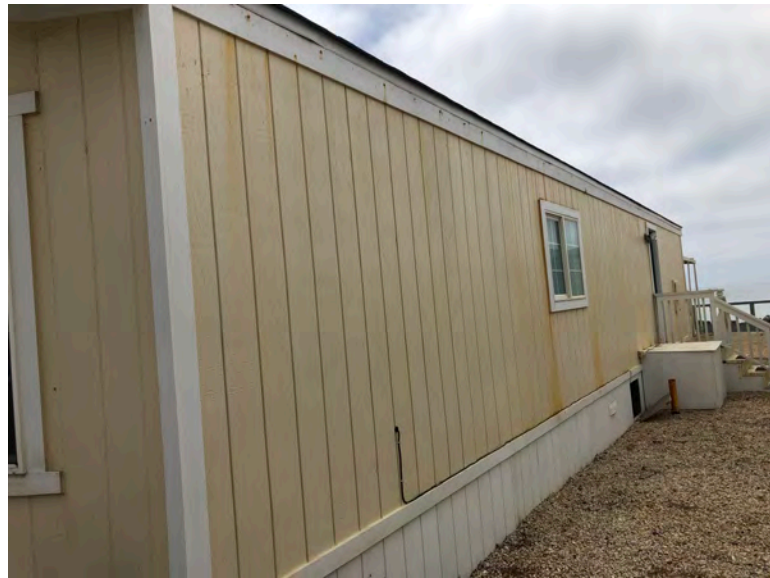
**325 Third Ave - Side view with T1-11 siding. Evidence of non-structural repair and maintenance (e.g., caulking, sealing) of T1-11 wall covering. T1-11 siding typical of original construction. No indication that any removal or replacement of structural wall framing has occurred.**

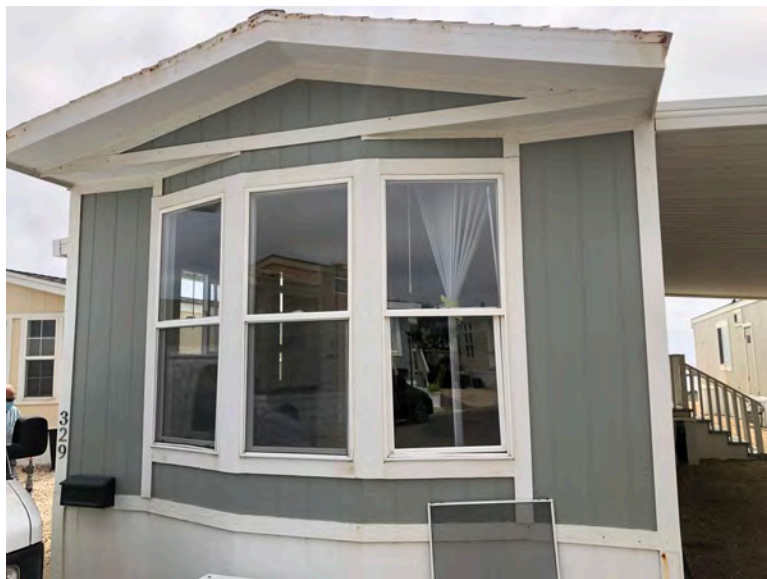
**329 Third Ave - Front elevation. Gable roof construction with no overhang, typical of original construction. No indication that removal or replacement of structural roof framing has occurred. Replacement would have had significant impact on wall framing and interiors and likely would have been constructed with an overhang.**

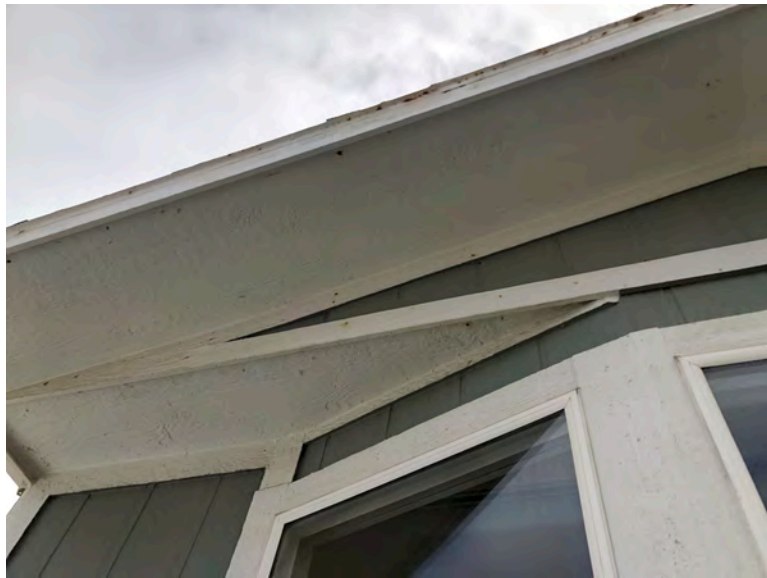
**329 Third Ave - Overhang at front elevation. Boxed soffit, typical of original construction. No indication of structural modifications to wall or roof systems.**

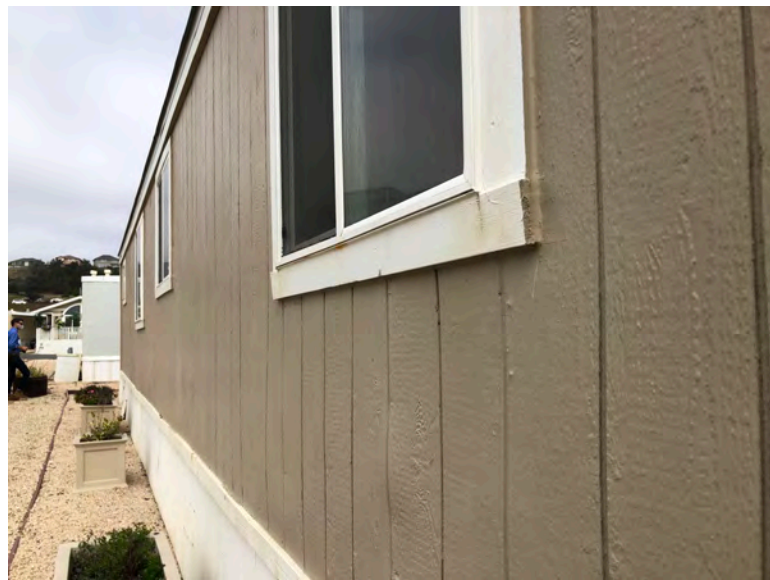
**332 Third Ave - Side elevation. T1-11 siding material typical of original construction.**

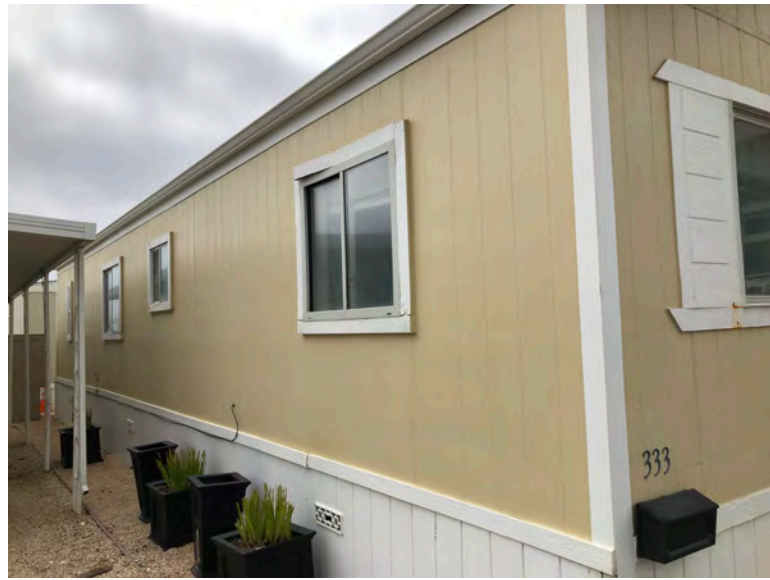
**333 Third Ave - Side view, no overhang. Side view with T1-11 siding. Evidence of non-structural repair and maintenance (e.g., caulking, sealing) of T1-11 wall covering. T1-11 siding typical of original construction. No indication that removal or replacement of structural wall framing has occurred.**

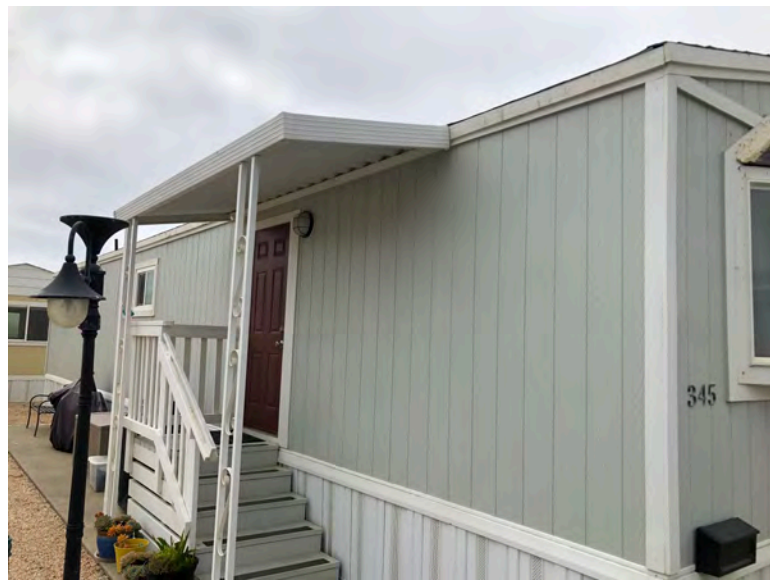
**345 Third Ave - Side view, entry steps. Gable roof, no overhang. T1-11 siding typical of original construction. No indication that removal or replacement of structural wall framing has occurred.**

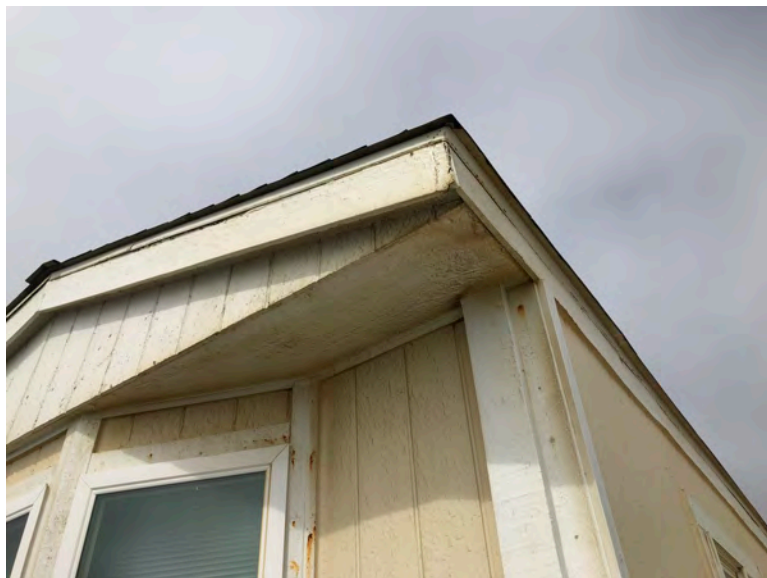
**404 Fourth Ave - Gable roof, no overhang. T1-11 siding typical of original construction. Fascia detail at roof reflecting non-structural repair and maintenance. Fascia typical of original construction.**

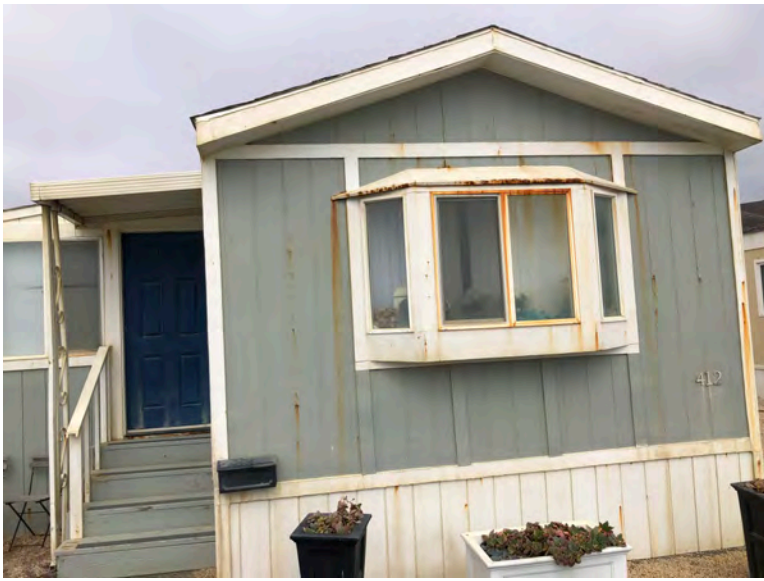
**412 Fourth Ave - Front elevation. Gable roof with no overhang, pop out window, typical of original construction. If roof framing had been replaced, likely would have been built with an overhang.**

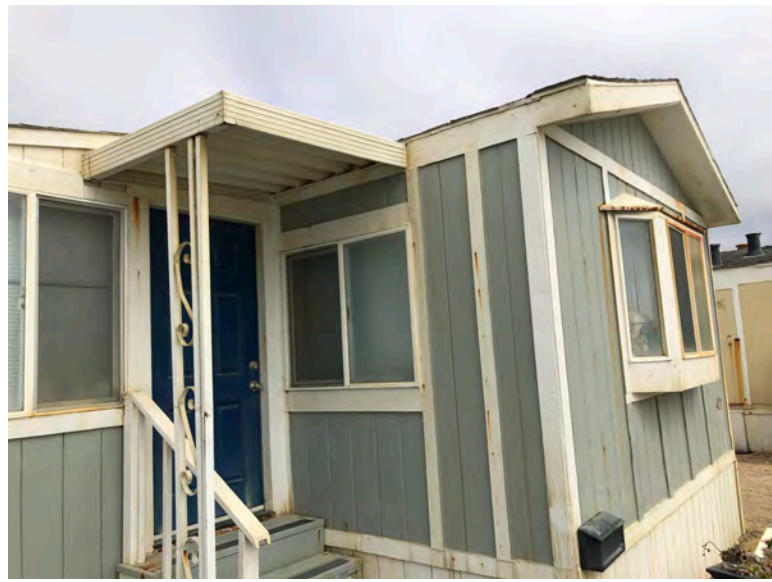
**412 Fourth Ave - Materials and gable roof with little or no overhang typical of original construction. No indication that removal or replacement of structural roofing has occurred. Replacement would have had significant impact on wall framing and interiors and likely would have been built with an overhang.**

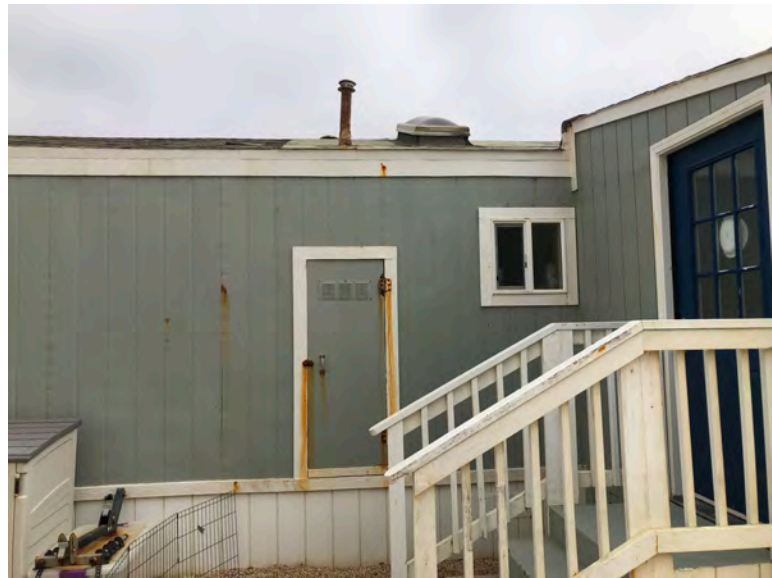
**412 Fourth Ave - Side view, entry steps. Gable roof, no overhang. T1-11 siding typical of original construction. No indication that removal or replacement of structural wall framing has occurred.**

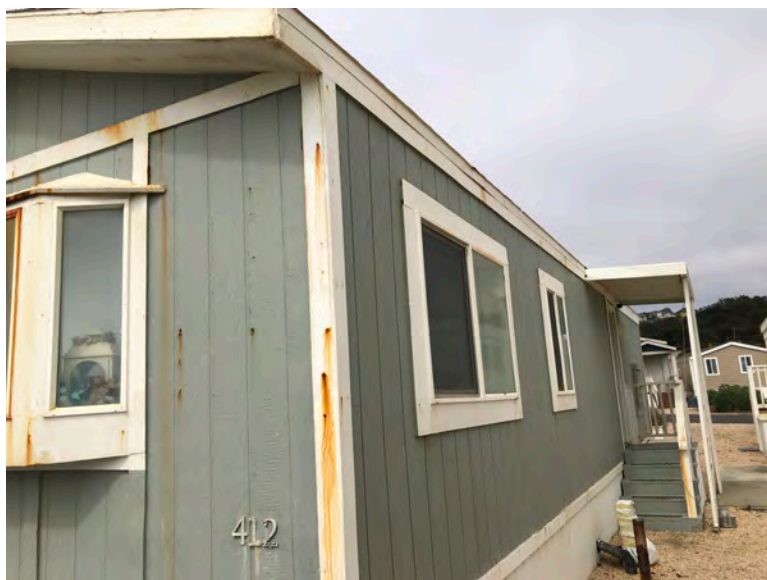
**412 Fourth Ave - Gable roof, no overhang. T1-11 siding typical of original construction. Fascia detail at roof reflecting non-structural repair and maintenance. If roof structural framing had been replaced, boxed eave and fascia would not show similar wear. Replacement of roof elements likely would have included overhang.**

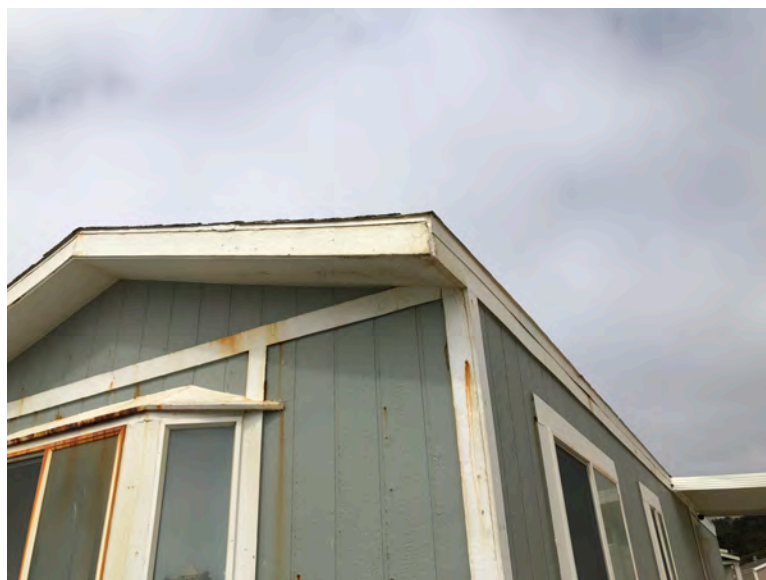
**412 Fourth Ave - Gable roof, no overhang. T1-11 siding typical of original construction. No indication that removal or replacement of structural wall framing has occurred.**

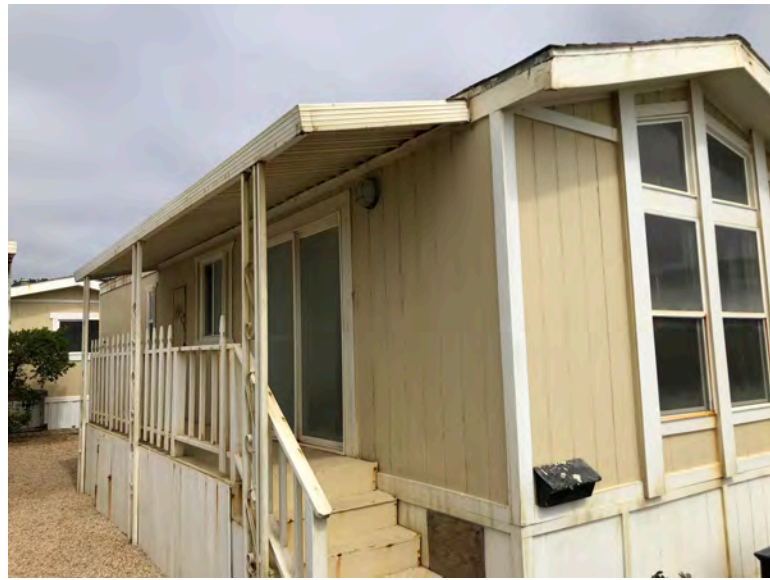
**416 Fourth Ave - Side view. T1-11 siding typical of original construction. Fascia wear at roof. If roof structural framing had been replaced, fascia would not show similar wear. Replacement of roof elements likely would have included overhang.**
