## **CALIFORNIA COASTAL COMMISSION**

**3-83-172-A9 (Viewpointe Armoring)  
November 18, 2022**

**SUBJECT:** Response to California Coastal Commission (CCC) Staff Questions in an August 18, 2022 Email Regarding Shore Protection Maintenance at 1300 Palmetto Avenue, Cottages at Seaside, Pacifica, California.

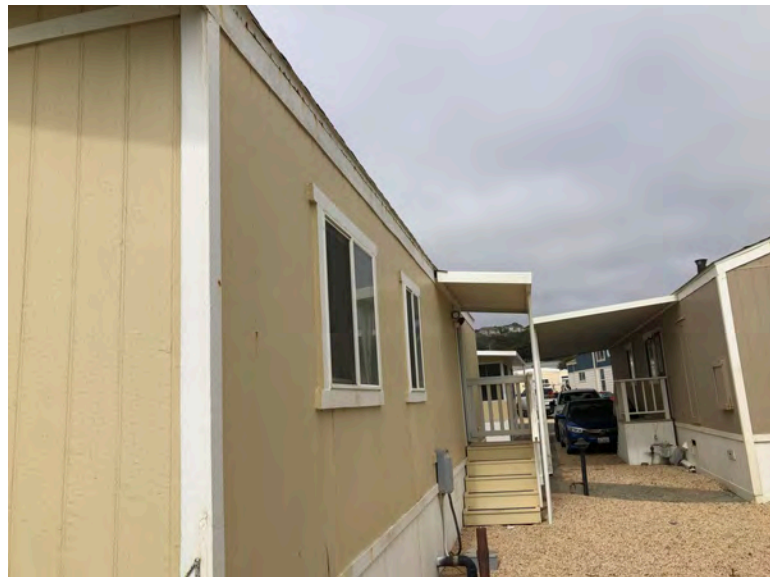
**416 Fourth Ave - Side elevation, entry steps. Gable roof, no overhang. T1-11 siding typical of original construction. No indication that any removal or replacement of structural wall framing has occurred.**

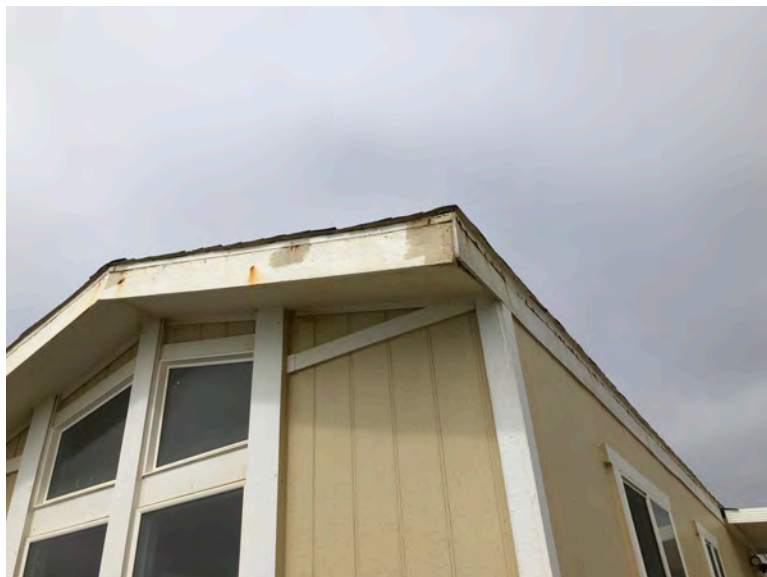
**416 Fourth Ave - Gable roof, no overhang. T1-11 siding and fascia typical of original construction. Fascia wear at roof and indications of repair and maintenance. If roof structural framing had been replaced, fascia would not show similar wear. Replacement of roof elements likely would have included overhang.**

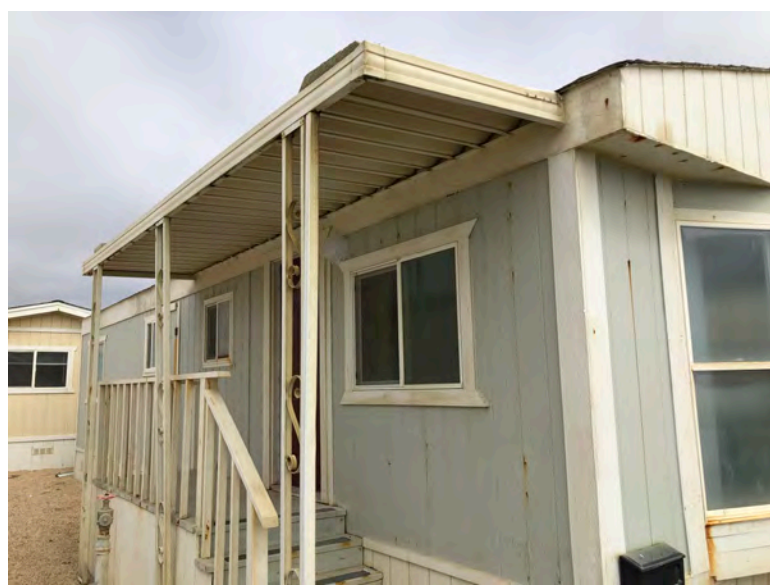
**420 Fourth Ave - Side elevation. T1-11 siding typical of original construction. Evidence of repair and maintenance of T1-11 wall covering. Fascia wear at roof. If roof structural framing had been replaced, fascia would not show similar wear. Replacement of roof elements likely would have included overhang. Evidence of prior window replacement without modification to structural elements.**

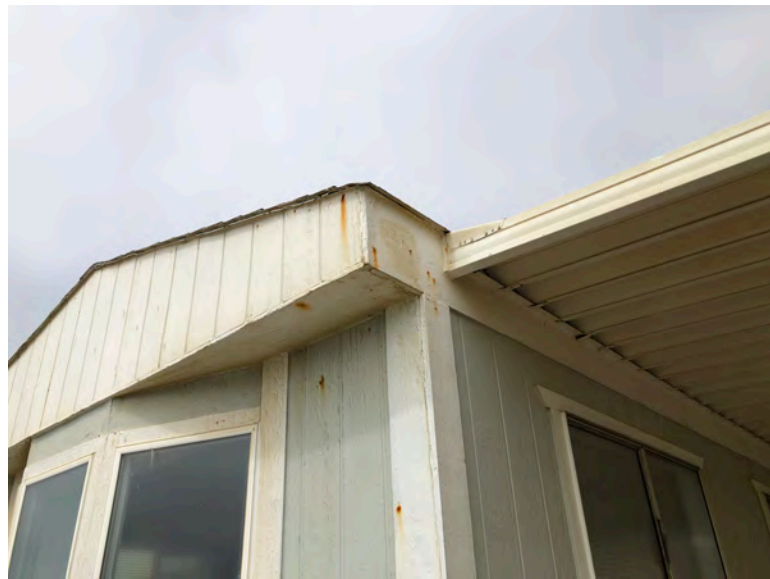
**420 Fourth Ave - Gable roof, no overhang. T1-11 siding typical of original construction. Fascia wear at roof. If roof structural framing had been replaced, fascia would not show similar wear. Replacement of roof elements likely would have included overhang.**

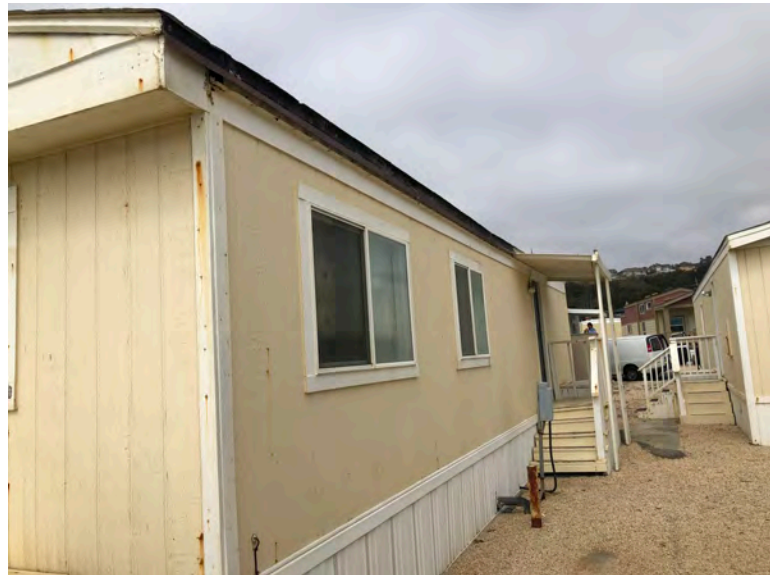
**424 Fourth Ave - Side elevation, entry steps. Gable roof, no overhang. T1-11 siding typical of original construction. No indication that any removal or replacement of structural wall framing has occurred.**

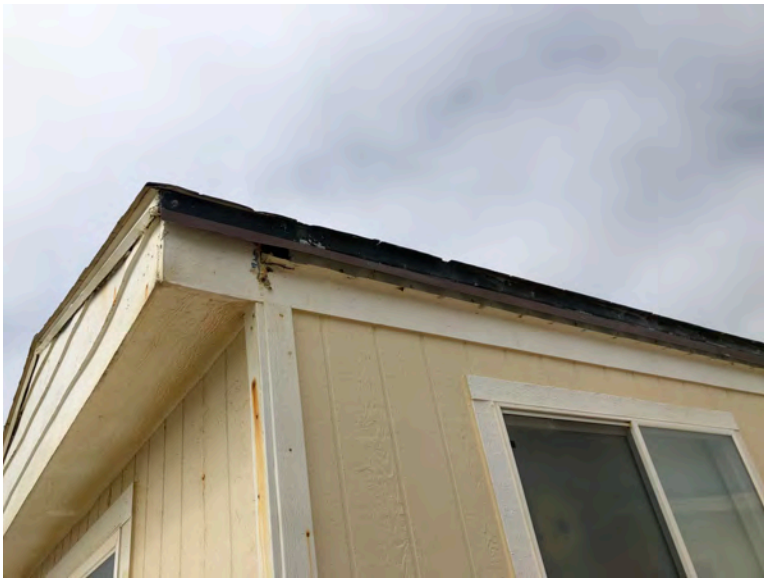
**424 Fourth Ave - Gable roof, no overhang. T1-11 siding and fascia typical of original construction. Fascia wear at roof. If roof structural framing had been replaced, fascia would not show similar wear. Replacement of roof elements likely would have included overhang.**

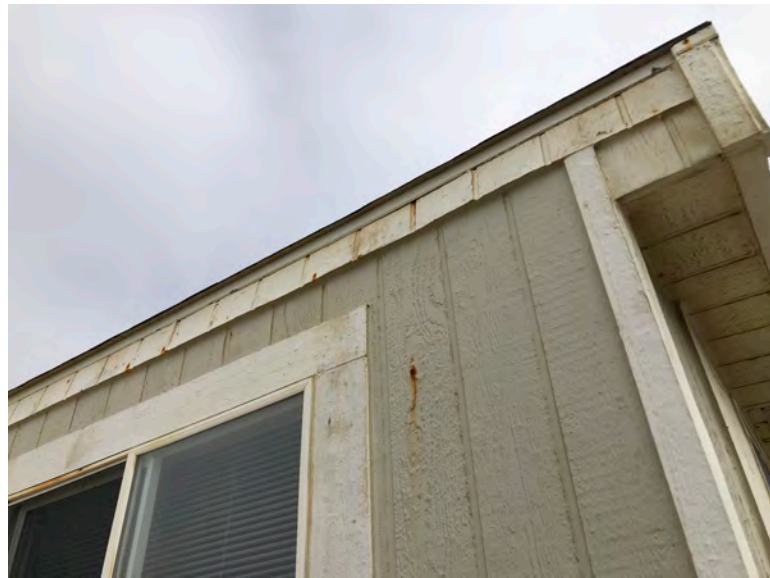
**428 Fourth Ave - Side elevation. Gable roof, no overhang. T1-11 siding typical of original construction. No indication that removal or replacement of structural wall framing has occurred.**

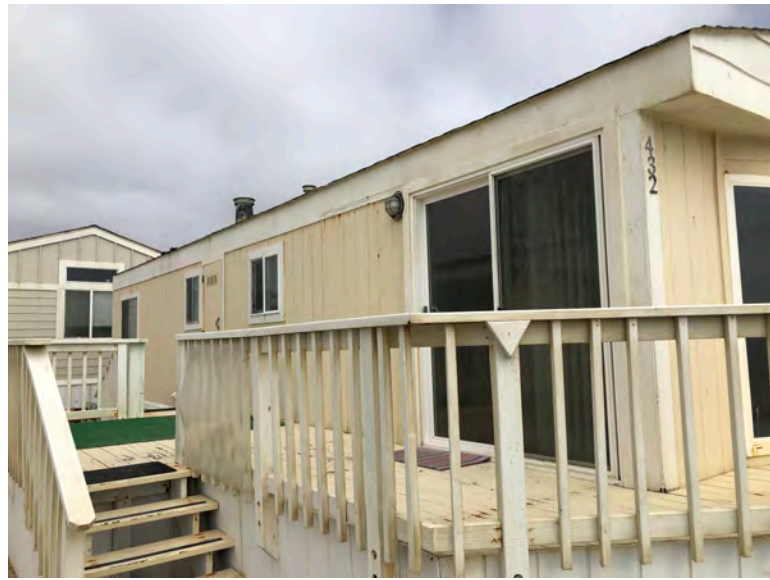
**432 Fourth Ave - Side view. Materials and gable roof with little or no overhang typical of original construction. No indication that removal or replacement of structural roofing has occurred. Replacement would have had significant impact on wall framing and interiors and likely would have been built with an overhang.**

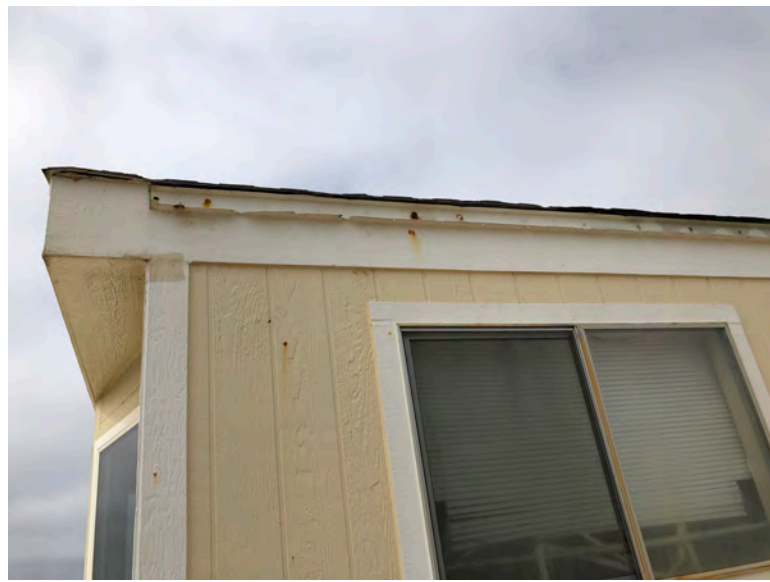
**432 Fourth Ave - Side elevation. Gable roof, no overhang. T1-11 siding typical of original construction. No indication that removal or replacement of structural wall framing has occurred.**

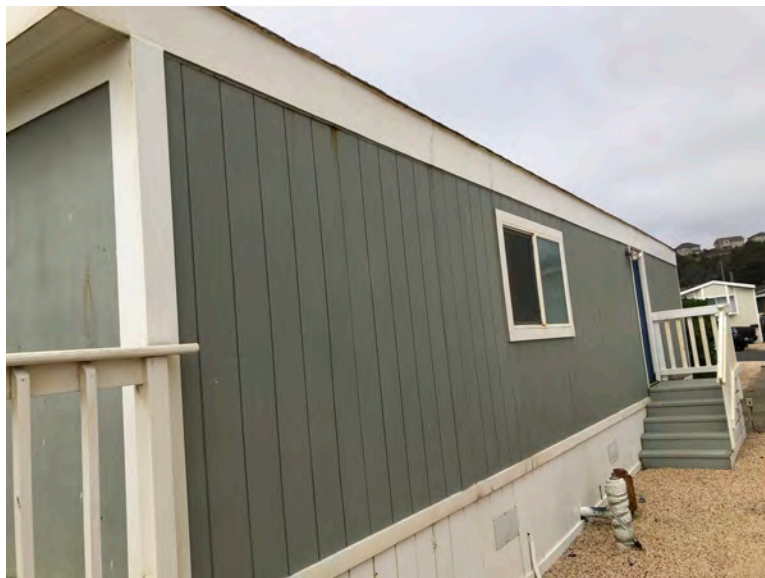
**436 Fourth Ave - Side elevation. T1-11 siding typical of original construction. Fascia wear at roof reflecting original construction. If roof structural framing had been replaced, fascia would not show similar wear. Replacement of roof elements likely would have included overhang.**

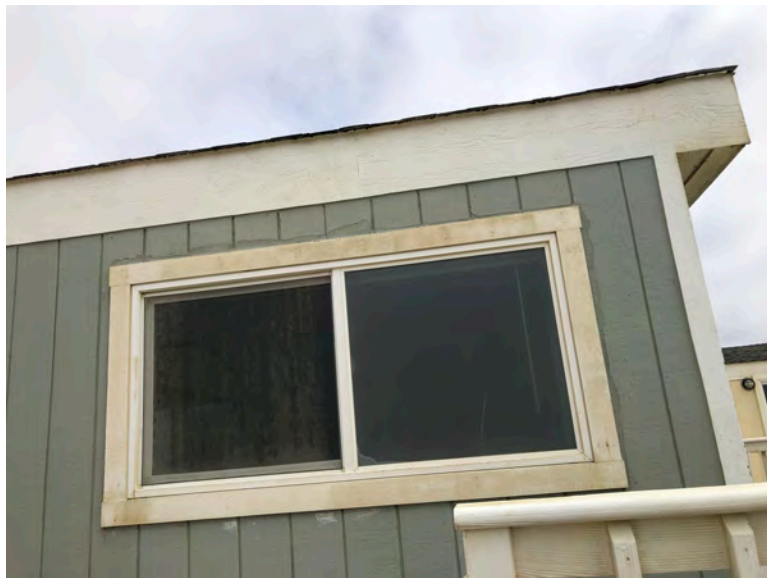
**436 Fourth Ave - T1-11 siding typical of original construction. Evidence of patch and repair of existing wall surface without modifications to structural wall framing. Evidence of prior window replacement without modification to structural wall elements.**
