CALIFORNIA COASTAL COMMISSION

COASTAL DEVELOPMENT PERMIT APPLICATION

Application number3-04-030, Pebble Beach Golf Links, 5th Tee and 5th Green Seawalls

Project location.....Pebble Beach Golf Links 5th Hole, Pebble Beach (Monterey County).

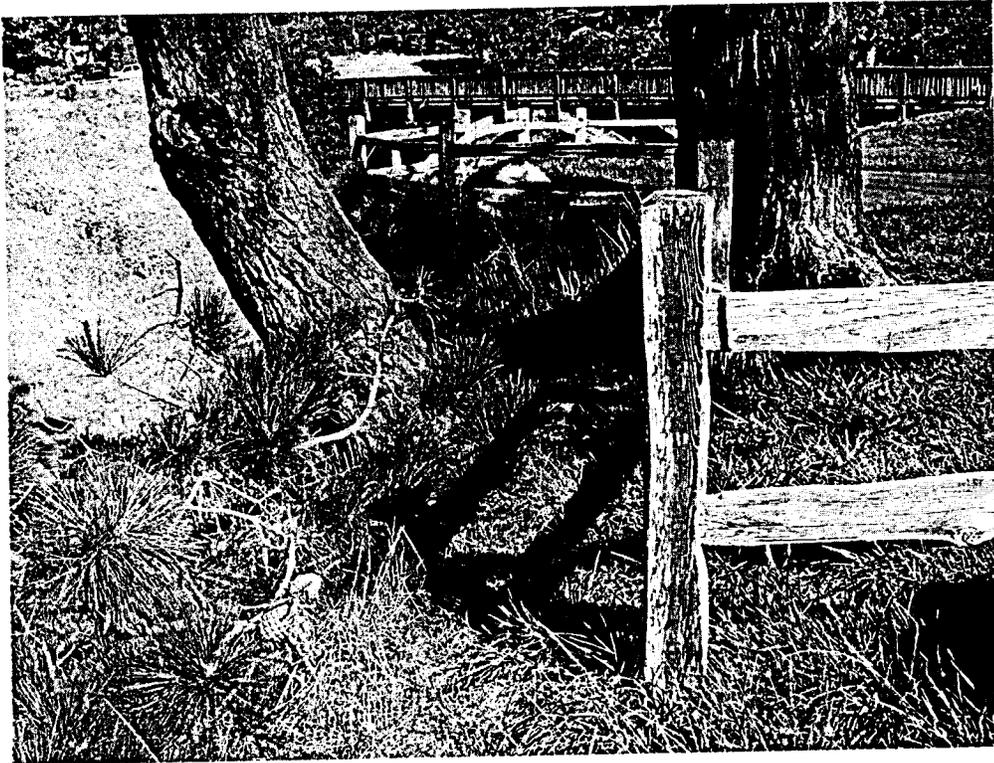
Photo 3.
Staff photo of 5th
Tee – showing tee
box retaining wall
along ravine and
edge of bluff at
undercut tree near
upper tee.

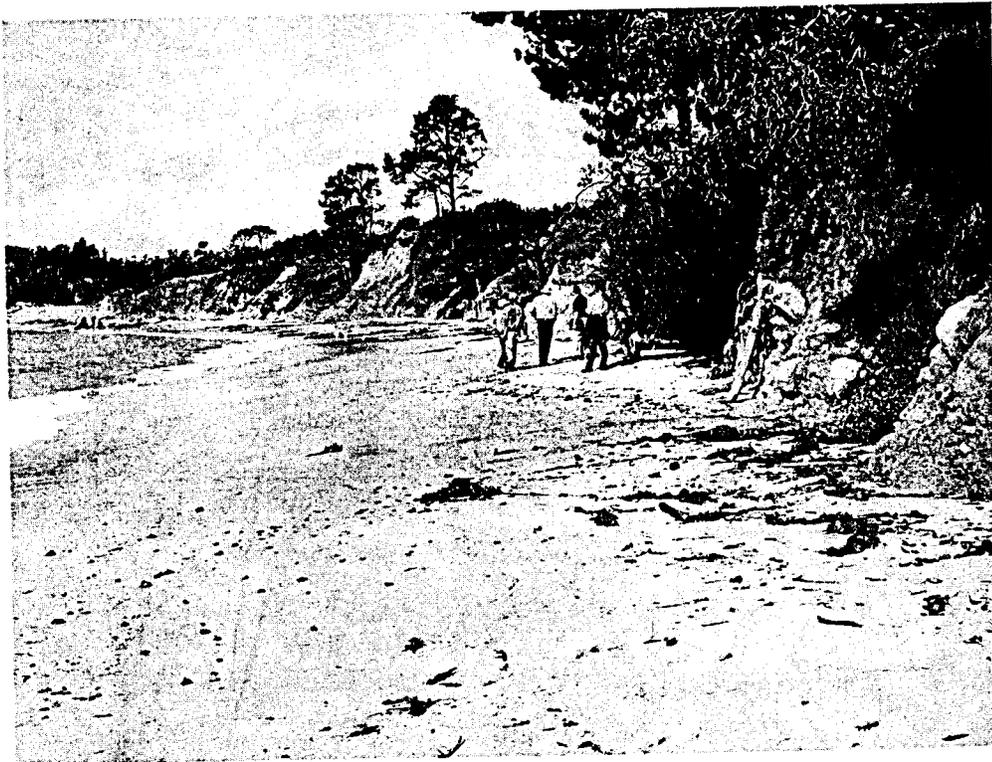
At the 5th tee complex, terrace deposits overlie the bedrock with an average slope inclination of about 55 degrees. Due to wave erosion at the toe, the bluff face at the 5th tee complex is over-steepened. As the toe of the bluff is eroded the bluff top recedes. At the 5th green complex, the bedrock face is near vertical with terrace deposits above sloping at about an average gradient of 35 degrees. Perched groundwater has also been observed above the bedrock contact, saturating the terrace deposits from an elevation of about 11 feet MSL up to about 18 feet MSL. Groundwater levels may fluctuate due to variations in rainfall and other factors.

Photo 4.
Staff photo of bluff
below 5th hole -
showing undercut
area near 5th tee.

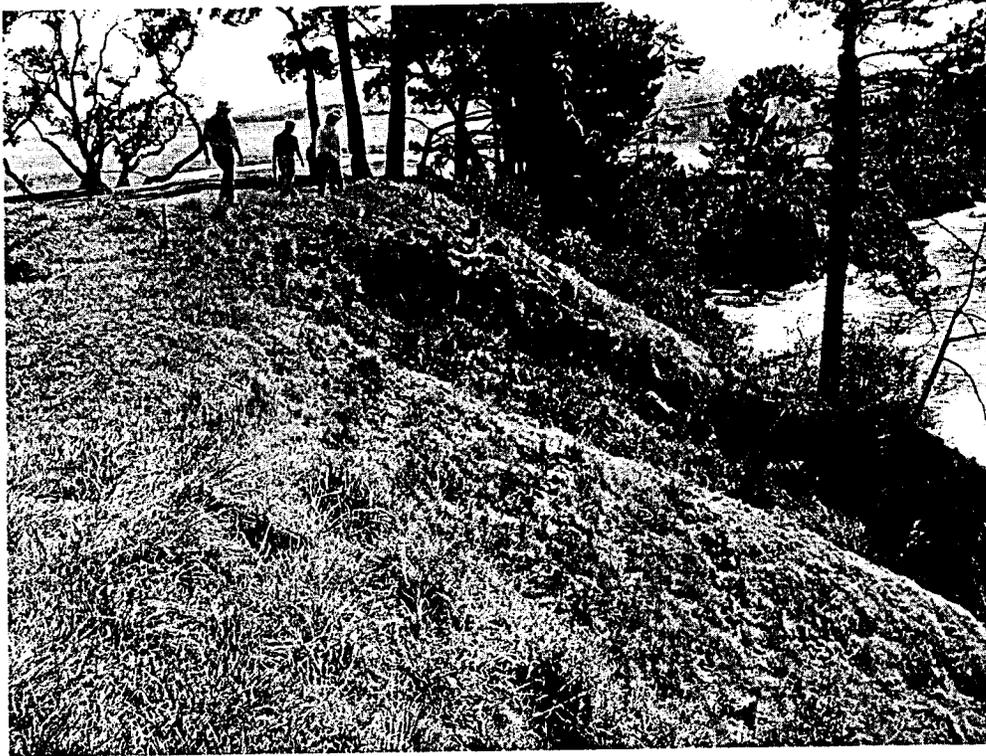
the HKA 5/04 report, the landslide at the 5th green occurred in an area where the bedrock is fractured and so more susceptible to erosion than other non-fractured areas of bedrock; they also noted that this area is one of the areas that is eroding most quickly. Based on measurements taken from project plans, the top of the bluff near the 5th green is about 8 feet from the erosional gulley created by the 2004 landslide and within about 5 feet of the upper scarp of a smaller, more recent surficial slide (see photos in Exhibit F). Bunkers that surround the green are also within about 5 feet of the top of the bluff.

Photo 5.
Staff photo of
landslide scarp
and erosional gully
near 5th green –
bunker to left.

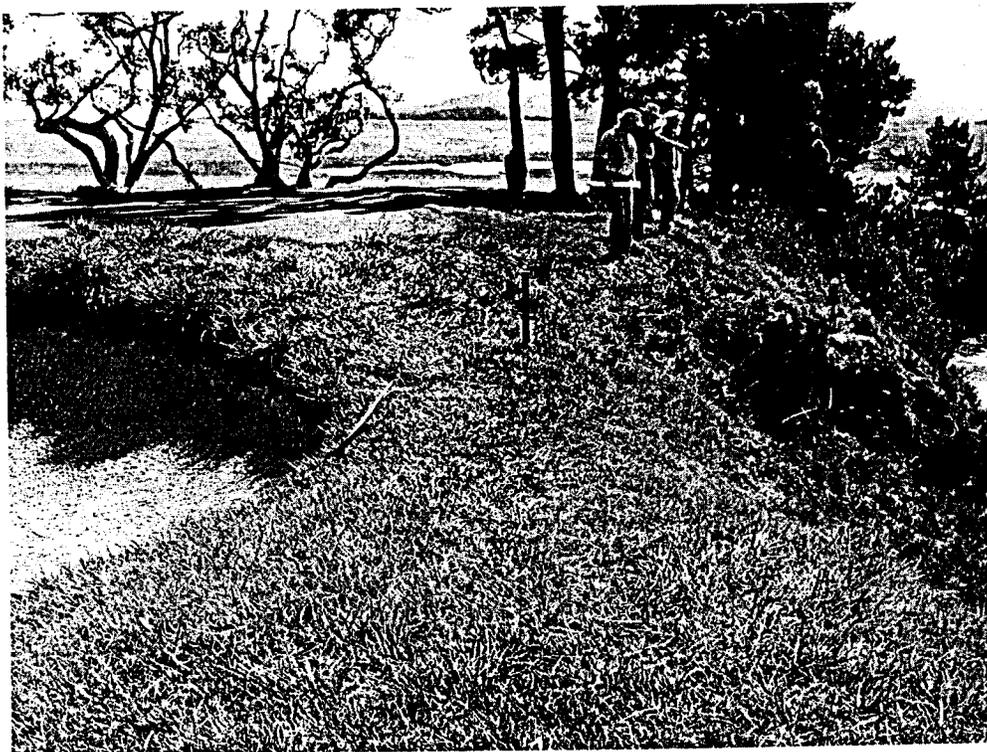
Photo 6.
Staff photo of
proximity of
sandtrap and 5th
green 5th to top of
landslide scarp

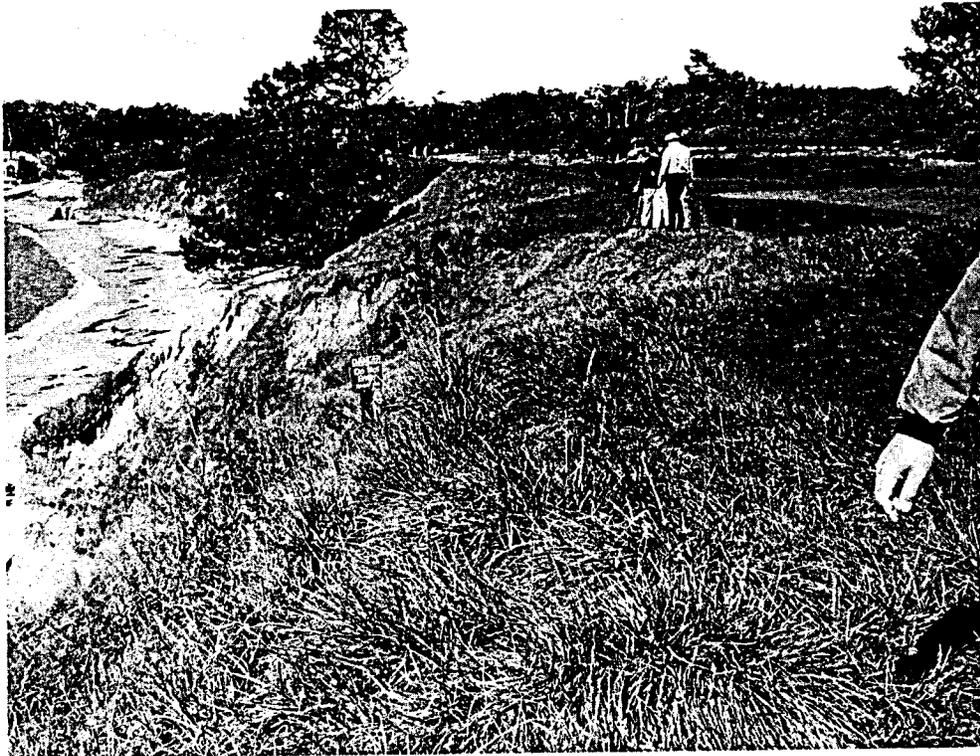
Photo 7.
Staff photo looking
north from 5th
green showing
proximity of hole
to top of bluff.

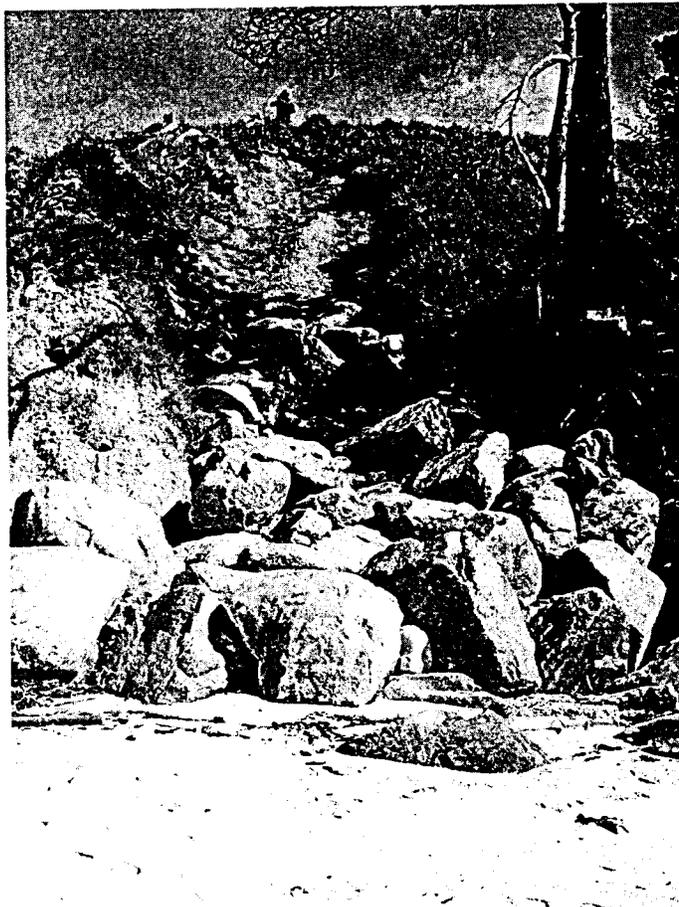
Photo 8.
Staff photo of
emergency
rebetment and
shotcrete in
erosional gully
formed by
landslide below
5th green.
