CITED AND APPLICABLE POLICIES AND IMPLEMENTATION PLAN SECTIONS

BUILDING NO. 23905	STREET, CITY, STATE, ZIP CLIFF DRIVE E, SANTA CRUZ CA 95060	Date of Inspection 1/26/07	No. of Pages 14 <i>15</i>
ANTIQUE TERMITE, INC. 1913 Stone Avenue, San Jose, CA 95125 Ph: (408) 995-6300 (408) 995-0517 Fax			
Firm Registration No. PR 1187	Report No. 37137	Escrow No.	
Ordered By: LITA RUBEL 52 FAIRVIEW PLAZA LOS GATOS, CA 95030 354-4368	Property Owner/Party of Interest LELIA NASLUND C/O LITA RUBEL	Report Sent To:	
COMPLETE REPORT <input checked="" type="checkbox"/>	LIMITED REPORT <input type="checkbox"/>	SUPPLEMENTAL REPORT <input type="checkbox"/>	REINSPECTION REPORT <input type="checkbox"/>
General Description: MULTI LEVEL SINGLE FAMILY DWELLING, WOOD FRAME WITH WOOD SIDING		Inspection Tag Posted: SUBAREA	
		Other Inspection Tags:	
An inspection has been made to the structure(s) shown on the diagram in accordance with the Structural Pest Control Act. Detached porches, detached steps, detached decks and any other structures not on the diagram were not inspected.

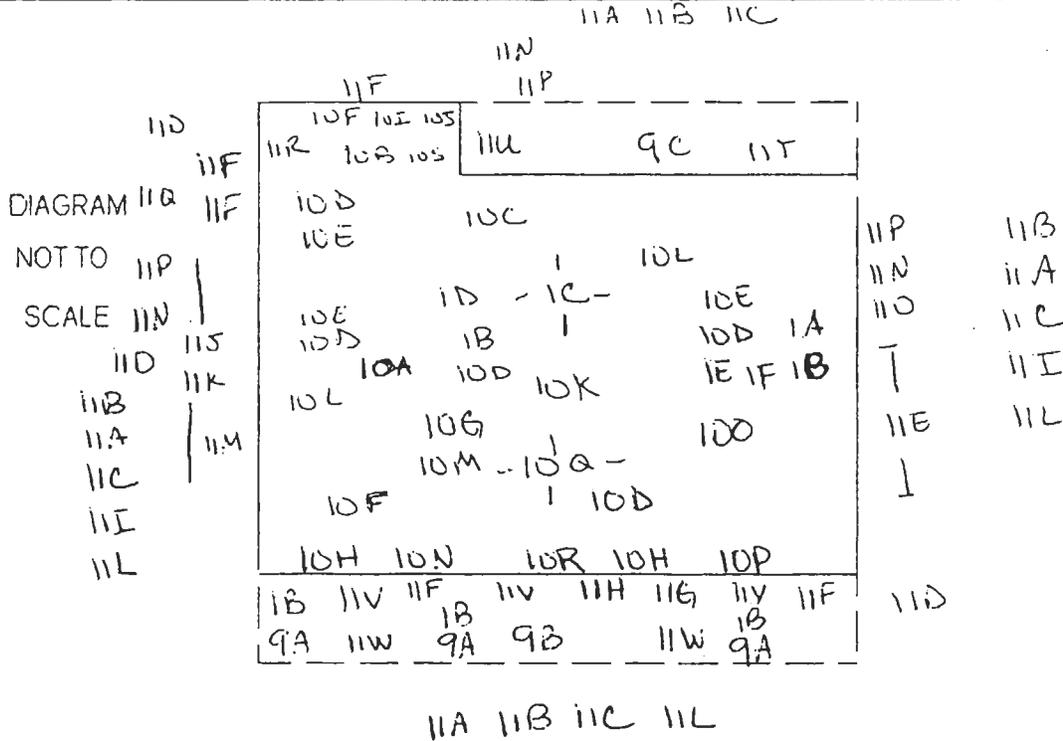
- ITEM 1A FINDING: Evidence of infestation by drywood termites was noted at the basement , interior and exterior. These infestations appear to extend into inaccessible areas.

- ITEM 1B FINDING: Evidence of infestation by drywood termites was noted in item #1A (fecal pellets).

- ITEM 1D FINDING: Fungus damage was noted to the framing at the wall. The extent of the damage is unknown at this time.

- ITEM 1E FINDING: A leak was noted at the 4" cast iron pipe in the subarea.

- ITEM 1F FINDING: The hot water heater was noted to be leaking at the time of this inspection.

ITEM 10D FINDING: Evidence of infestation by drywood termites was noted at the area indicated on the diagram. These infestations appear to extend into inaccessible areas.

ITEM 10F FINDING: Dampwood swarmers were noted at the window at the area indicated on the diagram. No active infestation was noted at this time.

ITEM 10G FINDING: Drywood termite damage was noted to the hardwood T&G ceiling at the area indicated on the diagram.

ITEM 10H FINDING: Fungus damage was noted to wood framed window at the areas indicated on the diagram.

RECOMMENDATION: Seal up and fumigate the entire structure with a lethal gas (VIKANE AND CHLOROPICRIN) for the control of drywood termites in all areas of the structure. Remove the seals for reoccupancy. NOTE Antique Termite is not liable for any damage which may occur to roof or plant life during fumigation. Fumigation cannot begin during inclement weather. In the case of rain or strong winds the job may be postponed to a later date. Additional information will be shown on the Occupants Fumigation Notice which must be signed and returned to the fumigation department before the fumigation date. Structure must be vacated for two nights (one night to fumigate,one night to allow for proper ventilation.) All preparation work to get structure ready for fumigation is owner/occupants responsibility. Should owner desire a fumigation prep company to do the necessary prep-work, they should contact Fumigation Department-there is a cost for this service, which will be in addition to price for fumigation.

RECOMMENDATION: In compliance with the Structural Pest Control Board, remove or mask over all accessible drywood termite evidence (pellets) upon completion of treatments.

RECOMMENDATION: Remove sheetrock to determine the extent of daamage, at that time we will issue a supplemental report outlining findings, recommendations, and any additional cost. NOTE: At this time this bid is for opening the sheetrock and perform a further inspection only.

RECOMMENDATION: Owner is advised to contact a licensed plumber to survey and repair as needed.

RECOMMENDATION: Other trades to remove and replace the hot water heater.

RECOMMENDATION: Seal up and fumigate the entire structure with a lethal gas (VIKANE AND CHLOROPICRIN) for the control of drywood termites in all areas of the structure. Remove the seals for reoccupancy. NOTE Antique Termite is not liable for any damage which may occur to roof or plant life during fumigation. Fumigation cannot begin during inclement weather. In the case of rain or strong winds the job may be postponed to a later date. Additional information will be shown on the Occupants Fumigation Notice which must be signed and returned to the fumigation department before the fumigation date. Structure must be vacated for two nights (one night to fumigate, one night to allow for proper ventilation.) All preparation work to get structure ready for fumigation is owner/occupants responsibility. Should owner desire a fumigation prep company to do the necessary prep-work, they should contact Fumigation Department-there is a cost for this service, which will be in addition to price for fumigation.

RECOMMENDATION: Owner is advised to schedule periodic inspections for dampwood termites.

RECOMMENDATION: Remove and replace the drywood termite damaged sections with new materials. Other trades to paint or stain as needed.

RECOMMENDATION: Owner is advised to contact the appropriate licensed tradesperson to remove and repalce the damaged window frames.
