CALIFORNIA COASTAL COMMISSION

1-09-050

> Mad River Streambank Protection Project **Project Description**

Photograph Log Mad River Streambank Protection Project School Road McKinleyville, Humboldt County, California

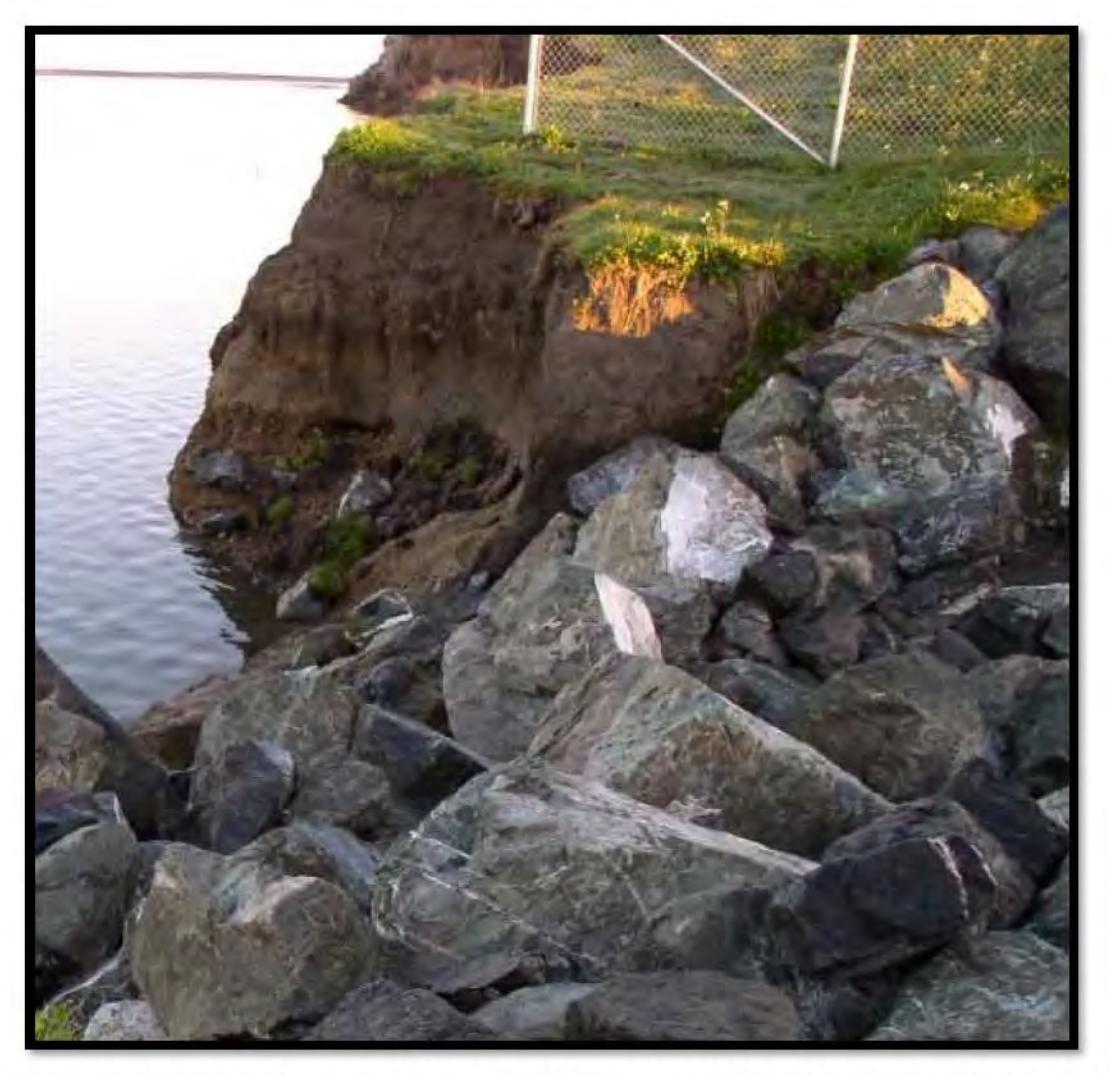
Photograph 2. School Road stormwater outfall February 2005. Note width of bluff between fence post and the Mad River. Image taken facing north and downstream.

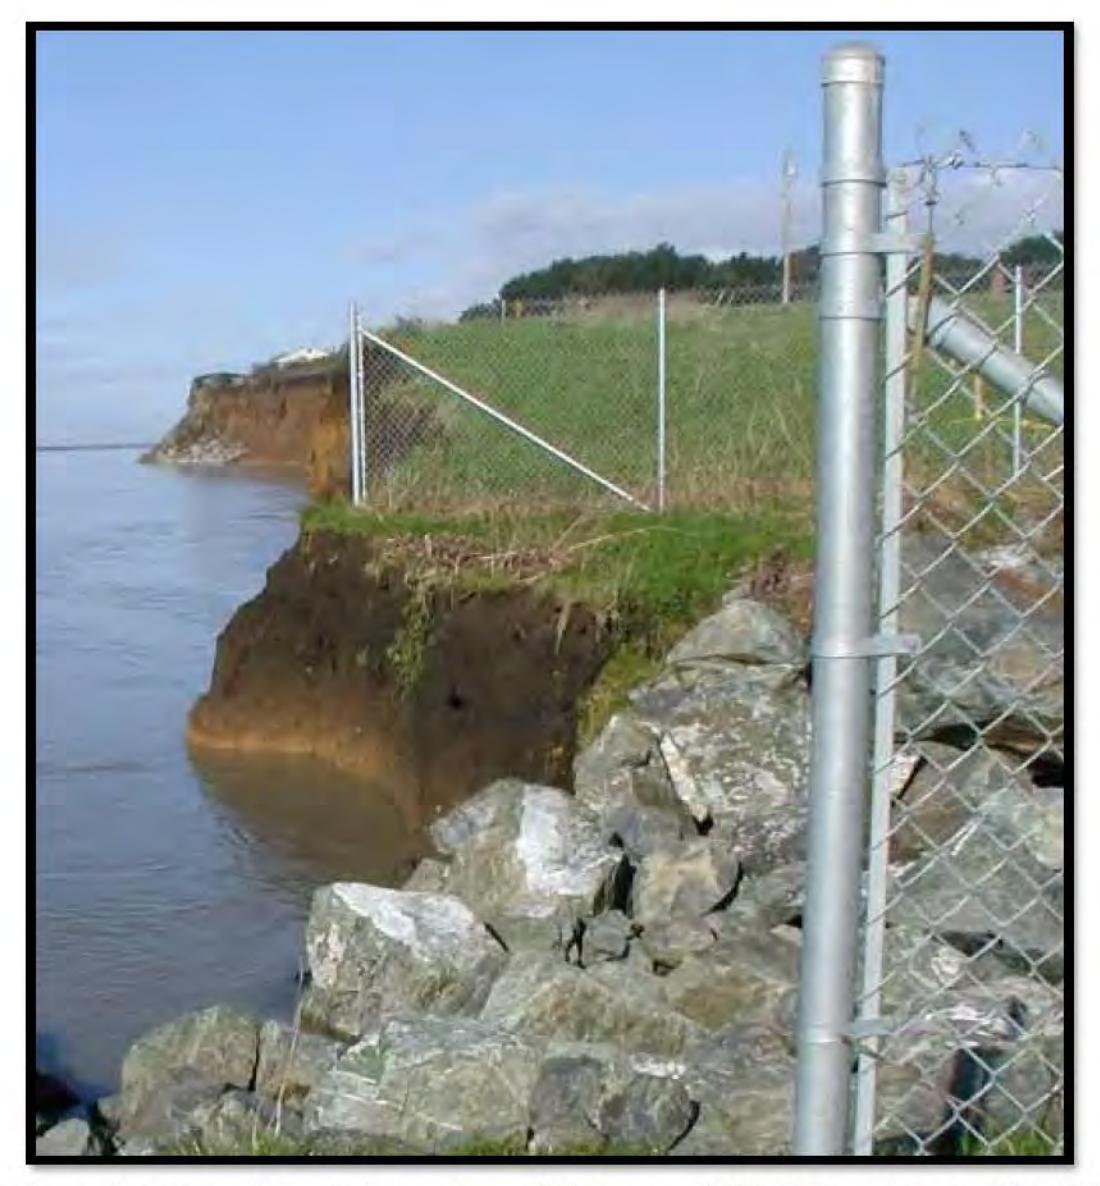
Photograph 3. School Road stormwater outfall January 2006. Note reduced width of bluff between fence post and the Mad River when compared to Photograph 2. Image taken facing north and downstream.

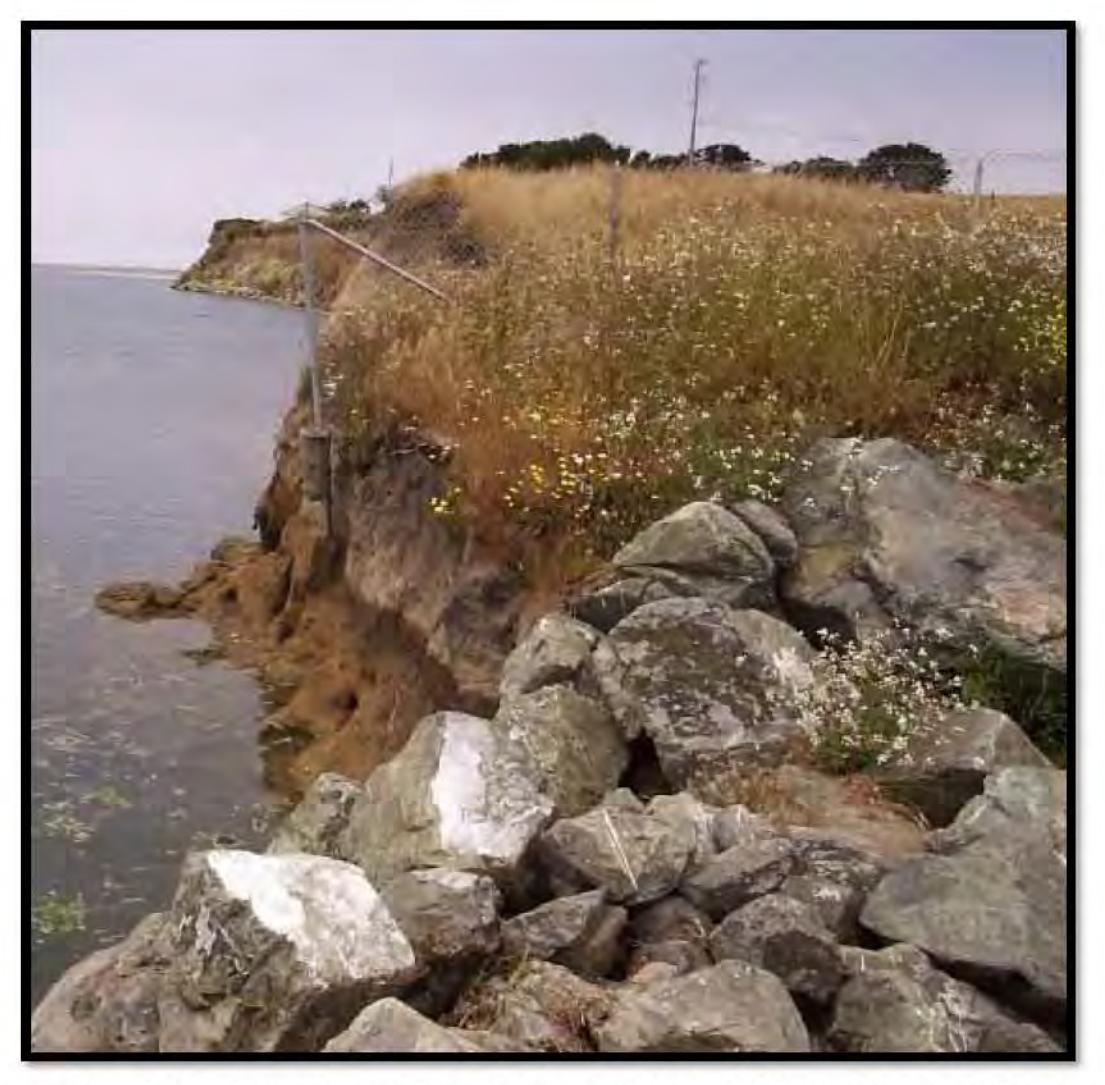
Photograph 4. School Road stormwater outfall June 2008. Bluff between fence post and the Mad River has completely eroded when compared to Photographs 2 and 3. The once bluffembedded post concrete base is now suspended off the bluff edge; an estimated three feet of retreat occurred at this point between 2005 and 2008. Image taken facing north and downstream.

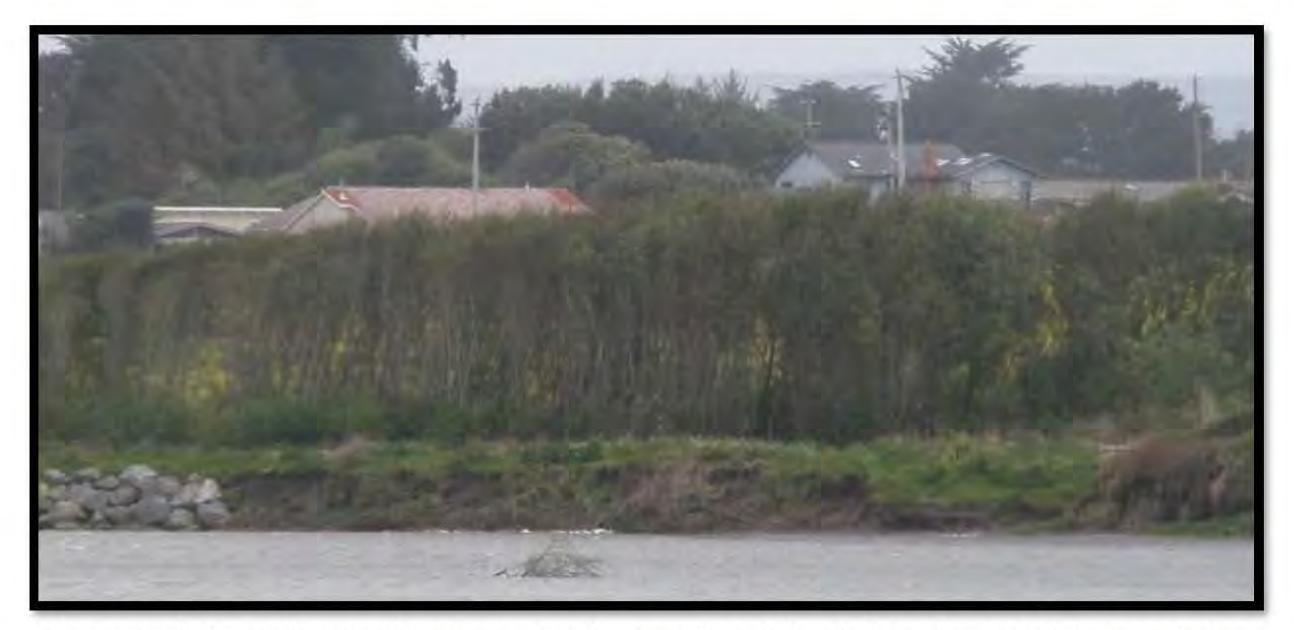
Photograph 11. Evidence of post-construction erosion of the right bank south (upstream) of revetment bay 15 in April 2010. Visible right bank erosion evident in this image has since stabilized, as is apparent in Photographs 19 and 21. Image taken facing north and downstream.

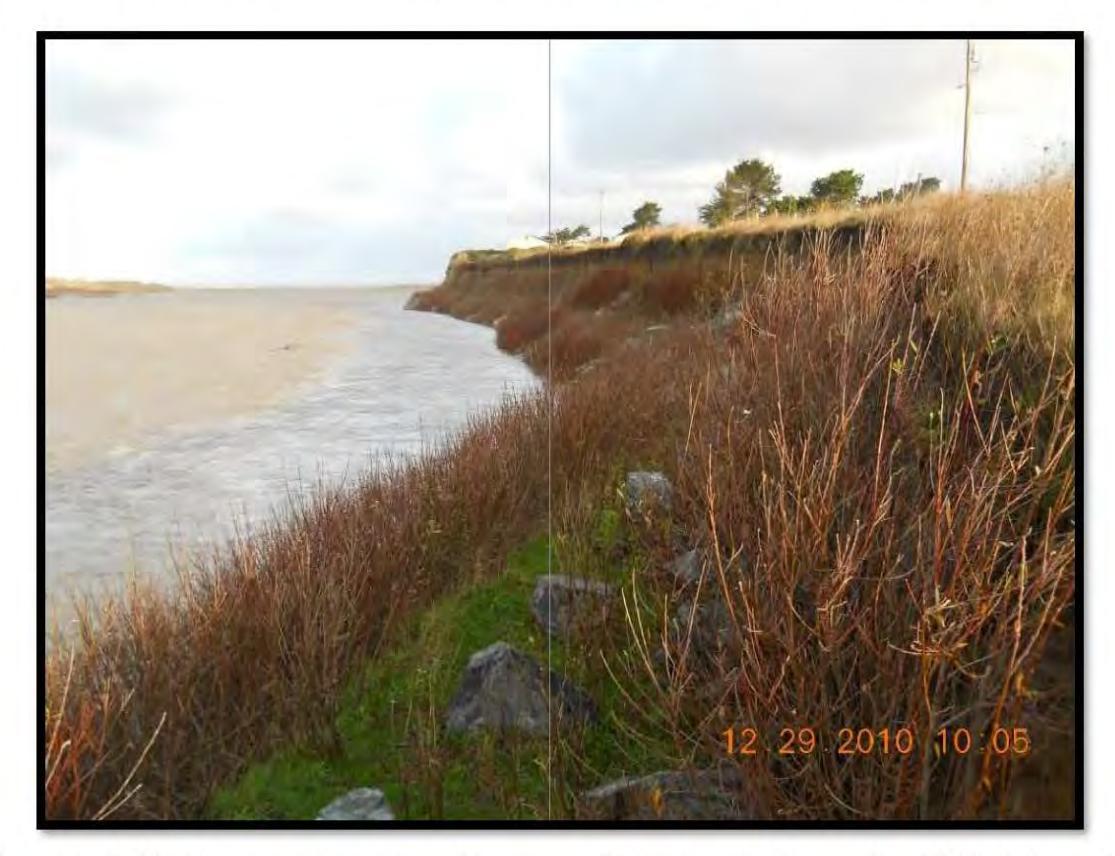
Photograph 12. Revetment as viewed from top of structure in December 2010 during a high discharge event; recorded discharge exceeded 30,000 cfs on this date. Image taken facing

north and downstream.

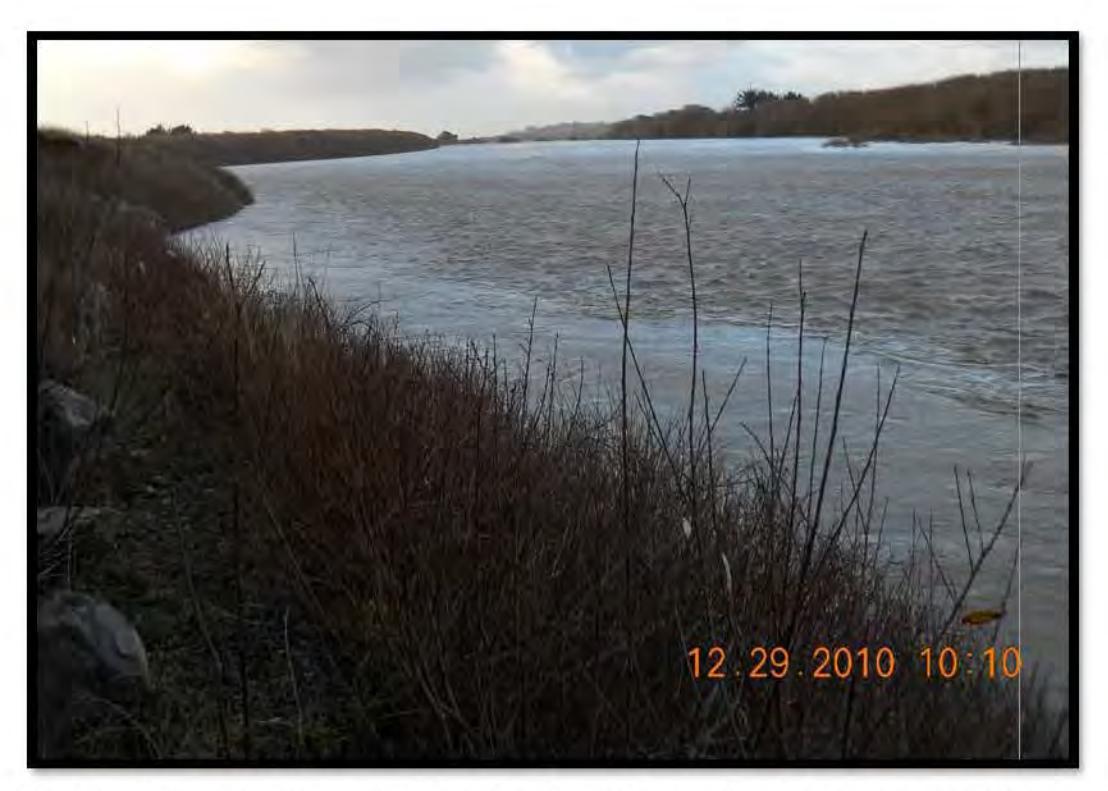
Photograph 13. Revetment south of School Road in December 2010 during a high discharge event; recorded discharge exceeded 30,000 cfs on this date. Image taken facing south and upstream.

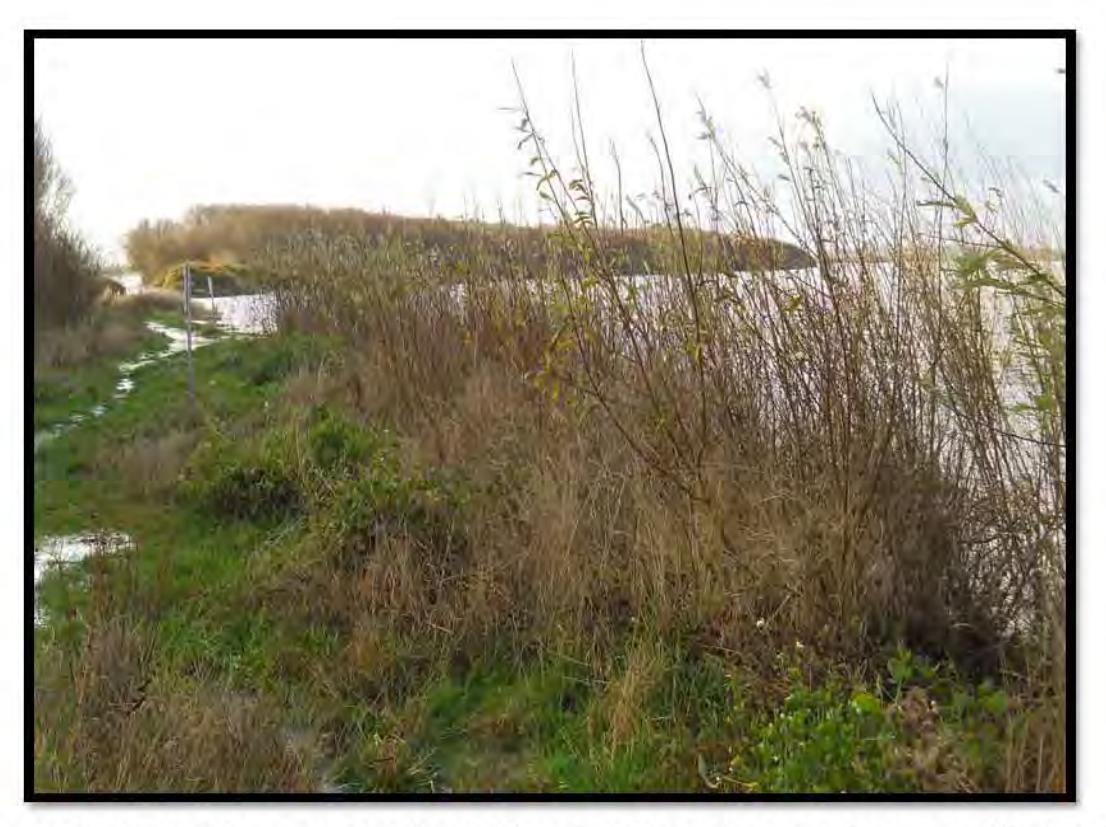
Photograph 14. Upstream revetment bay 15 south of School Road in December 2010 during a high discharge event; recorded discharge exceeded 30,000 cfs on this date. The Mad River access trail from School Road is visible on the left-hand side of the image; the current state of the access trail is presented in Photograph 28. Image taken facing south and upstream.

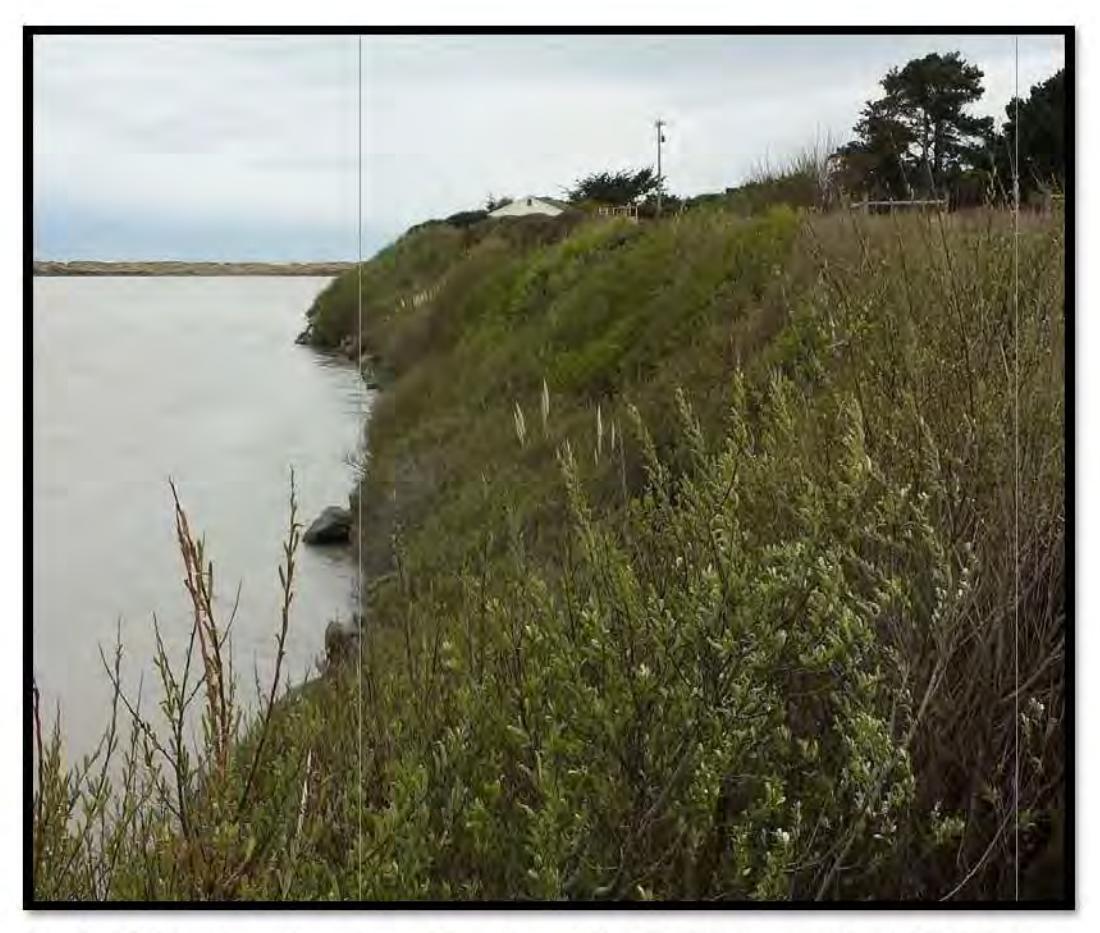
Photograph 16. Revetment as viewed from top of the bluff terrace in April 2018. Willow growth to bluff edge provides added layer of safety for members of public using this public space when compared to exposed vertical edge pre-construction. Image taken facing north and downstream.

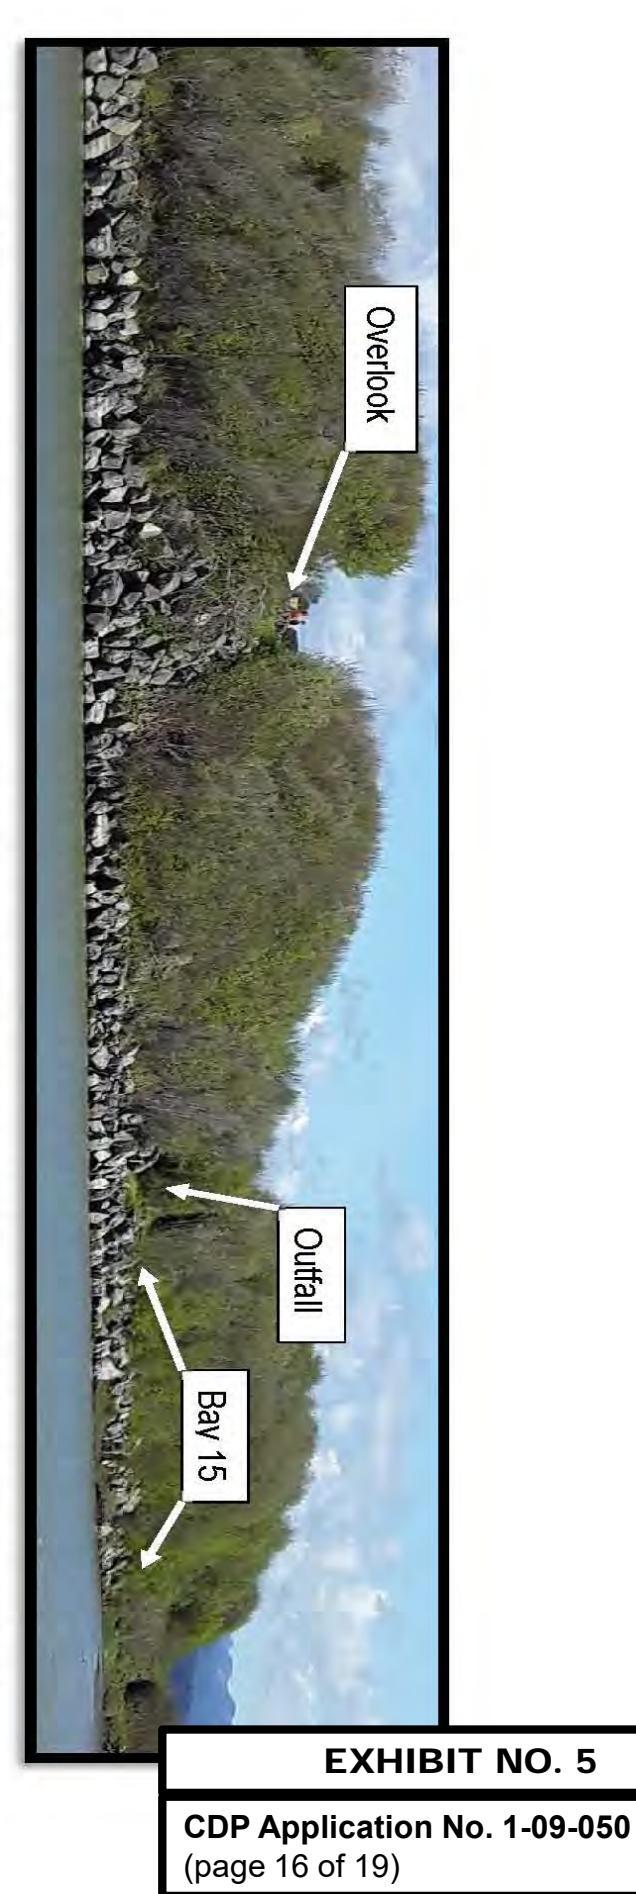
Photograph 19. Revetment upstream extent as viewed from the western bank of the Mad River in April 2020. Revetment flanking protection is provided by vegetated bay 15 upstream of the stormwater outfall. Image taken facing southeasterly.

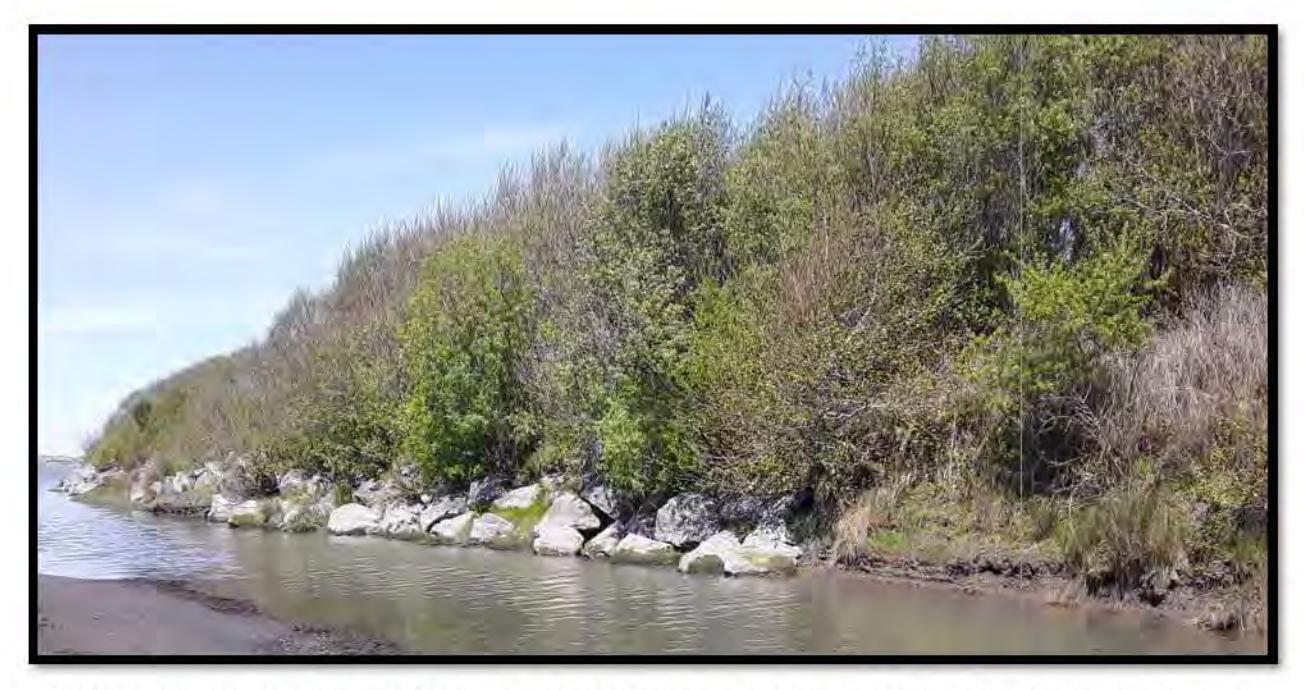
Photograph 21. Revetment bay 15 as viewed from an upstream Mad River gravel bar in April 2020. Note scour channel adjacent to bank. Mad River access path from School Road noted in Photographs 14 and 25 is in the willows along the bank. Image taken facing north and downstream.

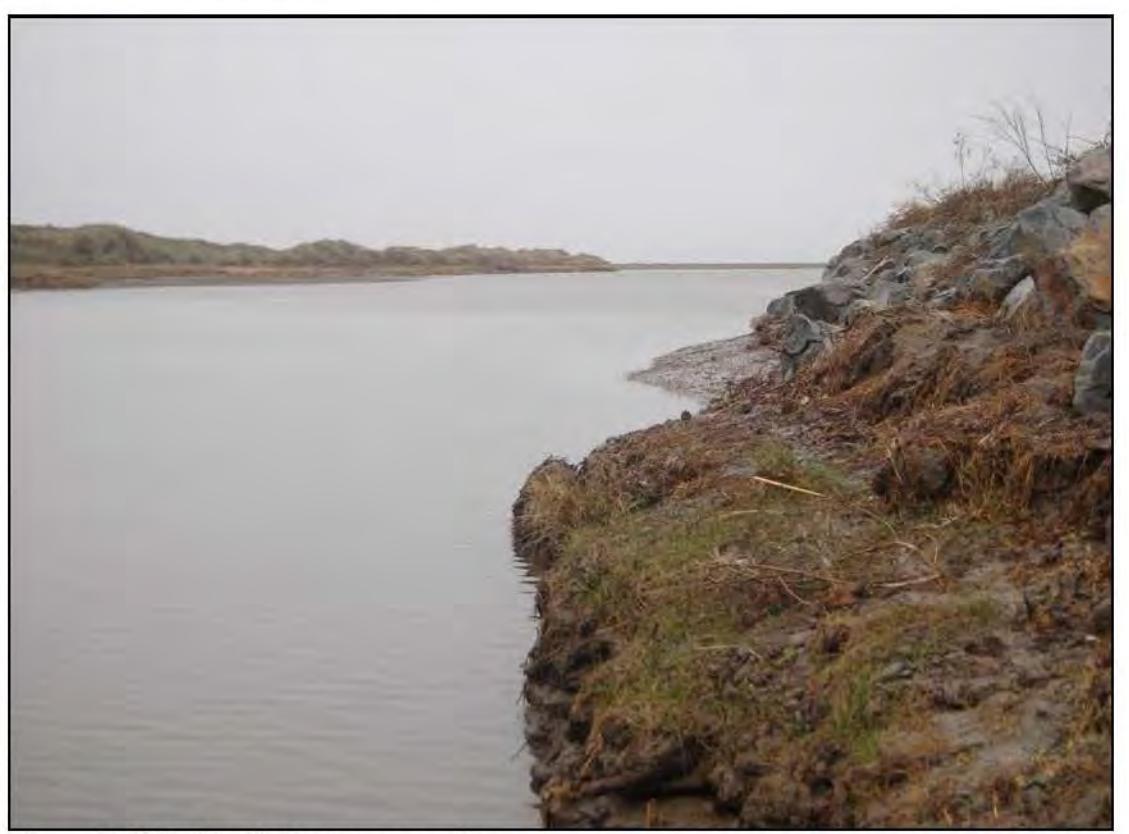
Figure 3: Salt Marsh Post-construction

- **2.1:** <u>As-Built Area Description:</u> Construction affected an area approximately 3ft. wide by 80ft long or 240 ft^2 along the bank side of the strip of salt marsh habitat. The remainder of the salt marsh area was not disturbed.
- 2.2 <u>Vegetation:</u> The species growing along the highest portion of the salt marsh were most affected by construction. The lower salt marsh habitat which contained the most intact vegetation was minimally impacted.
- 2.3 <u>Post Construction Mitigation:</u> The contractor was able to salvage large clumps (2ft x 2ft) of American three-square (*Scirpus americanus*) rhizomes which were then placed along the base of the rock rip rap.

- **1.4** <u>Mitigation for Potential Disturbance of Salt March Vegetation</u>: Any vegetation affected by placement of the rock will be salvaged and replanted once placement of the rock has been completed.

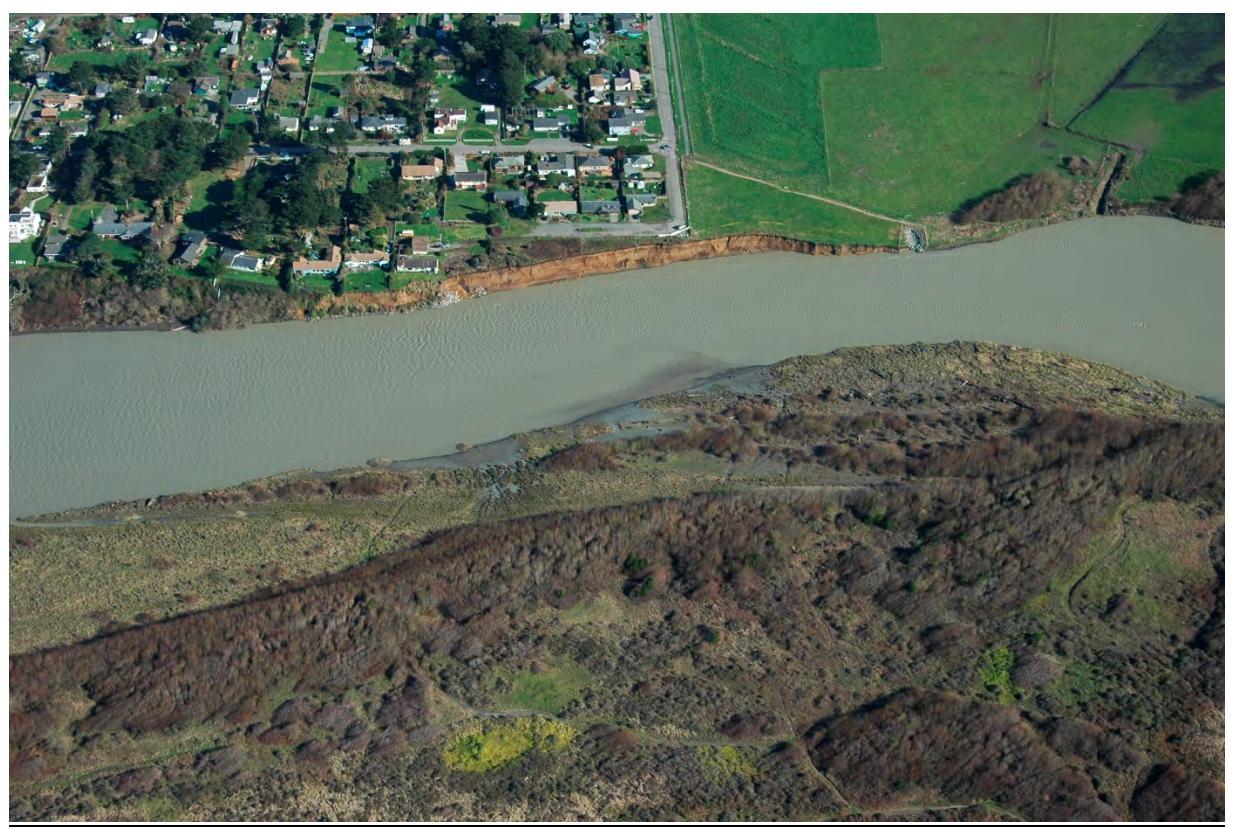
Bluff erosion initiated near the intersection of the surface expression of a fault trace of the Mad River Fault Zone and the right bank of the Mad River, approximately 700 feet south of School Road. North of the fault trace, the bluff is formed by late Pleistocene marine deposits comprised of moderately to poorly cemented interbedded silty sands and gravel conglomerate (Stillwater, 2008). South of the fault trace, surface deposits typically comprise unconsolidated Holocene fluvial deposits (gravel, sand, and silt).

Photo 1: View facing east (January 22, 2006).

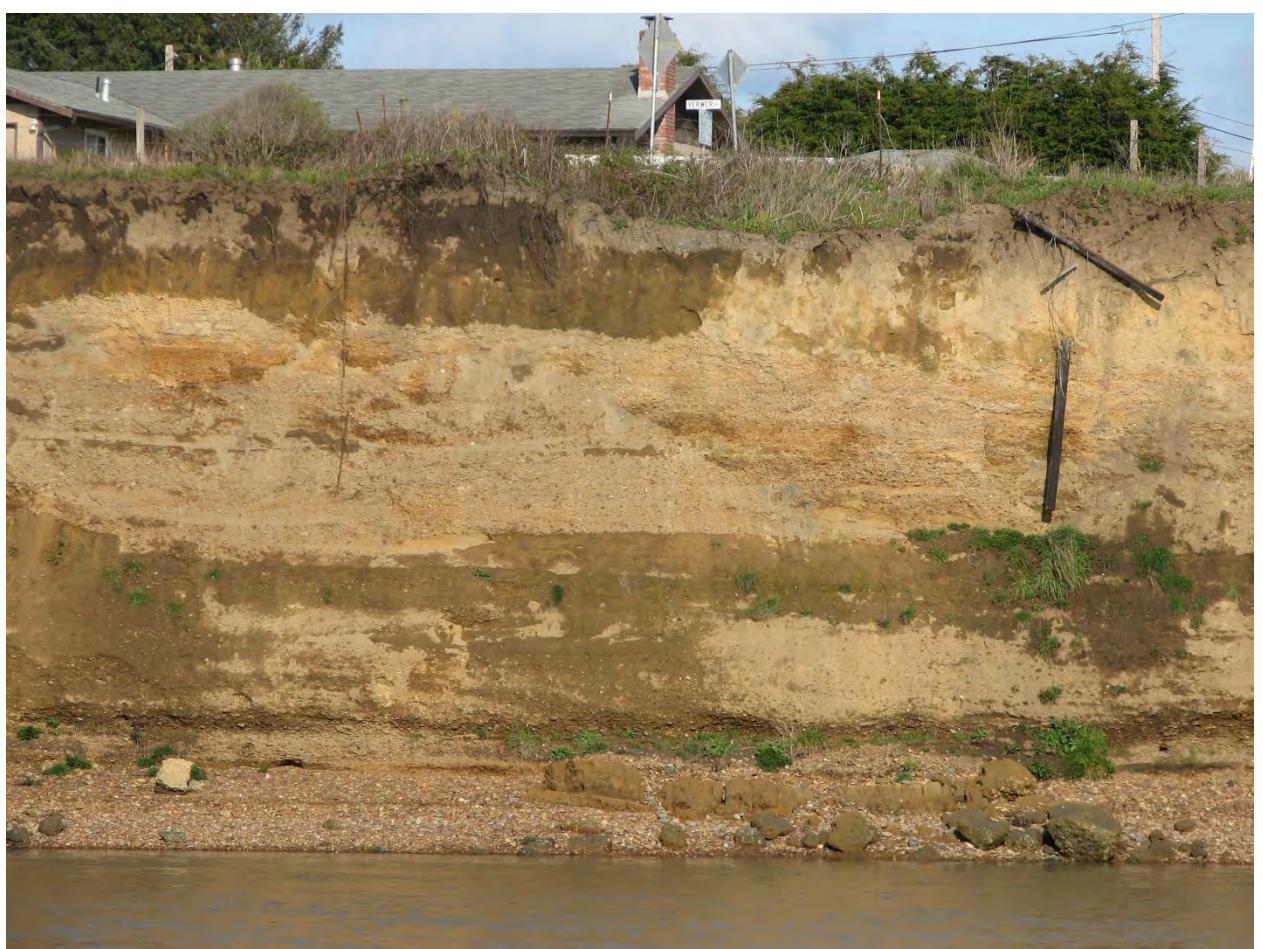
Photo 3: Representative pre-project photo of Segment 1 (March 20, 2006).
