CDP 5-17-0253-A1 (CALIFORNIA DEPT. OF FISH &
WILDLIFE)
AUGUST 12, 2020

Exhibit 2 -- *Habitat Impacts Related to Ballona Wetlands Ecological Reserve, Playa Del Rey, CA*, prepared by Dr. Jonna Engel, CCC Senior Ecologist, July 23, 2020

FROM: Jonna D. Engel, Ph.D., Senior Ecologist
TO: Mandy Revell, Coastal Program Analyst
SUBJECT: Habitat Impacts Related to Unpermitted Drains in Ballona Wetlands Ecological Reserve
DATE: July 23, 2020

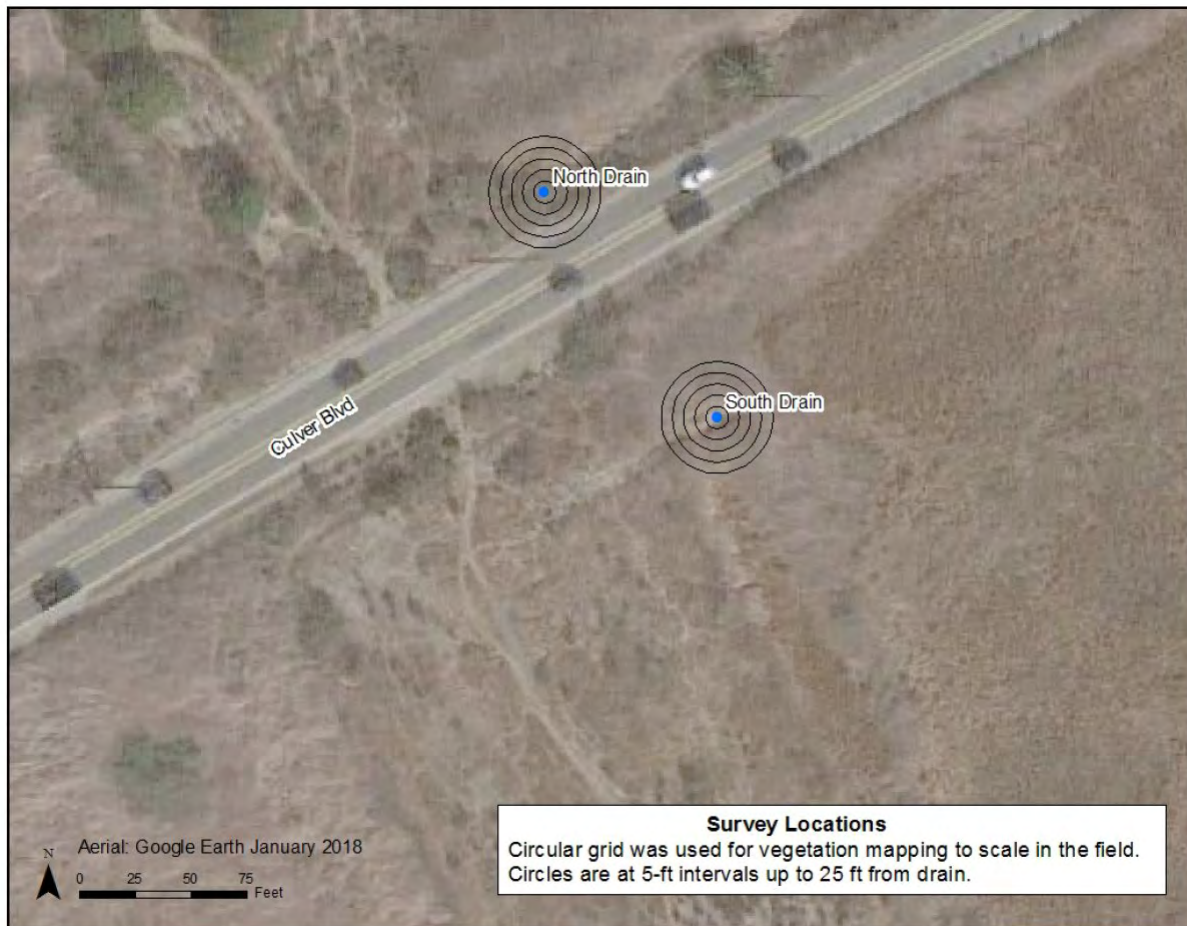
Exhibit A. Drain Locations

(FWM) storm drain overflow outlet pipe (Figure 1). The debris drain risers were at the end of pipes connected to the FWM storm drain overflow outlet pipe (Figure 2). The debris drain risers and pipes were not permitted. I have been asked to evaluate the history and current conditions of the natural resources within the vicinity of the unpermitted debris drains. To do this I visited the site on February 1, 2019 and have reviewed aerial photos and the documents listed above.

Figure 1. Exhibit A of E Read and Assc., Inc. September 19, 2018 Addendum showing the location of the drain risers on either side of Culver Boulevard and the area surveyed for vegetation mapping.

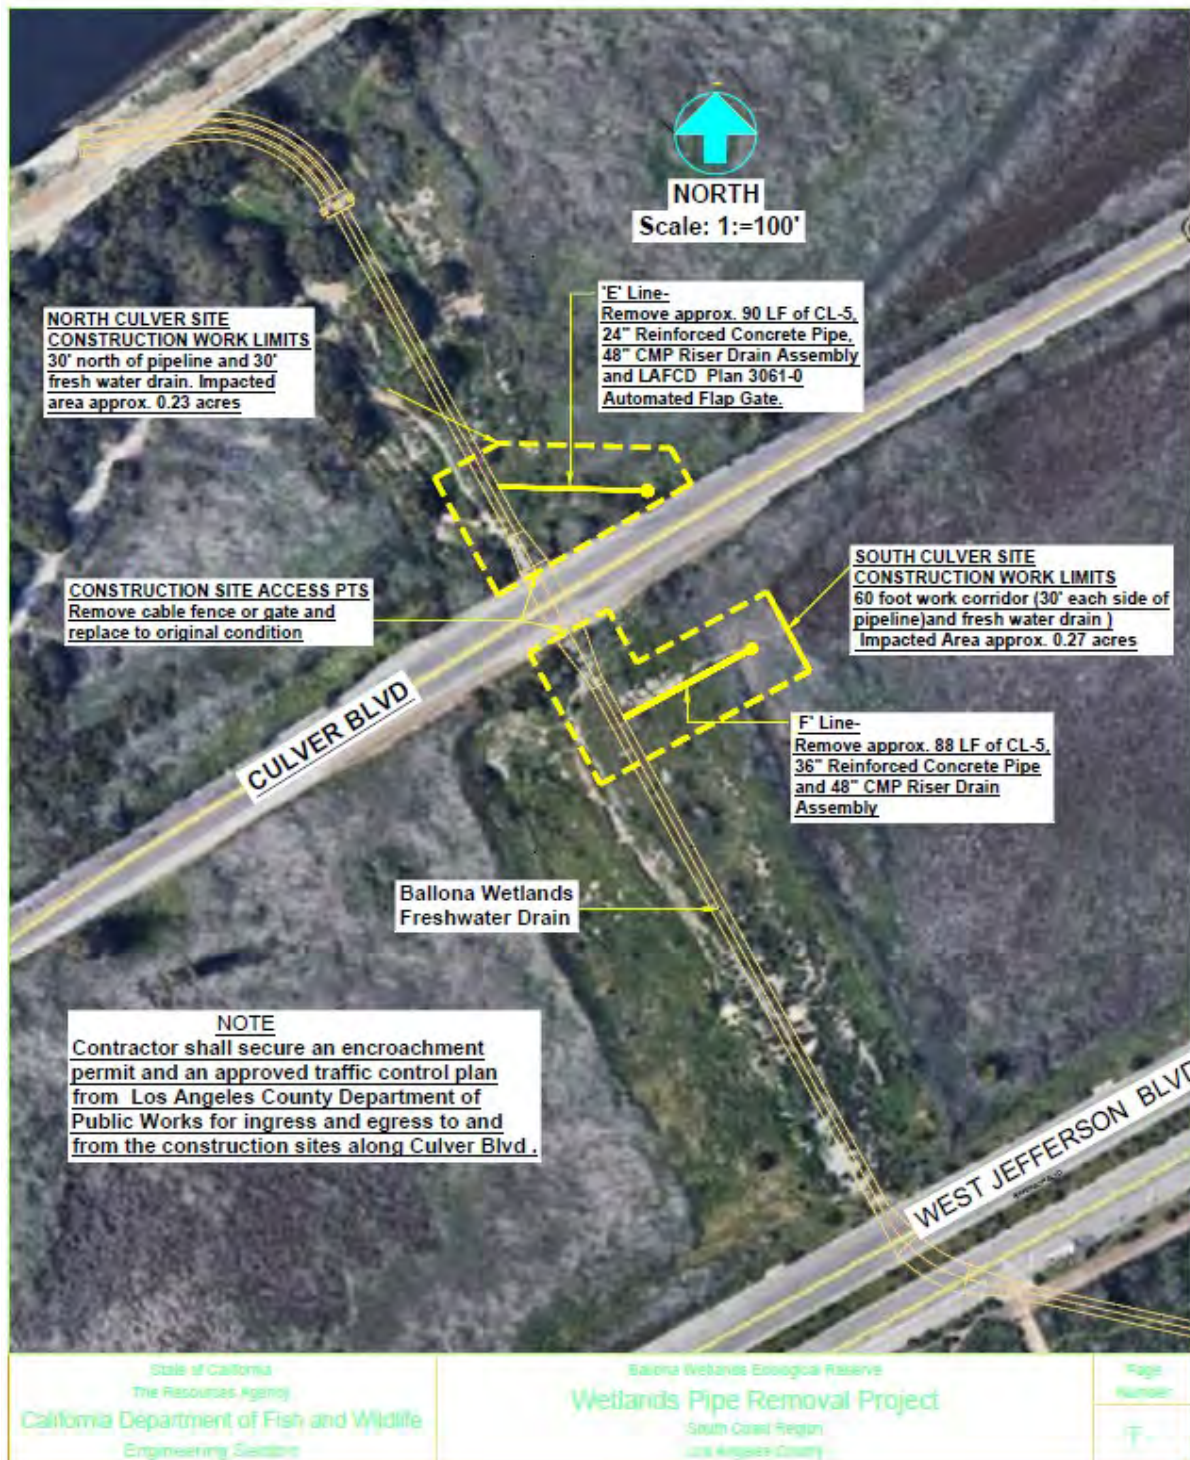
Figure 2. CDFW, Engineering Section, BWER Wetlands Pipe Removal Project exhibit (page number T -) that depicts the approximated areal extent of impact for removing the debris drain risers and pipes north and south of Culver Boulevard (that was used to calculate the mitigation acreage) and shows how the debris drain risers and pipes are connected with the freshwater marsh storm drain.

I worked with Commission staff and CDFW staff on an appropriate mitigation acreage and approach for the drain installation and wetland impacts. We used the dimensions of the CDFW Wetlands Pipe Removal Project (Figure 2) for the

north and south drains to calculate the mitigation area owed for the initial drain installation and the hydrology analysis report to estimate the mitigation area owed for wetland impacts at the south drain riser. We calculated the total mitigation area owed to be 0.53 acres⁵.

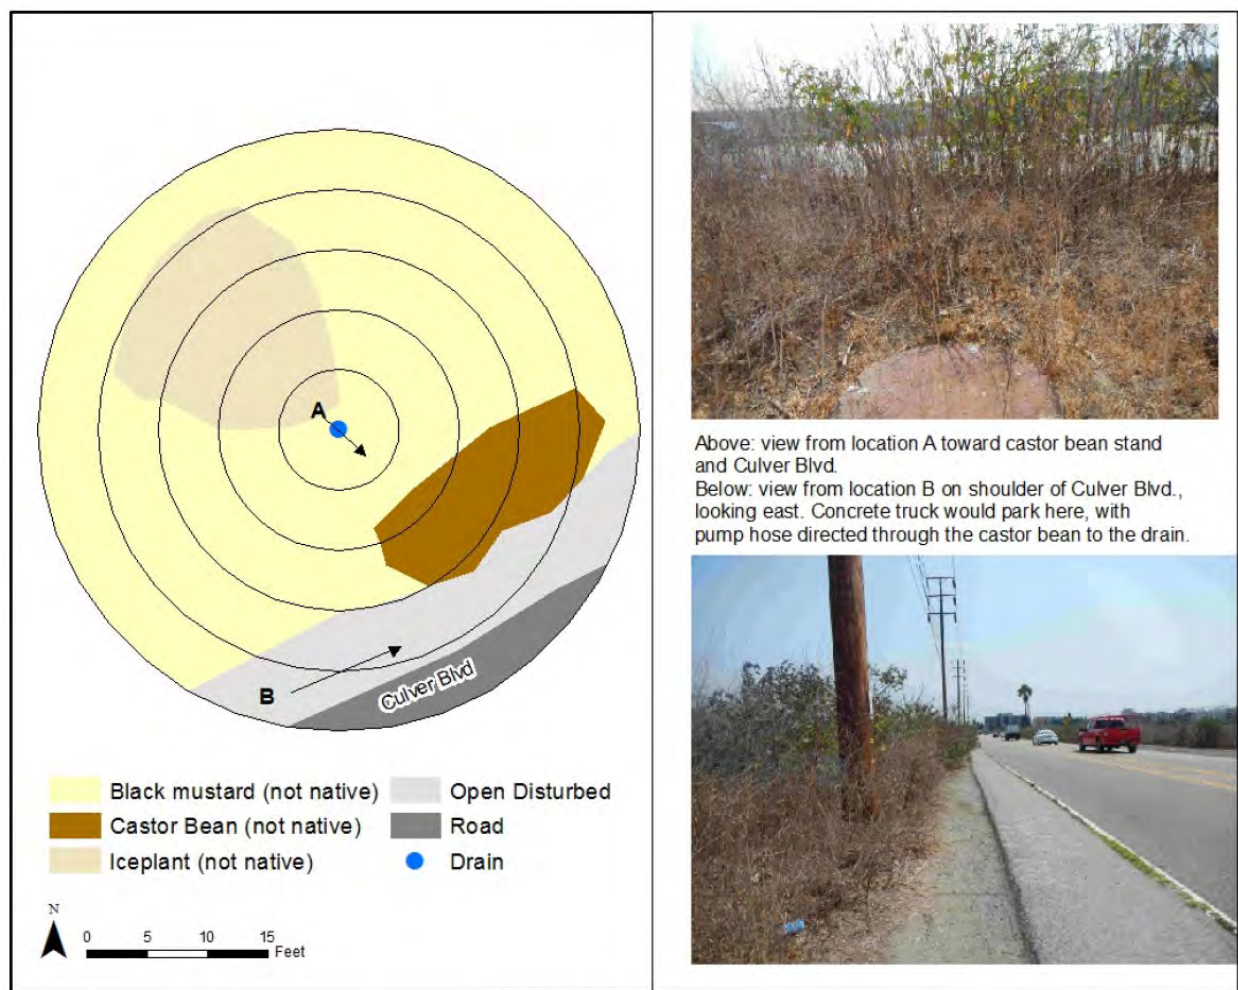
Exhibit B. North Drain Vegetation

*This area is occupied entirely by non-native weedy vegetation, primarily iceplant (*Carpobrotus edulis*), black mustard (*Brassica nigra*), and castor bean (*Ricinus communis*). This drain is about 15 feet north of Culver Boulevard below a stand of castor bean. (Figure 3)*

around the north drain was the same as the overall surrounding area; disturbed upland ruderal habitat. I observed that the north drain riser was not topographically situated to remove water from the area because it was not located in much of a perceptible depression. The area surrounding the south drain was in a slight depression that was enabling water to pond and I could envision water draining out of the area during and after big storms (Figure 5). My thought is that, along with residual salt in the soil, ponding storm water would facilitate and account for the occurrence of small patches of saltmarsh plants.

Figure 3. Exhibit B of E Read and Assc., Inc. September 19, 2018 Addendum. Survey of the Vegetation within a 25 foot radius around the North Culver Boulevard Drain. The vegetation is ruderal; comprised of non-native invasives including iceplant, mustard, and castor bean.

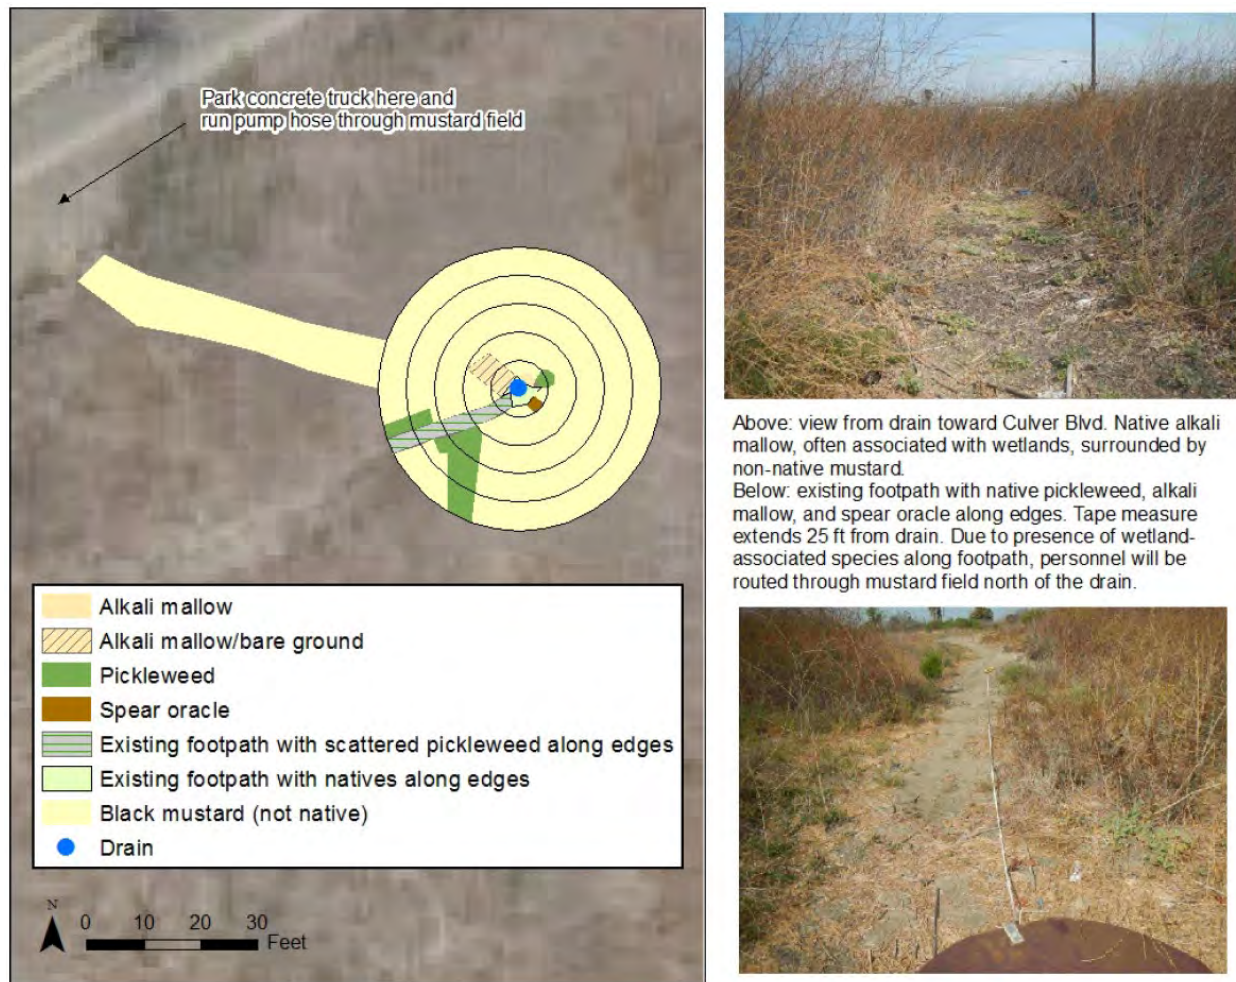
Exhibit C. South Drain Vegetation

*Unlike the north drain, this drain has patches of wetland-associated species growing in disturbed areas where black mustard is less prevalent. These species include pickleweed (*Salicornia pacifica*), spear oracle (*Atriplex patula*), and alkali mallow (*Malvella leprosa*). (Figure 4)*

Figure 4. Exhibit C of E Read and Assoc., Inc. September 19, 2018 Addendum. Survey of the Vegetation within a 25 foot radius around the South Culver Boulevard Drain. The dominant vegetation is ruderal; comprised of mustard with a small portion of the area by salt marsh species including pickleweed and alkali mallow.

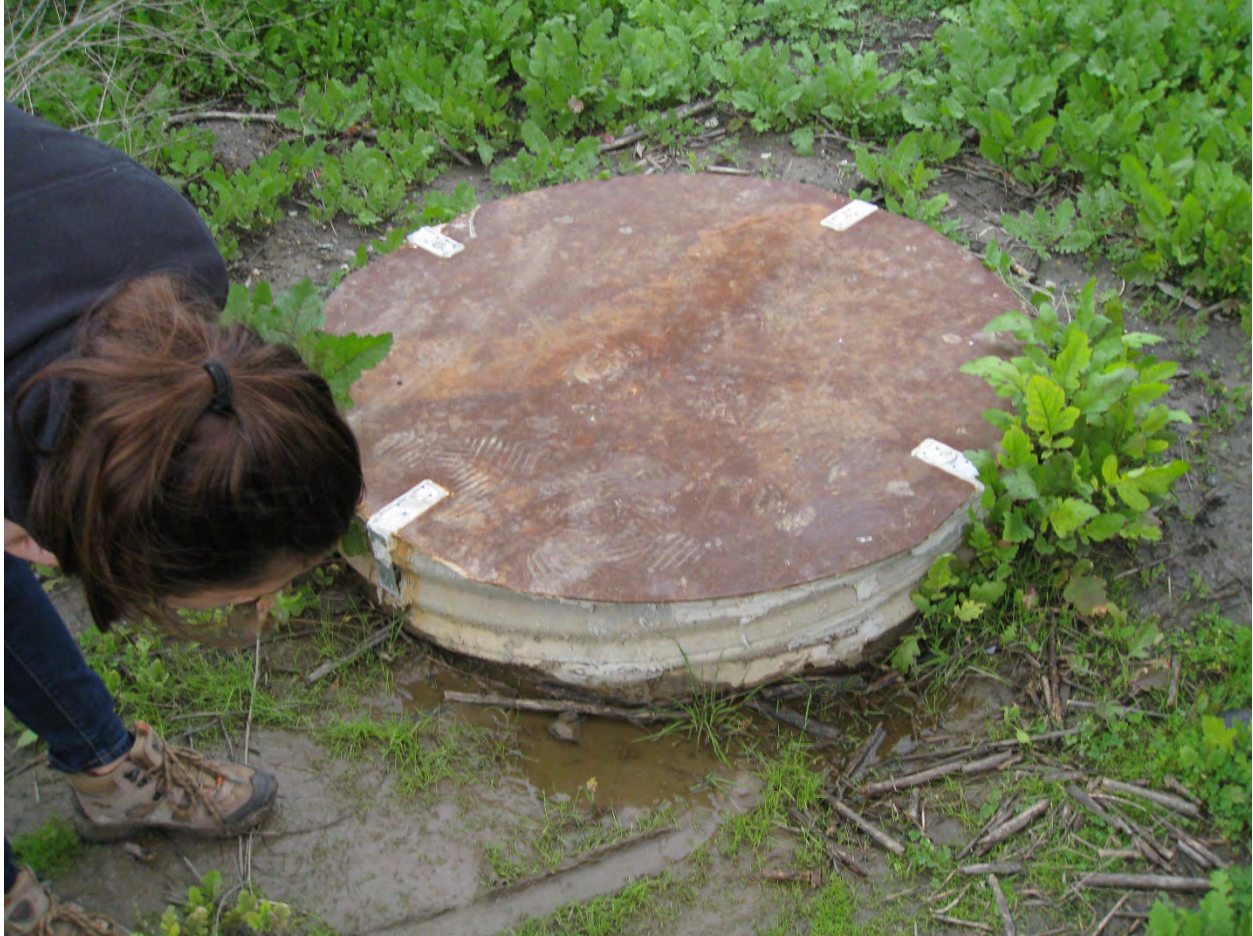
From PSOMAS hydrology report, 400 sq. ft. of wetland (saltmarsh) immediately around the South Culver debris drain riser was subject to impacts (subject to water removal).

Figure 5. February 1, 2019 photograph of the south drain riser showing small amount of ponded water.

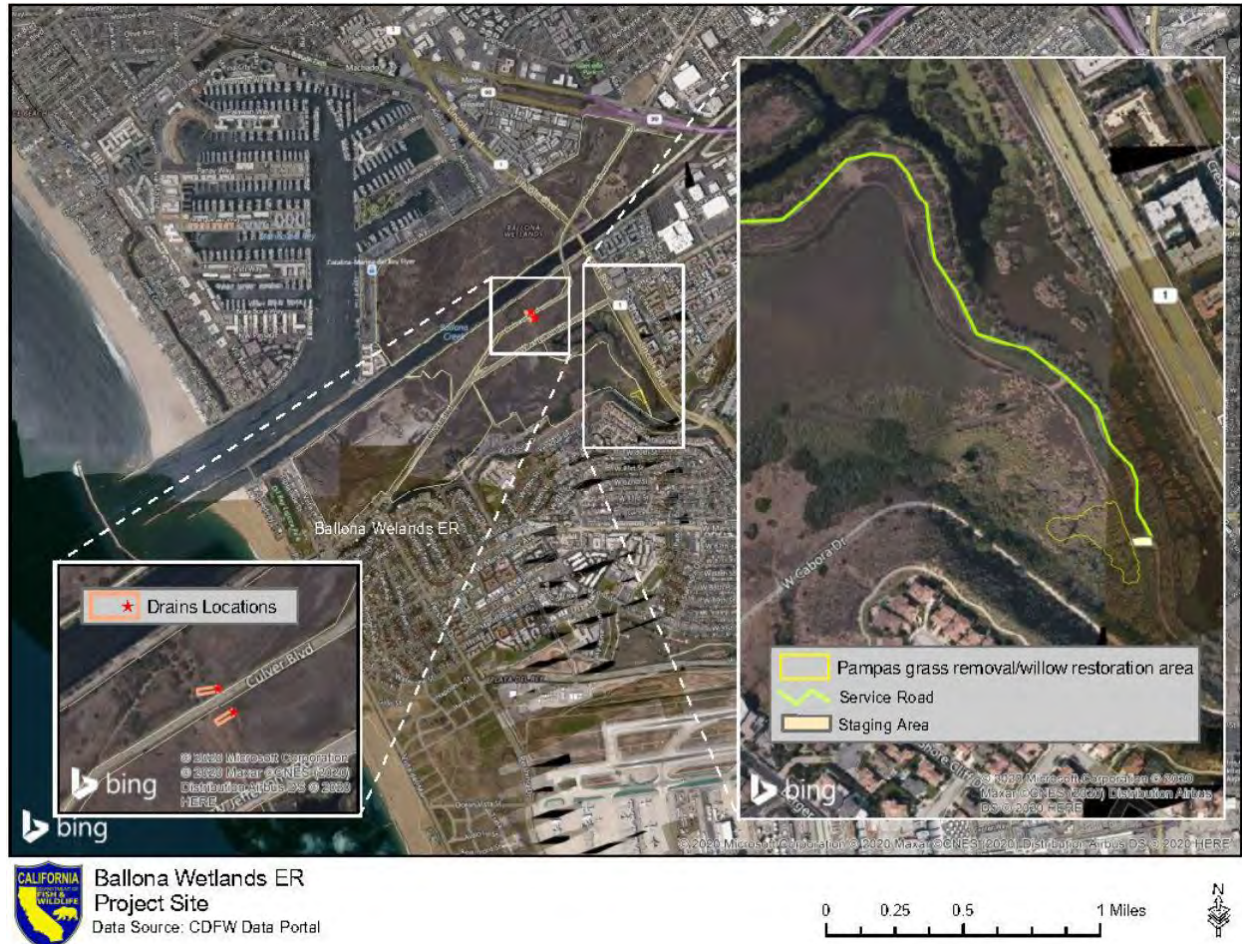
Figure 6. Figure 1, July 7, 2020 CDFW, BWER Willow Restoration Project. The left panel shows the proximal location of the drains and the pampas grass/willow mitigation area (approximately 0.35 acres apart). The right panel is a close up of the freshwater marsh and 0.6 acre pampas grass removal/willow restoration mitigation area outlined in yellow.

During our February 1, 2019 site visit we discussed mitigation options and visited potential mitigation sites. We coalesced on a nearby area of BWER invaded by a near monoculture of non-native invasive pampas grass (*Cortaderia selloana*) adjacent to the freshwater marsh (Figures 6). Many considerations go into determining what constitutes an appropriate mitigation site; Is the mitigation area in-kind?, Is it proximal to the impact area?, Is it within the same watershed? Does it make sense regarding future development plans, etc. etc. In this case the mitigation site is located in habitat invaded by non-native invasive species, proximal to the impact site (apprx. 0.35 miles away), and within the BWER and watershed. While the drains are located primarily in upland habitat, much of which is fill from building Culver Boulevard, that is invaded by several non-native invasive species (described above), the mitigation site is lower in elevation and is invaded by non-native pampas grass that is within wetland habitat that supports arroyo willow (*Salix lasiolepis*) and saltmarsh species and numerous wildlife species including the state and federally endangered least Bell's vireo (*Vireo bellii pusillus*) (Figures 7 and 8).

The mitigation site is a 0.6 acre (larger than the required 0.53 acres) area that was strategically chosen for its position regarding prevailing wind and as the outer boundary of pampas grass invasion in the area to facilitate invasive non-native species eradication, prevent re-invasion, and complement future large scale invasive non-native species removal efforts (Figure 9). Furthermore, the mitigation site is in an area of BWER that is outside the footprint of the large-scale restoration so it will not be disturbed in the future.

The mitigation plan (CDFW, July 6, 2020) involves removing pampas grass and any other invasive non-native species and planting native arroyo willow, mule fat (*Baccharis salicifolia*), and California blackberry (*Rubus ursinus*). The long-term goal of the mitigation is to sustain native vegetation and provide suitable habitat for native wildlife including the least Bell's vireo (CDFW, July 6, 2020). It is my professional opinion that the proposed mitigation is in-kind, proximal, practical, and compensates for the original installation of the debris drain risers and pipes and temporal wetland impacts at the south drain riser.

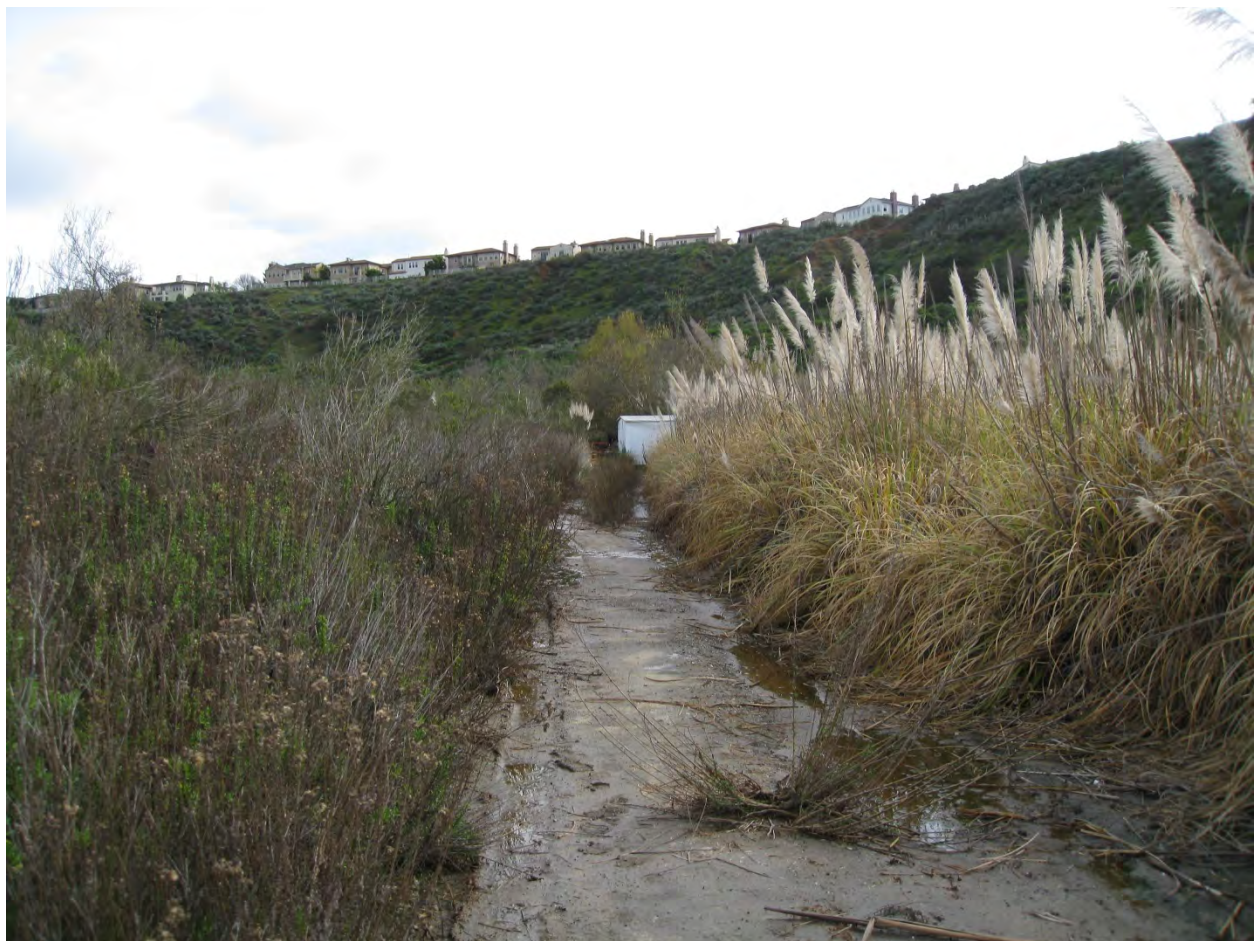
Figure 7. February 1, 2019 photograph facing east and showing the pampas grass mitigation site on the right and the freshwater marsh habitat on the left.

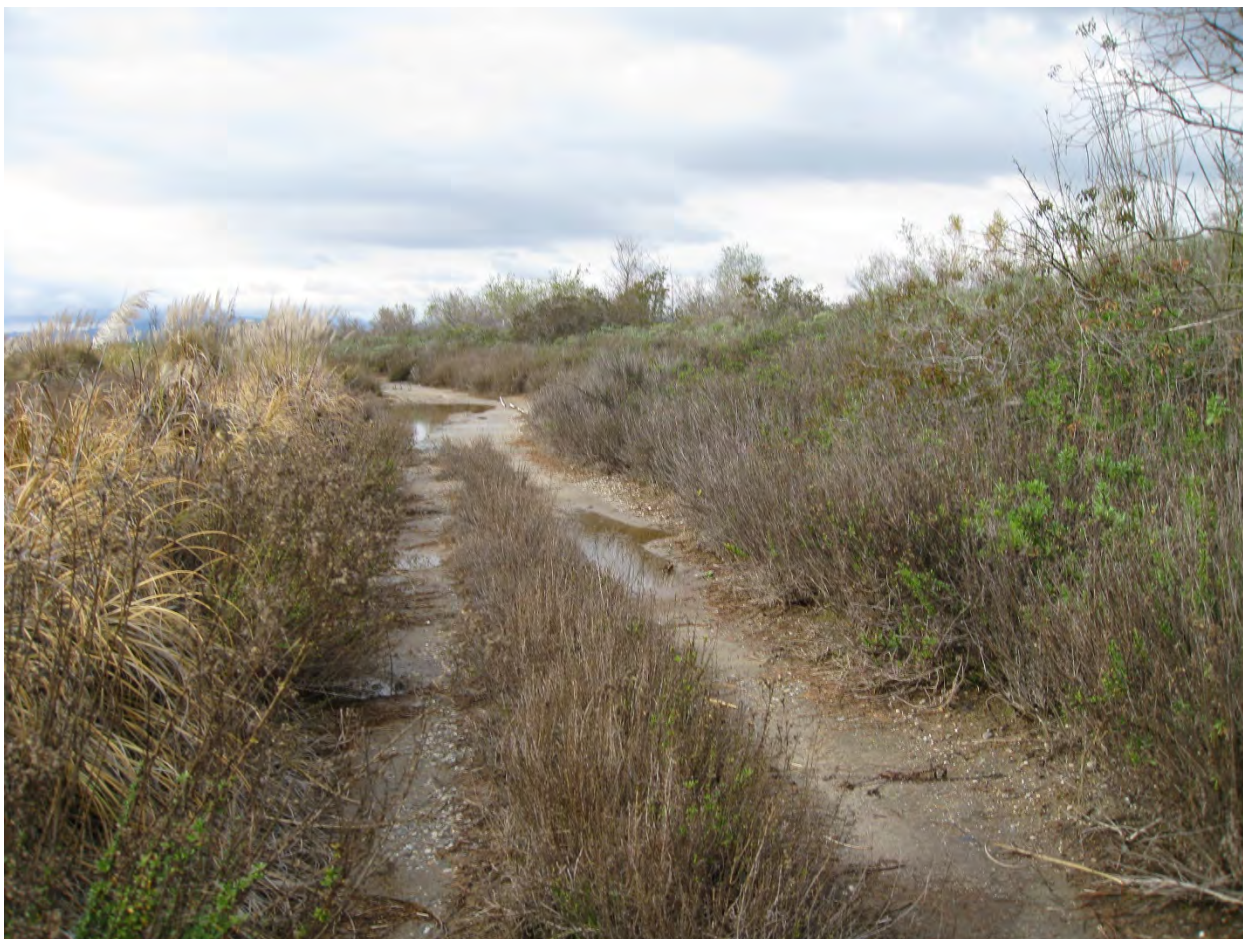
Figure 8. February 1, 2019 photograph facing north-west showing the pampas grass mitigation site on the left and the freshwater marsh habitat on the right.

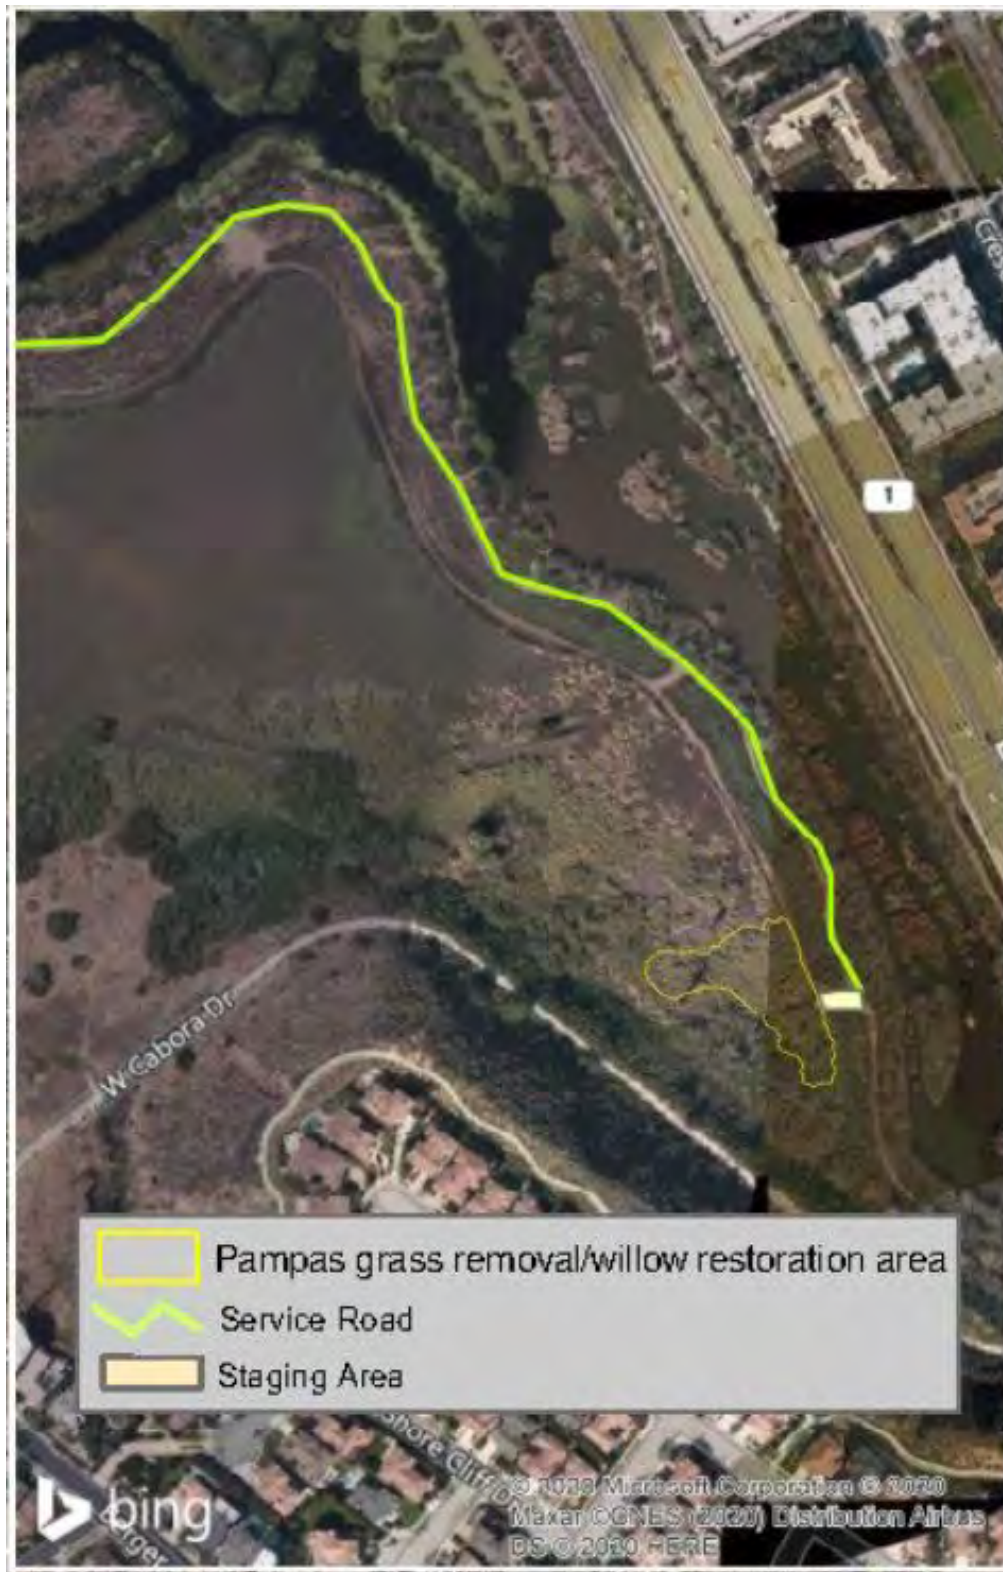
Figure 9. Excerpt from Figure 1, July 7, 2020 CDFW, BWER Willow Restoration Project, depicting the 0.6 acre pampas grass removal/willow mitigation area outlined in yellow.
