# CDP 3-18-1081 (SANTA CRUZ WHARF REPAIR AND MAINTENANCE PROGRAM) SEPTEMBER 9, 2021 HEARING EXHIBITS

# Santa Cruz Wharf

# **Maintenance Plan**

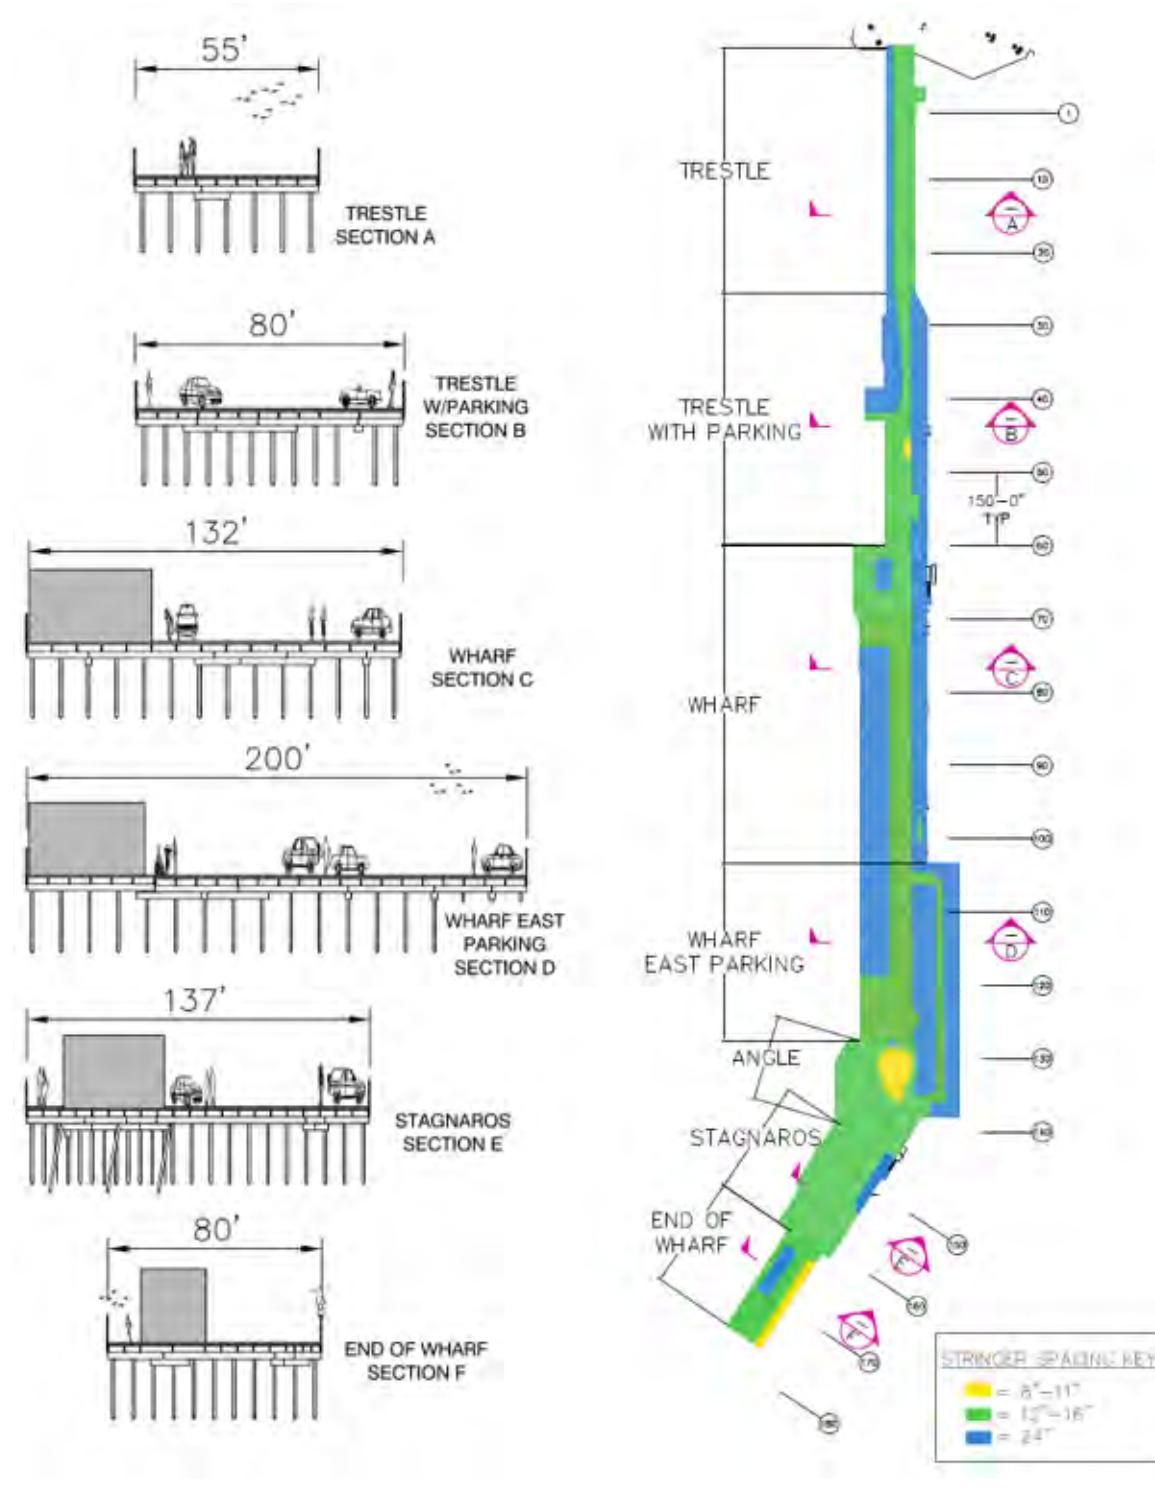
Figure 4. Structural Evaluation – Layout Summary Plan

The caps and stringers that support the decking are in serviceable condition. Many of the fasteners used in the caps and stringers are failing leading to a reduced sheer strength of the Wharf. The structural strength varies depending on the location and service area on the Wharf - roadways have a higher strength (areas in green in Figure 4) than under the buildings and parking stalls (areas in blue in Figure 11).

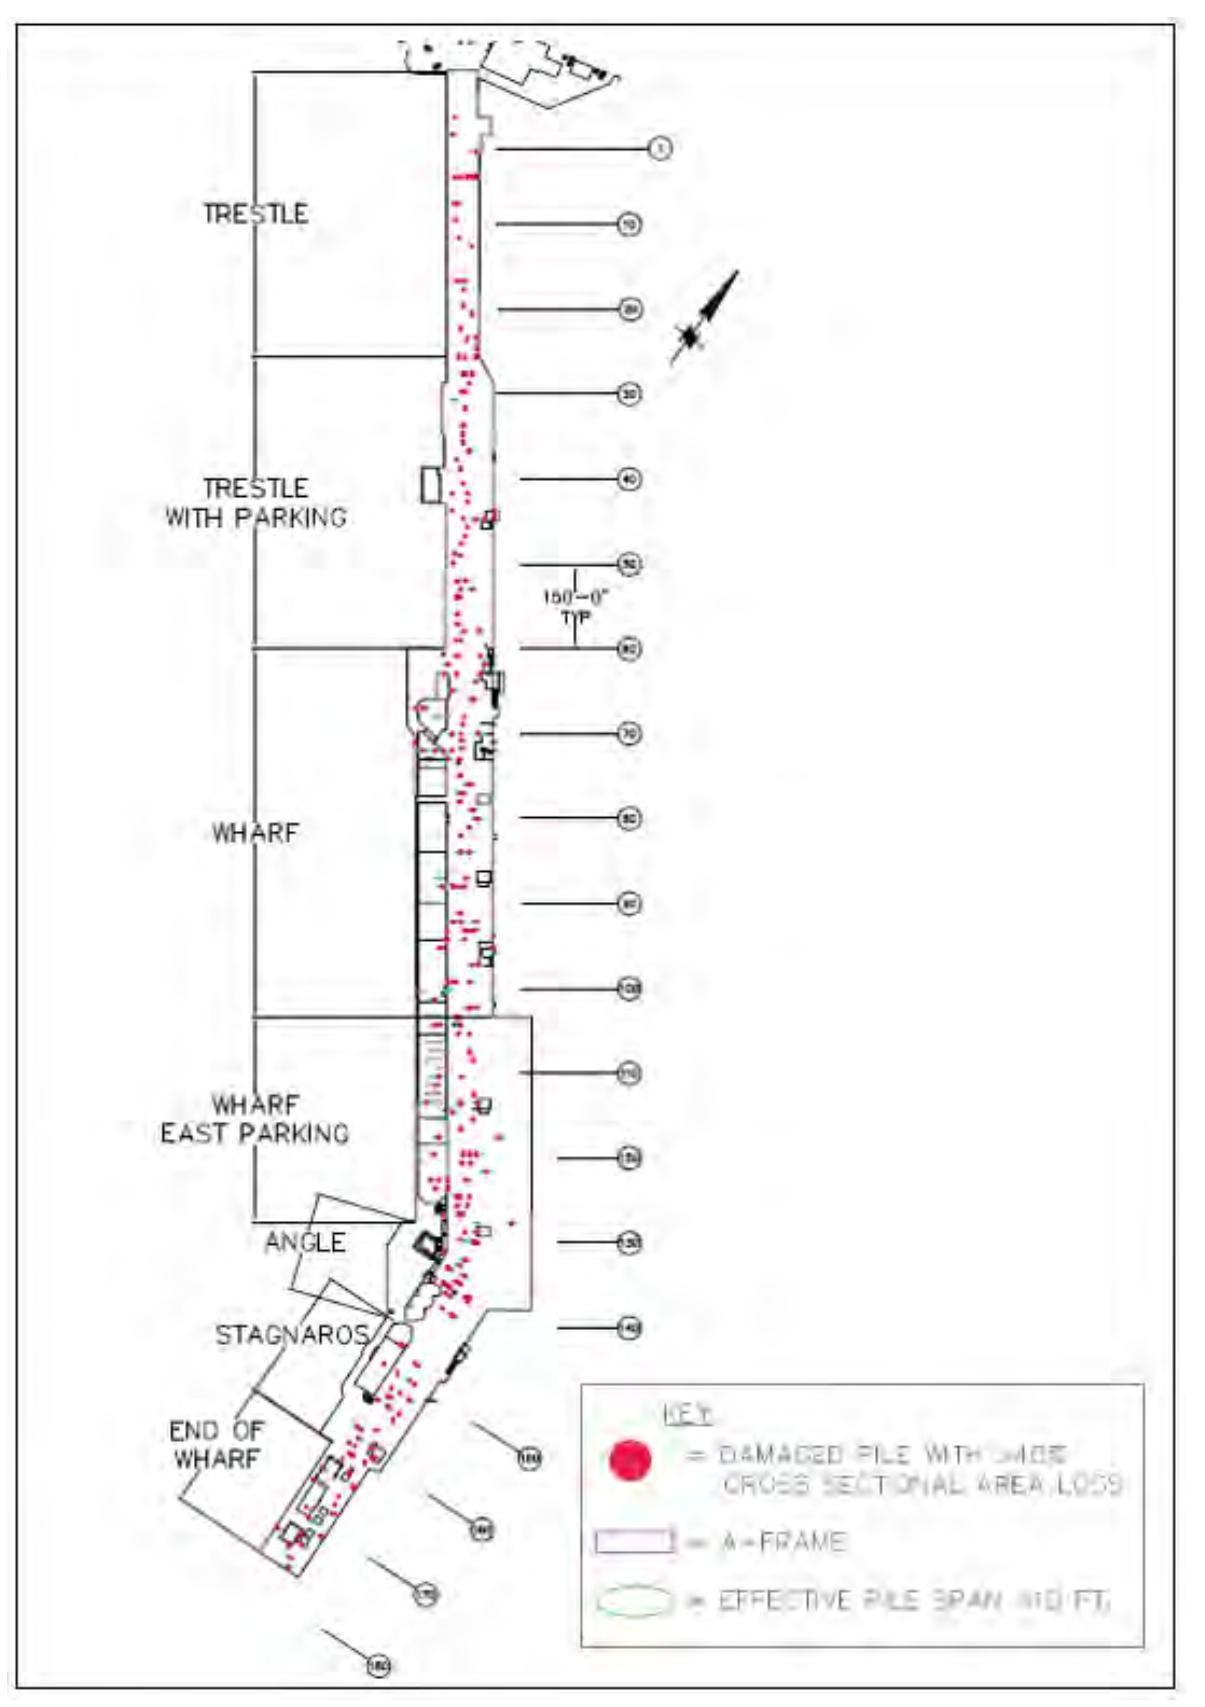
Figure 7. 2014 Pile Damage Survey

Replace up to 40 piles per year (up to 200 piles in 5-year maintenance period). Piles to be replaced are those with greater than 40% section loss and located at all A-frame locations, see Figure 7. The existing treated (creosote, ACZA, or ACZA treated polyurea coated) timber piles (of diameters up to 16-inches) will be replaced with timber piles (of similar diameter, diameters up to 16-inches) treated with ACZA or CA-A and coated in a polyurea compound. Install or replace steel T- connections and bolts, as necessary.

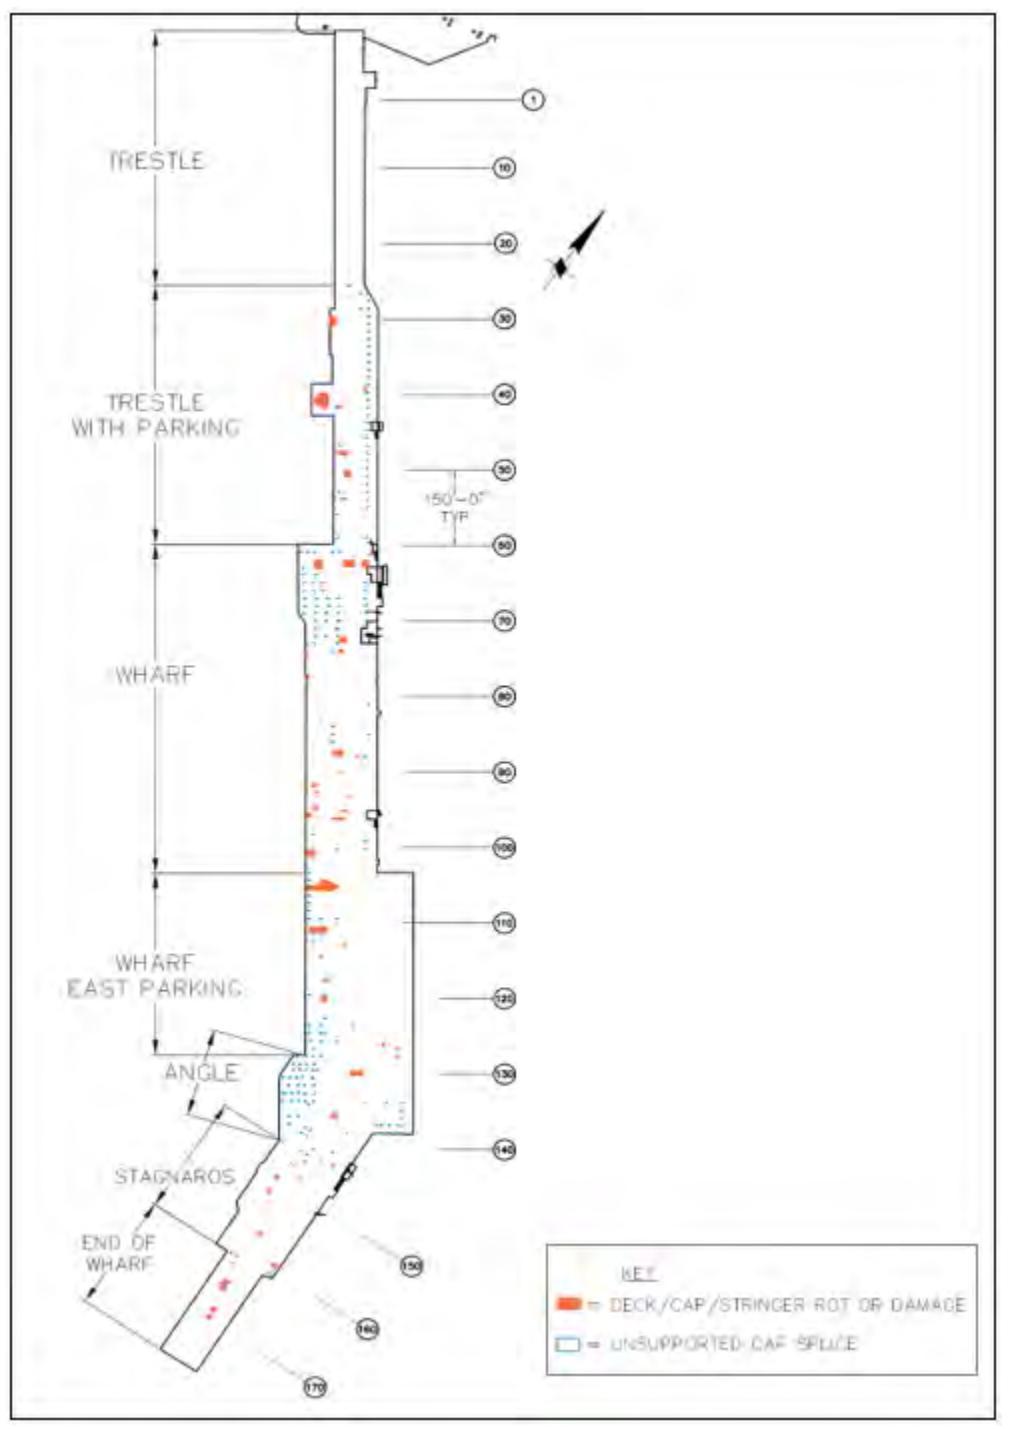
Figure 8. 2014 Wharf Structure Damage Survey

Repair or replace deteriorated pile ledgers, pile caps, stringers, decking, and any affiliated connections to stringers and caps. At unsupported cap splices installed side plate connections. Additional stringers may be provided beneath bearing wall loads. See Figure 8 for locations of rot and damage in decking, stringers, and pile caps as well as the location of unsupported cap splices.

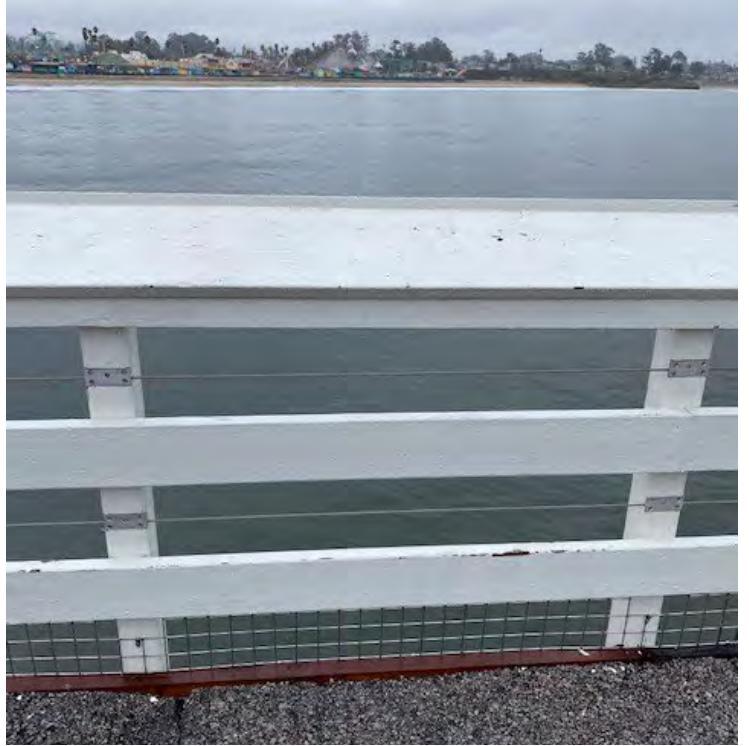
Figure 9. Santa Cruz Wharf Railing

This consists of railing that has rusted connection hardware, deteriorated wood, and feels loose when force is applied. Replace railing post and rails with members of the same size as original members. Set the railing post by bolting to the outside stringer. Butt splices should occur only at the railing posts. Stagger rail splices by 4 feet at a minimum. The cap rail should be laid with heart side down. Prior to the placement of the cap rail, protect the post top with several applications of the same preservative used to treat the post. The railing shall be installed to match existing, see Figure 9. This configuration has steel grating on the bottom that functions as a trash screen, cables added in between the timber members to ensure greater safety for children and is bird resistant.
