CALIFORNIA COASTAL COMMISSION

5-21-0907 (ORANGE COUNTY PUBLIC WORKS)
JULY 28, 2022

Project: Talbert Marsh Slope Repair and Living Shoreline Project

Exhibit 4 – Site Photos

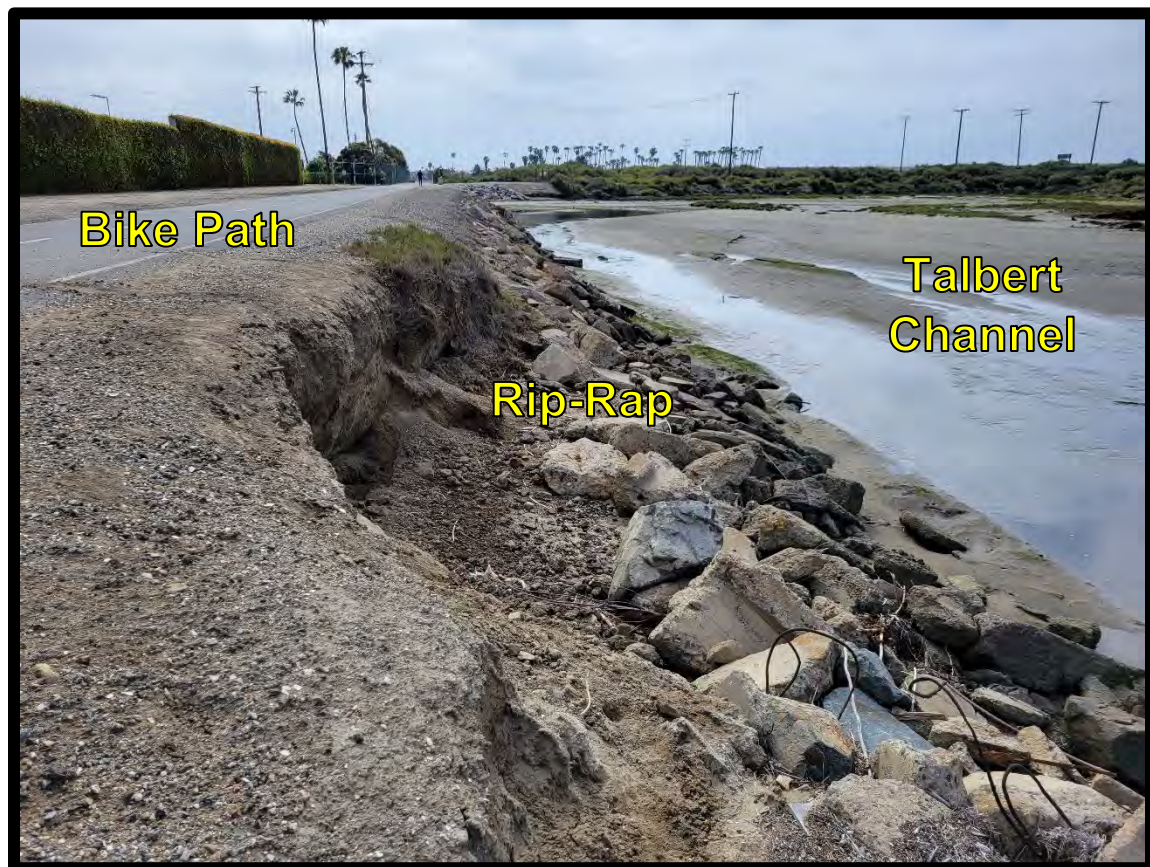
Figure 1. Portion of northeastern bank with sparse rip-rap and collapsed slope.

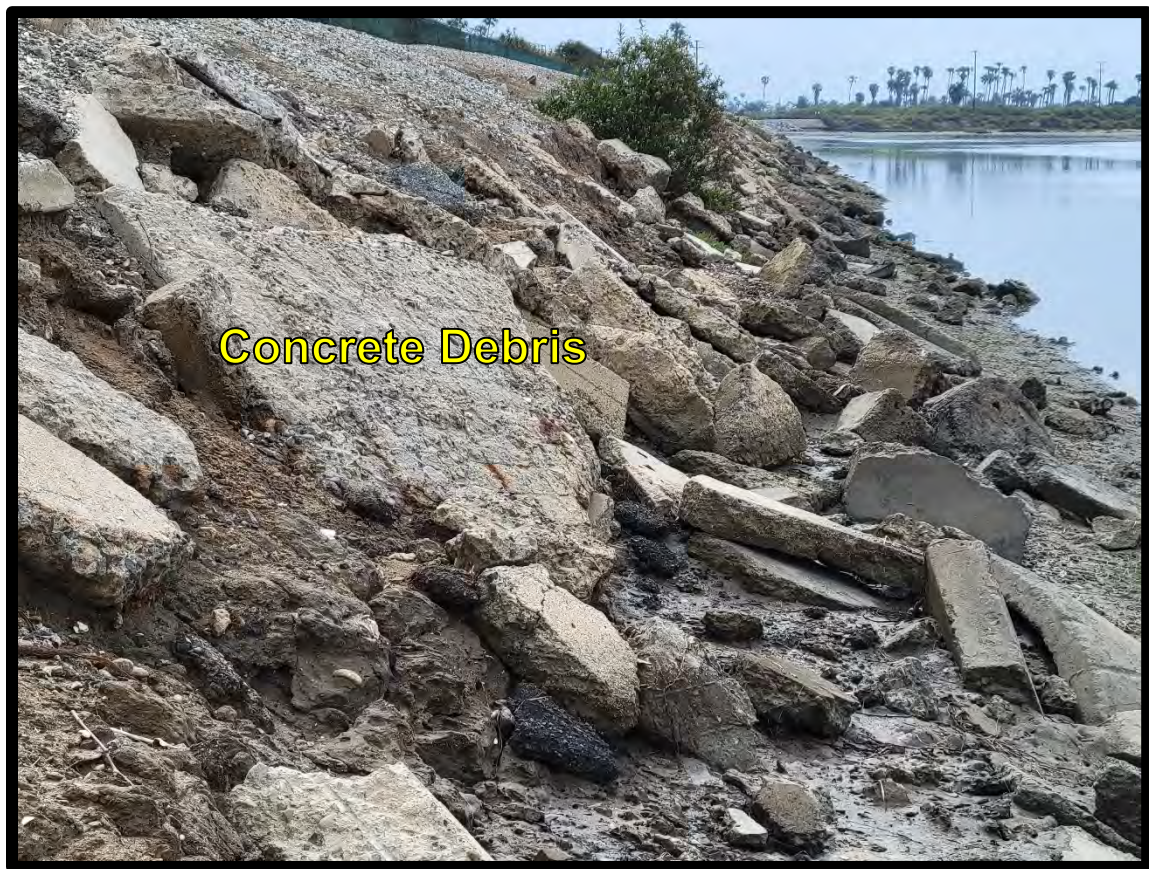
Figure 3. Northeastern bank with concrete rubble.

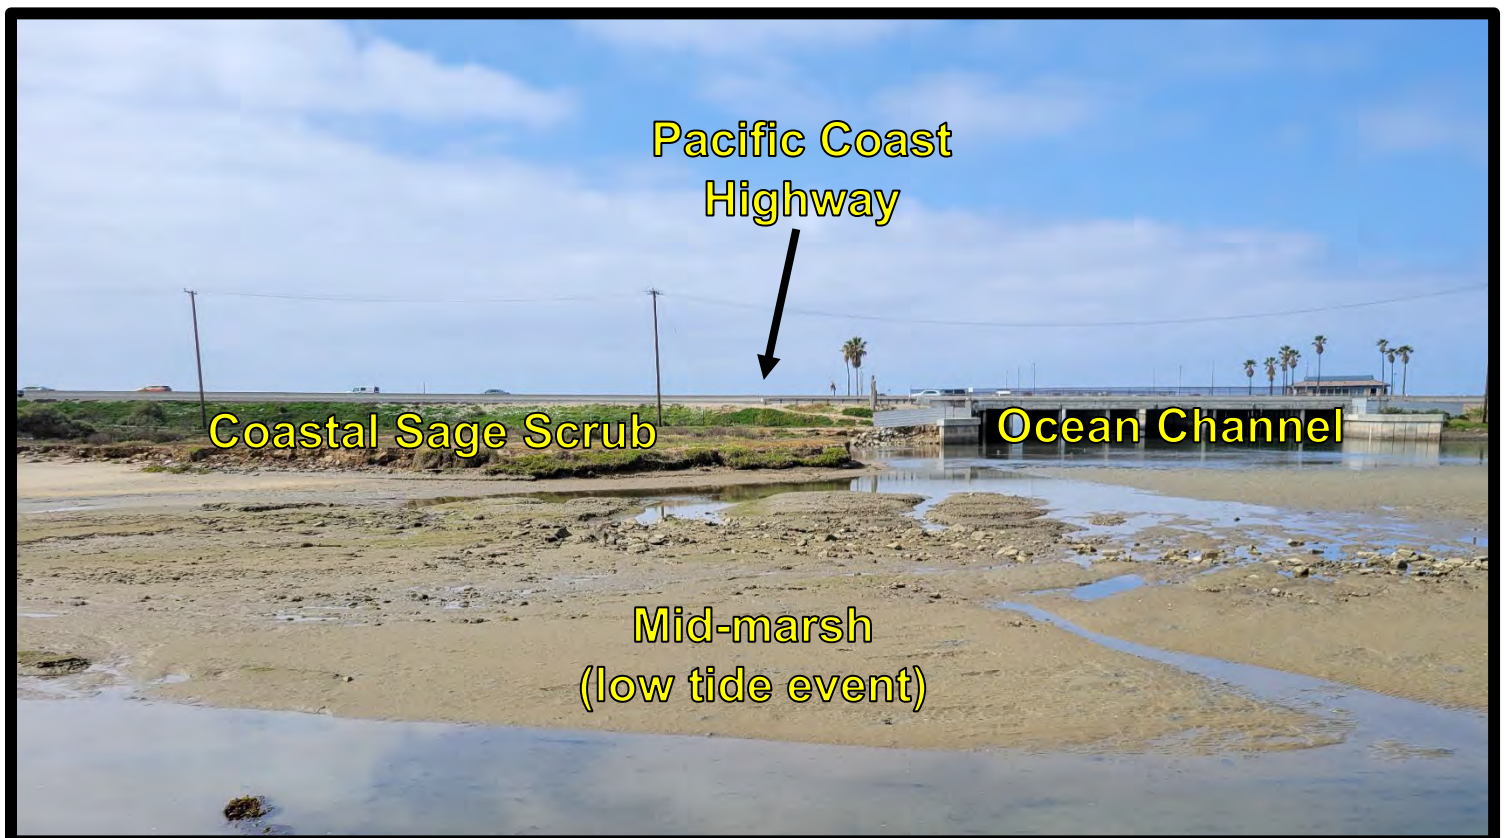
Figure 4. View of southwestern slope from opposite bank during low-tide event.
