# Th14a & Th14b

**A-5-LGB-20-0058-REC (32007 S. Coast Hwy, LLC) &  
A-5-LGB-20-0059-REC (32005 S. Coast Hwy, LLC)**

Subject: **Comments regarding Coastal Commission Staff Report  
“Request for Reconsideration”**  
32005 (32007) South Coast Highway  
Laguna Beach, California

Subject: **Geotechnical Investigation and Determination of  
the Bluff Edge Location**  
32005 (32007) South Coast Highway  
Laguna Beach, California

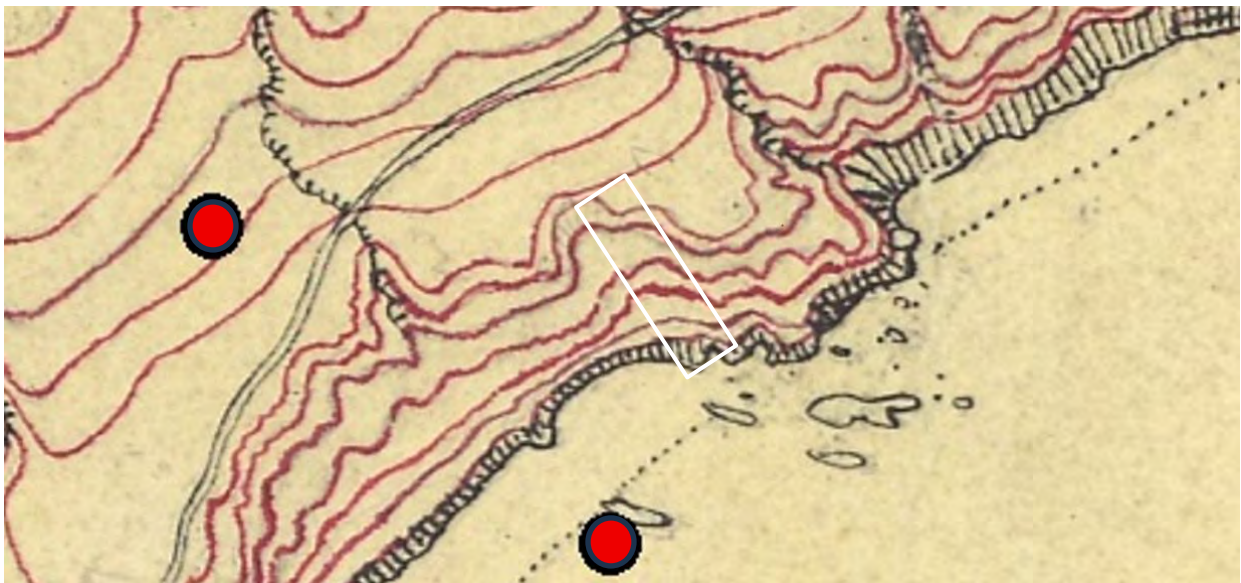
*Figure 2a: The historic topographic map (A.F. Rodgers, 1885, Vicinity of San Juan Capistrano map, U.S. Coast Survey Maps of California, Southern California Coast T-Sheets, map T-1645. Red dots indicate location of the property based on both sets of longitude-latitude marking on T-1645. White line indicates a best estimate of the actual property location. Future Virginia Way is indicated on the map as an unnamed road.*

Figure 2a is a blow-up of the T-Sheet as it relates to the properties and surrounding area. The lat./lon. for property plots on the two red dots. The hatching appears to reflect the beaches and drainages, including an old drainage that may have been present terminating near the property. Elevations presented are based on pre-NAVD 1927 data, possibly mean sea level or other. It appears to show a short bench or break in slope at the 40, 60, and 120 foot contours, but it is important to note that the contouring is  $\pm 10$  feet, and we know today that there are no breaks or steps at 40, 60, or 120 feet at the site. The maximum elevation on the property based on the T-1645 map appears to be approximately 120 feet.

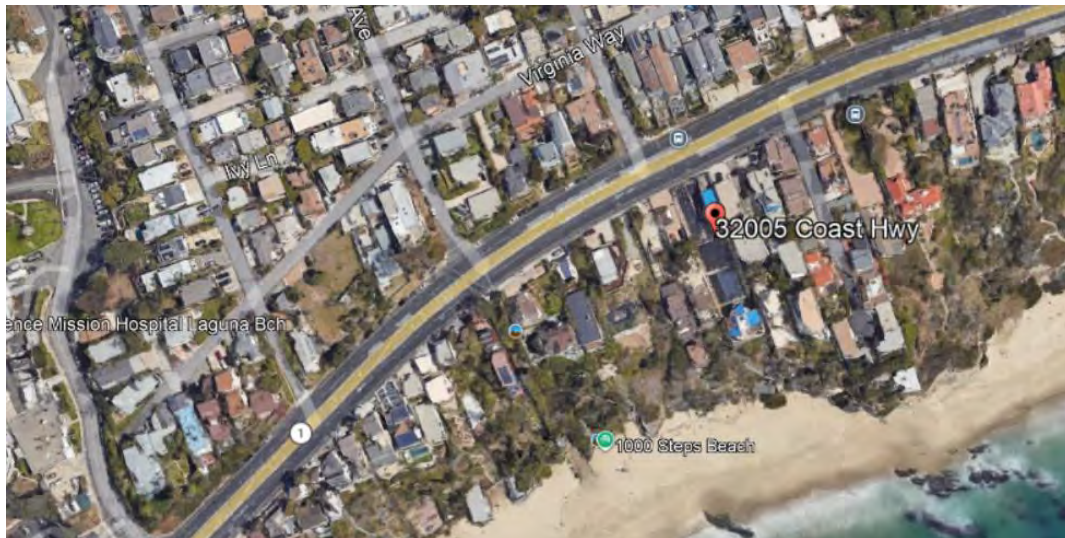
*Figure 2b: Google Earth current aerial overview of property.*

There is no step-like feature or bluff edge shown at 150 feet, and the statement that “slope inclination flattens significantly to that of the marine terrace surface, which is very shallowly inclined seaward, is not only inaccurate but makes no sense because, as demonstrated by our multiple investigations, there is no marine terrace surface at that elevation. Given the current standards, reliance and a significant opinion cannot be based on a document this old and inaccurate, particularly when more recent and reliable information demonstrates to the contrary. The contouring of the slope is clearly innacurate. Figure 2b is a current photo of the same area for perspective and approximate scale.

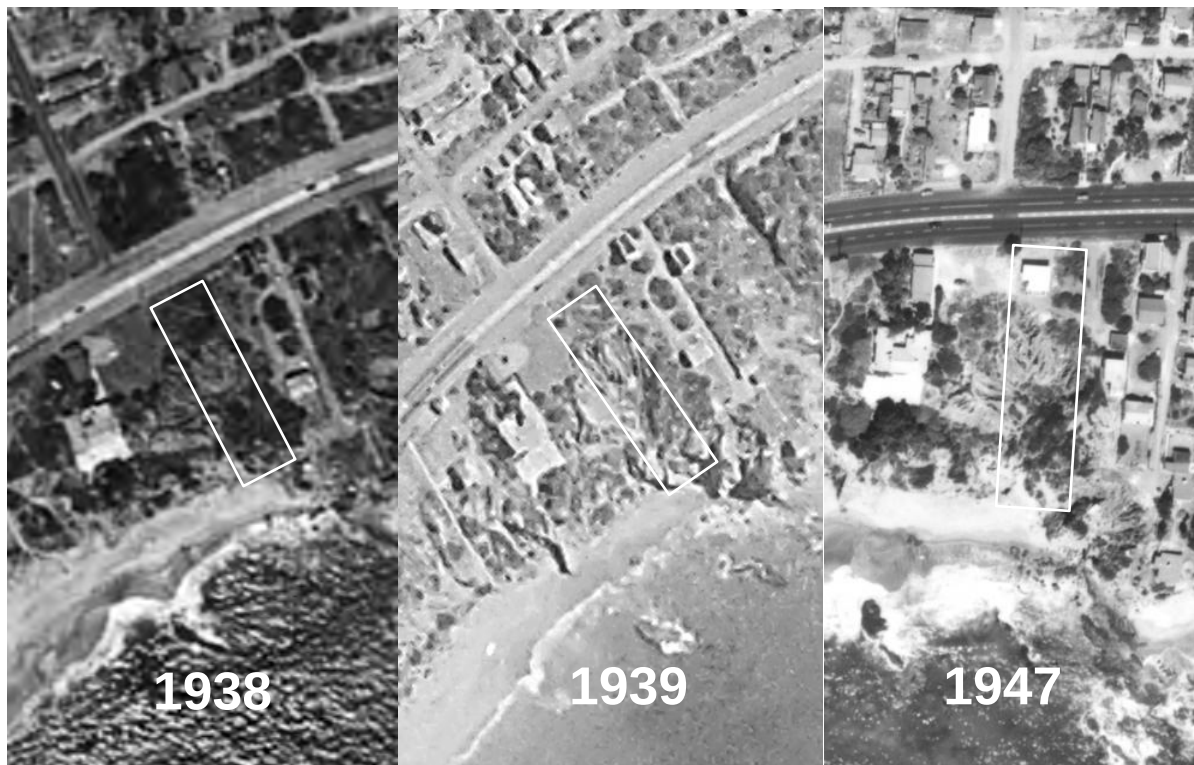
Our July 2025 Geotechnical Report provided and analyzed numerous aerial photographs, including old aerals from 1938, 1939, and 1947, included in Figure 3. These do not show a natural bluff edge on the upper lot at the 150-foot elevation contour or otherwise on the non-marine (terrestrial) terrace deposits.

However, the geomorphic features observed in the 1938-1939 photographs do not suggest the upslope drainage extended across the undeveloped (natural-looking) slope underlying the site and vicinity. In either case, however, the upslope portion of the drainage would have been incrementally backfilled to allow the construction of Coast Highway and adjoining residences. The photos also indicate the presence of a large, roughly bowl-shaped, deeply rilled slope spanning the width of the site, onto the adjoining properties to the north and south, and appears to be the result of severe surface erosion, perhaps caused by long-term uncontrolled water discharged from Coast Highway.

*Figure 3: Aerial overview of property in 1938, 1939, and 1947, showing surface rilling of the terrestrial slope surface. No shoreline erosion or bluff edge is present above beachside cliff.*

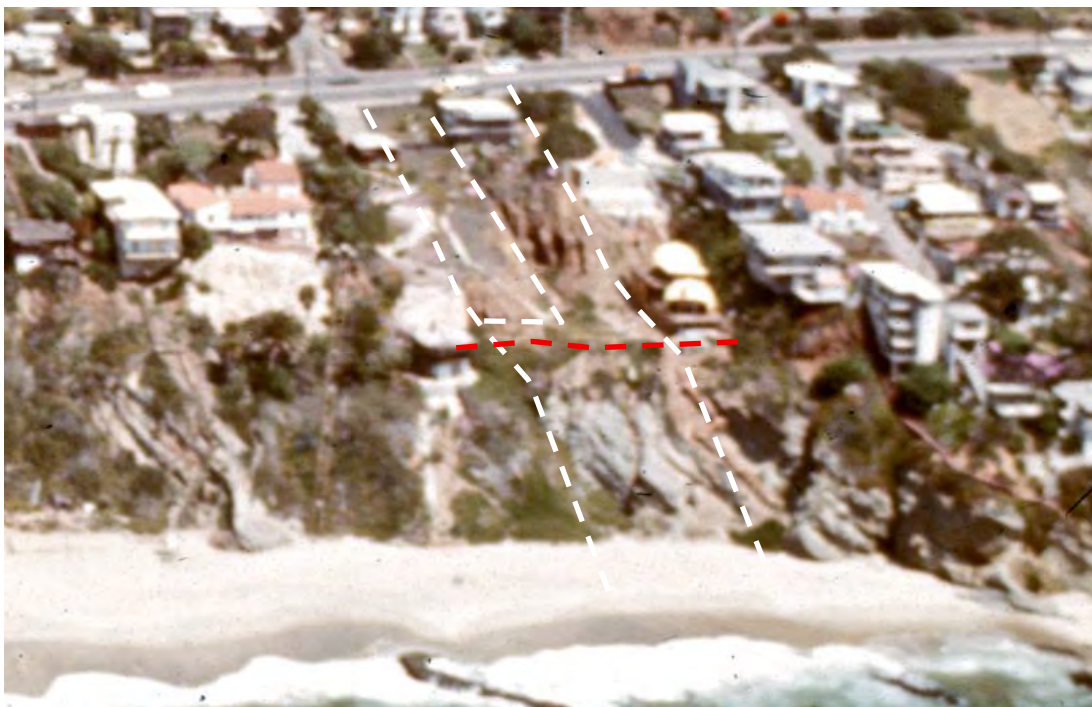
*Figure 4: Close-up of a portion of California Coastal Records Project frame 7238102 dated 1972, showing the 32005 and 32007 properties prior to the 32007 residence construction. Approximate property lines depicted in white dash. Interpreted bluff edge depicted in red dash. The origin of the bench at elevation 89 feet appears to be*

*the result of non-marine terrace retreat and surficial gully erosion depositing onto a more resistant marine terrace, forming a level bench. This is not a geologic step from marine erosion or rounding of the bluff face.*

Figure 4 is an oblique aerial from 1972 which shows the former house off Coast Highway on the upper lot and the slope to the natural bench before construction of the existing house at 32007 Coast Highway, which then breaks and slope vertically at approximately the 89-foot elevation contour to the beach below. In 1972, the Orange County Planning Commission approved a garage and tram to the lower property, explaining: “The property slopes gently from Coast Highway to the edge of the bluff, and from there to a steep cliff to the mean high tide line.” The gentle slope is visible in the aerial. There is no natural bluff edge on the slope.

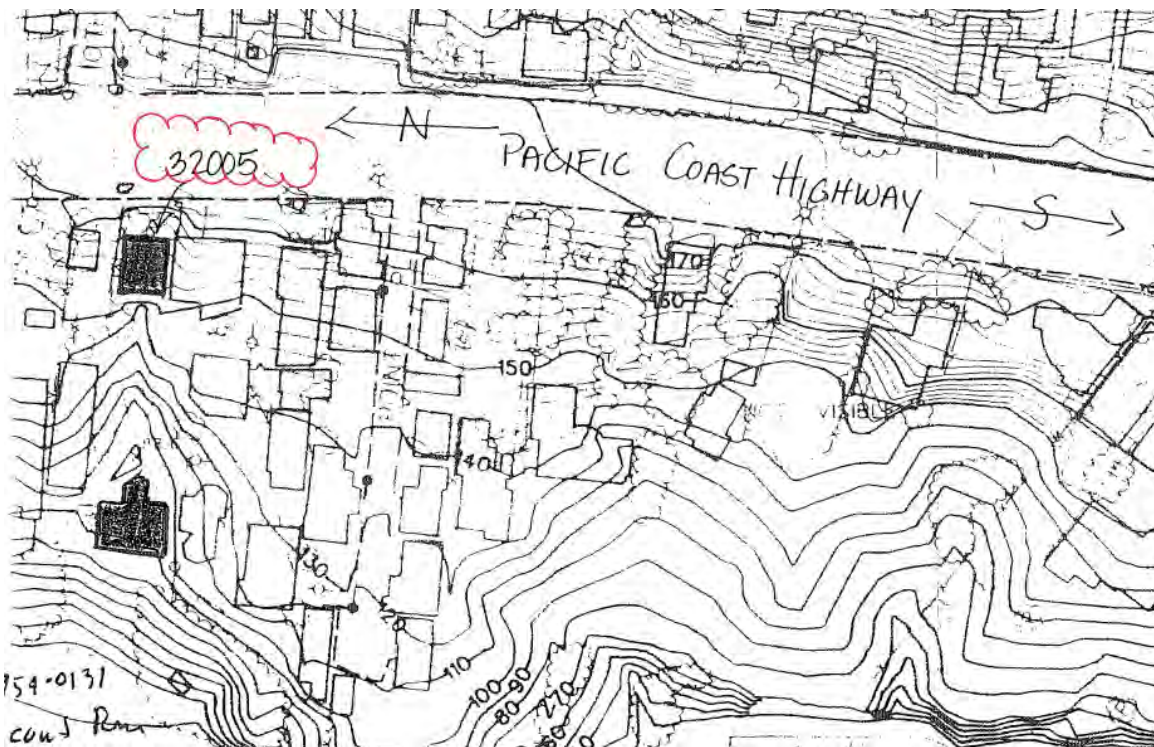
Figure 5: Post-storm drain failure erosion map of the property from Borella Geology, (1997).

Borella Geology, Inc., also previously conducted a geotechnical evaluation following a failure of the storm drain on Coast Highway next to the upper lot. Figure 5 is a November 1997 letter from Borella, with a hand-drawn topo of the site, which shows no natural bluff edge at the 150 feet elevation contour and also no flat pad on the form home site. The letter that accompanied the topo states: “The non-marine terrace sands to silty sands that are being eroded usually form gullies that are parallel to the downslope direction. However, in this case, large erosion channels are forming across the slope face.”

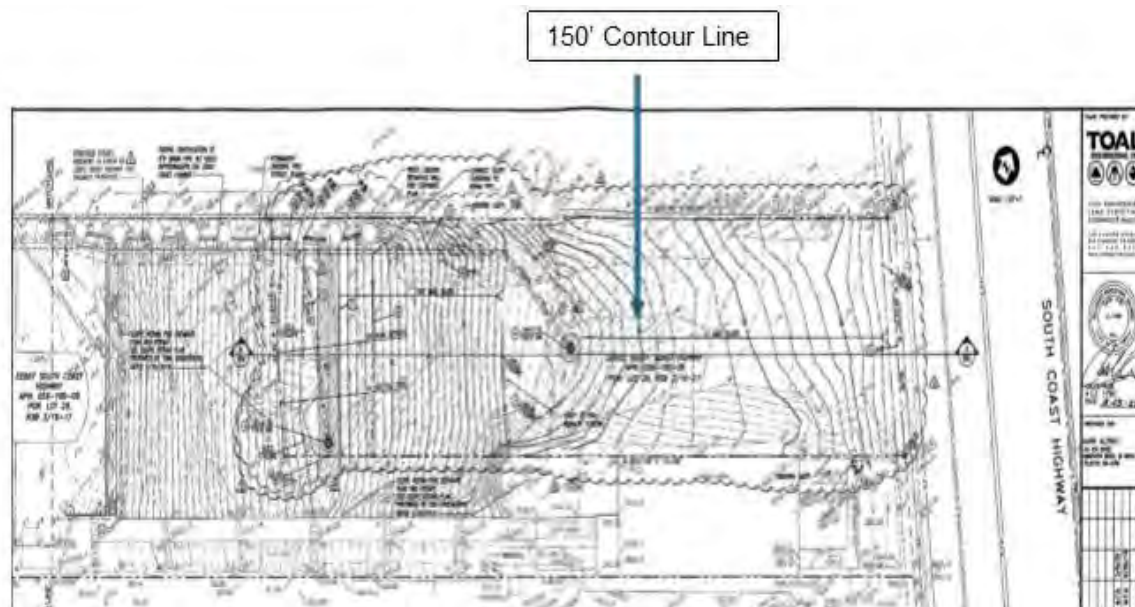
Figure 6: Toal Engineering topographic comparison of property.

Figure 6 is a composite of both surveys. In the underlying 2017 survey, the underlying contour lines show the badly damaged slope ended up with a somewhat varied topography closer to Coast Highway. On the downside, the contour lines drop off, on the upcoast side, they proceed in a different direction, and in the middle, they are somewhat wider where the water passed over the slope, generally creating a more gentle slope as it descended from Coast Highway.

The 2018 survey reflects the temporary stabilization work after the damaged slope was modified, with contour lines going in the opposite direction. The contour lines at a 150-foot elevation contour are a part of the new, temporary, man-made repaired slope, and do not reflect any bluff edge or step-like feature.

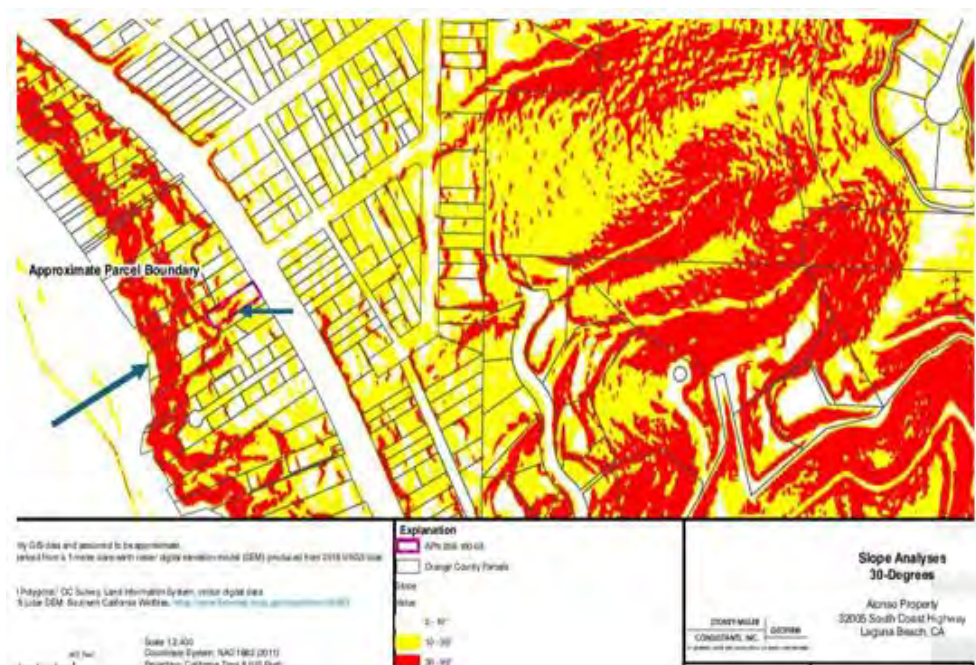
Figure 7a: Lidar analyses of 30 to 90-degree slopes

In our July 2025 Geotechnical Report we provided a three-dimensional view of the entire slope with LiDAR figures, LiDAR being used to create 3-D maps of the earth's surface. Figures 7a and 7b include two LiDAR figures, one with a 30 degree slope and the other with a 45 degree slope. They show plainly that there is a no step-like feature or bluff edge at the 150-foot contour elevation but a clear demarcation of the bluff edge seaward of the lower house at the 89-elevation contour, continuing all along this bluff.

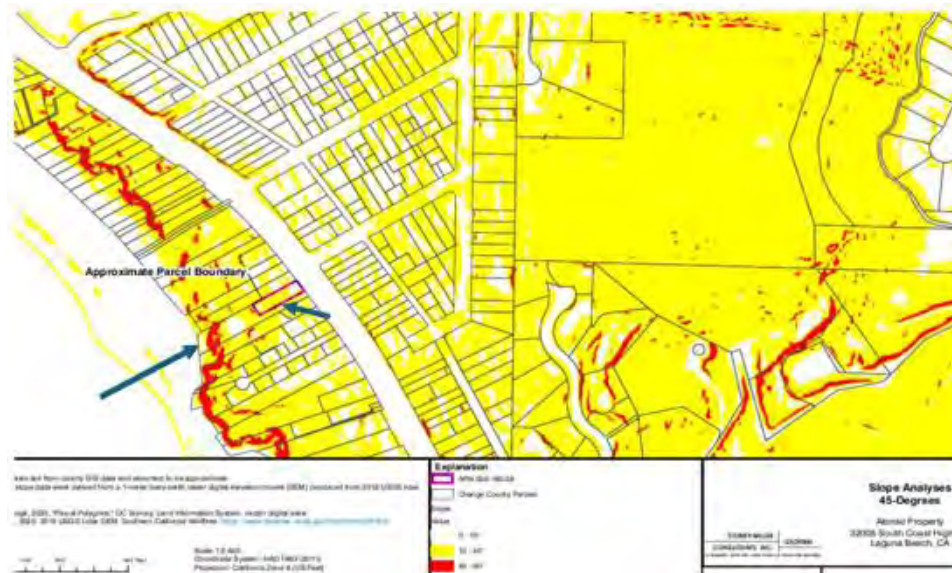
Figure 7b: Lidar analyses of 45 to 90-degree slopes (red).

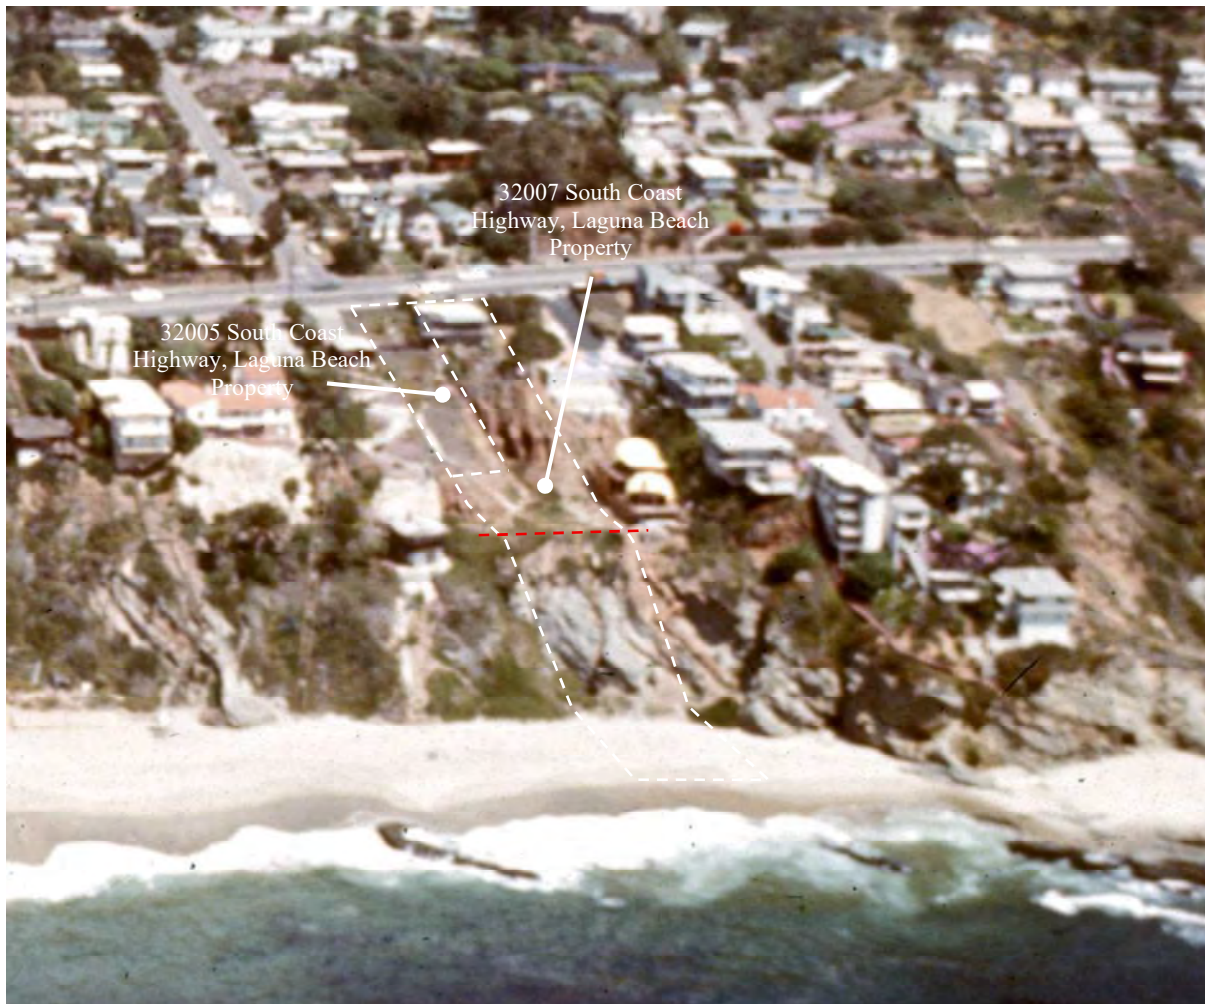
Photo 1: Close-up of a portion of California Coastal Records Project frame 7238102 dated 1972, showing the 32005 and 32007 properties prior to the 32007 residence construction. Approximate property lines depicted in white dash. Interpreted bluff edge depicted in red dash. The origin of the bench at elevation 89 feet appears to be the result of non-marine terrace retreat and gully erosion depositing onto a more resistant marine terrace, forming a level bench.

This is not a geologic step from marine erosion or rounding of the bluff face.

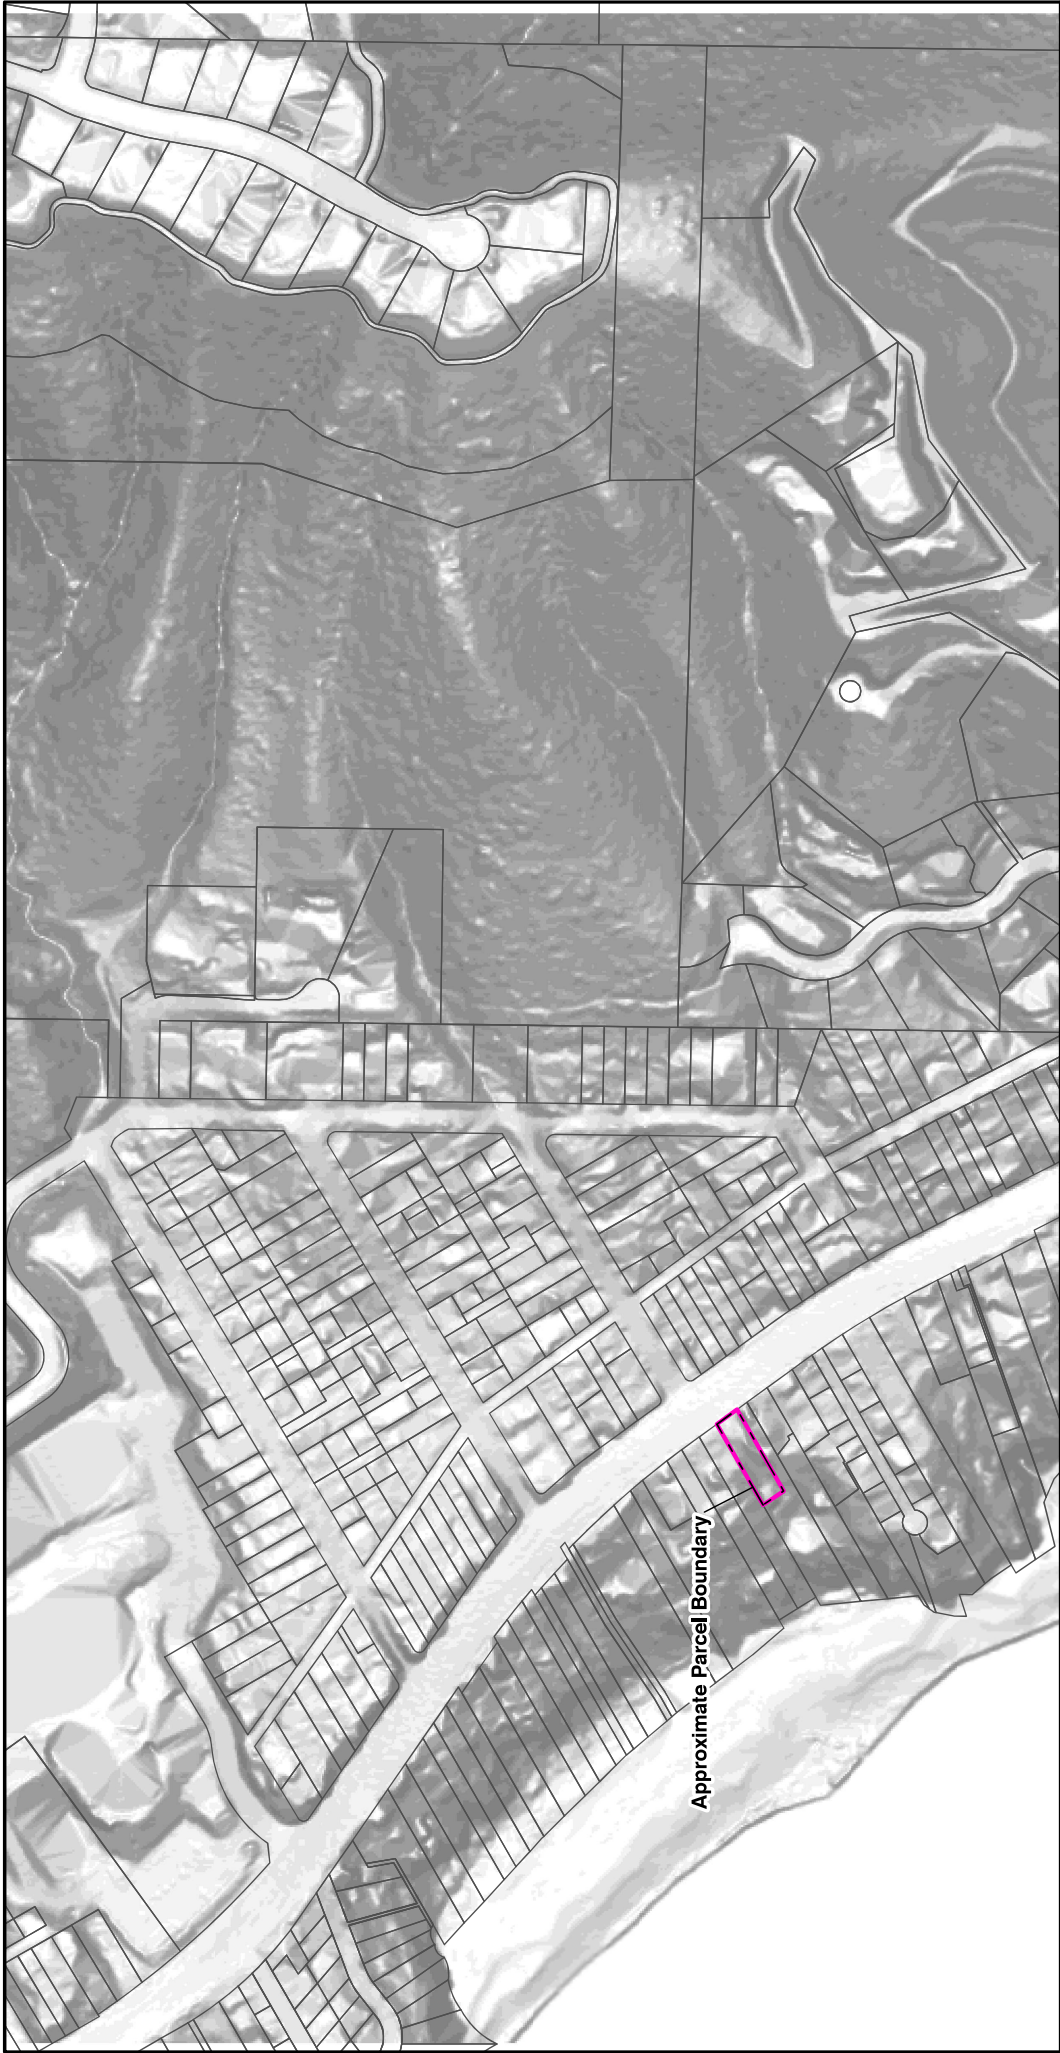
Figure 1

To further evaluate the potential for various steps or other grade breaks in the topography within the property and in the ascending terrain, our office presents the Lidar in a Digital Elevation Model in Figure 1. This format highlights the irregularities in the topography, with level or gently sloping areas in a white to lighter grey and steeper slopes depicted in darkening shades of grey, depending on the severity of the steepness. This LiDAR survey was obtained prior to the 32005 slope repair and shows the former southerly flowing drainage that transected the middle and lower portion of the property.

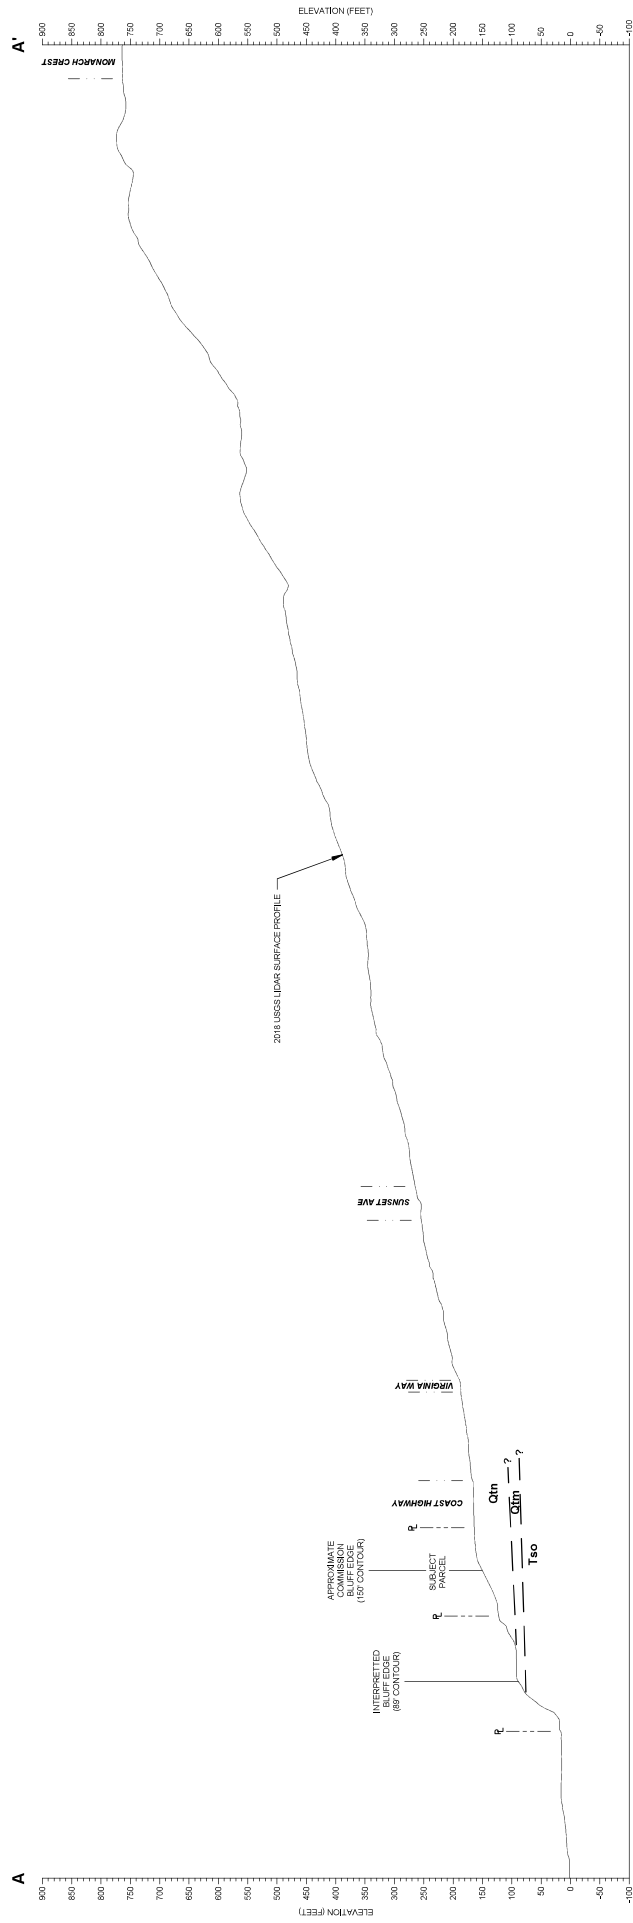
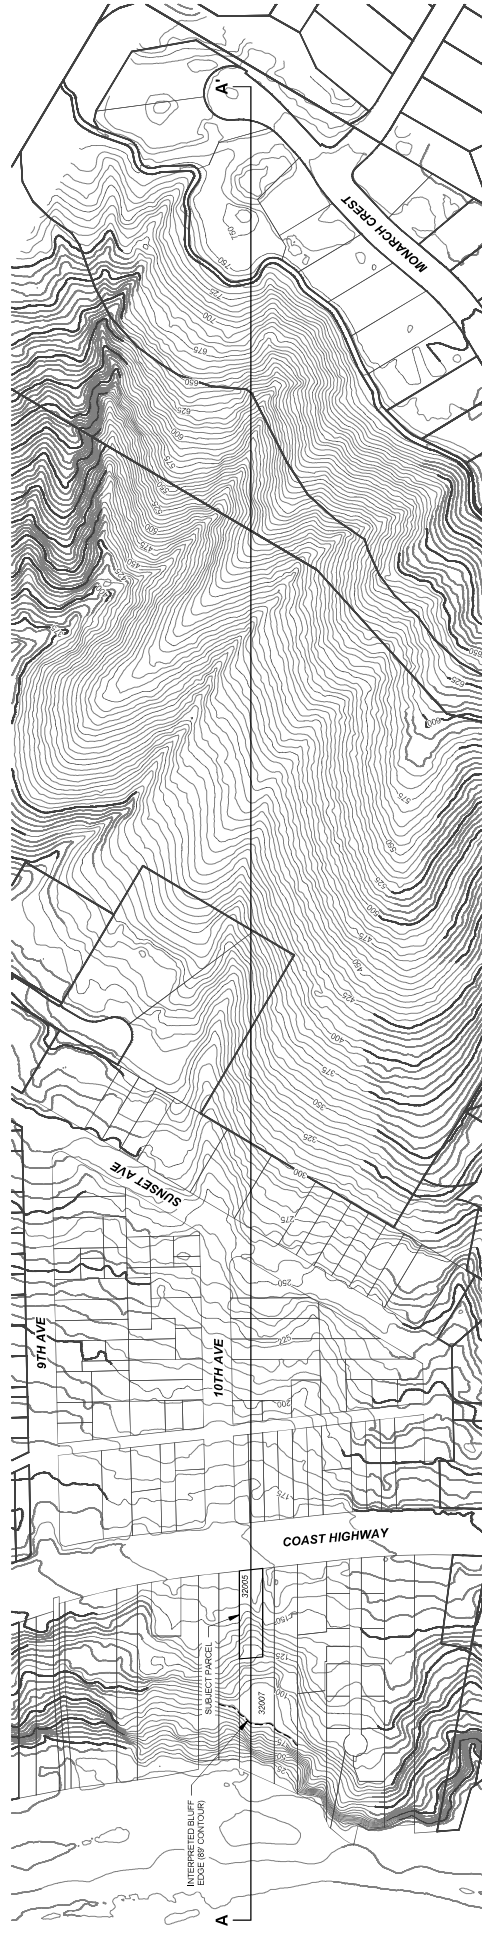
Additionally, our office prepared cross-section A-A' transecting 32005 and 32007 South Coast Highway, and continuing northeast to the ridgetop at Monarch Crest. The section depicts the normal terrestrial irregularities that occur in natural slopes. The 150-foot elevation contour location is depicted, as well as the location our office recommends for the 89-foot contour that depicts the bluff edge for the 32007 property. Based on our findings, there is no bluff edge or setback within the 32005 property boundary.
