**CALIFORNIA COASTAL COMMISSION**

**STAFF REPORT: REGULAR CALENDAR**

**APPLICATION NO.:** 4-06-113

**PROJECT DESCRIPTION:** Construct three soldier pile retaining walls (with wall lengths of 86.5 linear ft., 49 linear ft., and 26.5 linear ft. respectively and heights ranging from approximately 1 to 3 ft. above grade; install a subsurface drain pipe system; and relocate existing power pole.

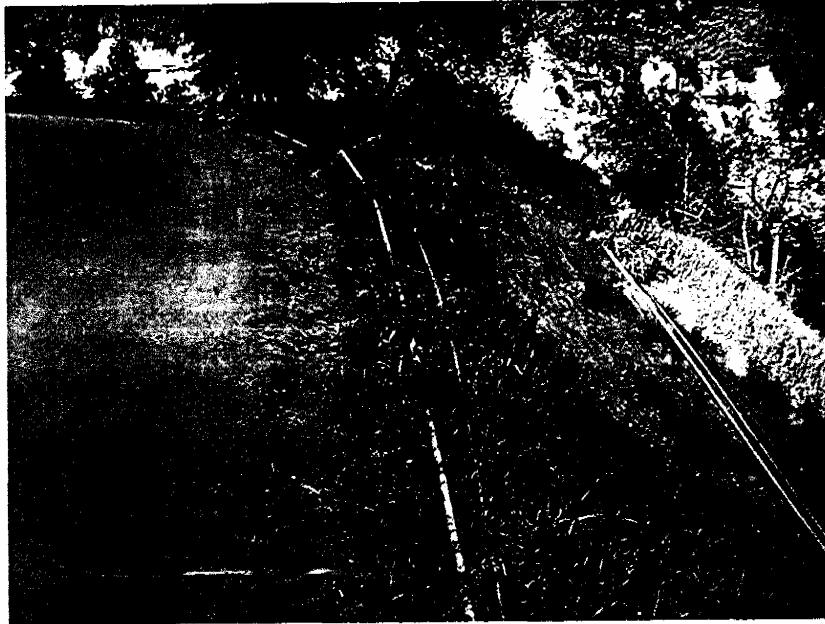
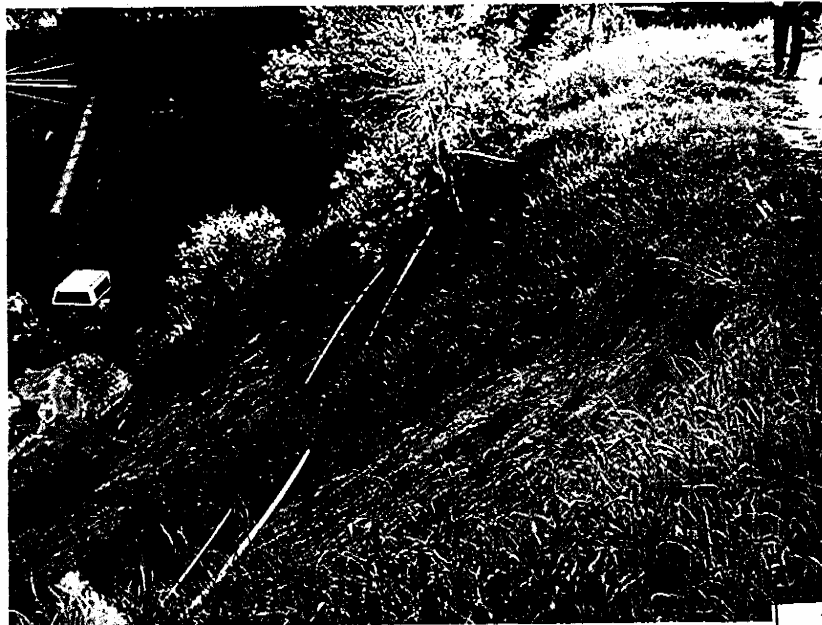
**EXHIBIT 11**  
**App. No. 4-06-113**  
**Site Photographs**

GREENLEAF CANYON ROAD MM 0.59 TO MM 0.68  
R831336050

During the January 2005 winter storm season, a heavy rainstorm caused the outboard slope to fail on Greenleaf Canyon Road from Mile Marker 0.59 to Mile Marker 0.68. Some portions of the slope have slid causing visible damage to the existing road. In order to prevent failure of the road, the County Public Works Department is proposing to construct a cantilever soldier pile retaining wall with drain pipe system at three locations along the outboard section of Greenleaf Canyon Road. The purpose of this project is to prevent failure of the roadway and slope and maintain the public's ability to use this two lane road for vehicular access and to provide for emergency services/access to the private developed and undeveloped property in the vicinity of the project.

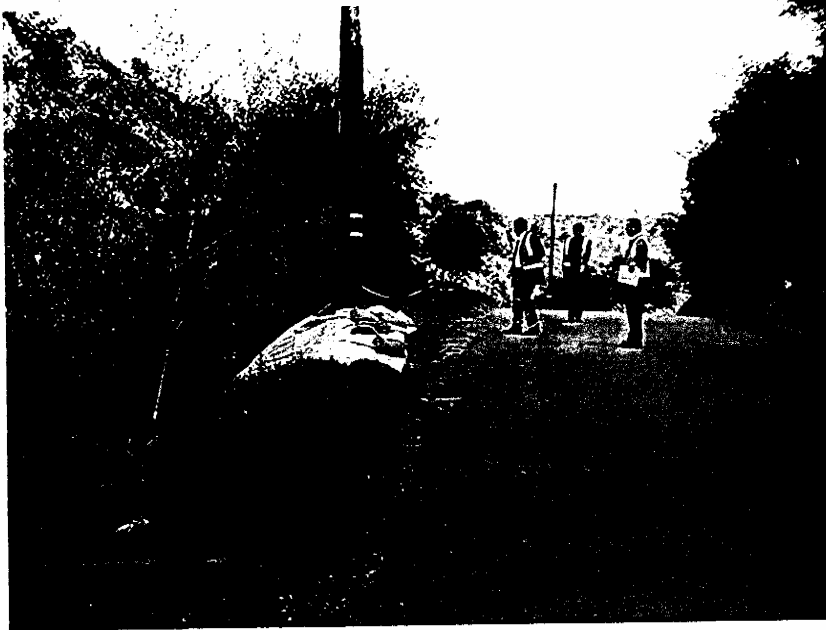
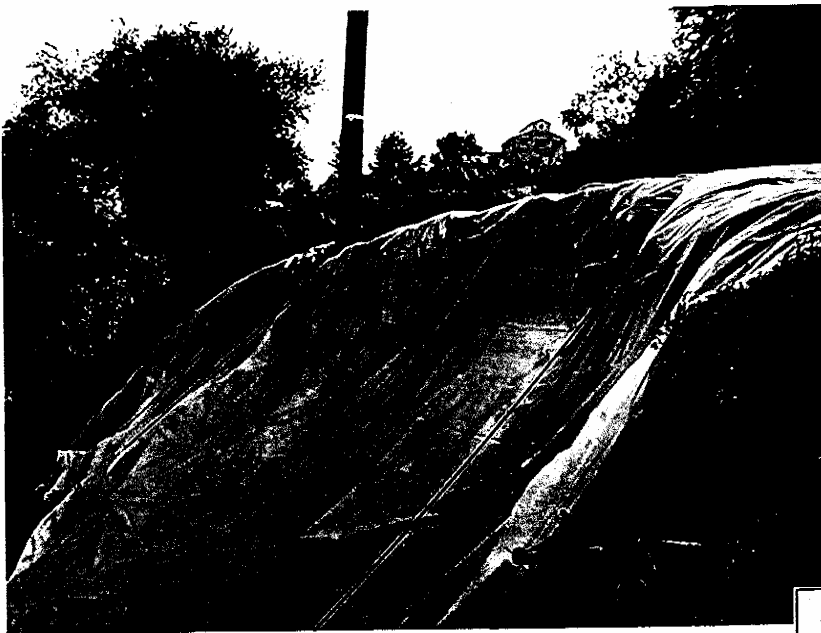
EXHIBIT 12  
App. No. 4-06-113  
Photographs  
Location 1

GREENLEAF CANYON ROAD MM 0.59 TO MM 0.68  
R831336050

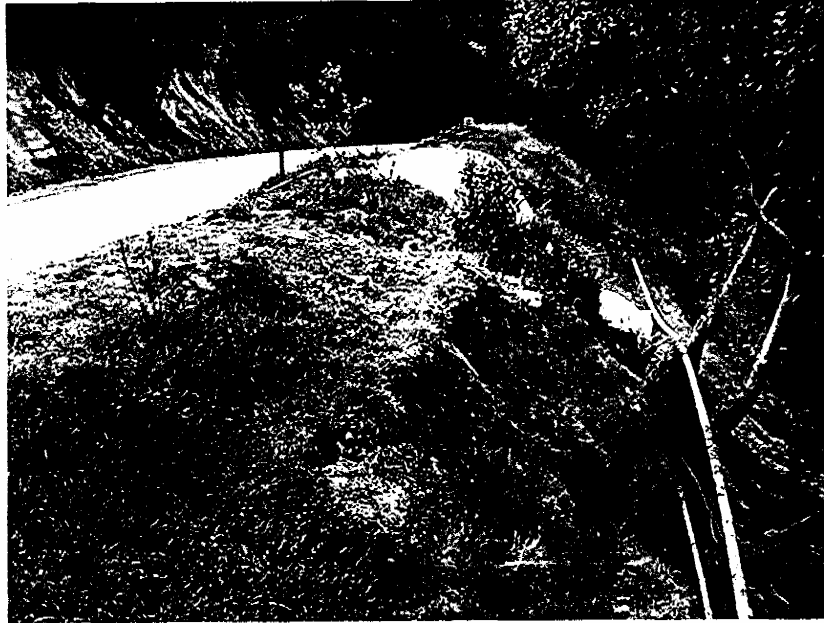
EXHIBIT 13  
App. No. 4-06-113  
Photographs  
Location 2

GREENLEAF CANYON ROAD MM 0.59 TO MM 0.68  
R831336050
