SUBJECT: ADDENDUM TO **ITEM Th16b**, COASTAL COMMISSION PERMIT APPLICATION **#5-06-325 (Walker)** FOR THE COMMISSION MEETING OF **November 2008**.

APPLICATION NUMBER: 5-06-325

PROJECT LOCATION: 1203 Buena Vista, San Clemente (Orange County)

PROJECT DESCRIPTION: Installation of three (3) 30" diameter, approximately 30' deep caissons interconnected by a grade beam system and a 4' to 10' deep concrete retaining wall in an "L" shaped configuration along the southwest corner of the lot; installation of five 36" diameter, approximately 30' deep caissons and a grade beam system beneath the patio along the southeast corner of the lot; reconstruction of the concrete patio along the seaward (rear yard) side of the lot; removal of existing wrought iron patio fence along the seaward side of the lot and replacement with a glass wall on a coastal bluff lot.

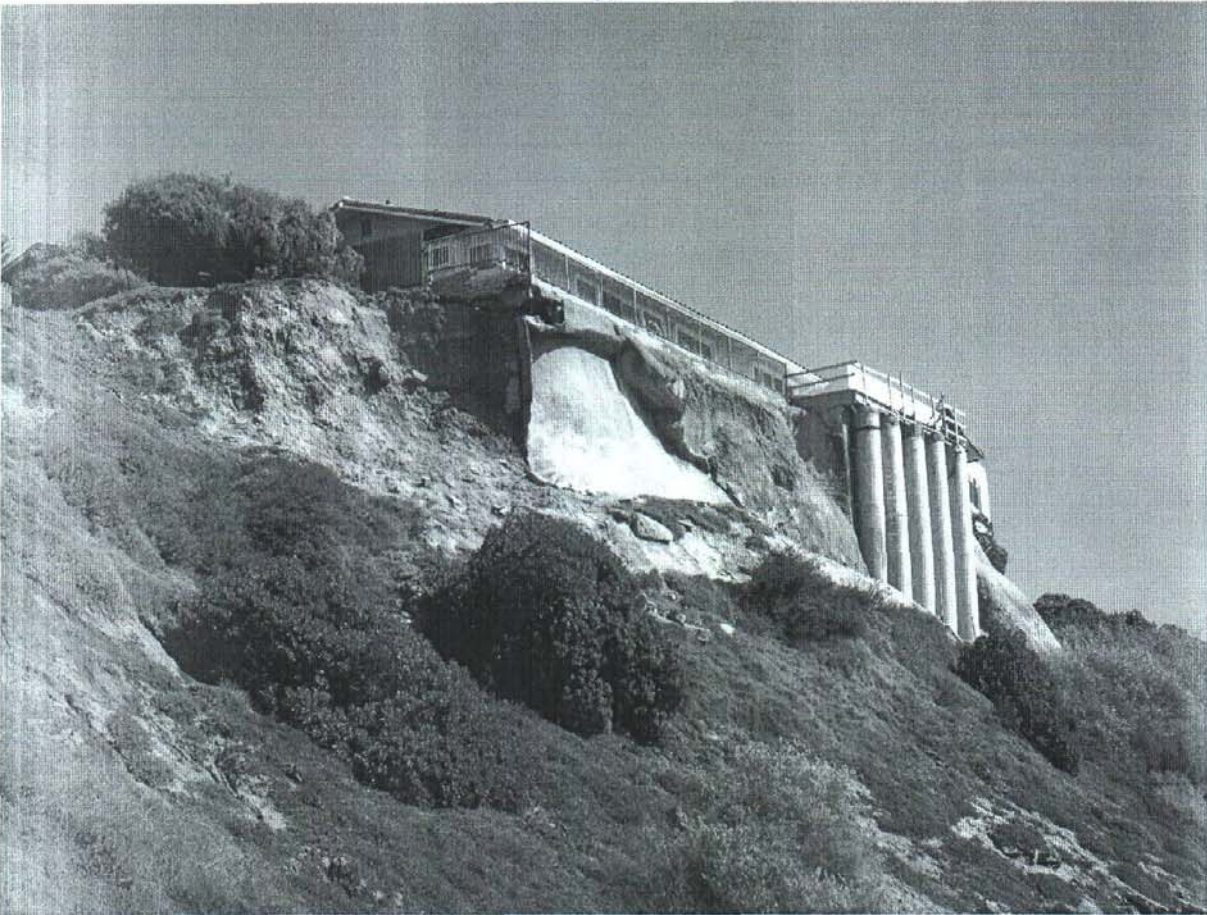
EXHIBIT # 6
PAGE 1 OF 3

2006 - Prior to emergency CDP work
