CALIFORNIA COASTAL COMMISSION

Subject: **Addendum to Commission Meeting for Friday, November 19, 2010**
North Coast District Item F 8c, CDP No. 1-10-010 (Maier)

Staff is proposing to make minor changes to the November 4, 2010 staff recommendation on Coastal Development Permit Application No. 1-10-010. The project description includes the proposed development of a new 416-square-foot, maximum 15.5-foot-high attached one-car garage and associated compacted crushed gravel driveway. Special Condition No. 1 of the staff recommendation, which would require submittal of revised plans prior to permit issuance for the Executive Director's review and approval that demonstrate the following: (a) any new development proposed seaward of the 160-foot geologic setback line from the bluff edge shall be deleted, including the proposed compacted crushed gravel driveway and proposed stamped concrete walk, and (b) the proposed one-car garage shall be redesigned so that access to its primary entrance is landward of the 160-foot geologic setback line from the bluff edge. The applicants' consulting engineer has informed staff that the redesign of the one-car garage and driveway required by Special Cond

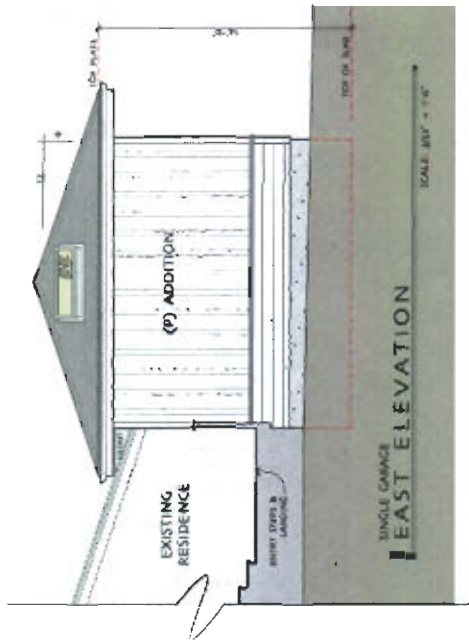
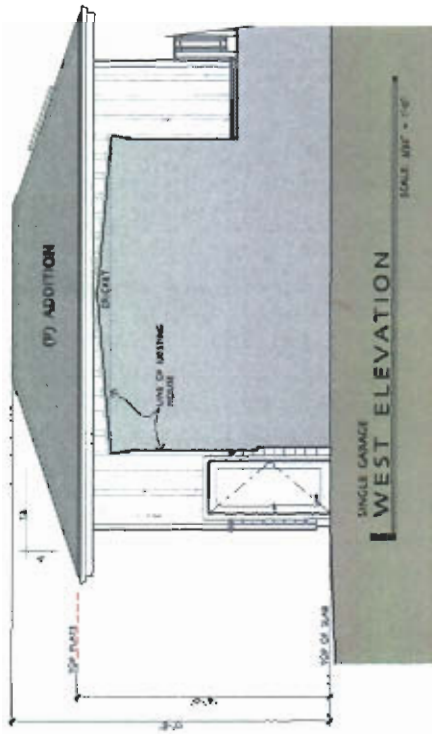
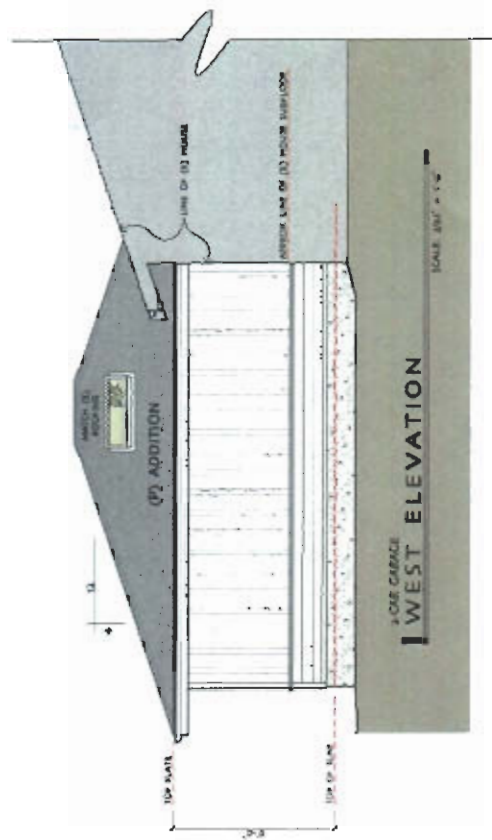
**PROPOSED SITE PLAN &
ELEVATIONS (1 of 5)**

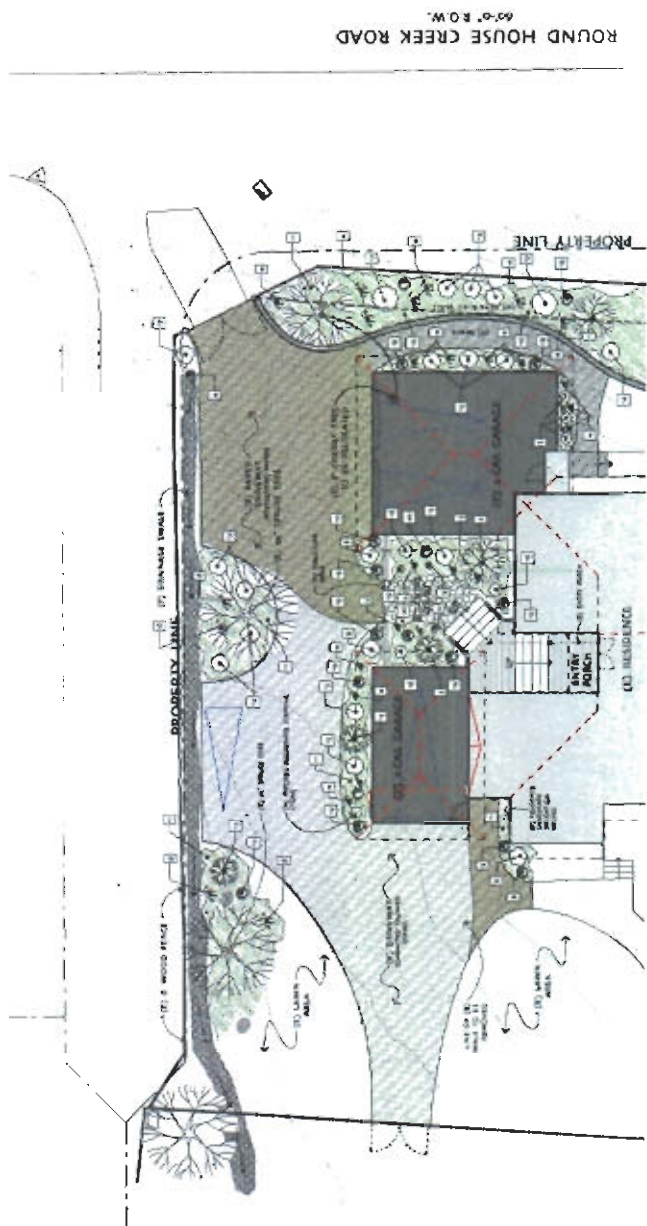
SCALE SEE DRAWING
DRAWN JAB
CHECK JAB
APPROVED JAB
DATE 5/25/2010
JOB NO. 77197.00
SHEET **LA-1**

MAIER GARAGE ADDITION
LANDSCAPE PLAN
RICHARD AND CINDY MAIER
294 ROUND HOUSE CREEK ROAD
BRD LAGOOM, CA 95570

LANDSCAPE PLAN

The applicants have submitted a landscaping plan for the subject site (Exhibit No. 6), which proposes the use of a variety of native species and non-invasive horticultural varieties on the property. To help in the establishment of landscaping vegetation, rodenticides are sometimes used to prevent rats, moles, voles, gophers, and other similar small animals from eating the newly planted saplings. Certain rodenticides, particularly those utilizing blood anticoagulant compounds such as brodifacoum, bromadiolone and diphacinone, have been found to pose significant primary and secondary risks to non-target wildlife present in urban and urban/ wildland areas. As the target species are preyed upon by raptors or other environmentally sensitive predators and scavengers, these compounds can bio-accumulate in the animals that have consumed the rodents to concentrations toxic to the ingesting non-target species. Therefore, to minimize this potential significant adverse cumulative impact to environmentally sensitive wildlife
