January 24, 2011

SUBJECT: Engineering Review of the Sweetwater Mesa Project

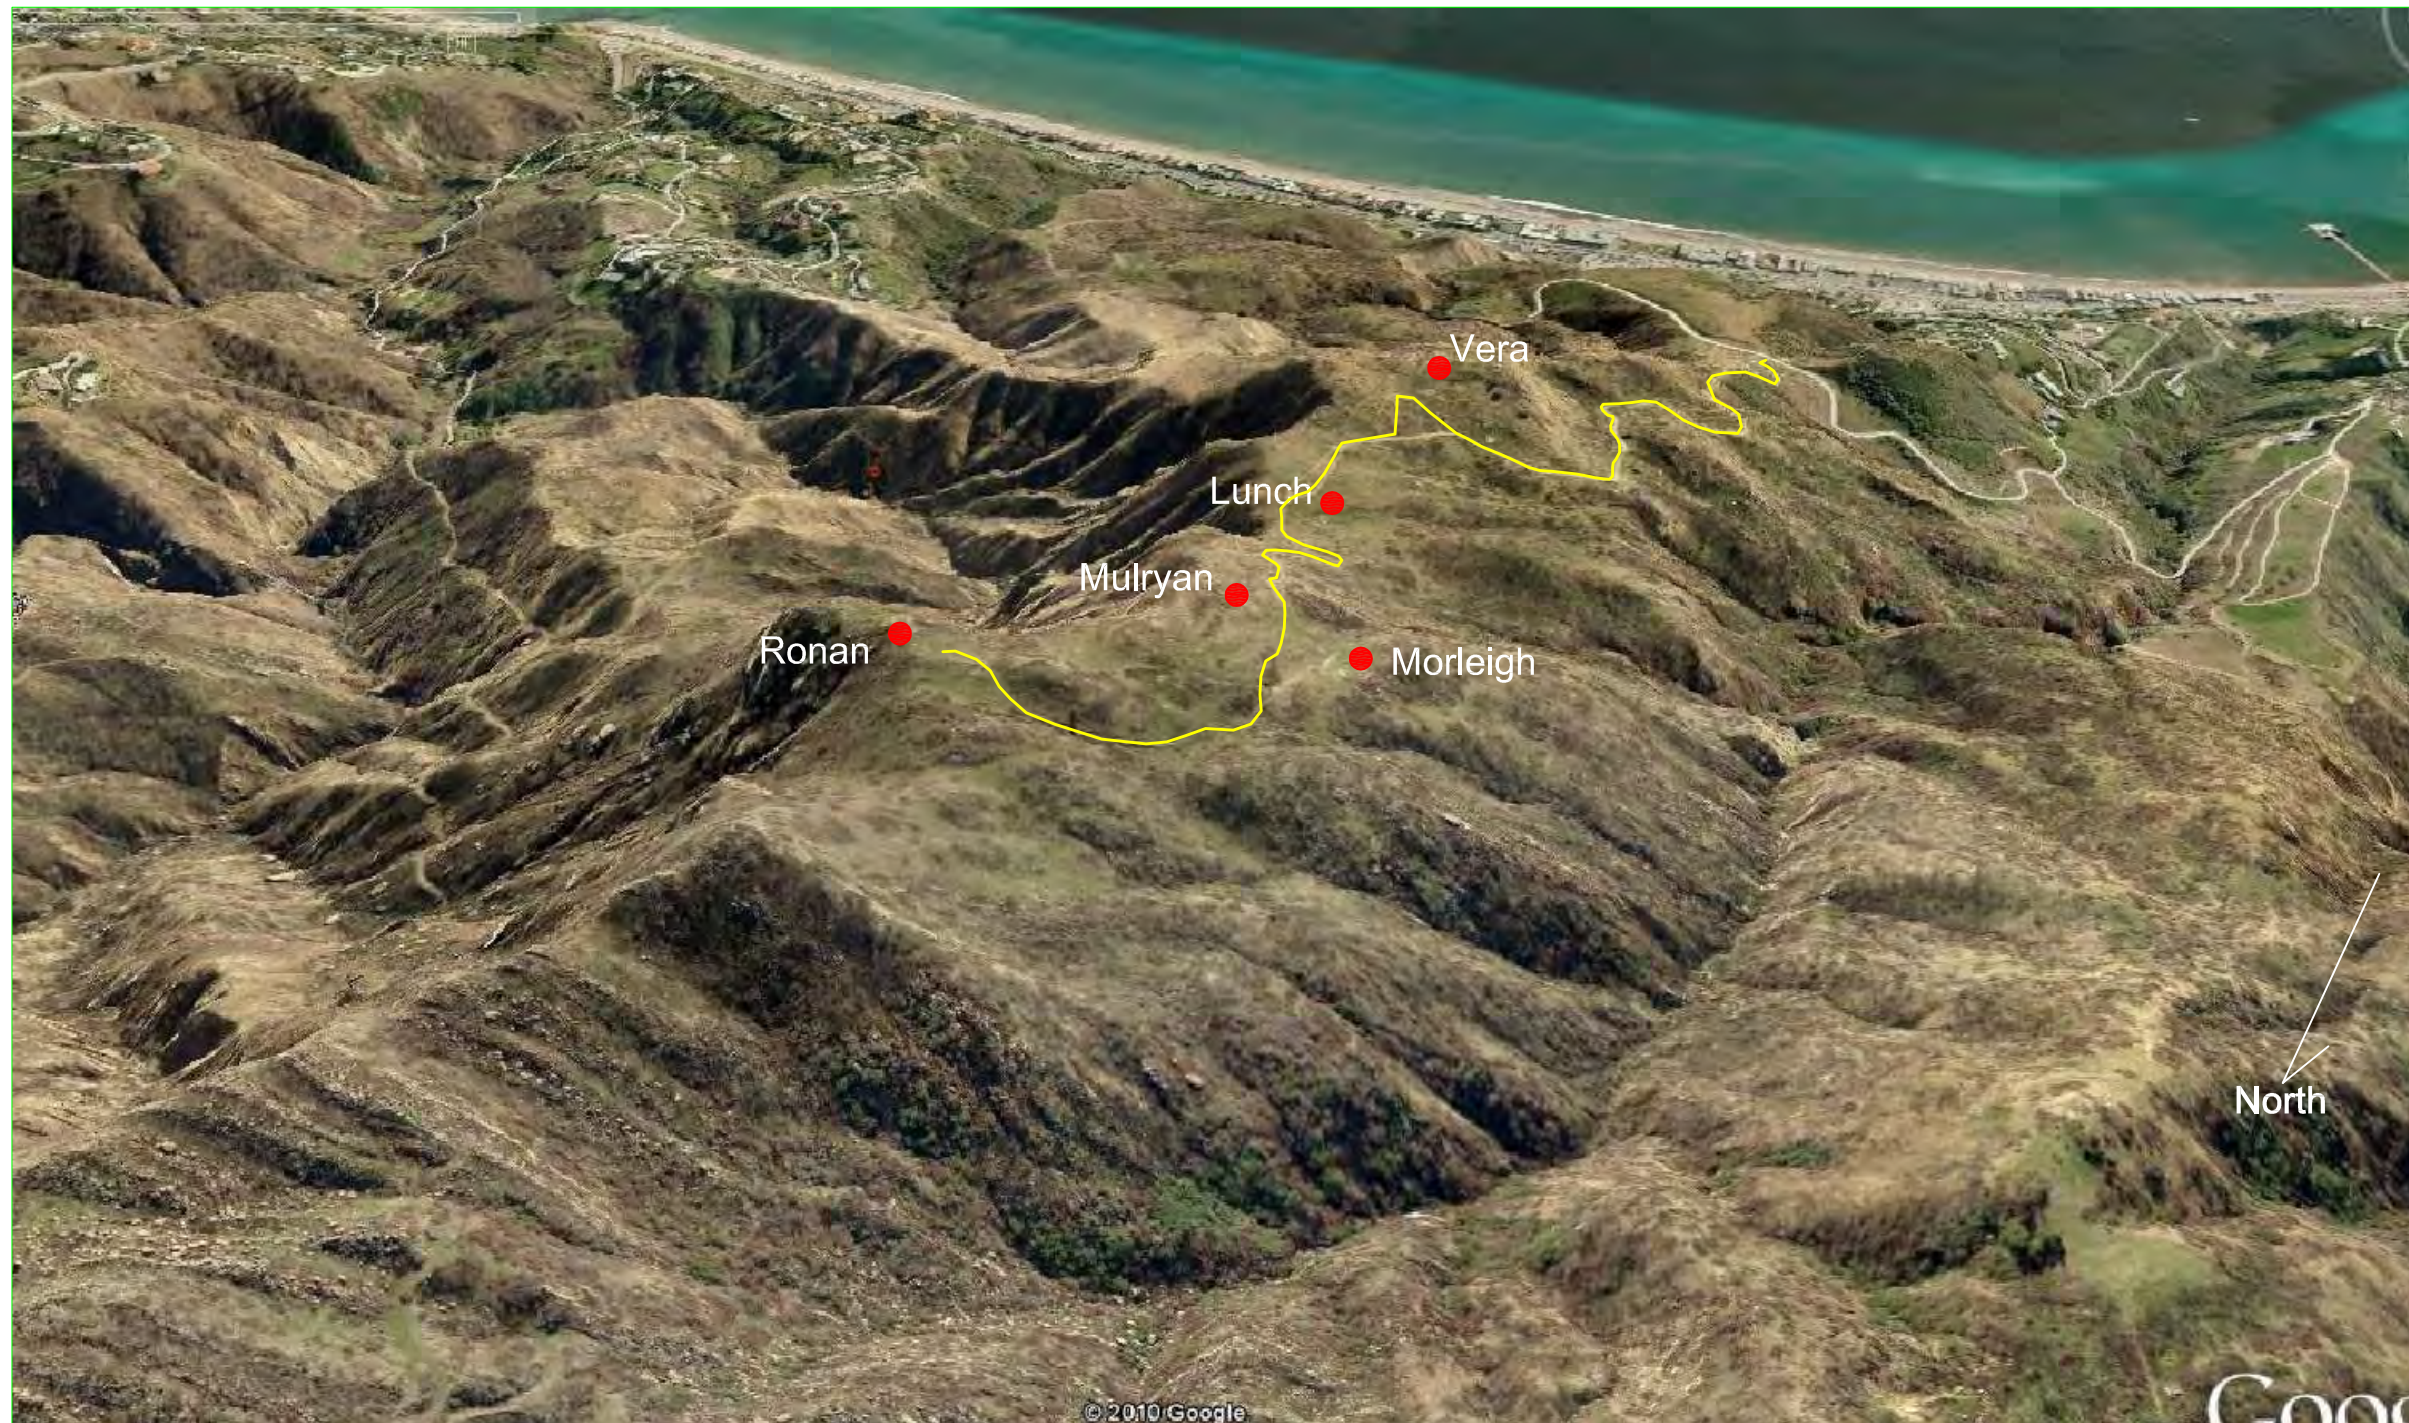
GEO/ENG BY <b>JW</b>	SCALE <b>NA</b>	PROJECT NO. <b>E5050</b>
APPROVED BY <b>JW/POS</b>	DATE <b>March 2010</b>	FIGURE NO. <b>1</b>

**AERIAL SITE VIEW**  
**Sweetwater Mesa Development Project**  
**Malibu, California**
