**Wetland Mitigation and Monitoring Plan  
Humboldt State University Corporation Yard  
1601 Samoa Boulevard, Arcata  
Humboldt County, California**

<b>EXHIBIT NO. 7</b>
<b>APPEAL NO.</b> A-1-ARC-12-003 - HUMBOLDT STATE UNIVERSITY FOUNDATION WETLAND MITIGATION AND MONITORING PLAN (WINZLER AND KELLY, APRIL 2011) (1 of 45)

**UPDATED FINAL  
WETLAND MITIGATION AND MONITORING PLAN  
HUMBOLDT STATE UNIVERSITY, CORPORATION YARD FACILITY  
AT 1601 SAMOA, BLVD  
ASSESSOR PARCEL NUMBERS (APN) 021-191-006, 505-251-011, 505-251-013, and 506-05-105  
ARCATA, CALIFORNIA**

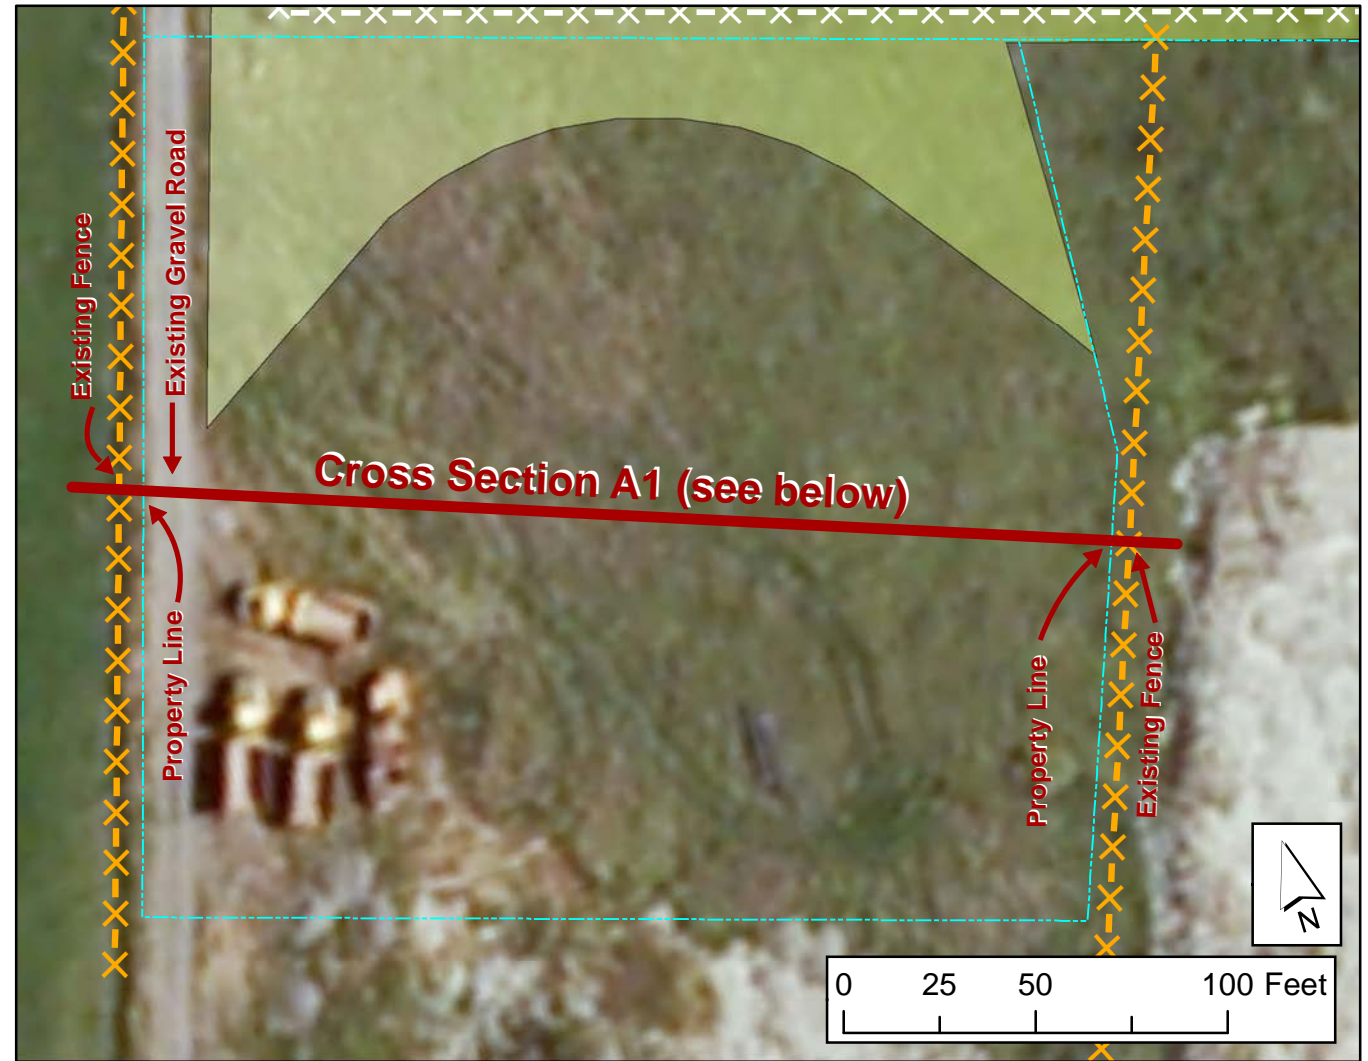
**Figure 5**  
**On-site Wetland Mitigation Area:**  
**Cross Section A: Existing Conditions**

**Cross Section A1:  
Onsite Mitigation Area  
Existing Conditions**

Approximately 34,132 sf of Palustrine Emergent Wetlands will be created through minor excavation adjacent to existing Palustrine Emergent Wetlands. A grading plan and cross sections are shown on Figures 5 and 6, Appendix A, existing conditions and conceptual grading plan.

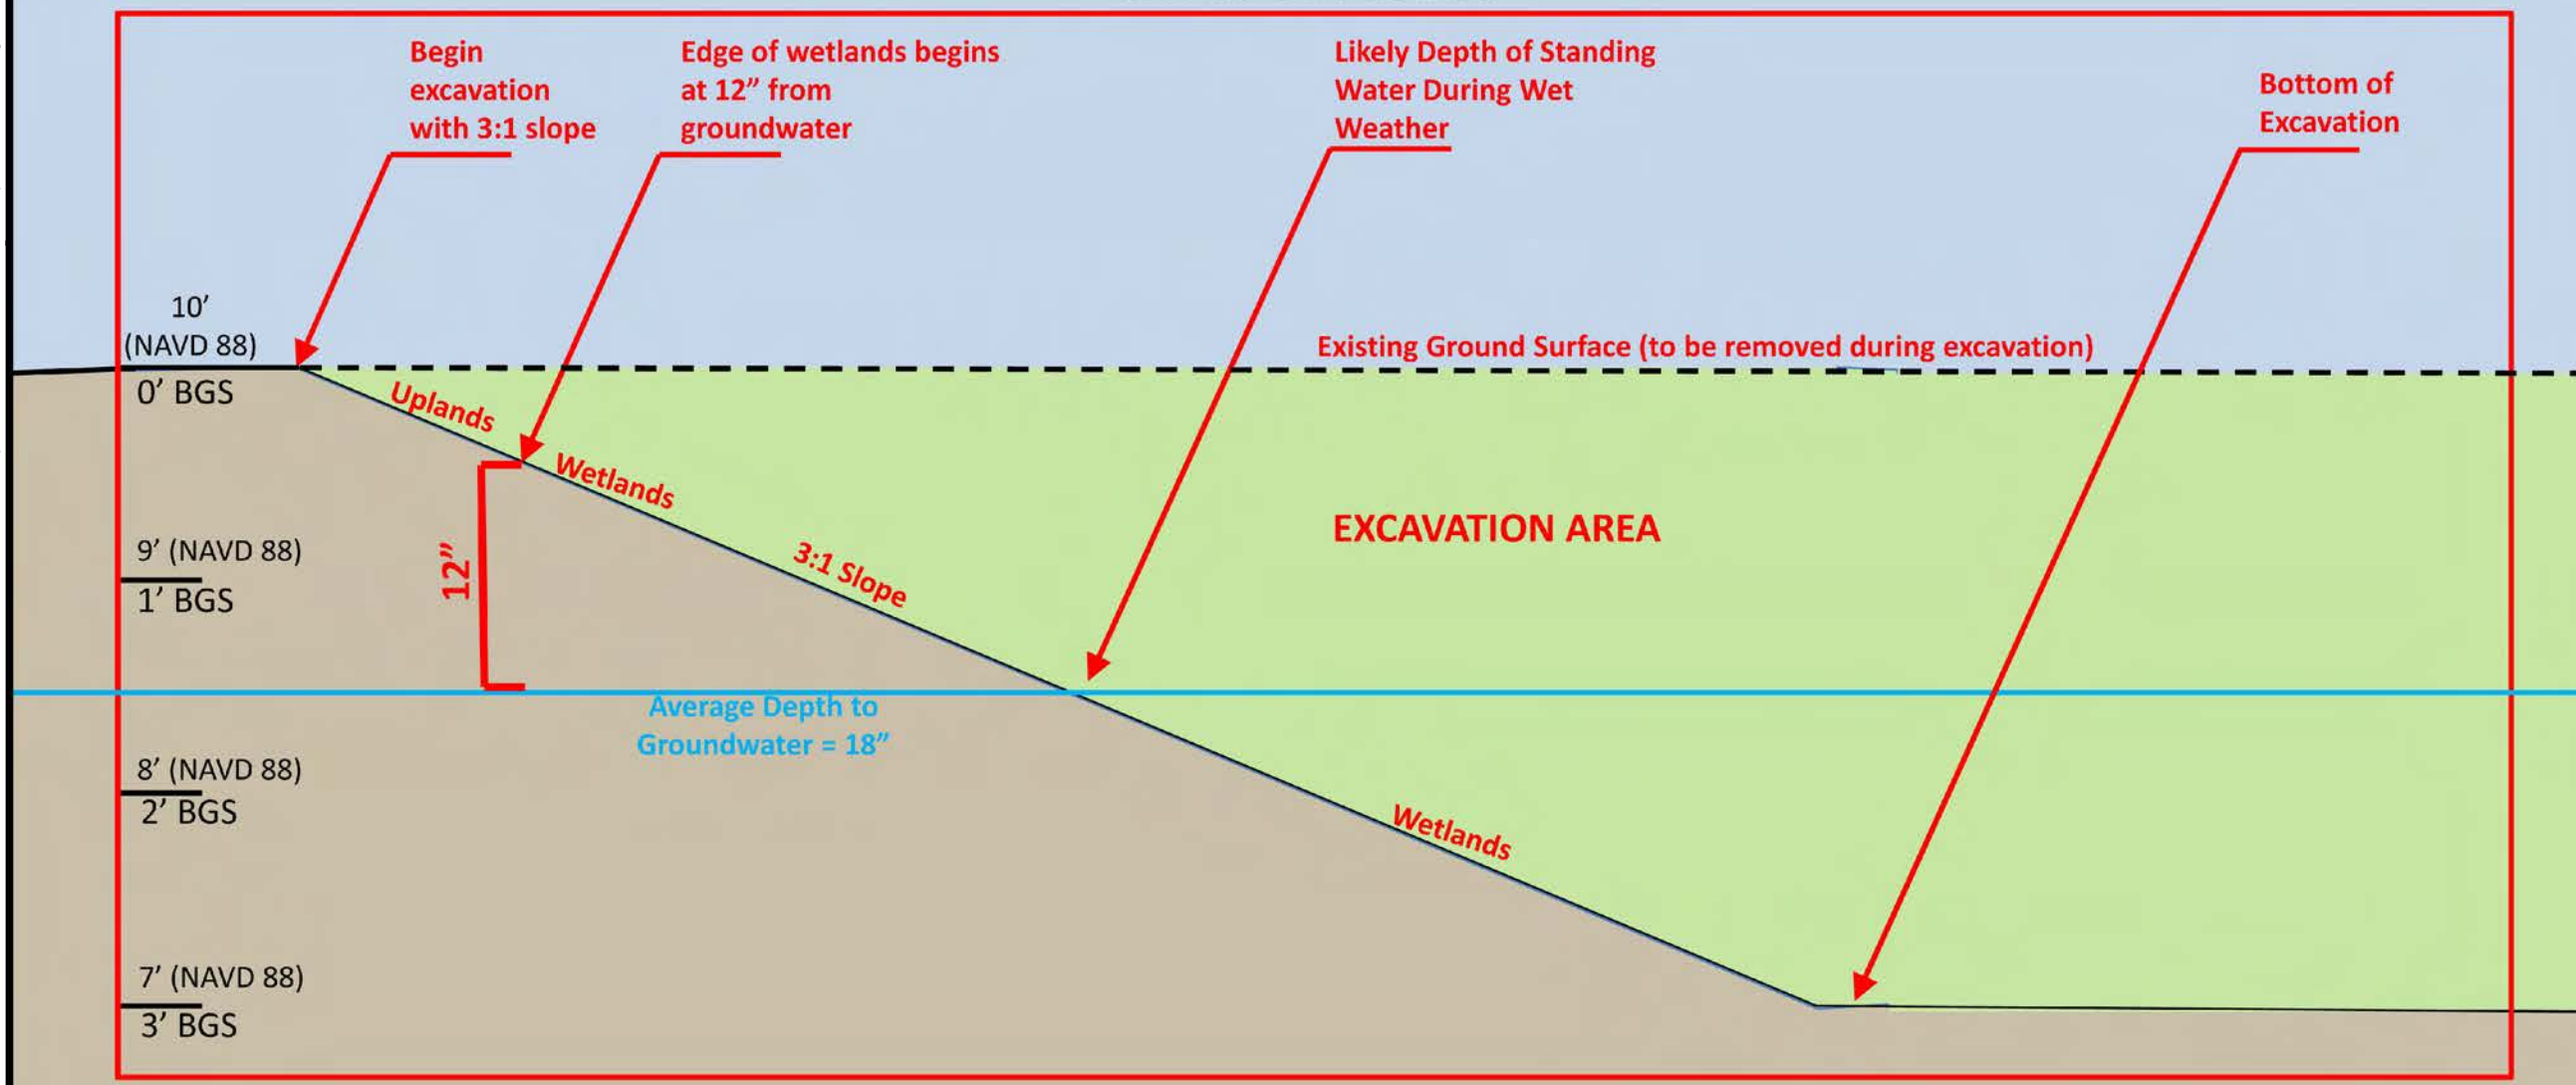
- Area of Excavation
- Soil
- Groundwater
- Excavated Ground Surface
- BGS Below Ground Surface
- NAVD88 North American Vertical Datum of 1988
