## STAFF REPORT: REGULAR CALENDAR

<b>Application No.:</b>	<b>5-12-303</b>
<b>Applicant:</b>	<b>Mesa Consolidated Water District</b>
<b>Project Location:</b>	San Diego Creek between SR-73 and Jamboree Road, Newport Beach, Orange County
<b>Project Description:</b>	Request for permanent authorization of emergency repairs to water main including removal of a damaged 16 foot length sections of a 42 inch diameter water main located in San Diego Creek and its replacement with new pipe section, installation of 12 cubic yards of gravel bedding, mowing of a 50'x200' area of native and non-native vegetation to 6 to12 inch height and installation of construction fabric and a 12 inch layer of aggregate to create a temporary construction access and staging area.
<b>Staff Recommendation:</b>	Approval with conditions

**SAN DIEGO CREEK PIPELINE REPAIR**  
Work Zone Area

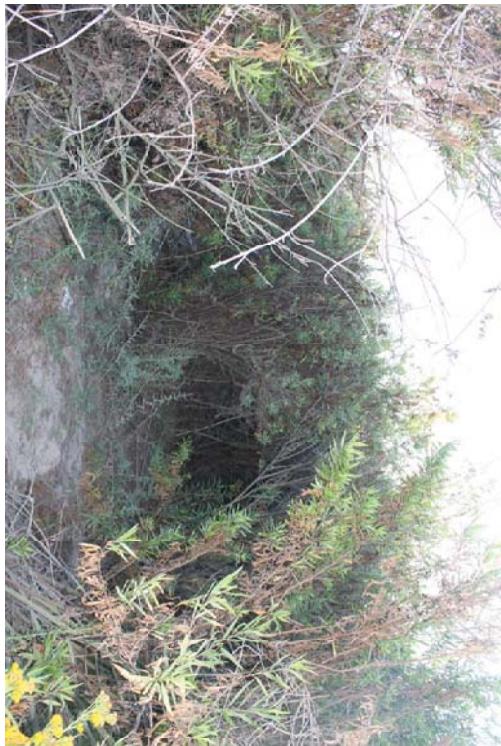
Photograph 3: Close up view of mulefat (*Baccharis salicifolia*) located near the northern extent of the work zone.

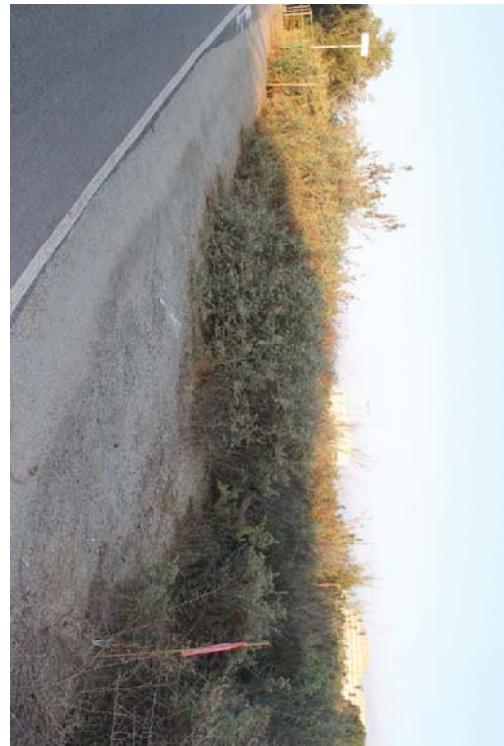
Photograph 1: View looking northwest at the northern limit of the work zone prior to clearing. Dominant vegetation depicted includes big saltbush (*Atriplex lentiformis*).

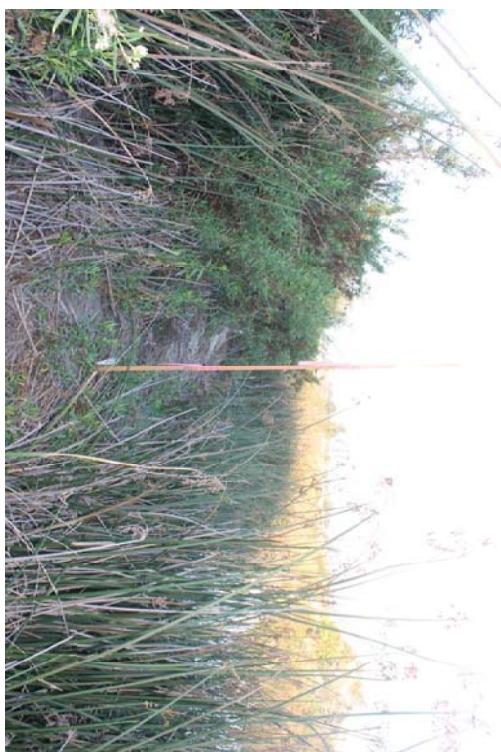
Photograph 4: View looking west at the northern limit of the work zone. Dominant vegetation depicted includes mulefat (*Baccharis salicifolia*) within the work zone and bulrush (*Scirpus* sp.) outside of the work zone.

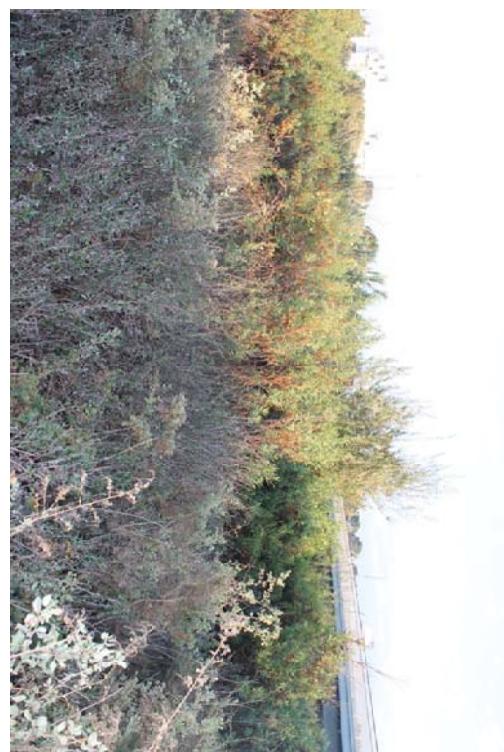
Photograph 2: View looking northeast at the transition zone between big saltbush (*Atriplex lentiformis*) in the foreground and mulefat (*Baccharis salicifolia*) in the background. The southbound lane of the 73 Toll Road can be seen in the background.

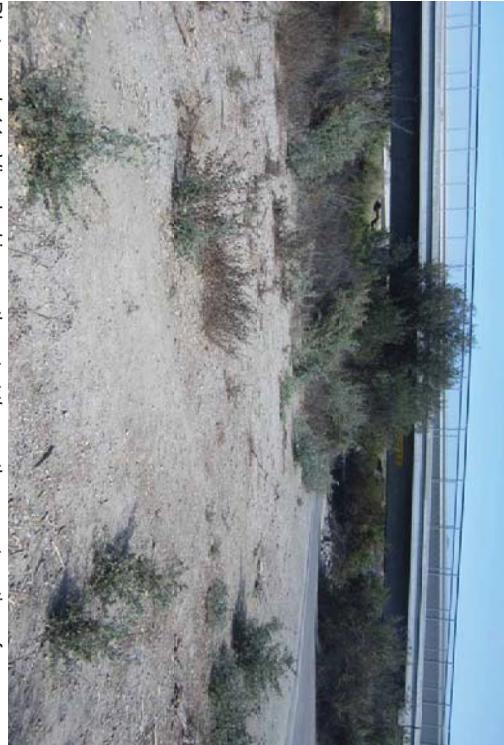
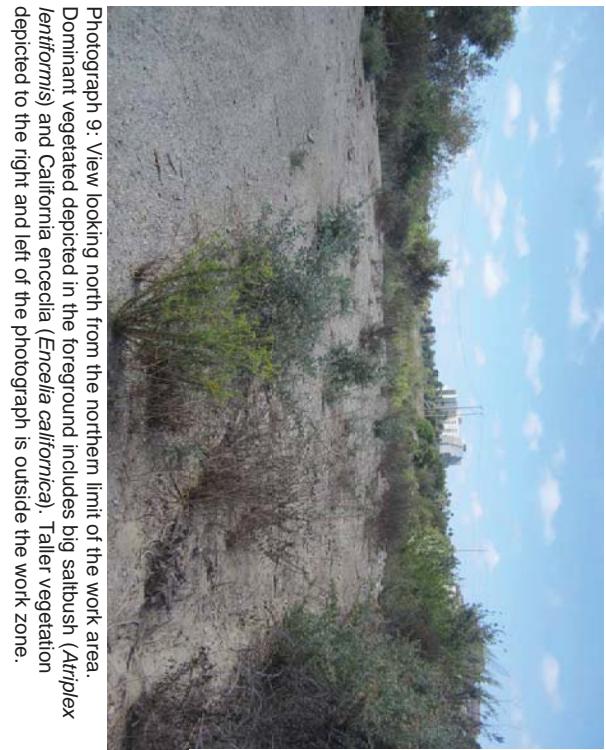
Photograph 9: View looking southeast at the southernmost portion of the work zone. Taller vegetation depicted is located immediately outside of the work zone. Dominant vegetation depicted includes big saltbush (*Atriplex lentiformis*) and California encelia (*Encelia californica*). Taller vegetation depicted to the right and left of the photograph is outside the work zone.

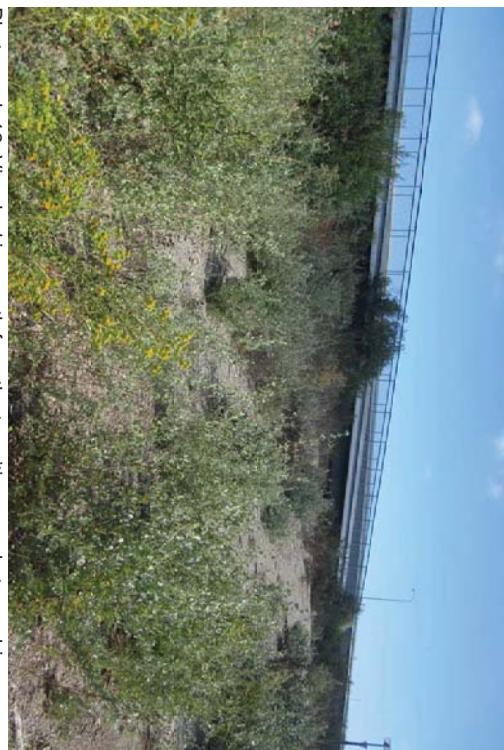
Photograph 11: View looking southeast at the southernmost portion of the work zone. Taller vegetation depicted is located immediately outside of the work zone. Dominant vegetation depicted includes big saltbush (*Atriplex lentiformis*) and California encelia (*Encelia californica*).

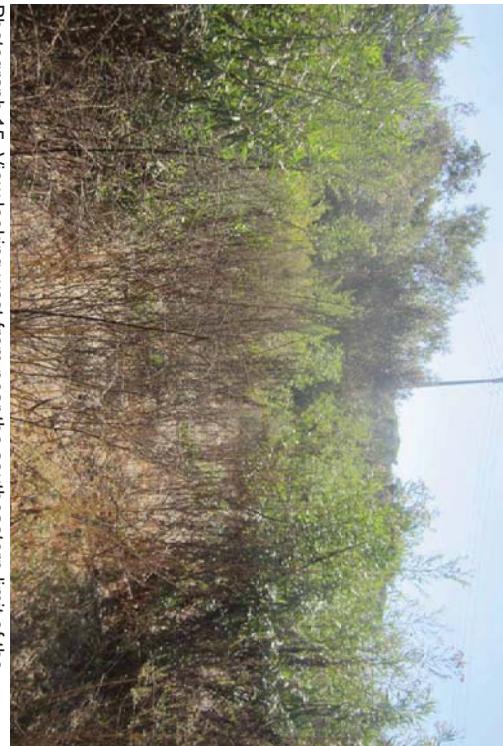
Photograph 15. View looking west from near the southeastern limit of the work area. Dominant vegetation depicted included mulefat (*Baccharis salicifolia*). Additional vegetation depicted includes black mustard (*Brassica nigra*).

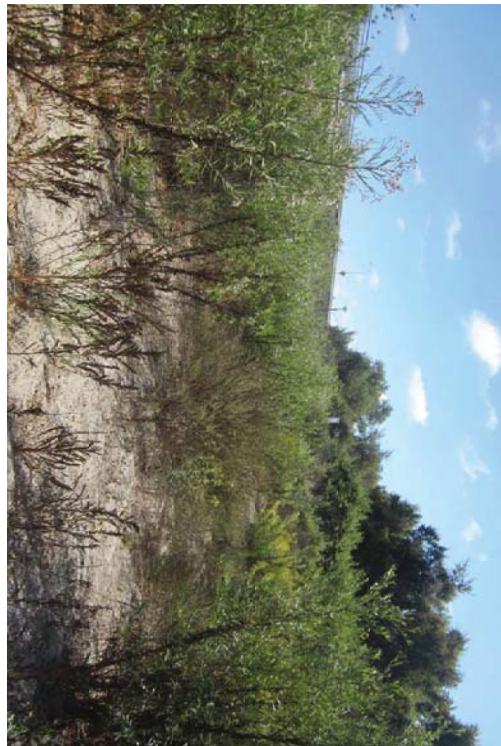
Photograph 13: View looking south from near the northern limit of the work zone. Dominant vegetation depicted includes mulefat (*Baccharis salicifolia*) and annual bursage (*Ambrosia acanthothecarpa*).

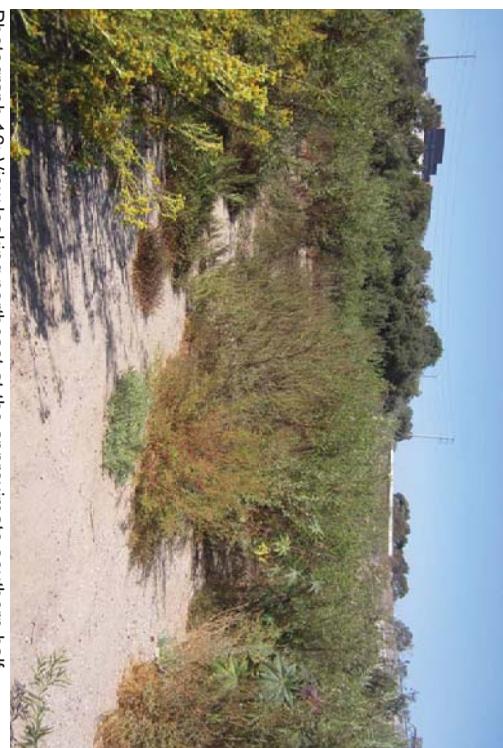
Photograph 16: View looking northeast at the approximate southern half of the work zone. Dominant vegetation depicted includes mulefat (*Baccharis salicifolia*). Other vegetation depicted includes coastal goldenbush (*Ioscomia menziesii*), and trace amounts of alkali heliotrope (*Heliotropium curassavicum*), castor bean (*Ricinus communis*), and Spanish sunflower (*Pulicaria paludosa*).

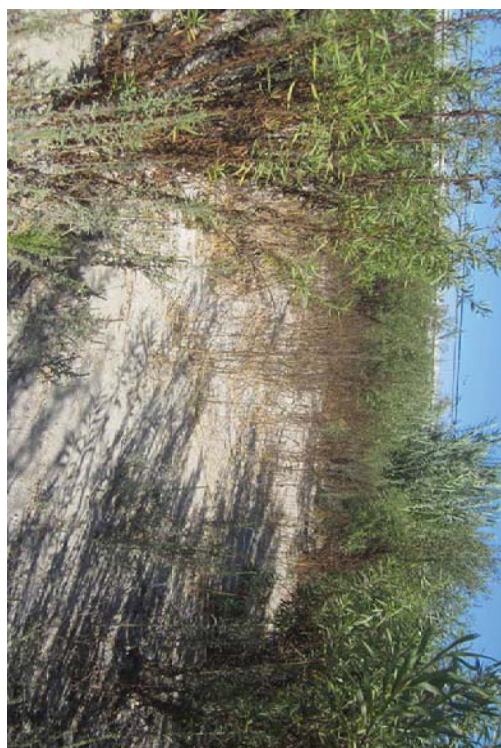
Photograph 14: View looking east at the northernmost limit of the work area. Dominant vegetation depicted included mulefat (*Baccharis salicifolia*) and annual bursage (*Ambrosia acanthothecarpa*).
