STAFF REPORT: REGULAR CALENDAR

Application No.: 4-12-076

Project Location: 909 South Kellogg Avenue, City of Goleta, Santa Barbara County
(APN 071-190-034)

Project Description: Request for after-the-fact approval of an existing, unpermitted concrete, asphalt, and aggregate recycling facility, including a 960 sq. ft. office trailer with entry platform stairway and ramp, vehicle scale, a 22,490 sq. ft. (and up to 23 ft. high) raw material stockpile area, a 22,755 sq. ft. (and up to 23 ft. high) finished material stockpile area, perimeter roads around the stockpiles, equipment storage, and crushing operation area for crusher, screening plant, and radial stacker equipment. In addition, the project includes construction of new fencing, gates, a new concrete curb and swale for runoff, a 25 ft. wide riparian buffer area where habitat enhancement using native plants is proposed, and removal of existing, unpermitted salvage vehicles stored on the site.

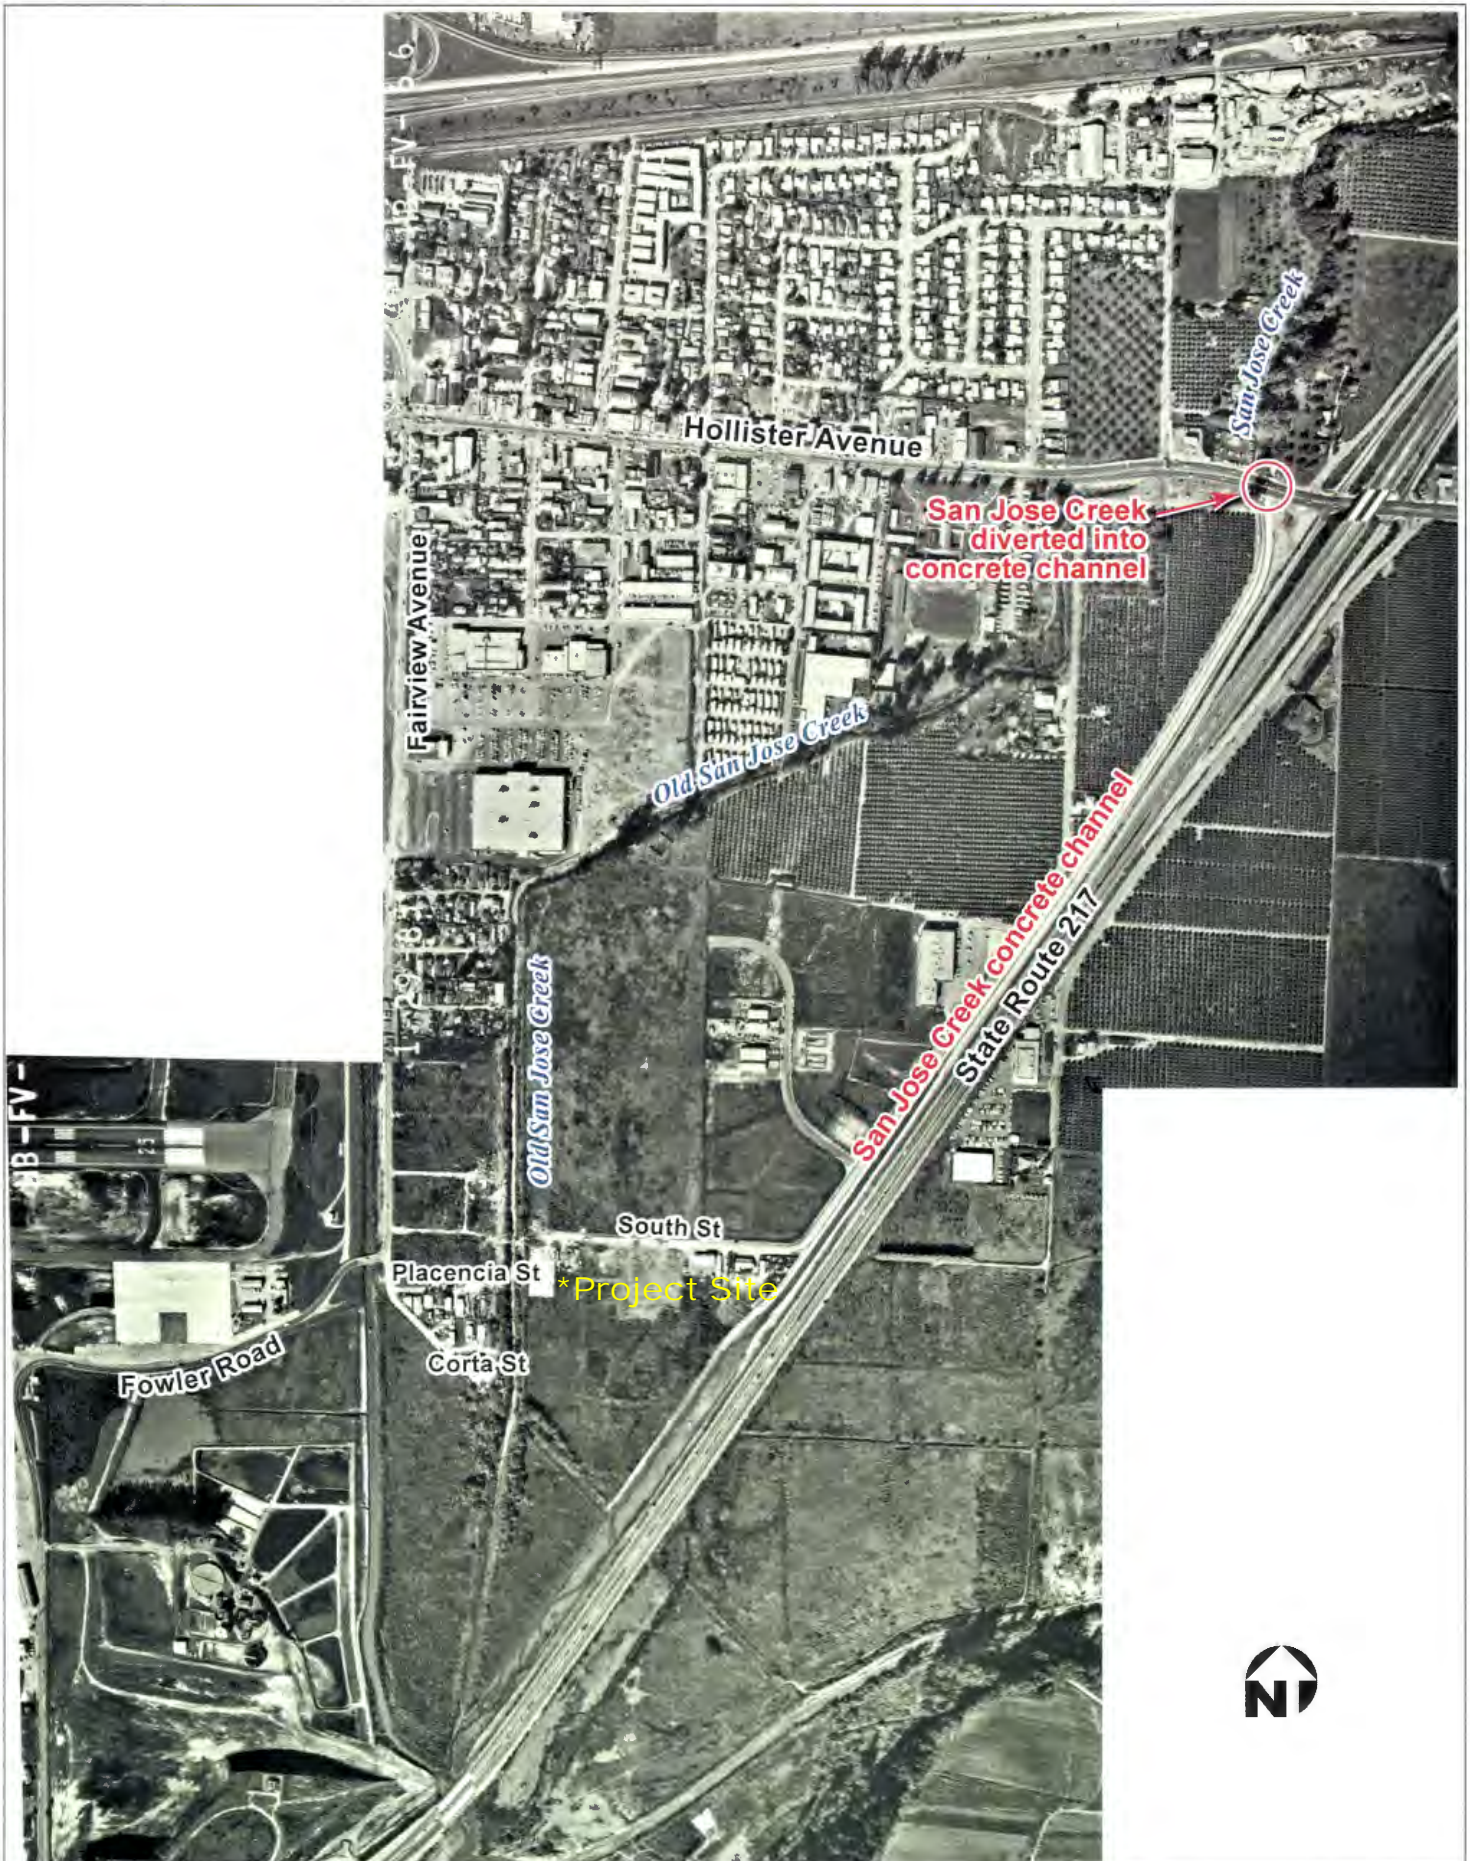
Exhibit 7 (pg 1 of 3)
Figure 10. 1929 Aerial Photograph
CDP Application 4-12-076

Old San Jose Creek Historic Aerials and Map

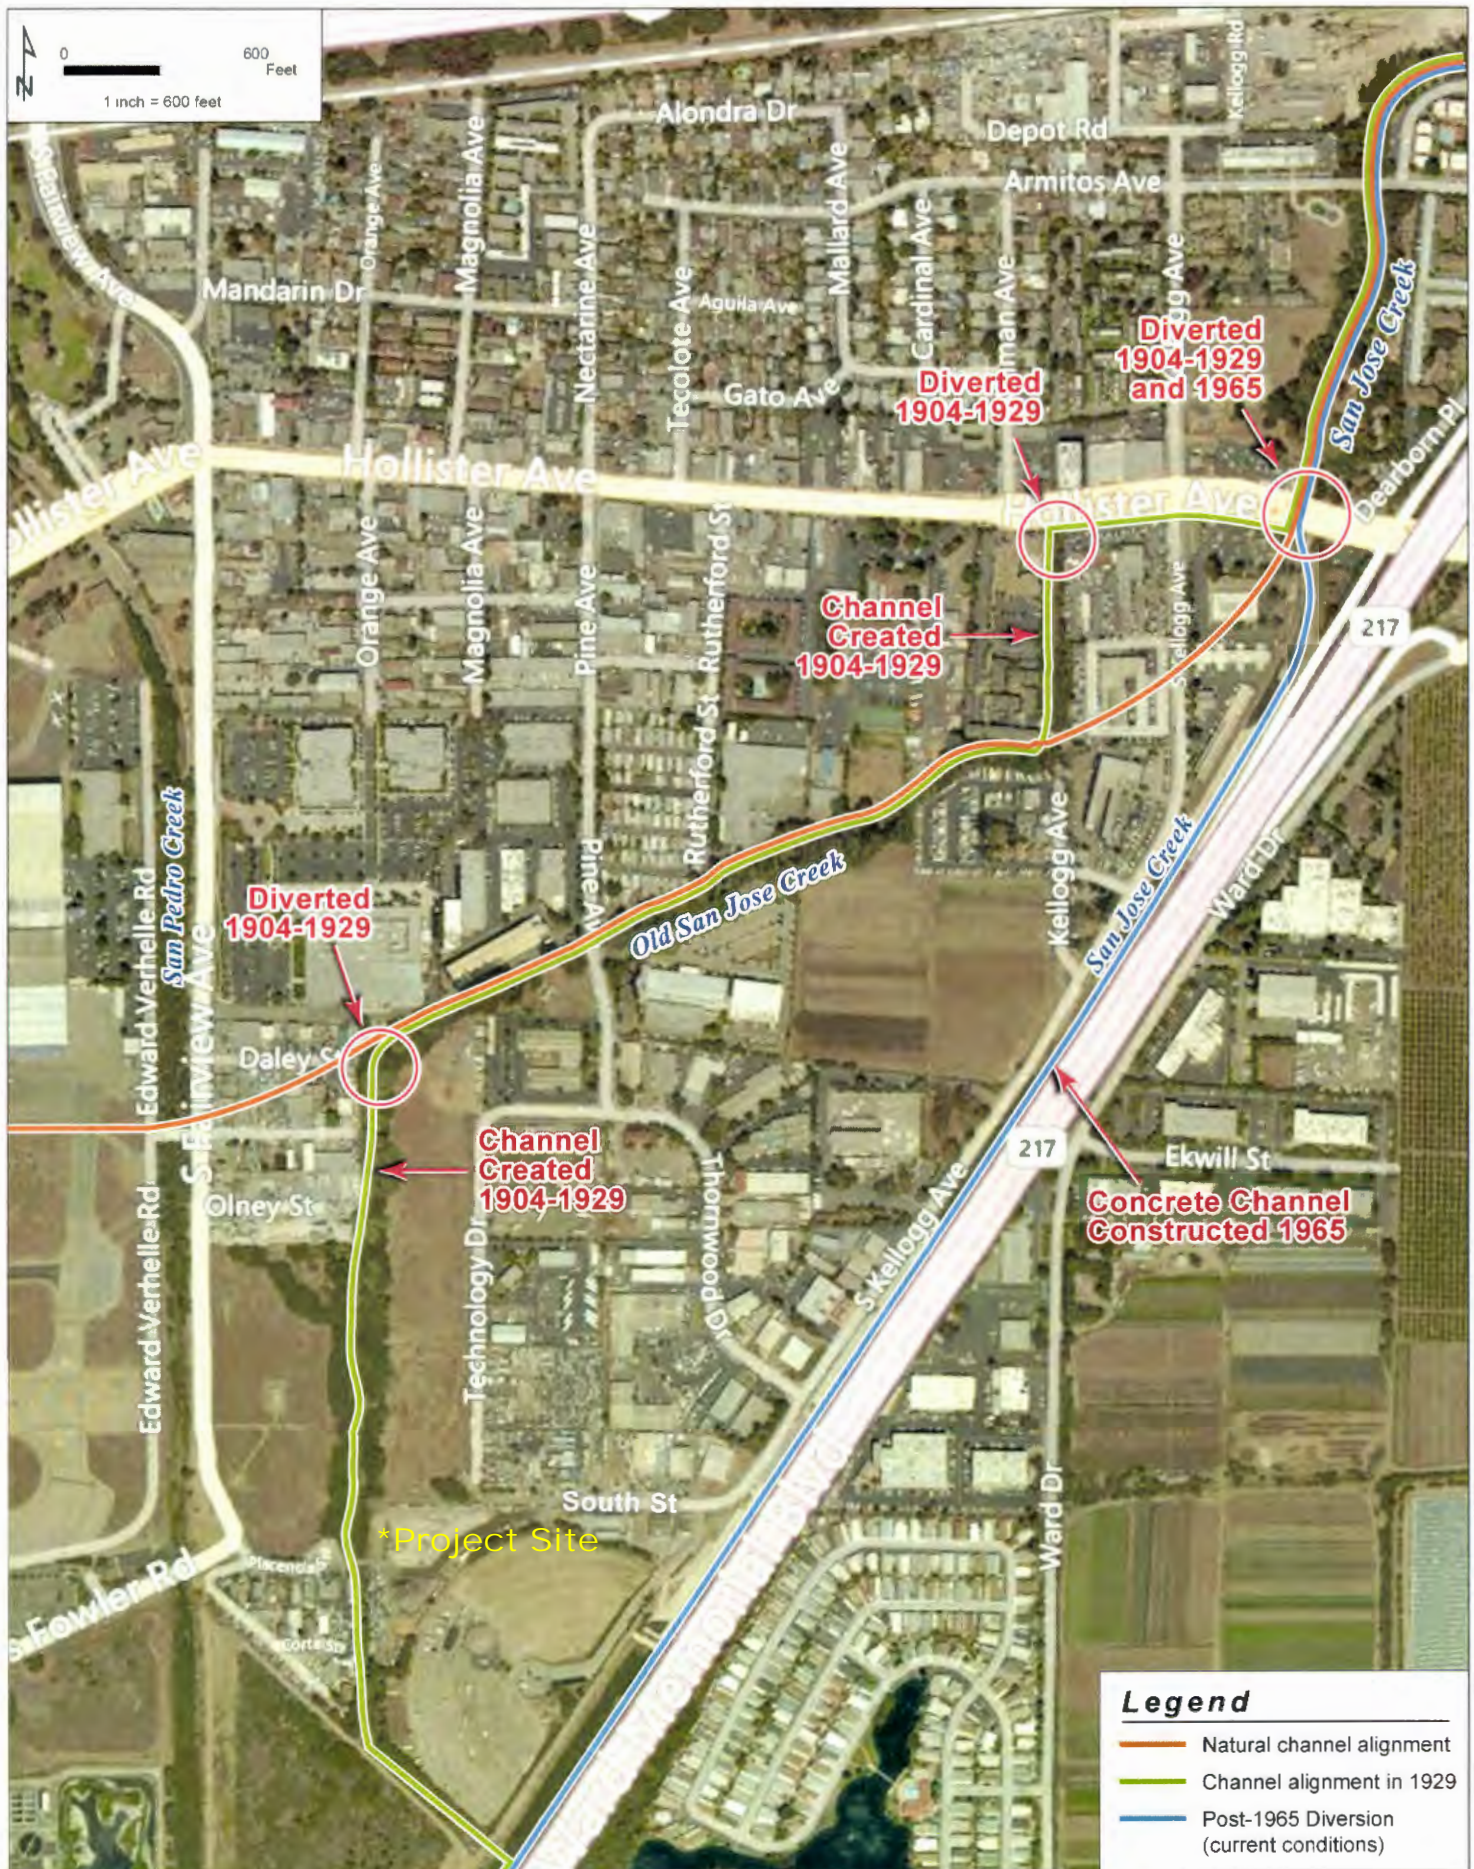
Exhibit 7 (pg 2 of 3)
Figure 11. 1965 Aerial Photograph
CDP Application 4-12-076

Old San Jose Creek Historic Aerials and Map

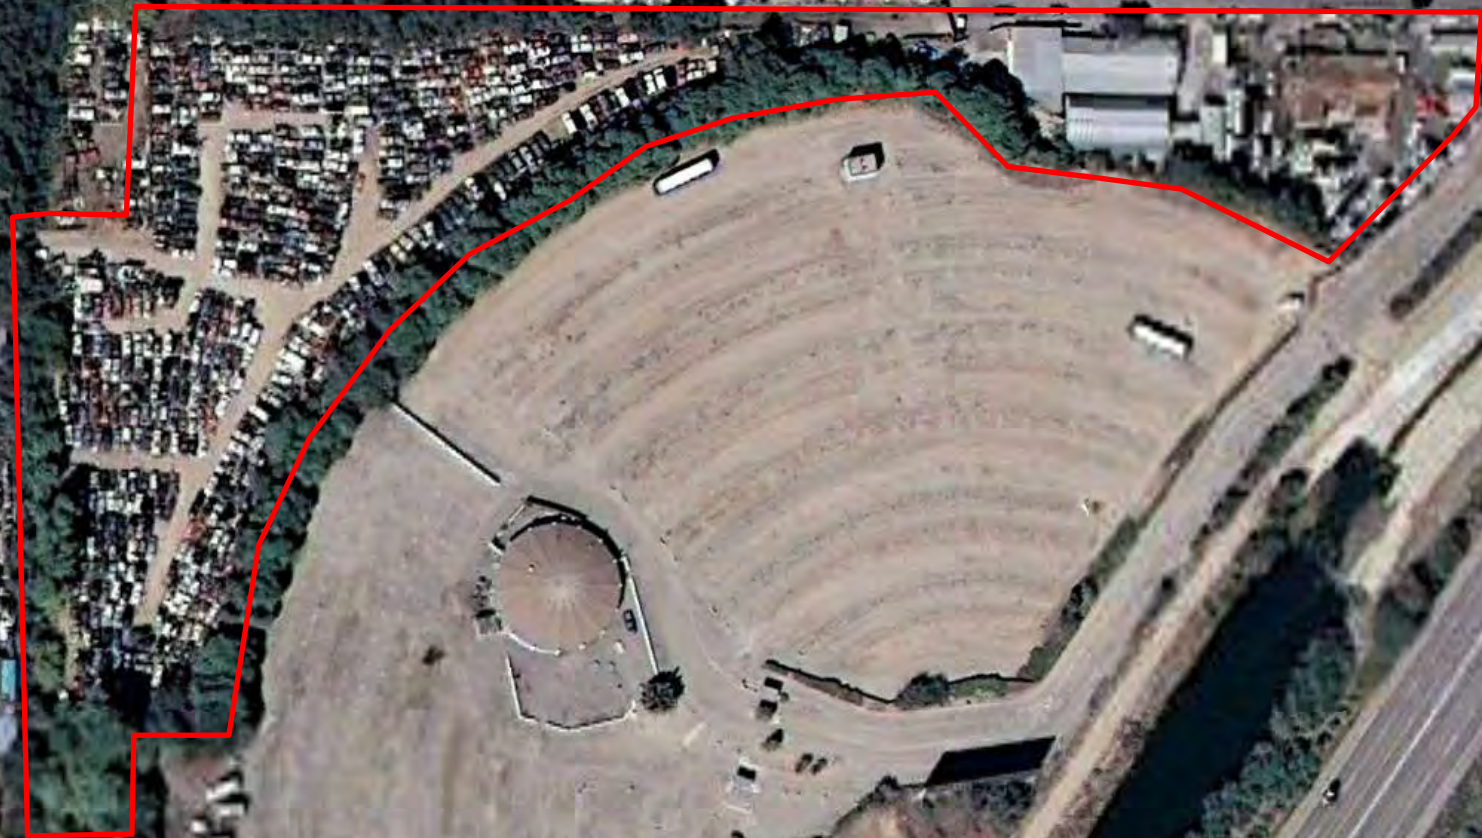
Figure 1. 2007 aerial photograph that shows a thick expanse of riparian habitat spanning both sides of the drainage and which merged with the riparian habitat along OSJC. The drainage borders the north side of the property and is perpendicular to and abuts OSJC.

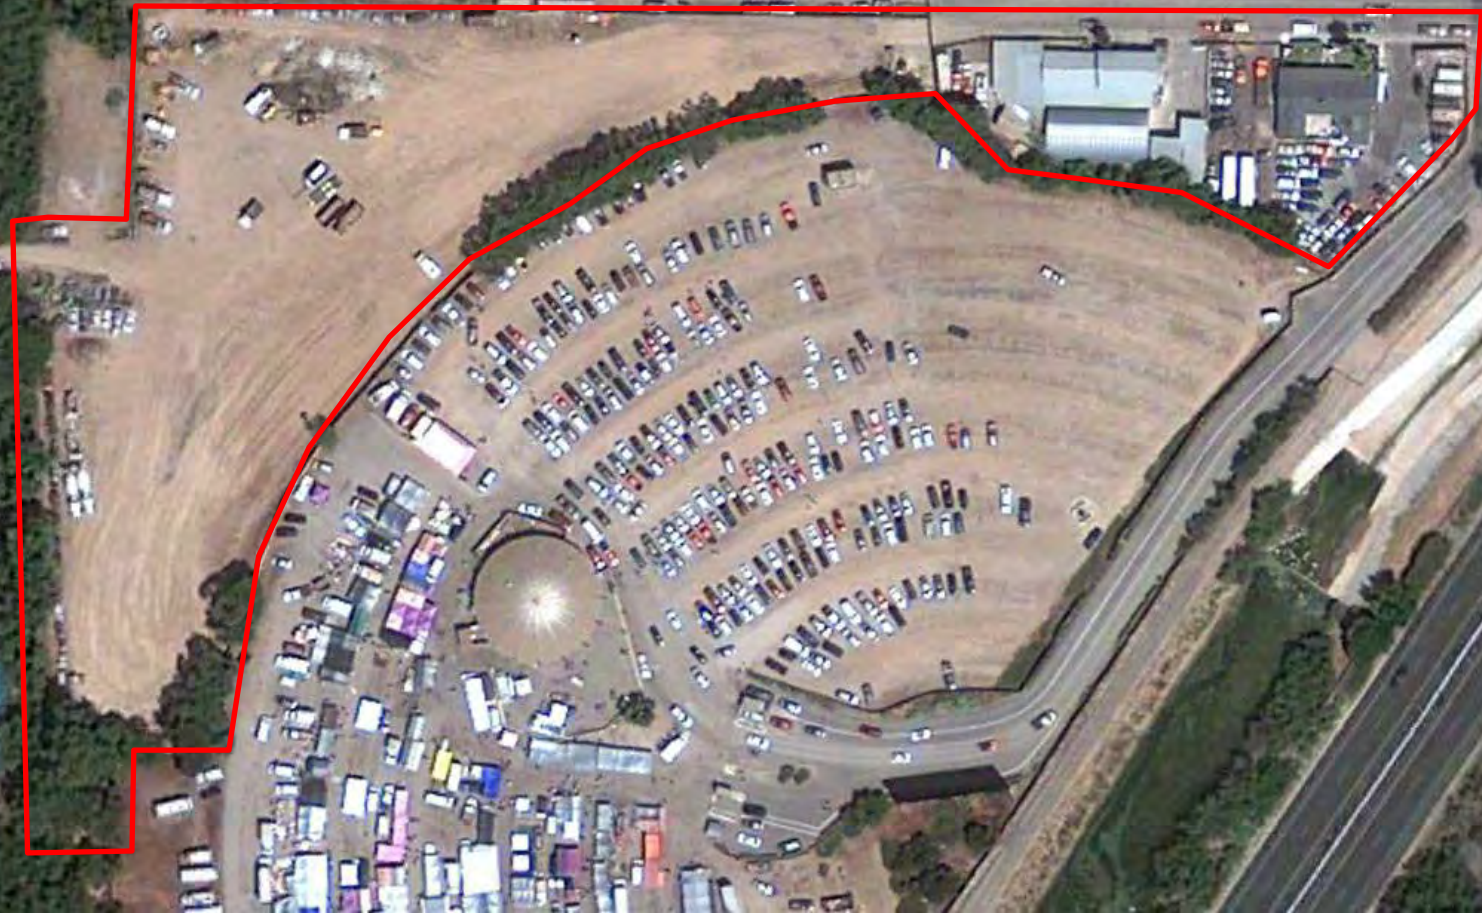
Figure 2. 2010 aerial photograph that shows all the riparian habitat on the south side of the drainage was removed sometime between 2007 and 2010.
