Port & Harbor Damage from the March 11, 2011 Tohoku Oki Tsunami

Lesley Ewing, Sr. Coastal Engineer
California Coastal Commission

**THE TOHOKU TSUNAMI OF MARCH 11, 2011: A PRELIMINARY REPORT
 ON EFFECTS TO THE CALIFORNIA COAST and PLANNING IMPLICATIONS**

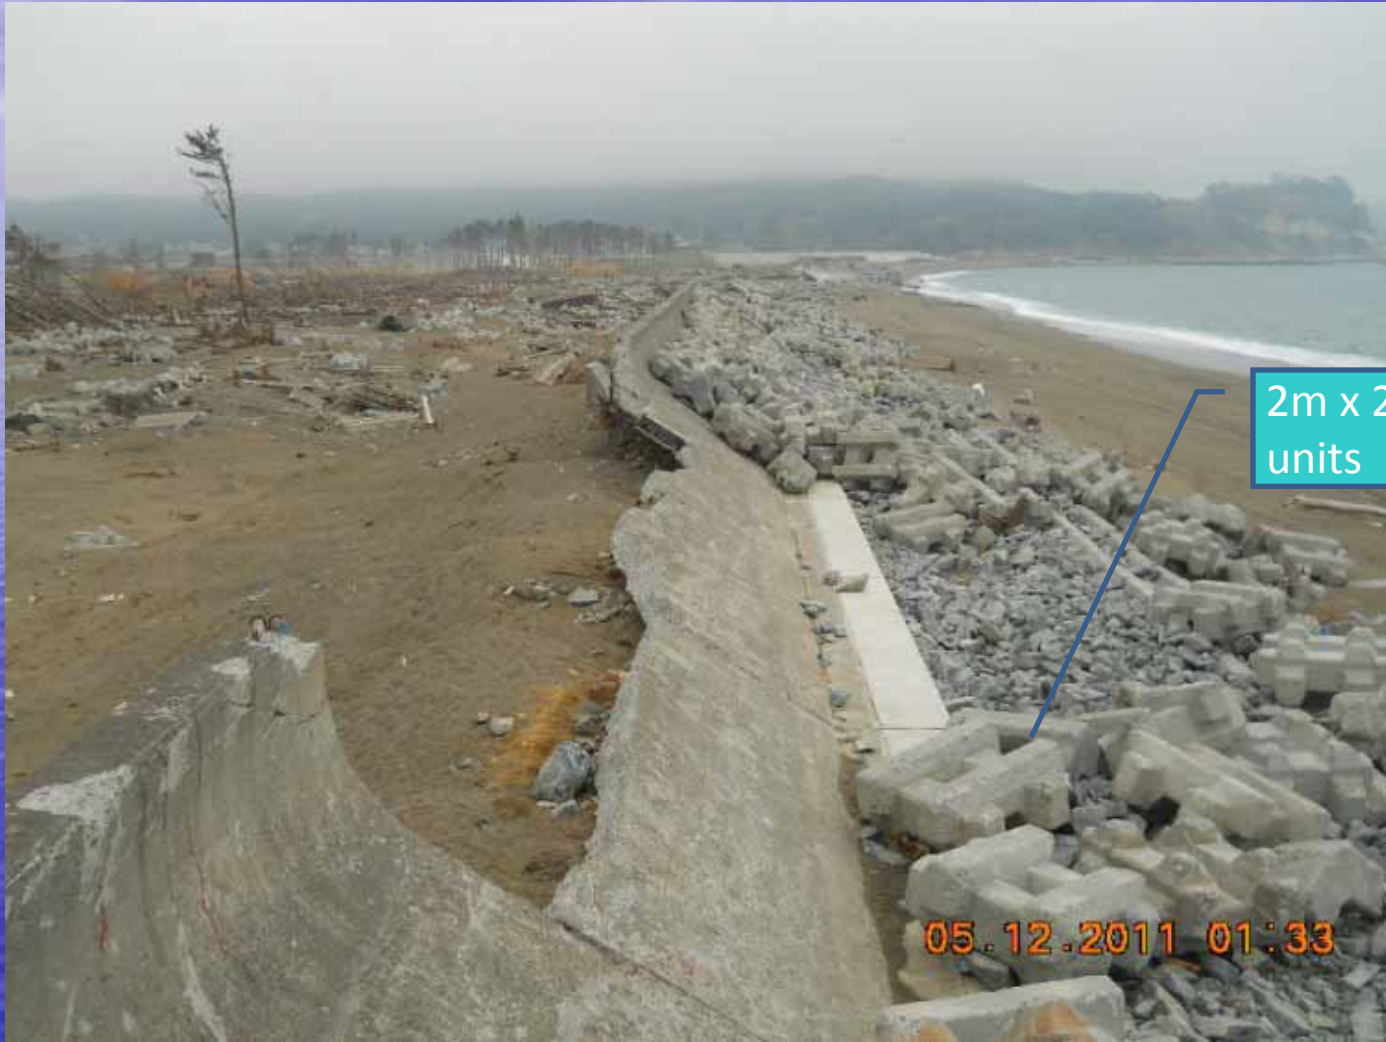
Noda Old Seawall

2m x 2m x 0.8m
units

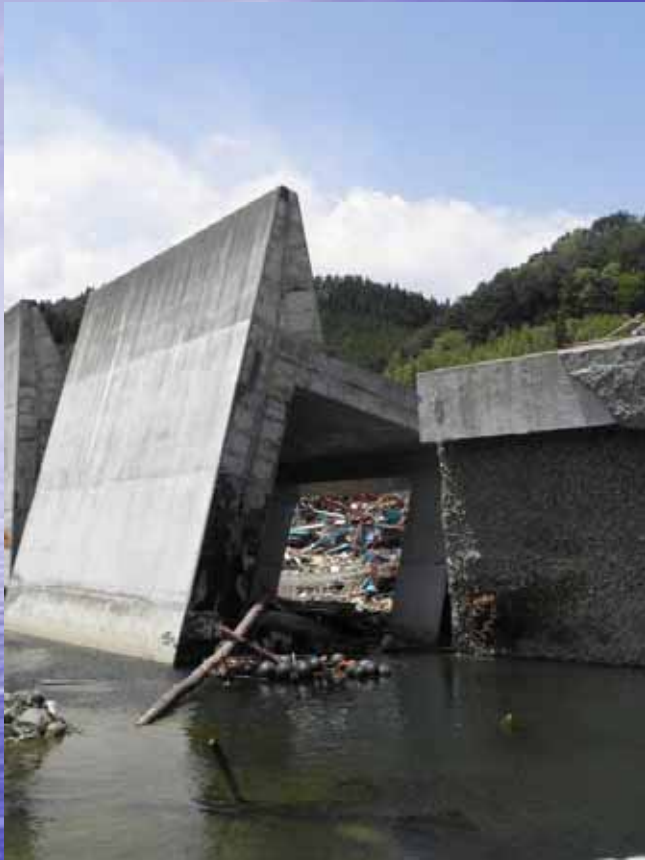
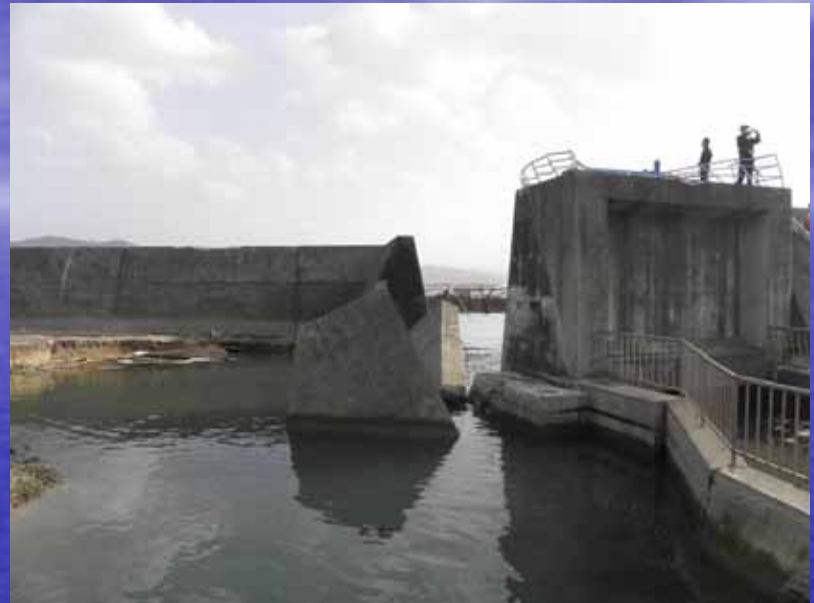
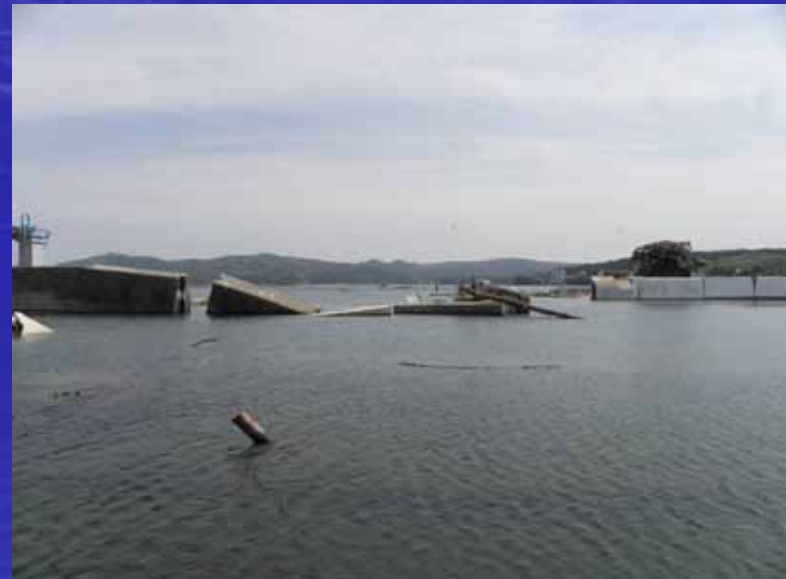
Foundations

Kojirahama (Top left),
Utuchi (Top right),
Tanesashi (bottom)

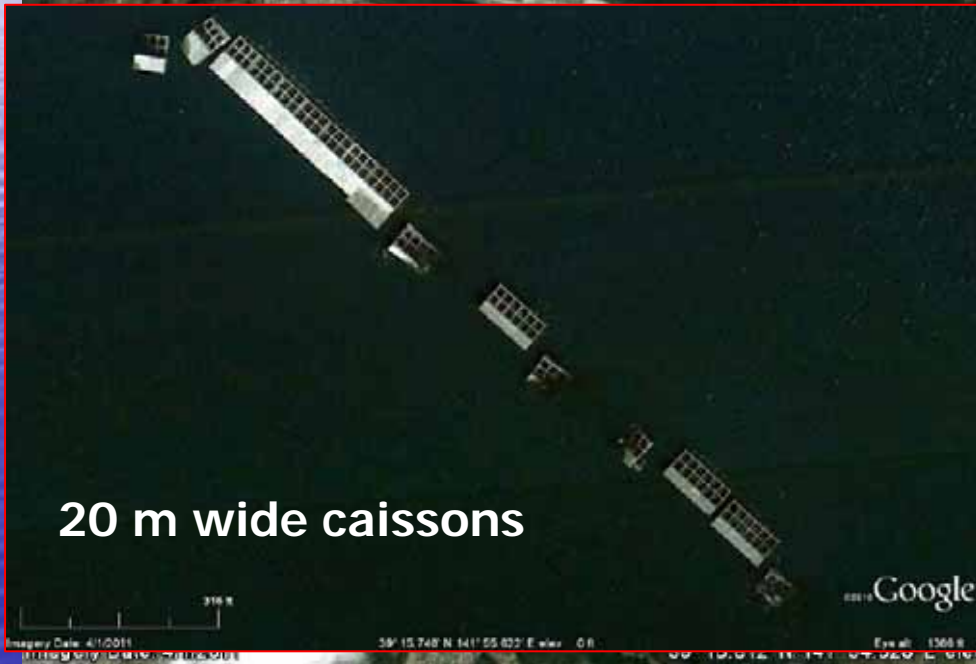
Kamaishi Tsunami Breakwater

After Tsunami

20 m wide caissons

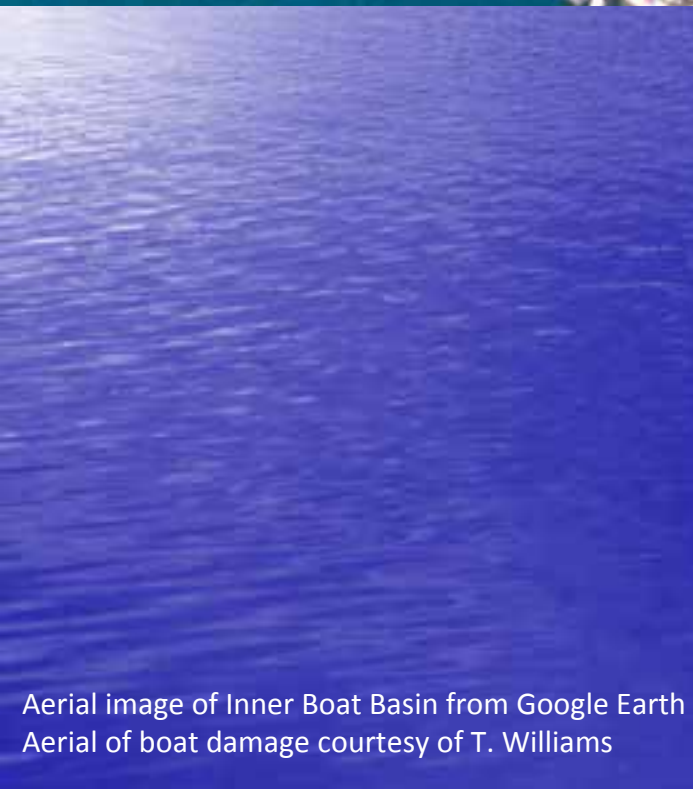
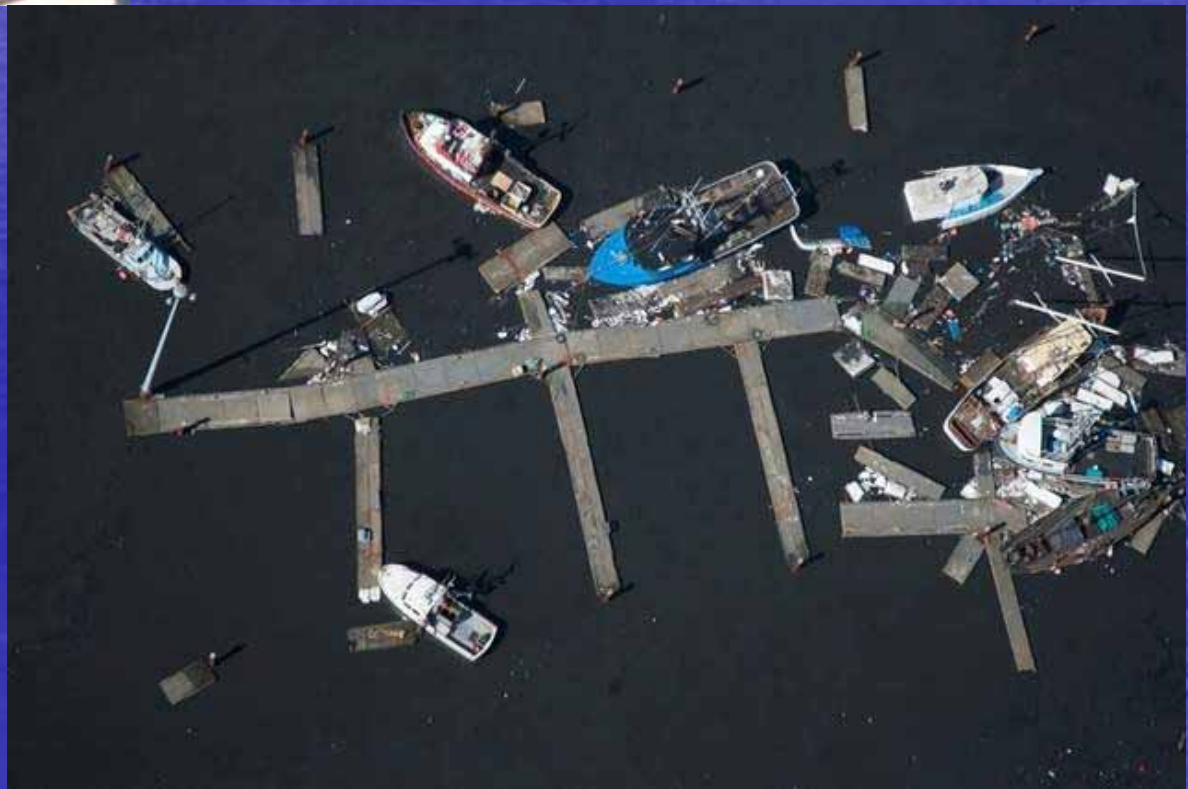
CRESCENT CITY, CA

Predicted Arrival Time: 15:22 UTC/Zulu

Predicted Max. Amplitude – 2.5 m

Observed Max. Amplitude - 2.47 m (8.2 ft)

Time of Observed Maximum Wave 16:56 UTC/Zulu

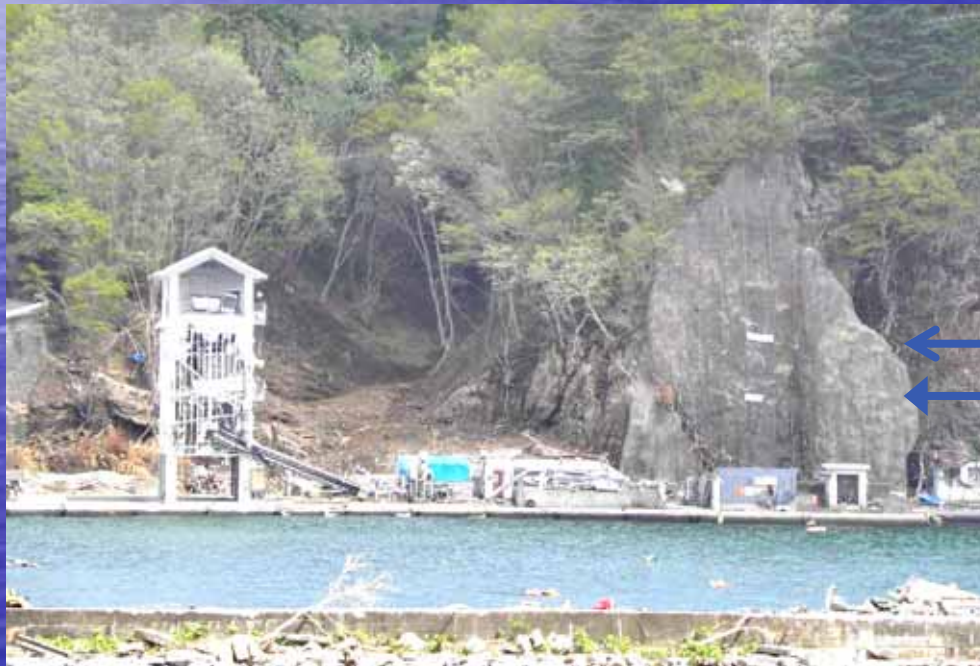
2011 tsunami elevations
~28 m north section
~20 m south section

Historic Tsunami
Elevations

Taro Bay
