STAFF REPORT: REGULAR CALENDAR

APPLICATION NO.: 4-95-162

PROJECT LOCATION: 5970 Ramirez Canyon Road, City of Malibu; Los Angeles County

PROJECT DESCRIPTION: Construction of a 72 foot long 4.5 foot high concrete retaining wall at the base of a slope in Ramirez Creek, with backfilling of the slope between the retaining wall and Ramirez Canyon Road.

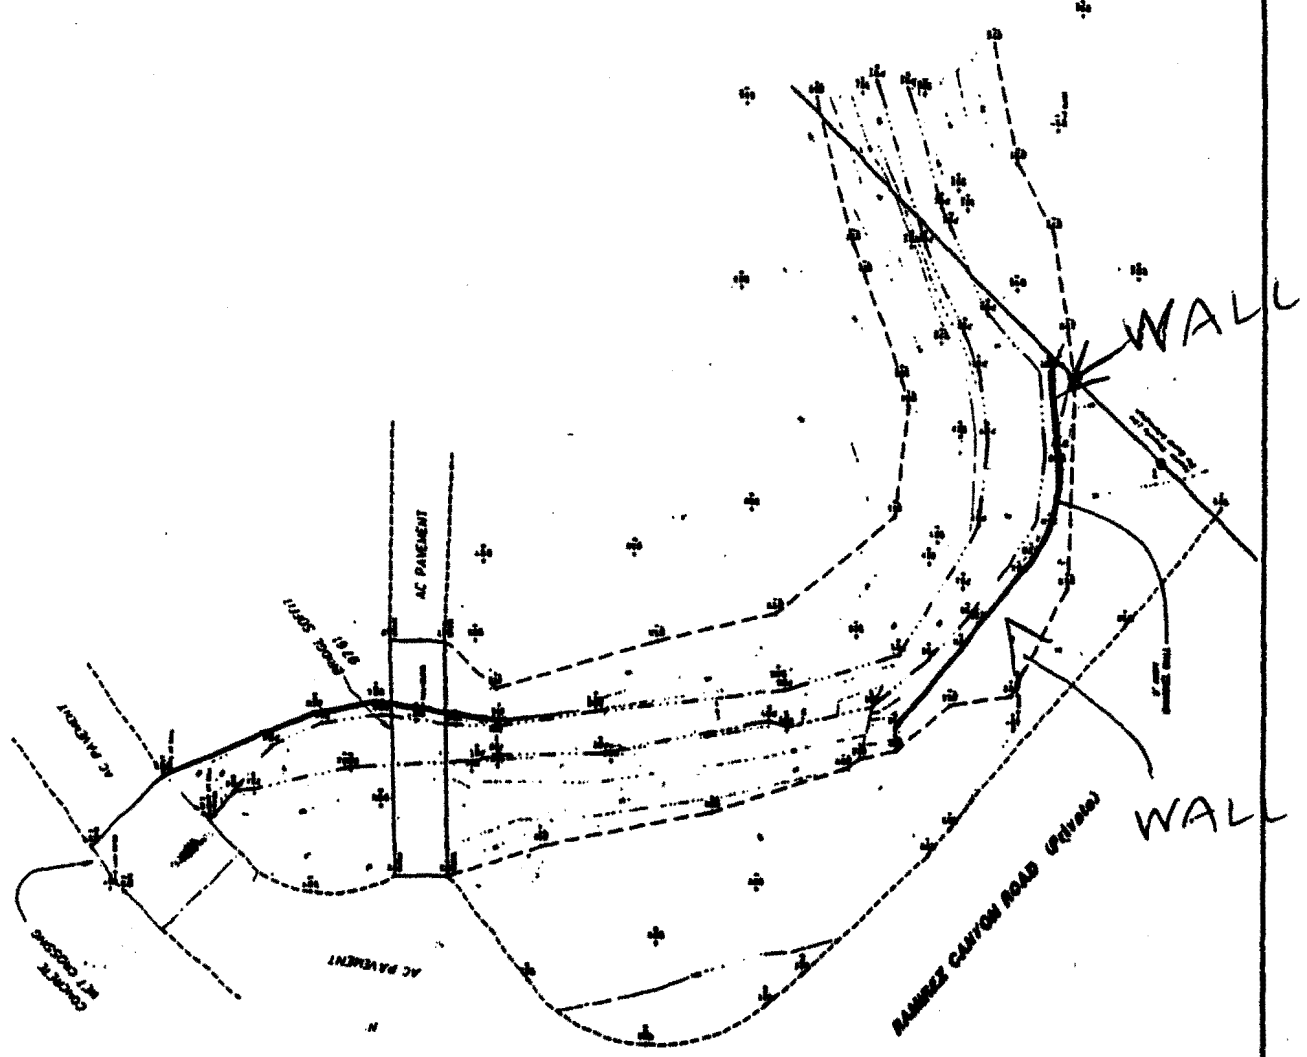
Exhibit 6: Wall Plan in creek
4-95-162

Wall 72' long

New Side
of road
side
creek
storm
side
before
road

creek

The proposed wall is located in the creek between the center line of the stream and the road which is at the top of the bank. According to the drawings submitted by the applicant (Exhibits 6 and 7) the wall is not located within the streambed but rather where the bank used to be. In fact, the cross-section shows that the wall is set slightly back for the original toe of the bank but is still within the streambed. The streambed is the area where the water flows. As stated previously, streams meander through a larger floodplain, widening and narrowing, and turning at different places over time, which in turn changes the location of the streambed. Water flow in this channel occurred where the wall is now located, and thus the wall is located within the streambed.
