CALIFORNIA COASTAL COMMISSION

**STAFF REPORT: REGULAR CALENDAR**

APPLICATION NO.: 5-97-269

PROJECT LOCATION: 1509 Buena Vista, San Clemente, Orange County

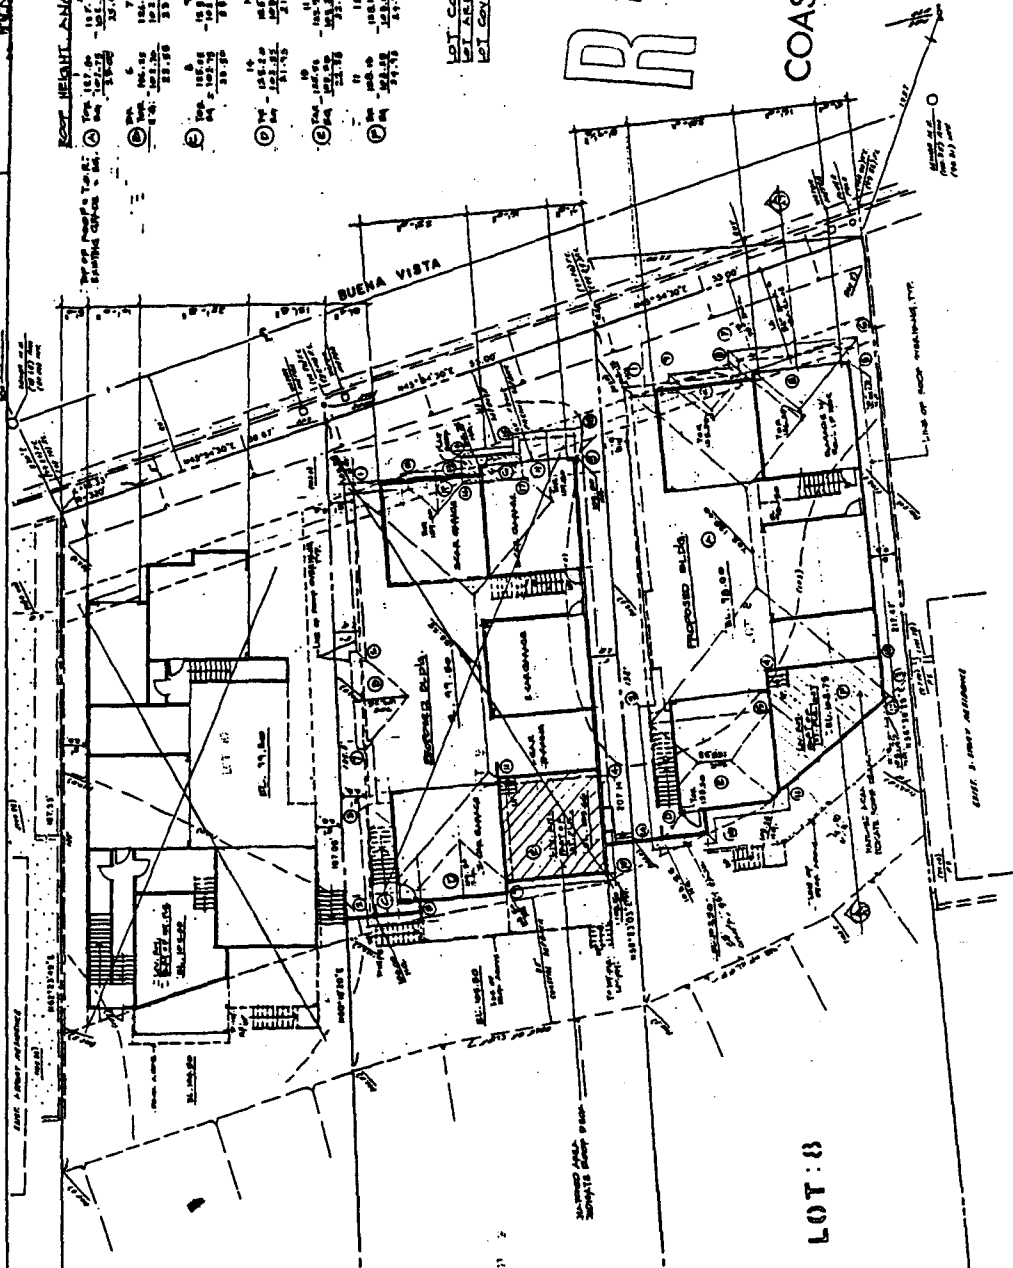
EXHIBIT NO. 2
APPLICATION NO.
5-97-269
SITE PLAN
California Coastal Commission

SITE PLAN
LOT: 8
TRACT: 821
A.P.N. 618-121-57
ADDRESS: 1507 BUCHA VISTA,
SAN CLEMENTE, CA.
