CALIFORNIA COASTAL COMMISSION

STAFF REPORT: REGULAR CALENDAR

APPLICATION NO.: 4-98-97

PROJECT DESCRIPTION: Remove two small unpermitted storage sheds (200 sq. ft. and 64 sq. ft.), a water tank and irrigation pipes and equipment, conduct 500 cu. yds. of remedial grading to recontour an unpermitted 6,000 sq. ft. graded pad, implement Restoration Plan (including revegetation) (Exhibit 1).

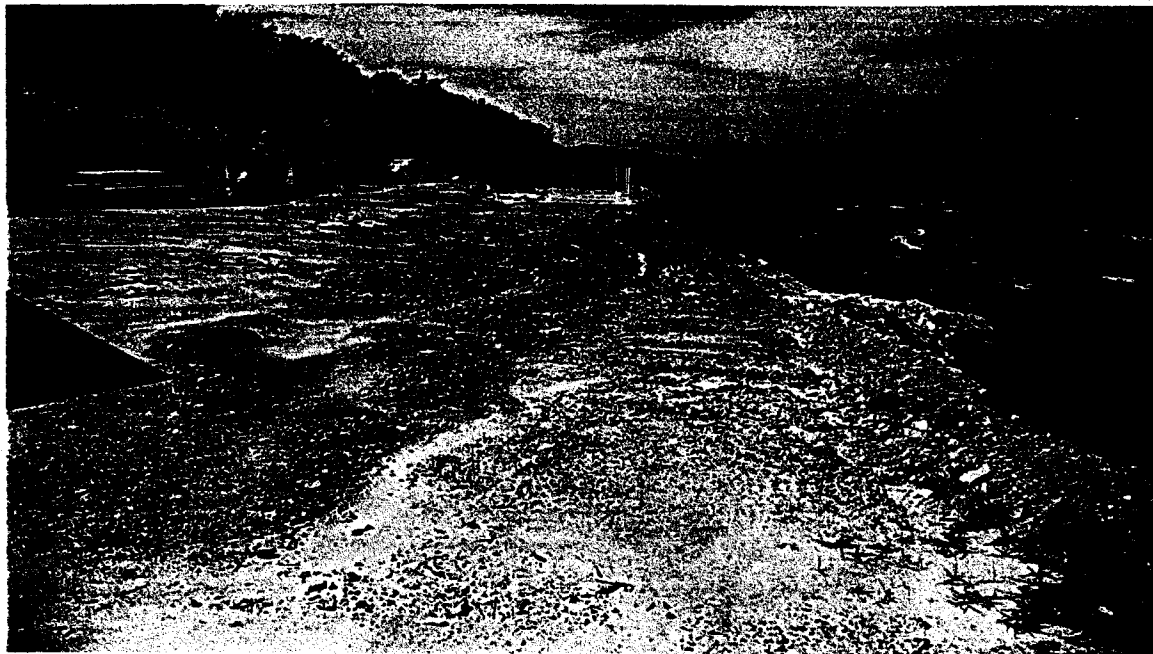
Photo 4 - The extended section of the pad is shown in this photograph. The white posts demarcate an occasionally used horse pen. As indicated by the dashed red line the fill slope of the pad (outer edge of pad) will be used to eliminate the pads and minor roads.

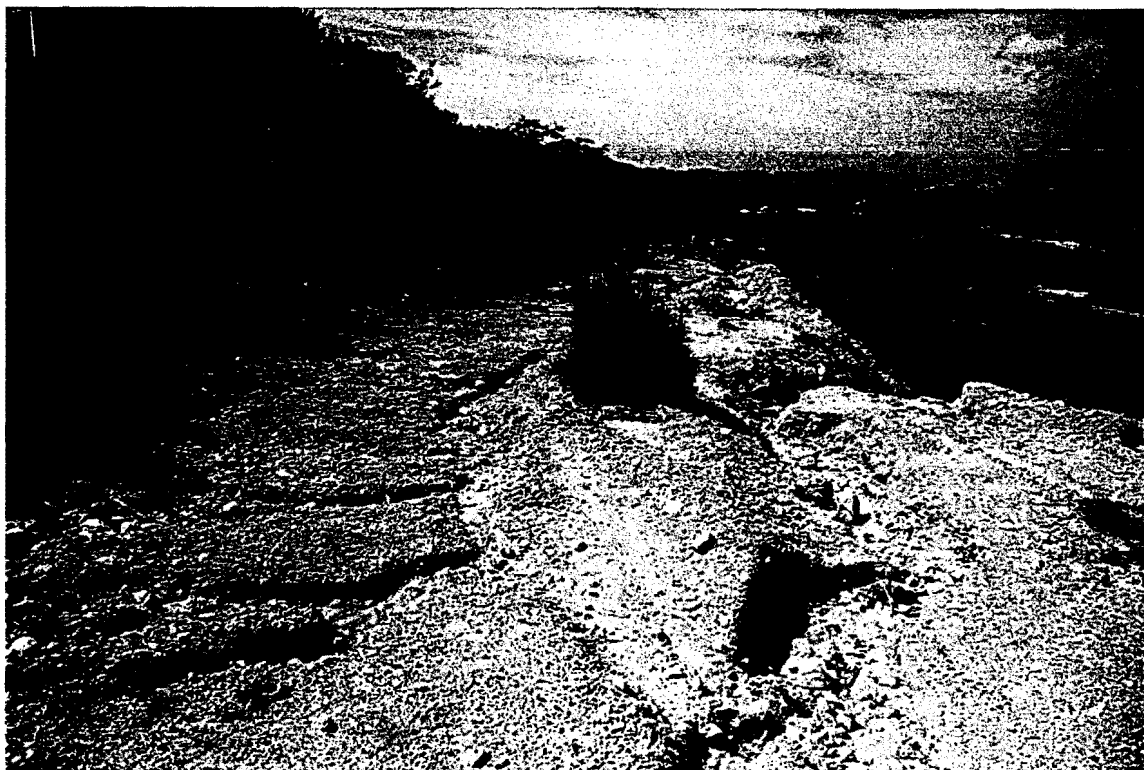
Photo 6 - Towards the west just beyond the horse pen a small road leads west towards the firebreak. Landform alterations here will also be readily eliminated by "putting the road back to bed".

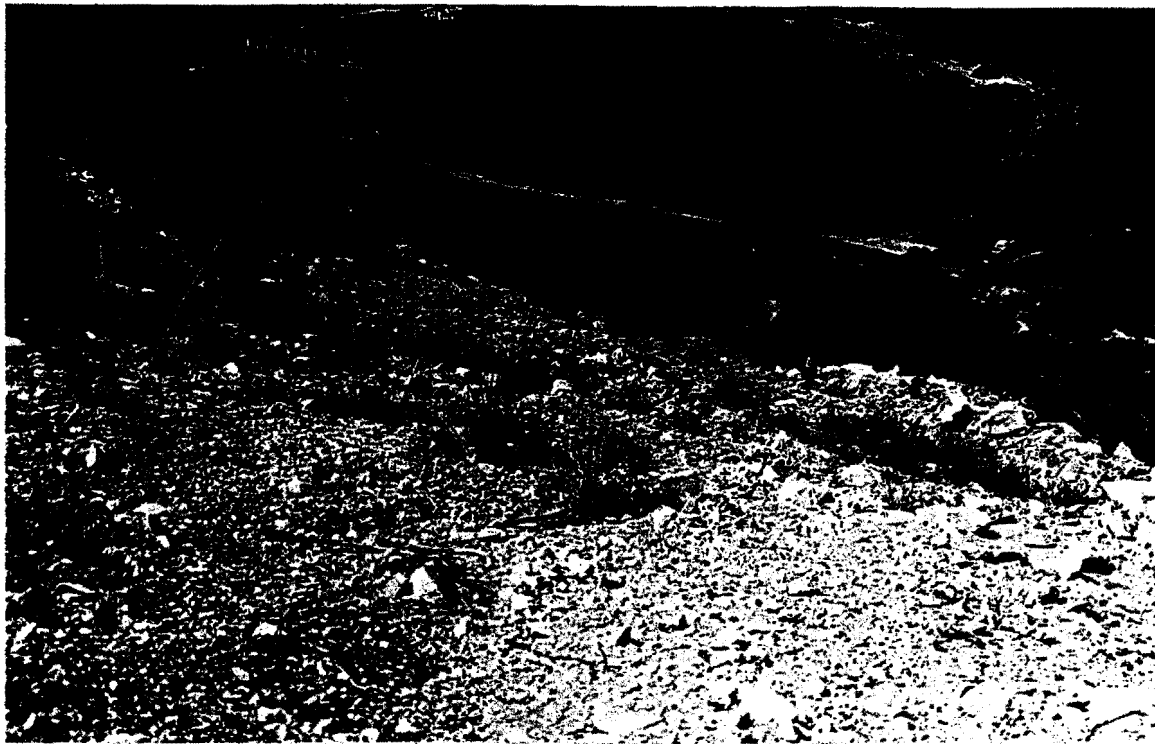
As indicated in Figure 3 and Photographs 1 and 2, an approximately 300-foot long and 40 + foot-wide swath leading downhill and sidehill from east to west along the northerly facing slopes of the parcel towards Castro Peak Motorway, along with a small section leading northeasterly from the firebreak, had been cleared by bulldozer of vegetation down to mineral soil in 1997. The large swath of cleared vegetation was enlarged to about 80 feet as it terminated along Castro Peak Motorway. Along with the vegetation, the bulldozer clearance also disturbed and removed much of the thin but nutrient-rich topsoil that contains most of the seeds that naturally regenerate a site after surface disturbance such as fire. The remaining lighter subsoil was left exposed to wind and water erosion. Occasionally bedrock was also exposed by the vegetation removal. This is the typical damage to a natural chaparral ecosystem that can be expected on steeper slopes when vegetation removal is carried out by bulldozer rather than by hand which would leave the topsoil intact, retain the soil seed pool and also the root systems and root crowns of the woody plants present.

Photo 7 - As shown here, an approximately 300-foot long and 40+ foot-wide swath leading downhill and sidehill from east to west along the northerly facing slopes of the parcel to Castro Peak Motorway had been cleared in 1997 by bulldozer of vegetation down to mineral soil and occasionally to bedrock wherever it was near the soil surface.

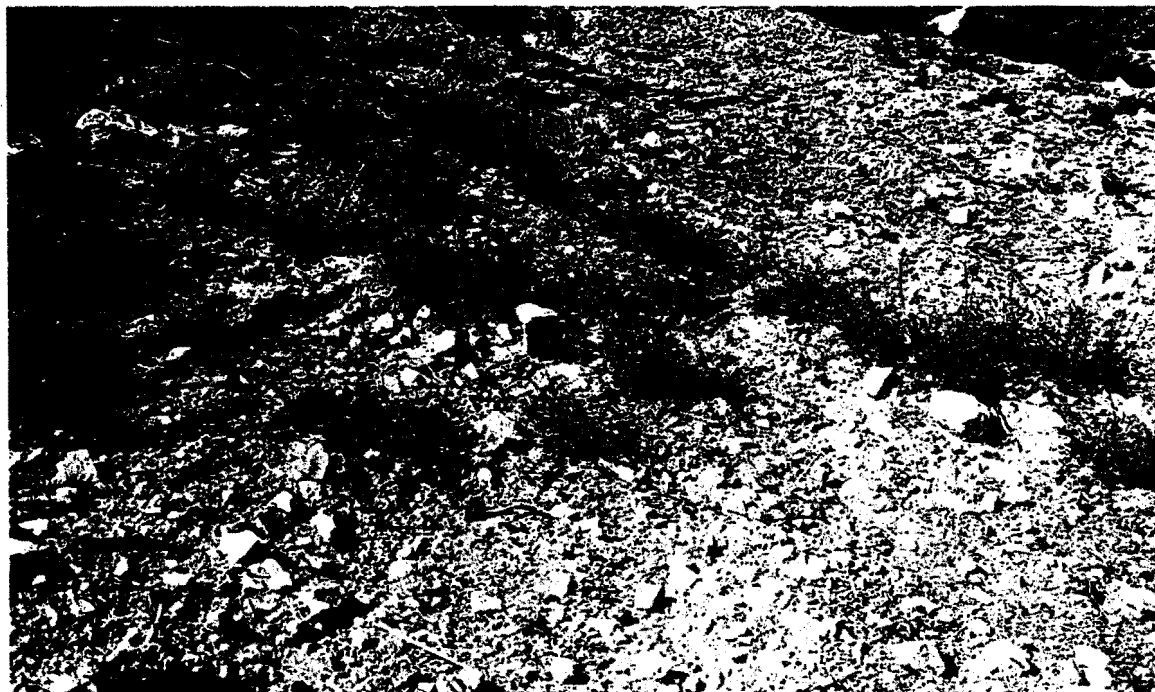
Photo 8 - A close-up of the seemingly bare section of the slope shown in Photograph 7 indicates crownsprouting clumps of Scrub Oak. When "fine grading" the site to cover it with soil, care must be taken to protect such resprouting vegetation.

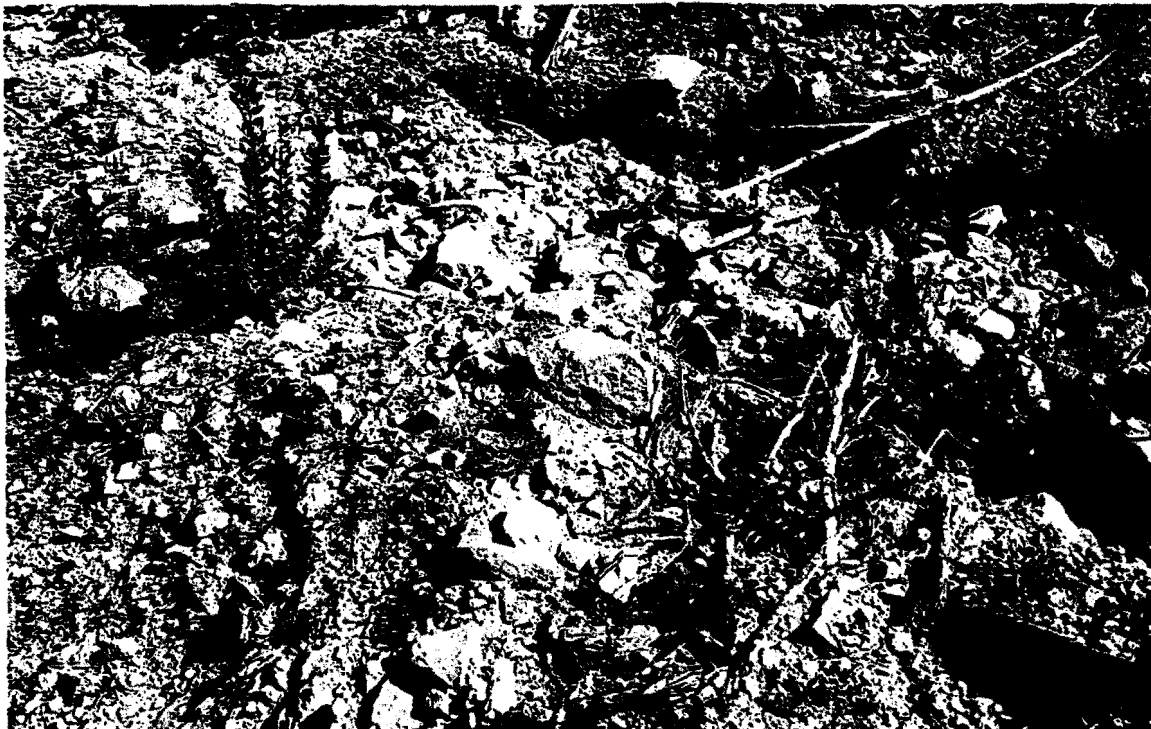
Photo 10 - A close-up of a section of Photo 9 indicates that the resprouting chaparral species consist of Eastwood Manzanita and Chamise. As indicated previously, care must be taken to protect such resprouting vegetation during the restorative minor grading.

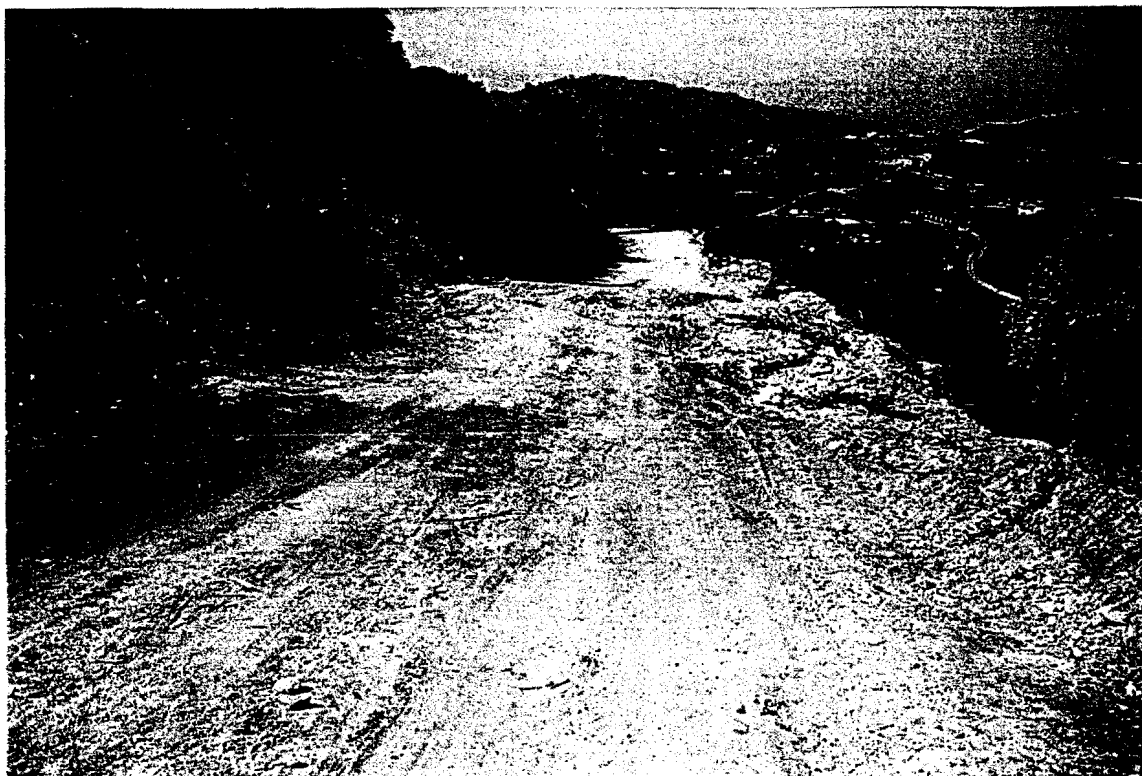
Photo 11 - This photo shows Castro Peak Motorway looking west from the area where the 1997 bulldozer-cleared wide swath of bare earth meets the roadway as it approaches from the left (south) and terminates. After contour and broadcast seeding have been completed, jutenetting shall be used to cover the width of the bulldozer-cleared swath to approximately 50 feet above (south of) Castro Peak.
