COASTAL DEVELOPMENT PERMIT APPLICATION

Application number 3-00-140, Scenic Road Armoring Repairs

Project description Repair and augment the existing shoreline armoring in several locations below Scenic Road at Carmel Beach.

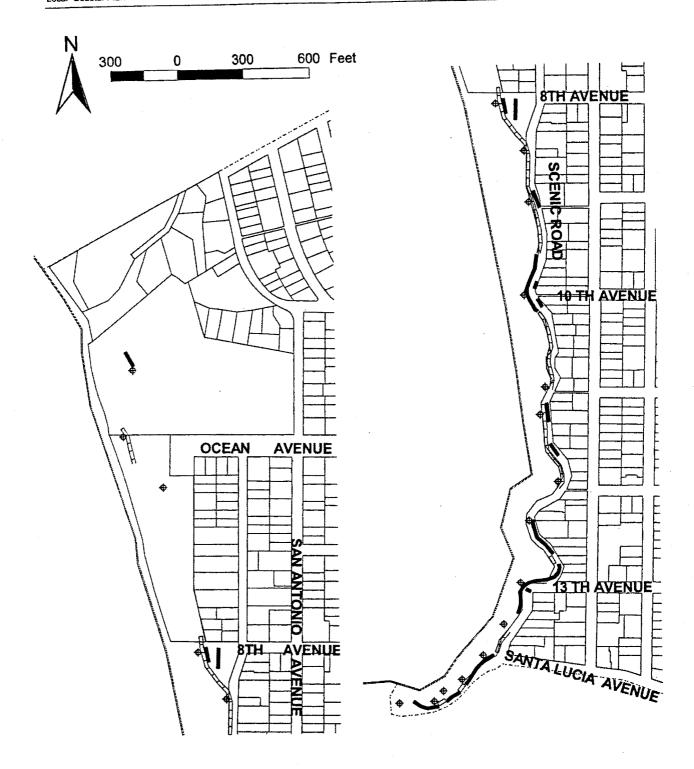
Figure 9.6a

Storm Outfalls
 Engineered Revetments
 Seawall/Retaining Walls

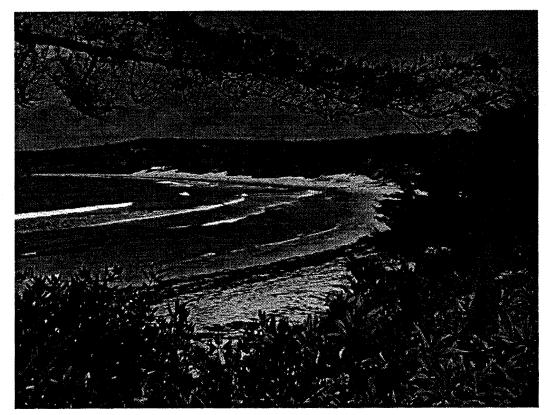
Photo 1: View of the northern portion of Carmel Beach and Carmel Bay as seen from the blufftop Scenic Drive recreational trail

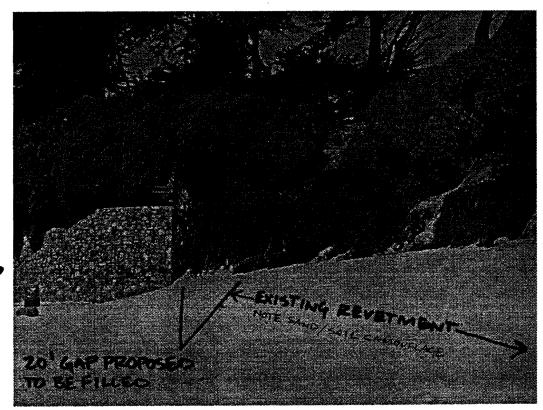
Photo 2: View of Site 1 from Carmel Beach

Approximately 200 to 225 tons of golden granite rock would be placed in a roughly 20 foot gap located between the 10th Avenue stairway and seawall (to the north) and an existing revetment extending to the south. This gap was meant to be filled as part of the larger revetment approved in 1983 at this location (CDP 3-83-217-A1), but, for whatever reason, the revetment was not extended to the stairway. This repair would address problems from end-scour and swirling eddies during storm events in the 20 foot missing segment of rock, and would complete the structure authorized in 1983. The revetment would be keyed into the underlying bedrock for structural stability. As is done for the existing adjacent revetment, the new rock would be camouflaged (i.e., covered with sand at its base and landscaped at its top) consistent with the previously approved planting plan (CDP 3-83-217-A2).

At Site 1 (see Exhibits C and D), the pathway atop the bluff is located roughly 3 feet from the bluff edge; Scenic Road and the City sanitary sewer are roughly 20 feet from the top of the bluff. Several large cypress trees are present at this location. Site visits indicate active erosion is ongoing in this location. Because the revetment was not completed after being permitted in 1983, the 20 foot gap proposed for additional rock could lead to failure of not only the bluffs here, but also the 10th Avenue public access stairway and the existing revetment. Without the proposed repair, it appears likely that the existing structures at this location will be undermined within the next year or so, if not before.

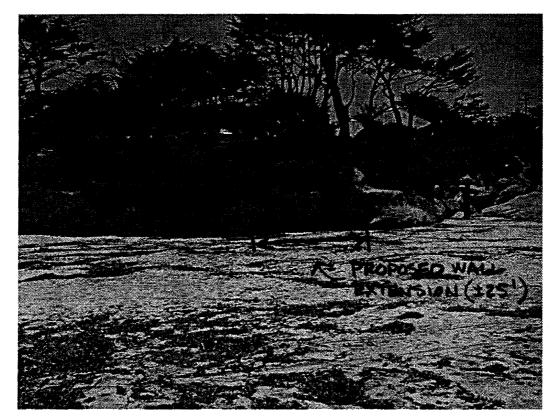
Photo 5: View of Site 3 from Carmel Beach

A roughly 25 linear foot extension would be added to the existing golden-granite faced seawall just south of the 13th Avenue stairway. The wall extension would match the existing wall, would be notched into the downcoast bluff, and is designed to repair and augment the failed end of the existing wall and to protect against additional end scour from storm events.

At Site 3 (see Exhibits C and D), the pathway atop the bluff is located roughly 10 feet from the bluff edge; Scenic Road is roughly 20 feet from the top of the bluff. Without the proposed repair, the existing permitted seawall can be expected to fail in segments during each successive storm event. In addition, without the proposed project, end scour effects can be expected to intensify at this location for the rock revetment located immediately adjacent to the south as well. In essence, the repair fills an existing gap between the existing golden granite seawall and the existing downcoast revetment. Without the proposed repair, it appears likely that the structures at this location will be undermined within the next few years, if not before.

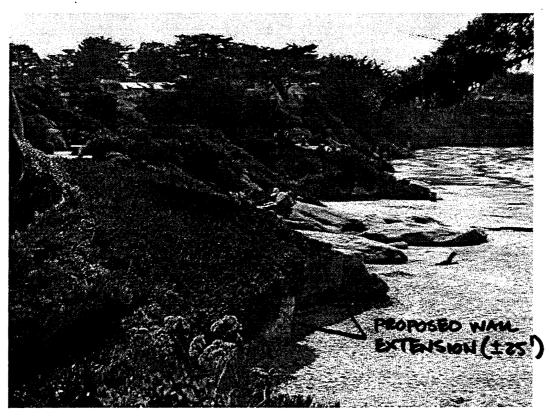
Photo 6: View of Site 3 from the blufftop Scenic Drive recreational trail

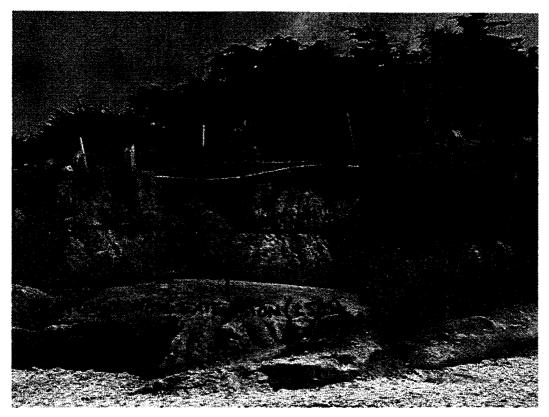
Photo 7: View of Site 4 from Carmel Beach

A roughly 50 foot linear extension would be added to the existing golden-granite faced retaining wall at Frank Lloyd Point near Santa Lucia Avenue. Directly inland at this location is the only public restroom facility currently serving the southern portion of Carmel Beach (there is another public restroom at the base of Ocean Avenue to the north). The bluff recently eroded away part of the recreational path, taking with it the benches and guardrails previously present here. The existing retaining wall and the repair extension proposed here is located on a sandstone outcrop above the summer sand levels.

At Site 4 (see Exhibits C and D), the pathway atop the bluff is located immediately adjacent to the bluff edge; the restroom and cypress hedge are located roughly 15 feet from the top of the bluff on the opposite side of the pathway. A portion of the pathway was recently lost to erosion at this location Without the proposed upper bluff retaining wall extension repair, the pathway will be lost and the restroom nestled in the cypress hedge will be threatened within the next year or so, if not before.

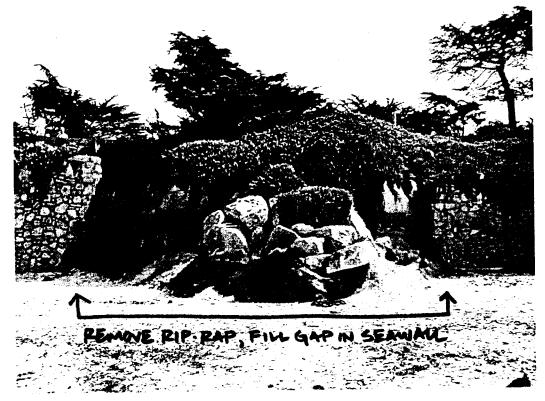
Photo 9: View of Site 5 from Carmel Beach

Two gaps in the existing golden-granite faced seawall, roughly 40 linear feet each, would be closed by adding additional like sections of wall. These sections will replace the existing non-engineered rock revetments at these locations, which will be removed.

At Sites 5 and 6 (see Exhibits C and D), the pathway atop the bluff is located from about 2 feet to about 10 feet from the bluff edge; Scenic Road is roughly 20 feet from the top of the bluff. There is already armoring present at these two sites (the proposal is to remove the stacks of rip-rap and replace with seawall to fill the gaps in the otherwise continuous seawall at this location). Some additional erosion might be expected from storm wave overtopping of the existing revetments, and from upper bluff erosion (surface runoff), but the extent to which this danger would threaten the pathway and the road is hard to calculate given the presence of the two existing revetments. The existing walls are experiencing some failure now because of erosion and scour at their ends (i.e., at the gaps). In any case, the existing revetments have been structurally compromised since their installation in the early eighties and will need to be reengineered without the proposed project to repair and support them. Without this repair, it appears likely that the structures at this location will be undermined within the next few years, if not before.

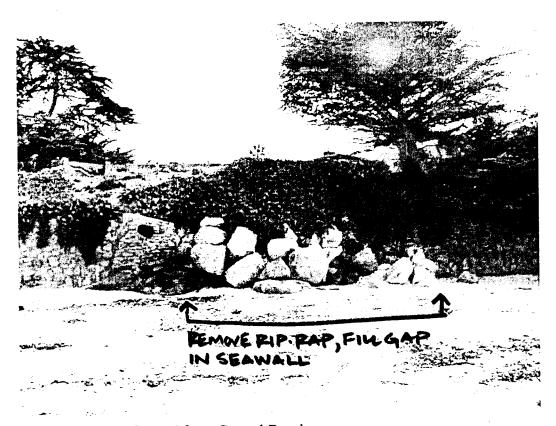
Photo 10: View of Site 6 from Carmel Beach

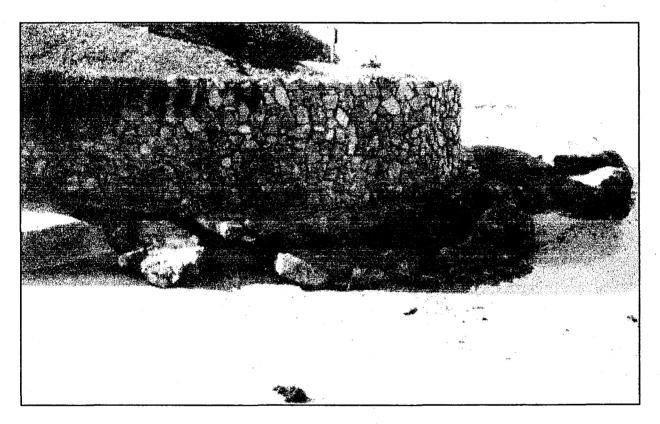
results in severe erosion of the natural sandstone outcrop located at the base of the bluff and the existing seawall on the southern side of the cove. Significant portions of this sandstone have already been extensively eroded just in the past decade. Continued loss of this sandstone will damage or destroy the existing seawall, bluff, and beach bluff pathway.

Figure 1. Photo showing current conditions at Site #2. Note large gap in sandstone and broken remains of rocks and concrete used in earlier repairs.

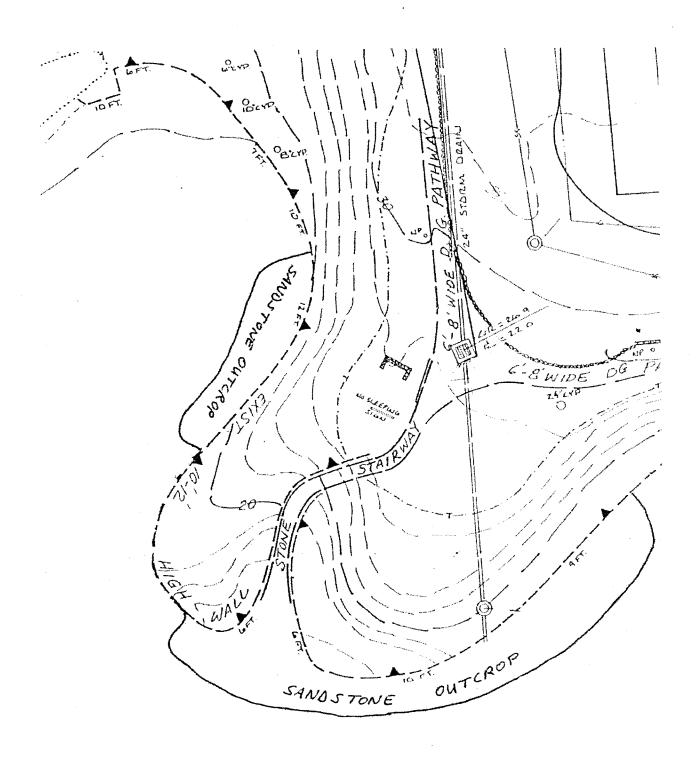
Figure 2. Drawing of current conditions at Site #2, showing gap in sandstone.

The City proposes to install an engineered revetment into the gap left by the eroded sandstone (see Figures 2, and 3). This revetment is designed to protect the existing seawall foundation, the adjoining beach access stairway, and the beach bluff pathway, as well as the protective sandstone that lines the southern portion of 13th Avenue cove. The City had considered an alternate option suggested by Johnson (in his 1998 letter): the construction of a reinforced concrete wall below the existing seawall. Both options will protect the existing seawall and beach access stairway. However, the City believes that the revetment option will add an additional degree of protection – it will help diffuse the energy of waves entering the cove. This should reduce the potential for further erosion of the sandstone, the cove's seawalls and bluffs, and the beach bluff pathway above. These areas will otherwise become vulnerable when future storm waves further erode the remaining sandstone along the cove's southern side.

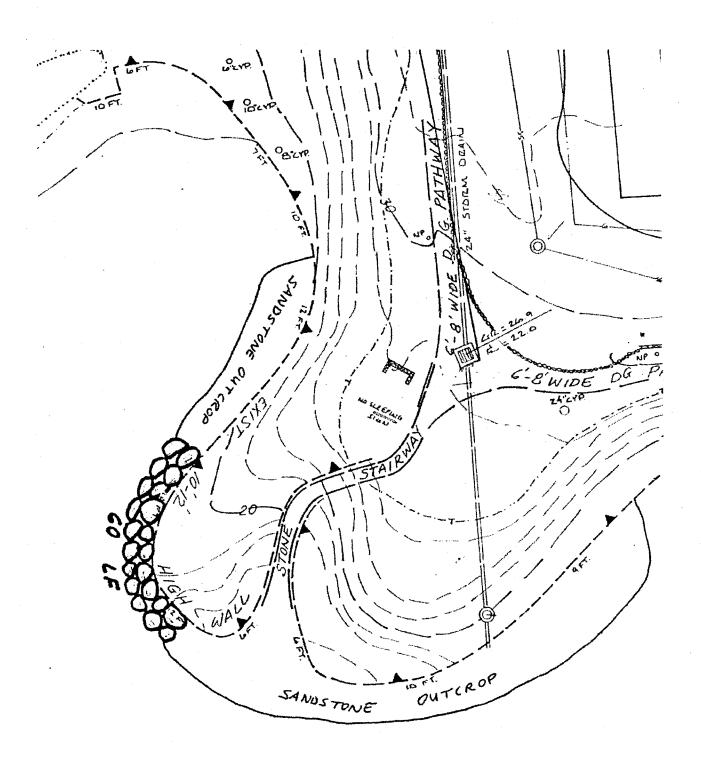
Figure 3. Drawing of proposed Site #2 revetment installed in sandstone gap.
