STAFF REPORT: REGULAR CALENDAR

APPLICATION NO.: 5-01-112
APPLICANT: Curt Ensign
AGENT: David Neish
PROJECT LOCATION: 3415 Ocean Blvd., City of Newport Beach, County of Orange
PROJECT DESCRIPTION: Request for after-the-fact approval of a new switchback bluff face stairway with keystone-type earth retention blocks, landscaping and in-ground irrigation on a beachfront lot adjacent to Corona del Mar State Beach.

The applicant is requesting after-the-fact approval for construction of a new switchback bluff face stairway, installation of an in-ground irrigation system and landscaping with primarily non-natives. The proposed project is located along a coastal bluff immediately inland of Corona Del Mar State Beach, a public beach. The primary issue before the Commission is the appropriateness of approving the project given landform alteration, the importance of preserving scenic resources, community character and impacts to public access. Staff recommends that the Commission **DENY** the proposed project.

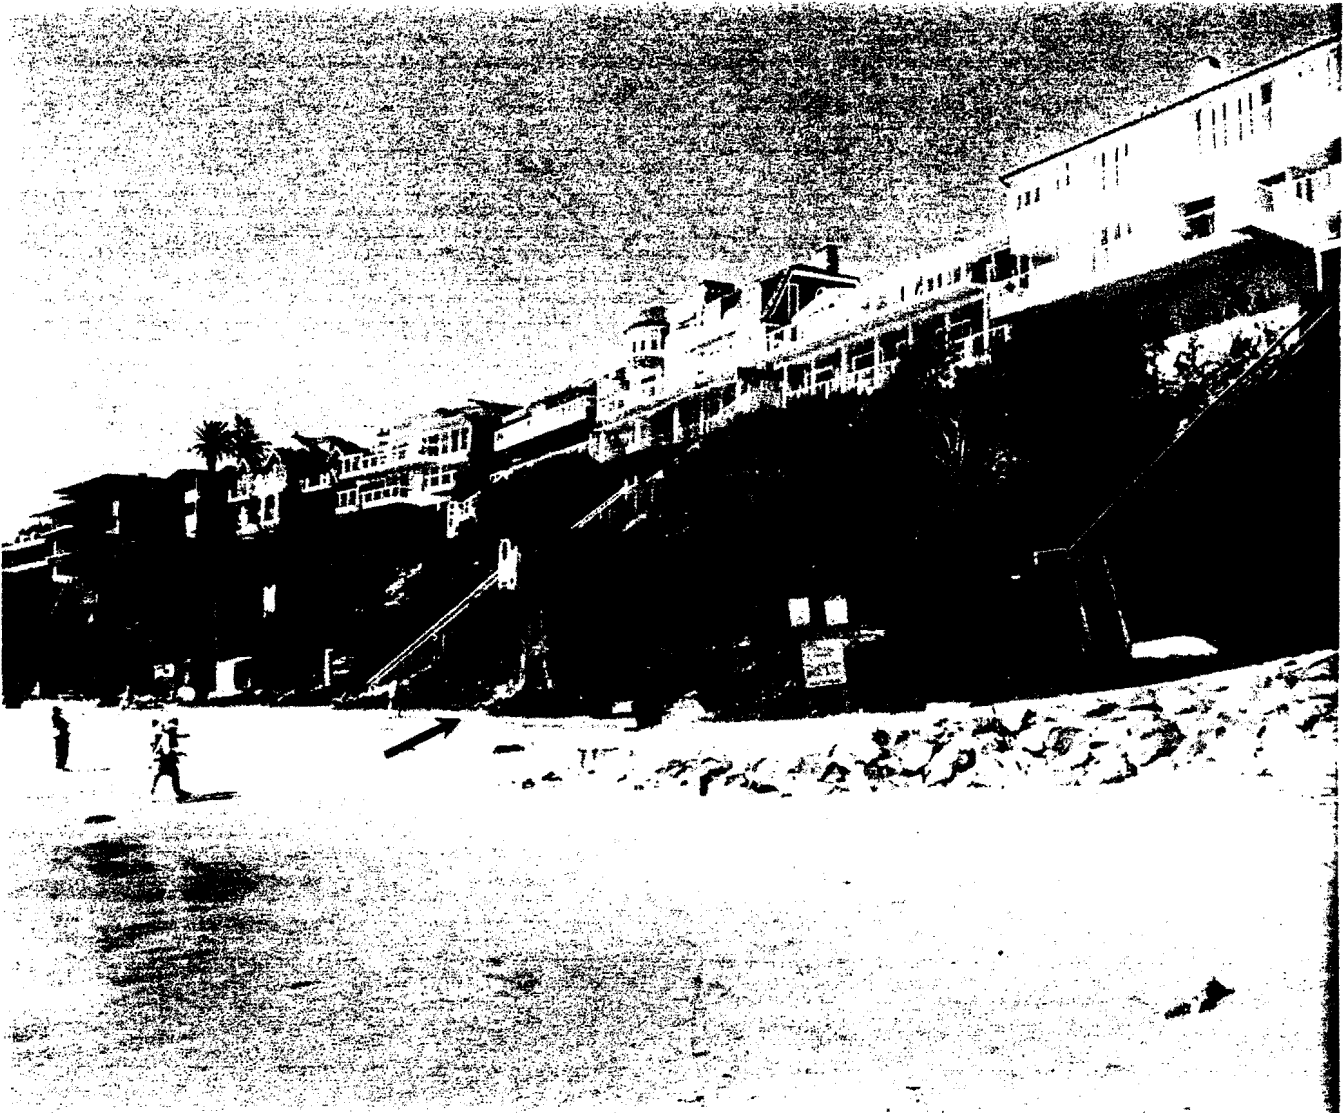
Historical Precedence

There are thirteen homes located along this bluff. Ten homes have individual stairways leading to the bottom of their property. Two other homes share a stairway to the bottom of their property along their common property line. The applicant's home was issued a permit by the City of Newport Beach to construct a stairway to the beach when the original home was constructed. It has been debated as to whether the stair was never built or built and abandoned. However, the trail system that has been constructed has been designed to minimize its physical impact on the slope as compared to the other stairways in existence.

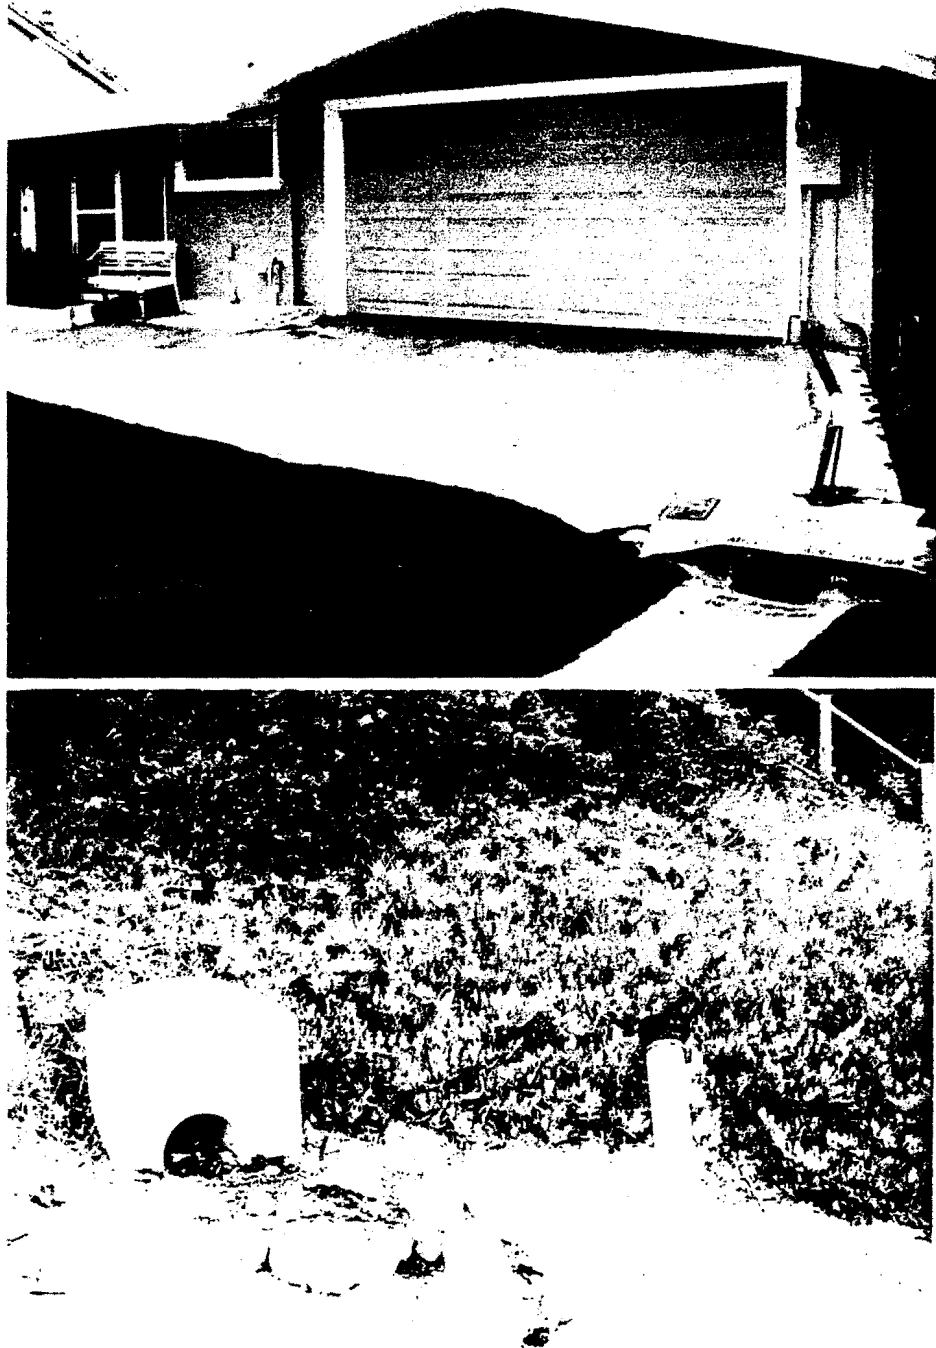
Drainage Protection

A drainage easement incorporating a catch basin, stormdrain line and outflow structure are located along the western edge of the property (within the legal lot) and provide for drainage of several acres of surrounding property as well as the front yards for this and five other homes. In the event of a blockage at the outflow structure, the water would overflow the curb and potentially create significant damage to the applicant's home and property. The applicant needs to be able to have reasonable physical access to clear any debris located at the outflow structure in order to prevent damage to the property and home.

The applicant has submitted a letter from CSL Engineering, Inc. which evaluates the drainage patterns adjacent to the subject property (Exhibit 12). After reviewing the inlet on the alleyway west of the front door, the existing erosion along the westerly side yard of the home, and the outlet structure at the beach below the property, the consultant makes various recommendations regarding drainage. The first recommendation involves "quick access" to the outlet at the toe of the slope. As stated in the letter, *"it is necessary that you maintain your ability to get quick access to the outlet structure in the event of a stoppage of flows exiting the pipe."*

While the blockage of a drainage outlet is a concern, the potential does not present a significant hazard that justifies the need for the currently requested ATF stairway. The outlet is located within a City easement that should be maintained as needed by the local government. The applicant can view the base of the bluff from the patio above and report any blockage to the City if necessary. Also, the applicant may access the beach below from a public ramp located approximately 200 feet downcoast.

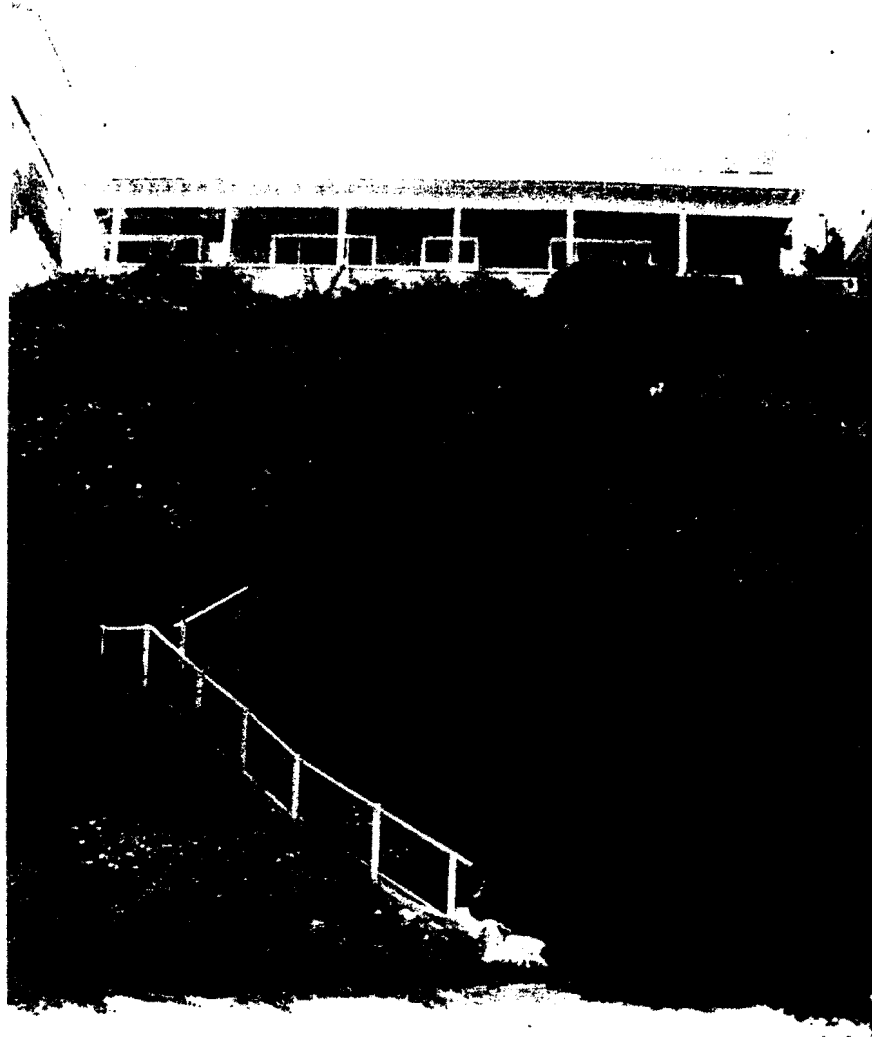
Fire Protection

The exterior of the home is made of wood. The irrigated slope provides a safe fire buffer from an accidental brush fire started by someone on the beach either smoking or barbecuing (both activities occur regularly on the sand below).

The applicant contends that the landscaping and irrigation currently requested is necessary to reduce potential fire hazard at the subject site. An evaluation prepared by Firewise 2000, Inc. indicates that the recently installed ornamental landscaping and irrigation system is consistent with Orange County Fire Authority (OCFA) guidelines for fuel modification (Exhibit 10). As stated in their letter of October 27, 2001, "the current green, moist and succulent landscaping, with periodic irrigation, meets or exceeds the County Fire Ordinance criteria." The letter also indicates that native vegetation, such as coastal sage scrub, would create a dry fuel bed adjacent to the residence, placing it in danger during the summer months. The fire safety consultant recommends that the applicant "challenge any direction or orders from the California Coastal Commission requiring you to remove the current irrigation of your landscaped yard or the replanting of the hillside to native Coastal Sage Scrub due to the additional fire hazard and risk it will create."

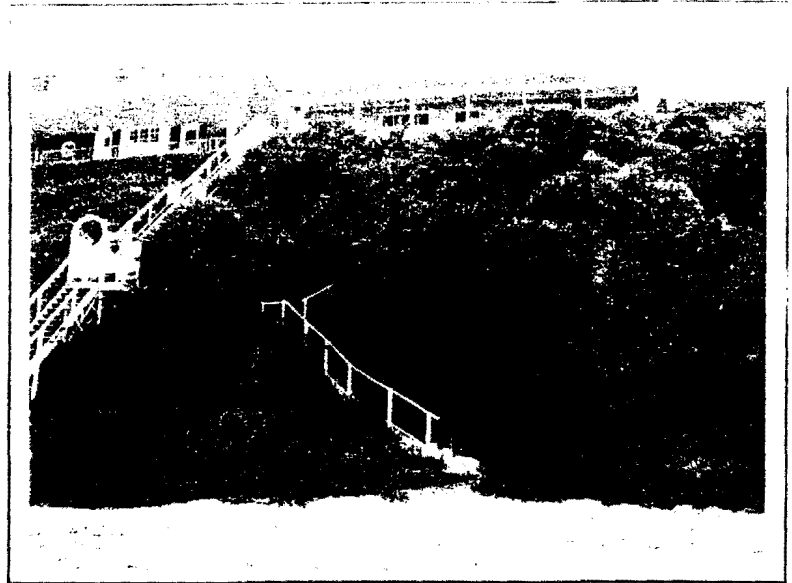
↑ Photo 1: Current Landscaping at 3415 Ocean Blvd.

The current landscaping, with irrigation, will not support the spread of a vegetation fire or additional fire brands originating from such a fire.

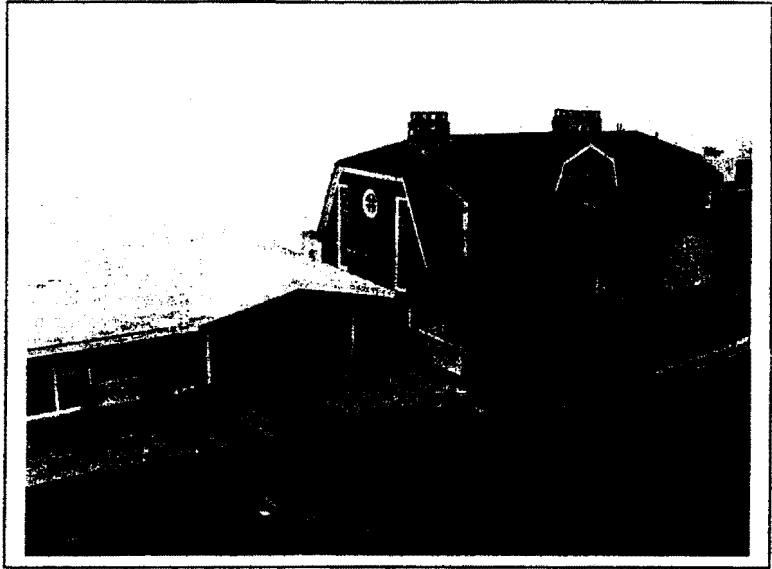
One big concern is the shake/shingle roof and shingle-sided residence located at 3401 Ocean Blvd. This residence is immediately next to your property line.

↑ Photo 3: Home with Shake/Shingle Roof and Siding (Dark Brown Home).
