CALIFORNIA COASTAL COMMISSION

Subject: Commission determination of conformity with the Coastal Act of the Coastal Conservancy's enhancement plan *In Progress Review: Ancillary Data and Observations from Caulerpa Taxifolia Eradication Efforts at Agua Hedionda Lagoon and Huntington Harbor of the Southern California Caulerpa Action Team (SCCAT)*.

RAPID RESPONSE AND ERADICATION PROGRAM FOR THE INVASIVE GREEN ALGA, *CAULERPA TAXIFOLIA* AT AGUA HEDIONDA LAGOON, CARLSBAD, CALIFORNIA

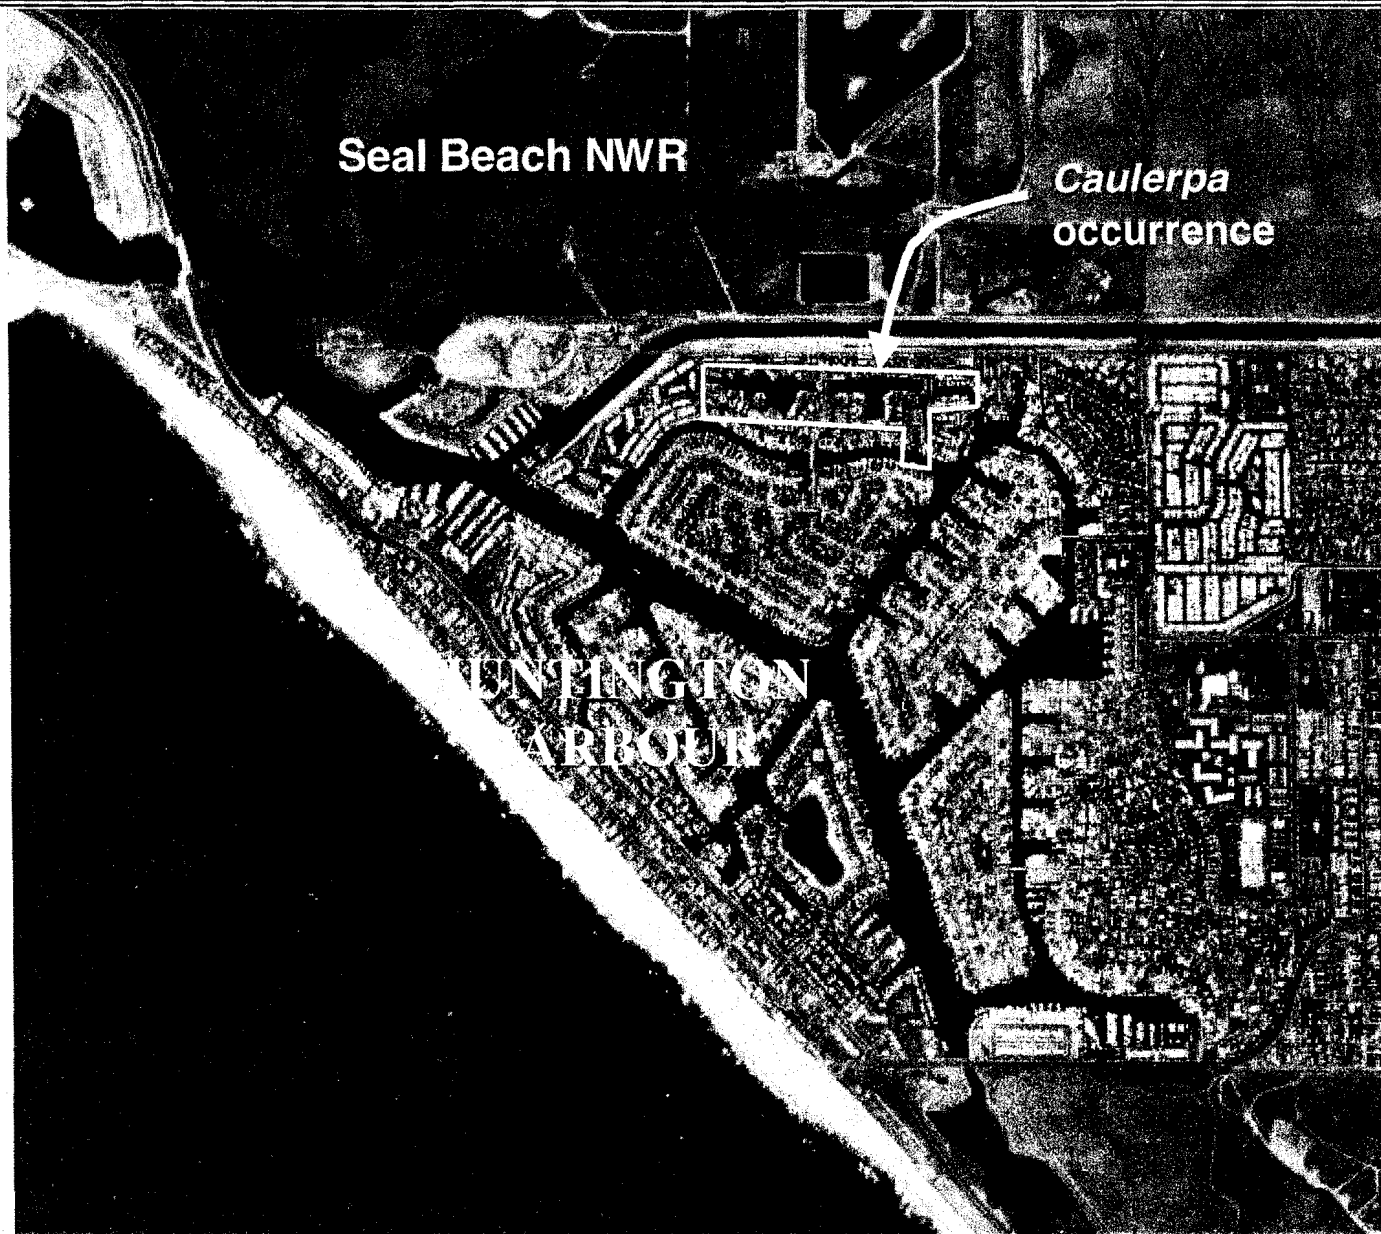
Figure
1

Map of Known *Caulerpa taxifolia* Infestation in Huntington Harbour
October 26, 2000
Huntington Beach, CA

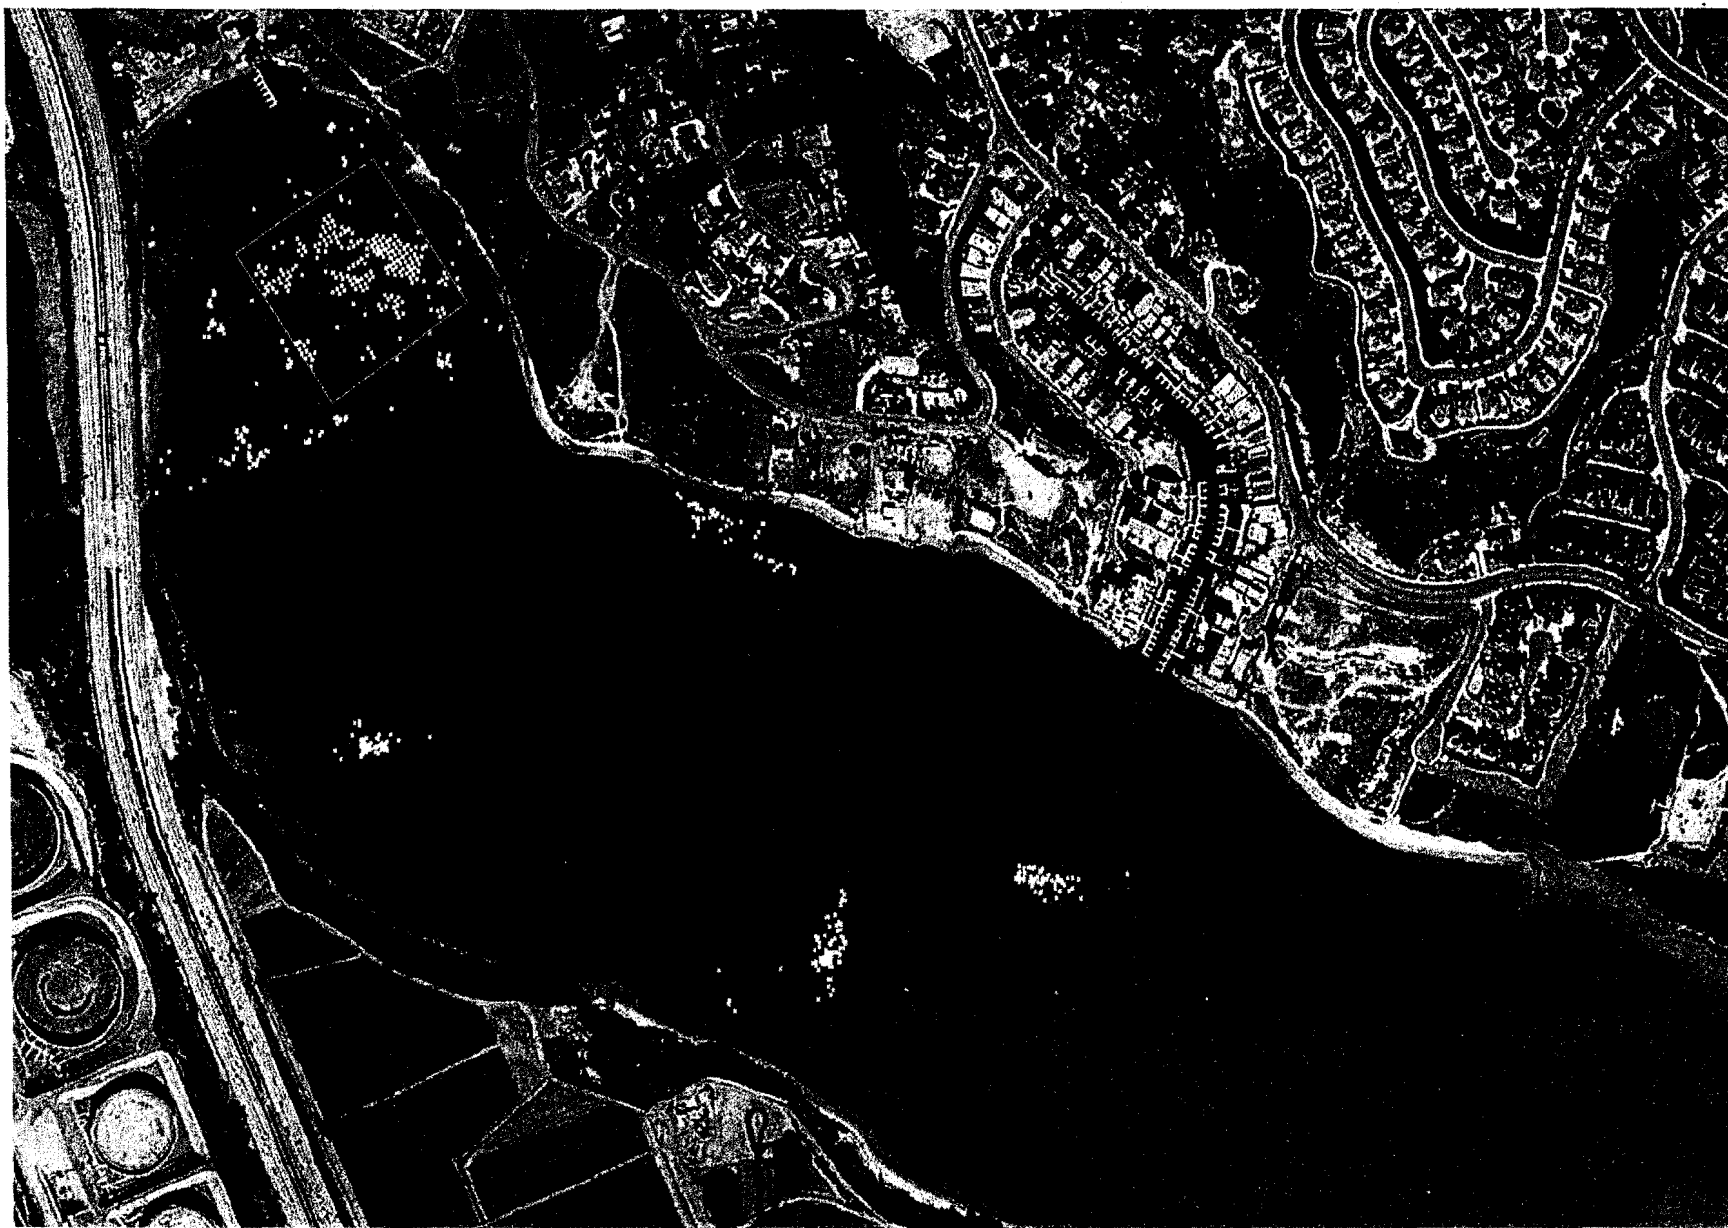
Figure
4

**Cumulative Distribution of *Caulerpa taxifolia* in Agua Hedionda
November 2001
Carlsbad, CA**

Information about the known distribution of *Caulerpa* in Agua Hedionda over time has been compiled into a of four maps. Each map shows the distribution of *Caulerpa* in the East Basin (the only basin found to be infested to date) and a summary of the total extent of the *Caulerpa* cover. References to “the grid” refer to the square seen in the northernmost cove of the basin (Snug Harbor). This is a rope grid permanently deployed on the lagoon bottom that allows for repeated, systematic surveys that can be used to closely monitor trends in *Caulerpa* distribution. This grid was originally deployed shortly after the discovery of the infestation and was believed at the time to encompass the full extent of the infestation. The terminology used in the legends is explained in detail in the enclosed document entitled: Defining, Describing, and Assessing Metrics for Success in the Eradication of *Caulerpa taxifolia* at Agua Hedionda Lagoon, Carlsbad CA (November 2001).

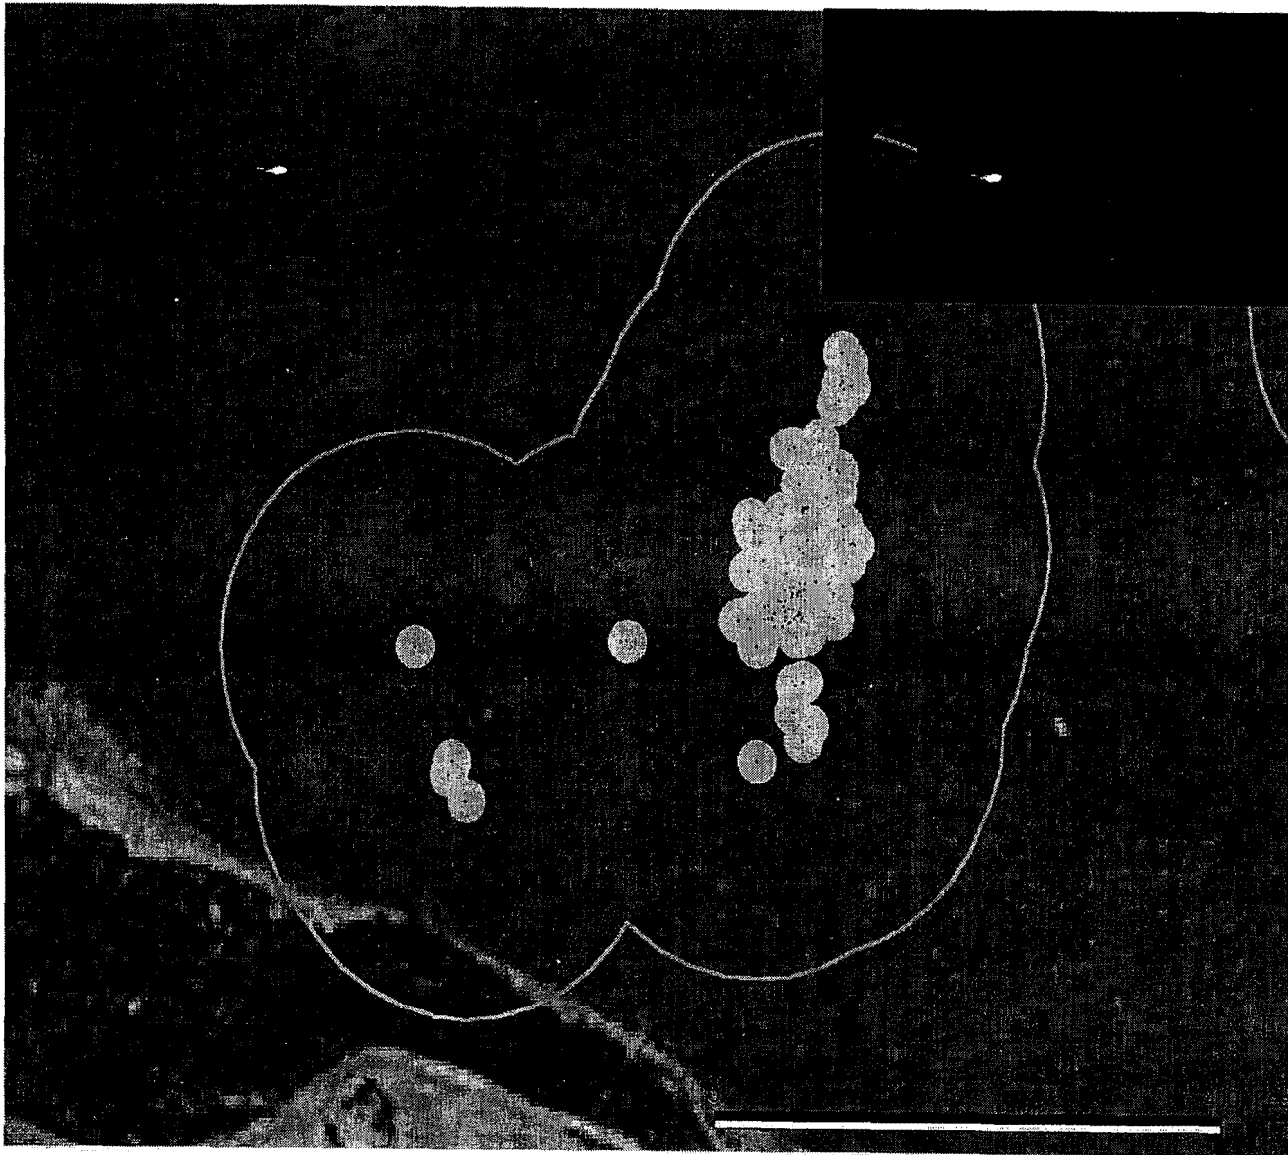
Figure 2. Expanded view of an infestation area with its associated *Caulerpa* and debris fields.

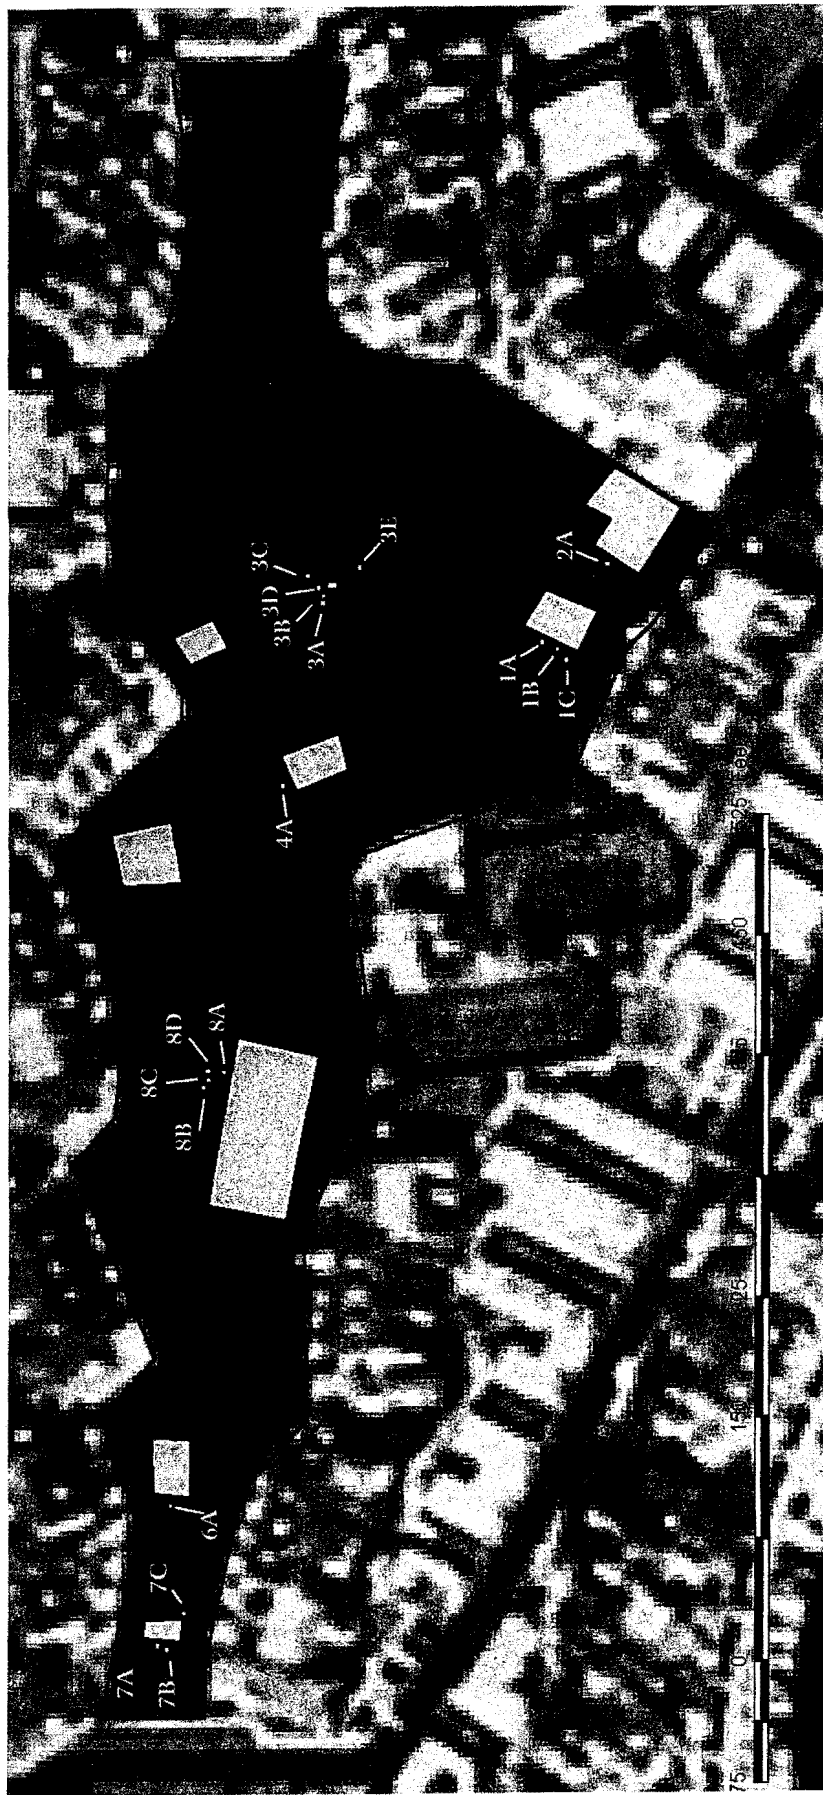
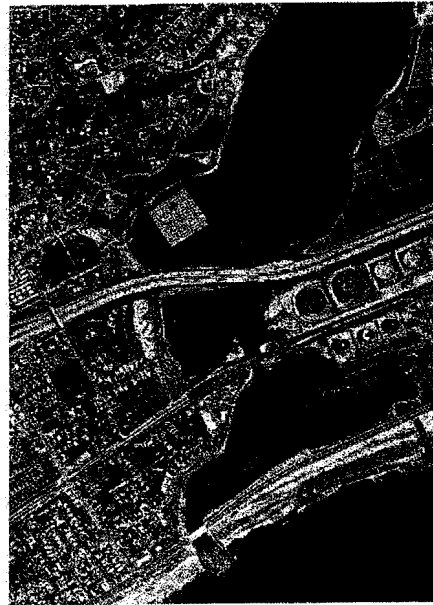
Location of Study Plots in West Pond (small plots adjacent to Huntington Harbour
Huntington Beach, CA)

All study plots were mapped and randomly assigned one of the following six treatments, with five replicates of each: 1) PVC grid, open with no tarp or chemicals (control) 2) PVC grid, black PVC tarp (dark) 3) PVC grid, clear plastic tarp (clear) 4) PVC grid, black PVC tarp, chlorine application 5) PVC grid, black PVC tarp, acetic acid application 6) PVC grid, hand pick all *Caulerpa*. The locations of the study plots are mapped in Figure 2.

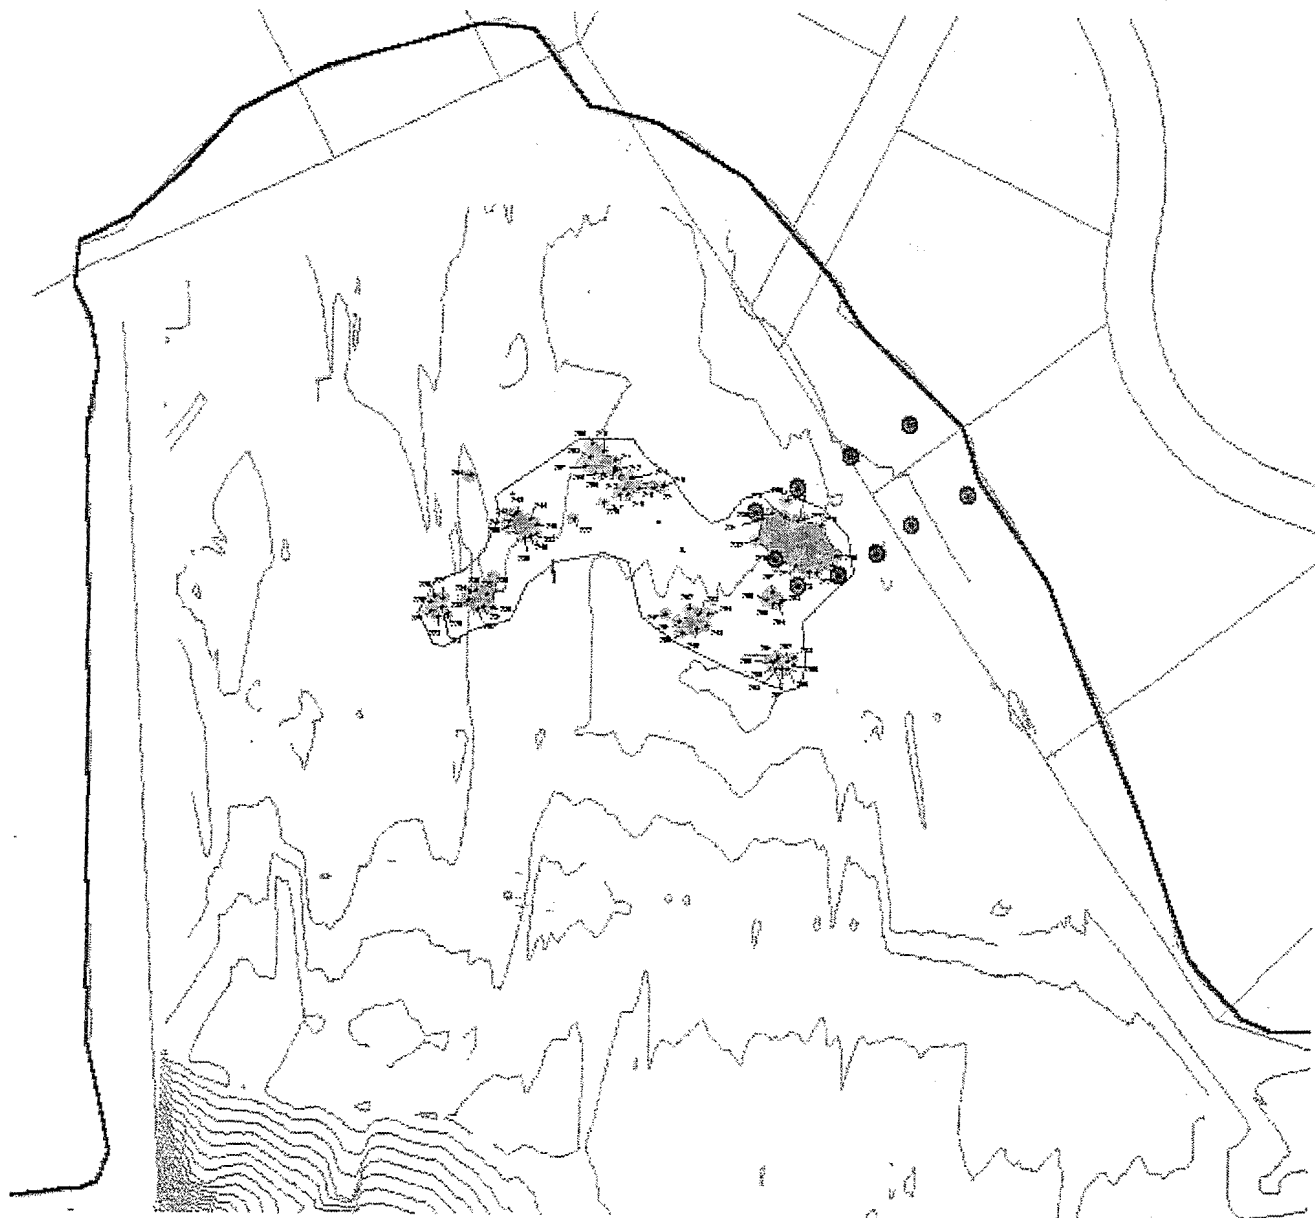
Figure 3. Known distribution of *Caulerpa* in Agua Hedionda Lagoon (July 8, 2000).
