CALIFORNIA COASTAL COMMISSION

STAFF REPORT: REVISED FINDINGS

APPLICATION NO.: 5-01-112
APPLICANT: Curt Ensign
AGENT: David Neish
PROJECT LOCATION: 3415 Ocean Blvd., Newport Beach, Orange County
PROJECT DESCRIPTION: Request for after-the-fact approval to construct a switchback bluff face walkway with keystone-type earth retention blocks, landscaping and irrigation on a beachfront lot adjacent to Corona del Mar State Beach.

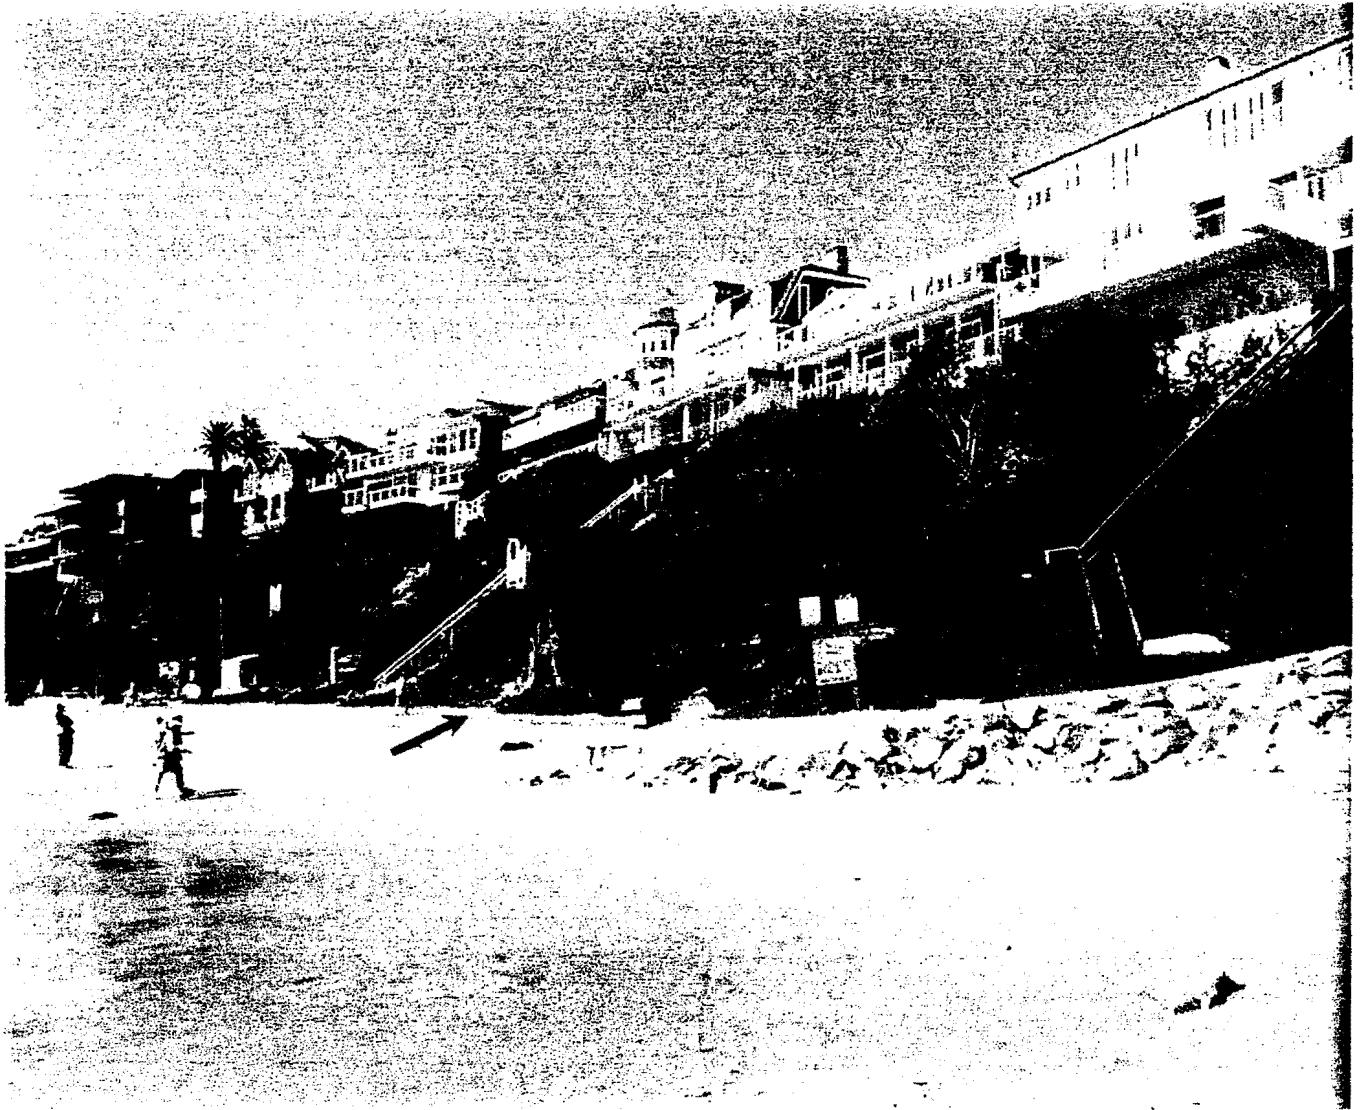
Historical Precedence

There are thirteen homes located along this bluff. Ten homes have individual stairways leading to the bottom of their property. Two other homes share a stairway to the bottom of their property along their common property line. The applicant's home was issued a permit by the City of Newport Beach to construct a stairway to the beach when the original home was constructed. It has been debated as to whether the stair was never built or built and abandoned. However, the trail system that has been constructed has been designed to minimize its physical impact on the slope as compared to the other stairways in existence.

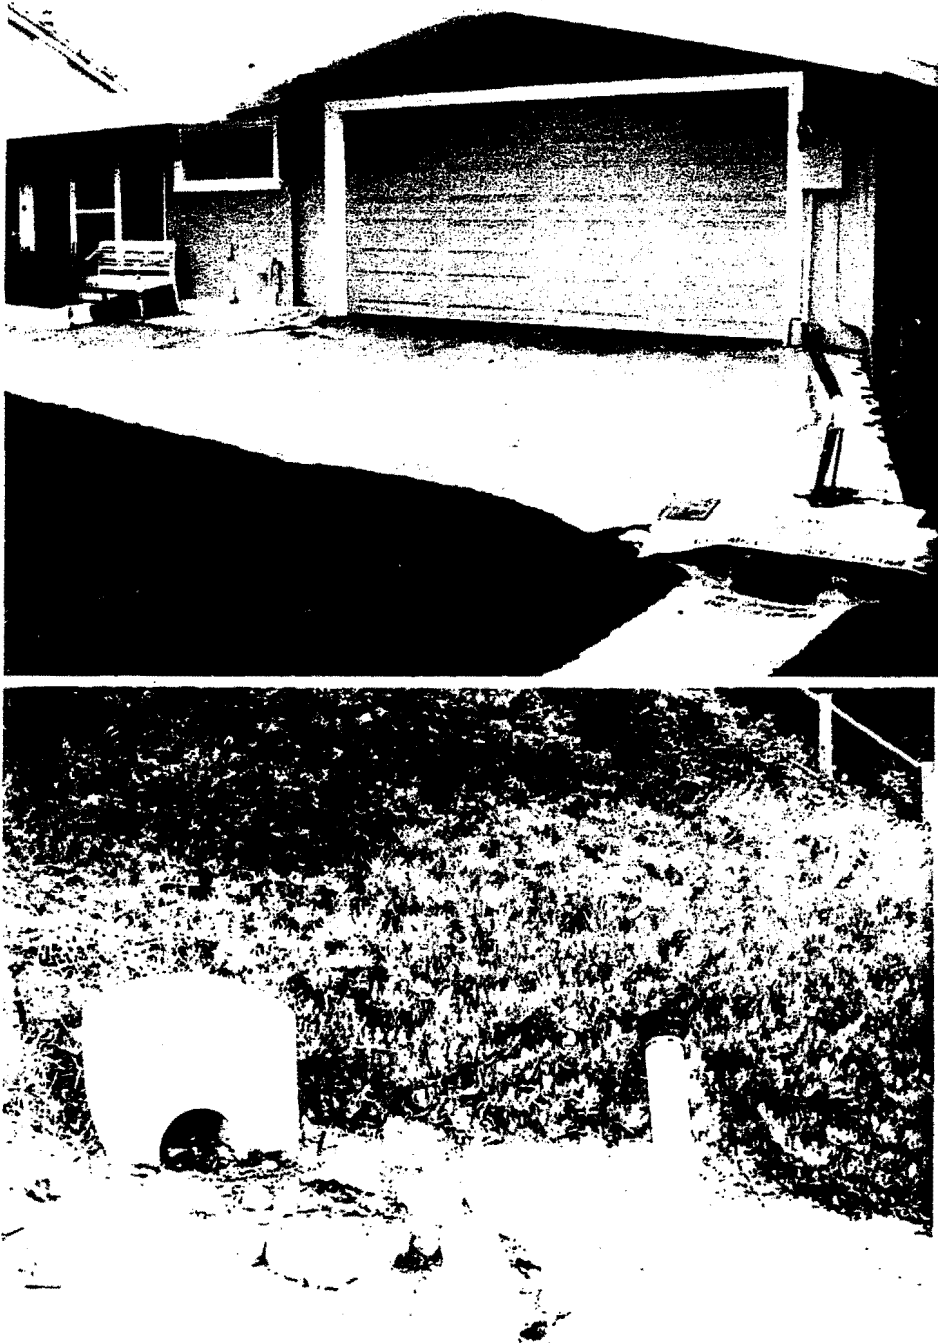
Drainage Protection

A drainage easement incorporating a catch basin, stormdrain line and outflow structure are located along the western edge of the property (within the legal lot) and provide for drainage of several acres of surrounding property as well as the front yards for this and five other homes. In the event of a blockage at the outflow structure, the water would overflow the curb and potentially create significant damage to the applicant's home and property. The applicant needs to be able to have reasonable physical access to clear any debris located at the outflow structure in order to prevent damage to the property and home.

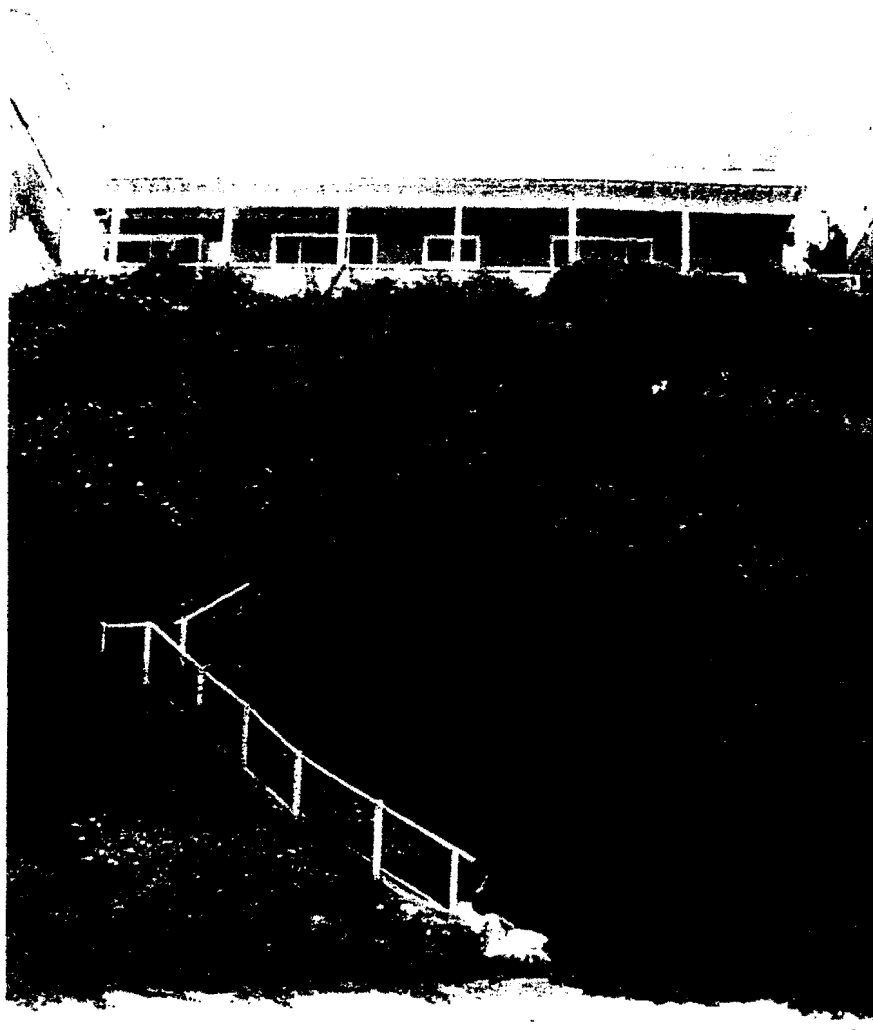
Fire Protection

The exterior of the home is made of wood. The irrigated slope provides a safe fire buffer from an accidental brush fire started by someone on the beach either smoking or barbecuing (both activities occur regularly on the sand below).

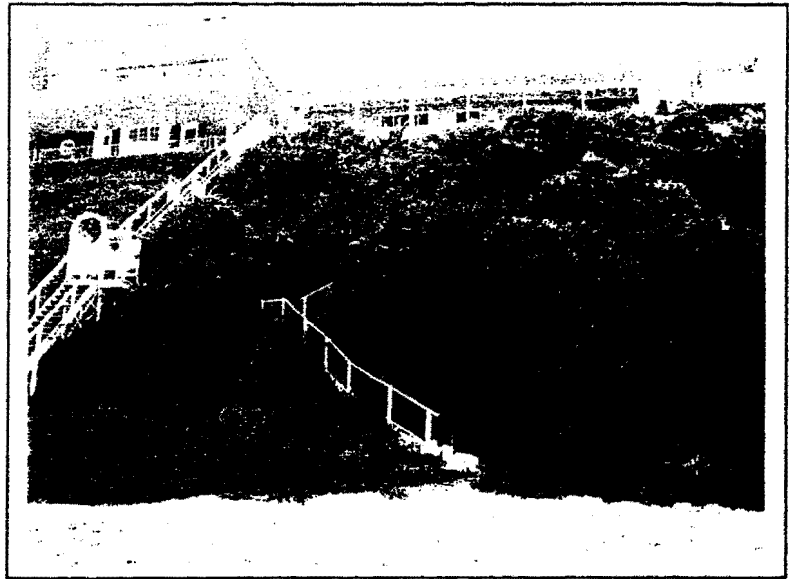
↑ Photo 1: Current Landscaping at 3415 Ocean Blvd.

The current landscaping, with irrigation, will not support the spread of a vegetation fire or additional fire brands originating from such a fire.

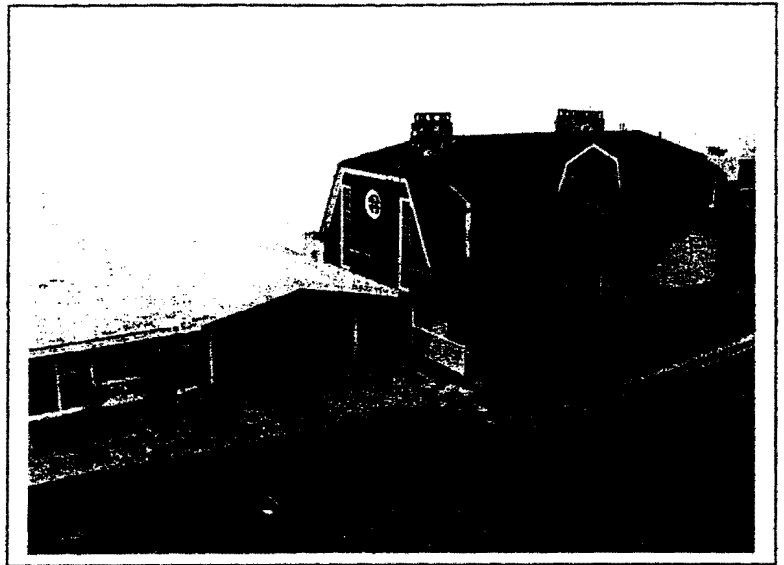
One big concern is the shake/shingle roof and shingle-sided residence located at 3401 Ocean Blvd. This residence is immediately next to your property line.

↑ Photo 3: Home with Shake/Shingle Roof and Siding (Dark Brown Home).

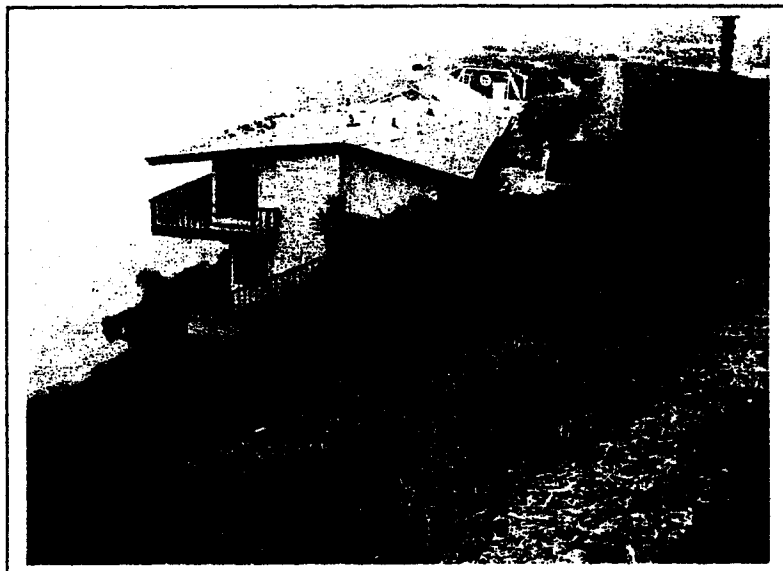
Having Coastal Sage Scrub vegetation below or adjacent to structures can create a serious fire problem during the late summer and fall months even within a coastal climate area.

↑ Photo 5: Coastal Sage Scrub on City Property Adjacent to the Ocean Blvd. Beach Front Properties.

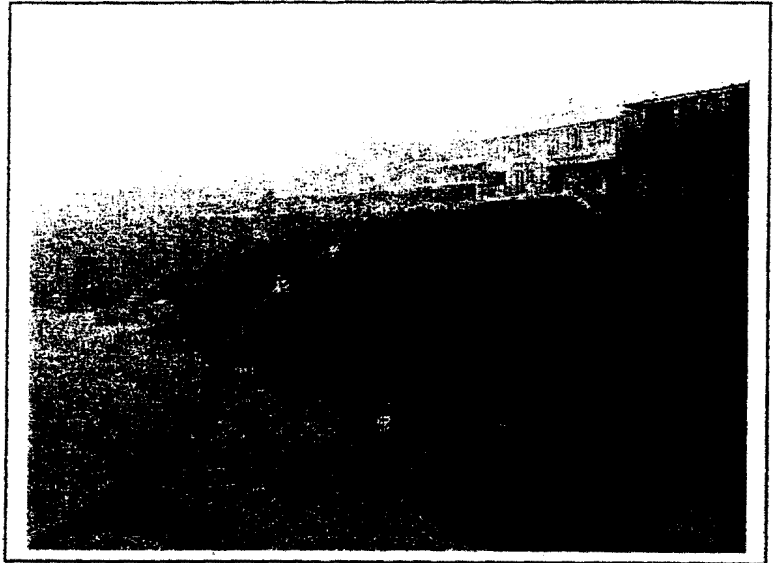
↑ Photo 6: Current Landscaping of All Four Beach Front Properties on Ocean Blvd.
