COASTAL DEVELOPMENT PERMIT APPLICATION**Application number**3-03-049 Scenic Road Armoring Repairs**Applicant**.....City of Carmel-by-the-Sea

Project location.....Three bluff locations below Scenic Road and the Scenic Road Recreational Trail (between 13th Avenue & Santa Lucia) along the back-beach of Carmel Municipal Beach in the City of Carmel-by-the-Sea, Monterey County.

Project descriptionRepair and augment the existing shoreline armoring in several locations below Scenic Road at Carmel Beach.

Application 3-03-049 Staff Report
City of Carmel-by-the-Sea Scenic Road Armoring Repairs
Page 2

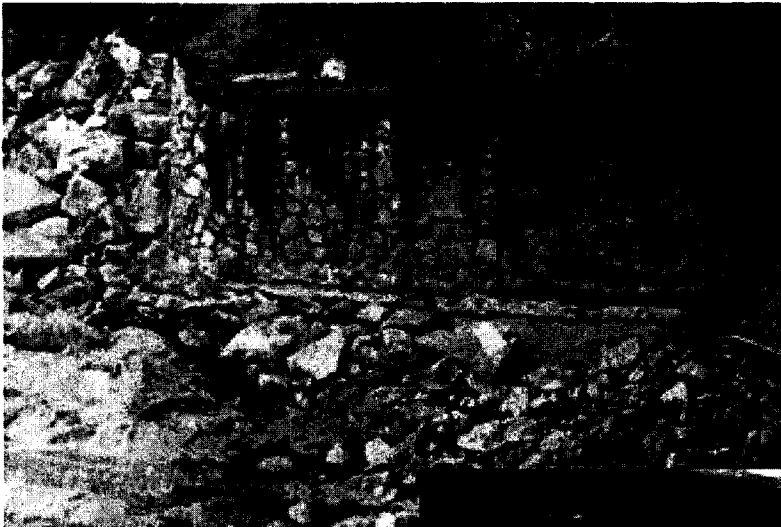
The City repaired the existing permitted rip-rap revetment by resetting displaced large armor stones and filling voids with approximately 50 tons of ¼ to ½ ton rock at the base of a currently undermined existing golden-granite faced seawall perched atop the sandstone just north of the 13th Avenue stairway. Installation of approximately 120 to 180 tons of rip-rap was approved in 2001 at this location (CDP 3-00-140), but due to significant wave action, structural integrity of the revetment had been compromised. The rock is keyed into the underlying bedrock for structural stability and extends roughly 60 linear feet between a natural notch in the sandstone below the existing wall. The rock was placed below the summer sand level and is designed to address ongoing scour that has undermined the existing wall. The rip-rap repair acts as the footing for the existing vertical seawall where erosive scour has removed the sandstone previously supporting this wall segment. Rip-rap was chosen for this repair location because of the scoured configuration of the underlying sandstone (the existing notch) as well to help diffuse wave energy that would otherwise be focused into the walled cove at this location during times of heavy storm driven waves. Emergency repair to the existing revetment was essential to protect the footing of the vertical seawall and prevent a collapse of this structure.

At Site 1 (see Exhibits C and D), the public access stairway is directly connected to the existing seawall that is being undermined. Absent the proposed repair and augmentation of the rip-rap at the base of this seawall to reset the displaced armoring stones and infill the voids in the revetment, the previously

effectiveness of protection against storm surf and creating a hazard for beachgoers. For example, the rip-rap revetment placed beneath the vertical wall at site 1 was installed under permit 3-00-140 in 2001 to prevent undermining of a vertical seawall and a public access stairway. Less than 3 years later, the rip-rap requires substantial maintenance and augmentation to reset displaced rock and back-fill the voids in the structure.

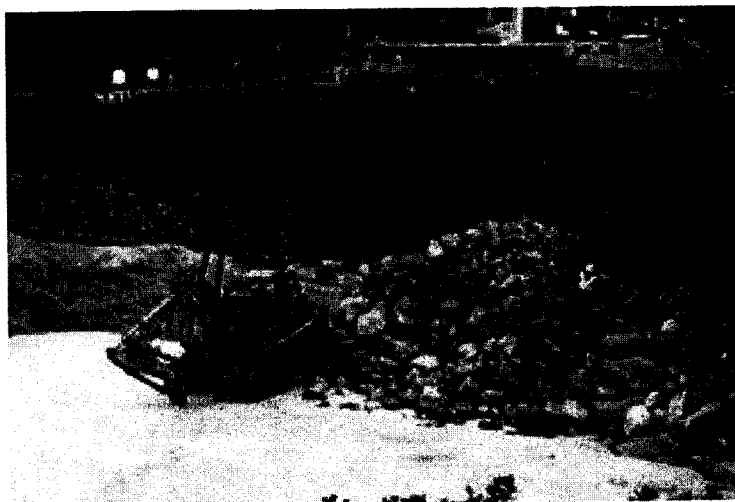
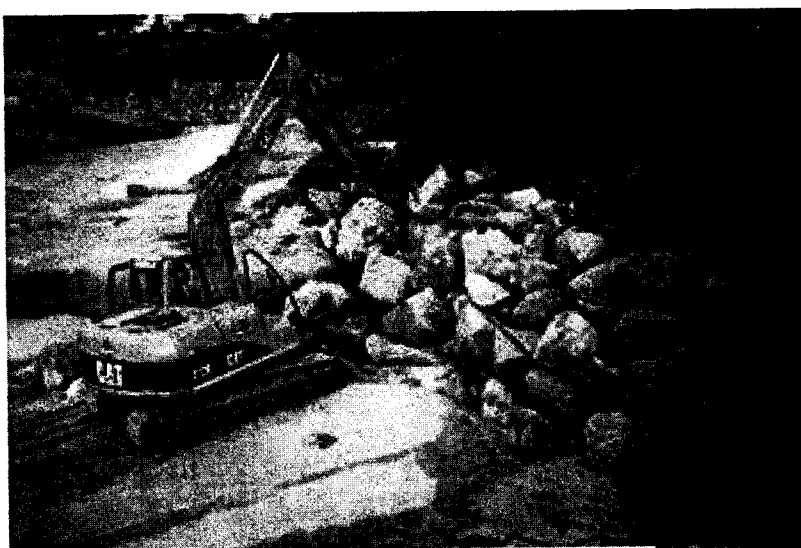
Repair and
Maintenance
activity

The emergency work undertaken involved resetting displaced rip-rap stones and filling voids in the rock with smaller armoring stones at two locations along Carmel Beach. In addition, the City filled a sinkhole that developed behind a granite-faced vertical seawall with gabion rock, and replaced the lost topsoil and native vegetation. The City proposes to maintain the existing Carmel back beach aesthetic through the use of sand contouring and upper bluff vegetation designed to hide the revetment segments that are the subject of this application.
