COASTAL DEVELOPMENT PERMIT APPLICATION**Application number**3-03-049 Scenic Road Armoring Repairs**Applicant**.....City of Carmel-by-the-Sea**Project location**.....Three bluff locations below Scenic Road and the Scenic Road Recreational Trail (between 13th Avenue & Santa Lucia) along the back-beach of Carmel Municipal Beach in the City of Carmel-by-the-Sea, Monterey County.**Project description**Repair and augment the existing shoreline armoring in several locations below Scenic Road at Carmel Beach.**Local approval**.....The City of Carmel-by-the-Sea City Council approved the project and certified the CEQA mitigated negative declaration on November 7, 2000.**File documents**.....Carmel Beach Management Plan (CDPs P-980, P-79-320, 3-83-217-A1, 3-83-217-A2, 3-83-217-A3, 3-83-217-A4, 3-00-140 and 3-03-013-G.**Staff recommendation** ...Approval with Conditions

Application 3-03-049 Staff Report

City of Carmel-by-the-Sea Scenic Road Armoring Repairs

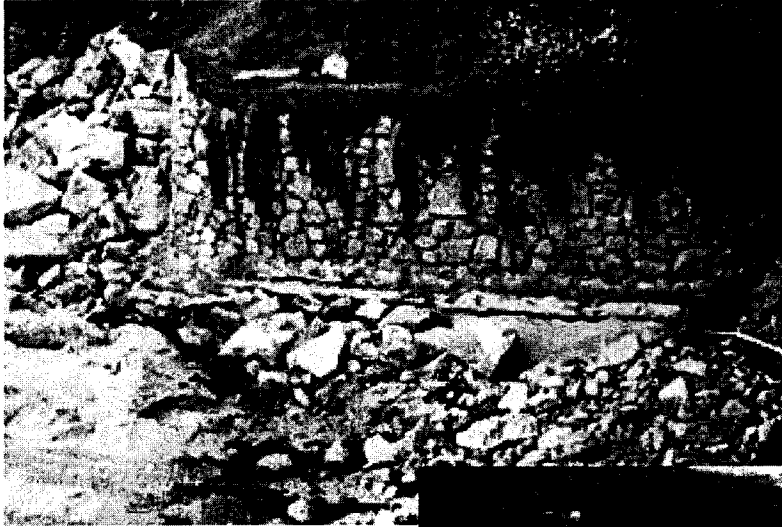
The City repaired the existing permitted rip-rap revetment by resetting displaced large armor stones and filling voids with approximately 50 tons of ¼ to ½ ton rock at the base of a currently undermined existing golden-granite faced seawall perched atop the sandstone just north of the 13th Avenue stairway. Installation of approximately 120 to 180 tons of rip-rap was approved in 2001 at this location (CDP 3-00-140), but due to significant wave action, structural integrity of the revetment had been compromised. The rock is keyed into the underlying bedrock for structural stability and extends roughly 60 linear feet between a natural notch in the sandstone below the existing wall. The rock was placed below the summer sand level and is designed to address ongoing scour that has undermined the existing wall. The rip-rap repair acts as the footing for the existing vertical seawall where erosive scour has removed the sandstone previously supporting this wall segment. Rip-rap was chosen for this repair location because of the scoured configuration of the underlying sandstone (the existing notch) as well to help diffuse wave energy that would otherwise be focused into the walled cove at this location during times of heavy storm driven waves. Emergency repair to the existing revetment was essential to protect the footing of the vertical seawall and prevent a collapse of this structure.

At Site 1 (see Exhibits C and D), the public access stairway is directly connected to the existing seawall that is being undermined. Absent the proposed repair and augmentation of the rip-rap at the base of this seawall to reset the displaced armoring stones and infill the voids in the revetment, the previously approved seawall will be lost, and the stairway itself could be compromised, within the next year or so, if not before.

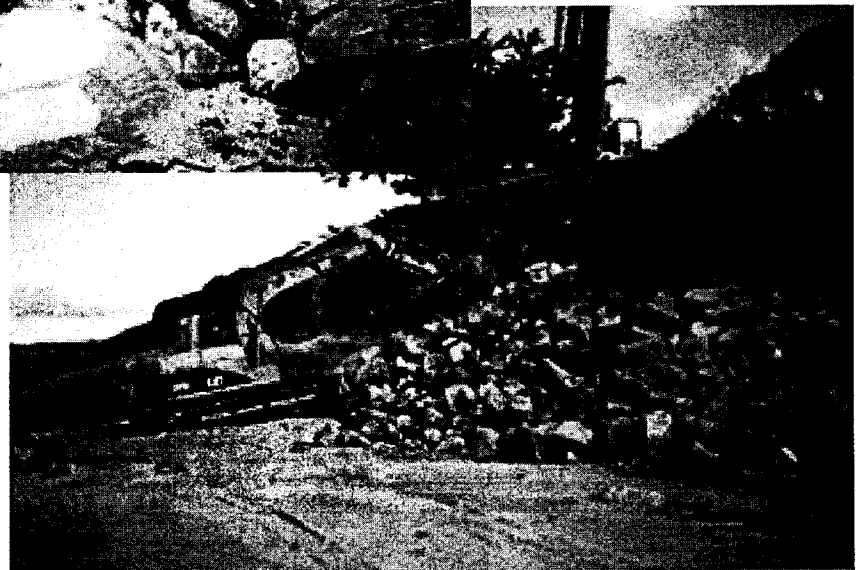
Repair and
Maintenance
activity

The emergency work undertaken involved resetting displaced rip-rap stones and filling voids in the rock with smaller armoring stones at two locations along Carmel Beach. In addition, the City filled a sinkhole that developed behind a granite-faced vertical seawall with gabion rock, and replaced the lost topsoil and native vegetation. The City proposes to maintain the existing Carmel back beach aesthetic through the use of sand contouring and upper bluff vegetation designed to hide the revetment segments that are the subject of this application.
