CALIFORNIA COASTAL COMMISSION

STAFF REPORT: REGULAR CALENDAR

APPLICATION NO.: 4-95-103

PROJECT DESCRIPTION: As built +/- 115 ft. long timber retaining wall, 20 timber piles with 3" to minus fill gravel, 18" – 24" 4 sack slurry underlain with 6" concrete as backfill within channel of Mission Creek. The retaining wall was constructed as an emergency action to replace a section of an existing timber retaining wall which was destroyed as a result of high storm flows and flooding on lower Mission Creek in January 1995. The new structure encroaches up to 10 feet further into the active channel of the creek beyond the location of the destroyed retaining wall.

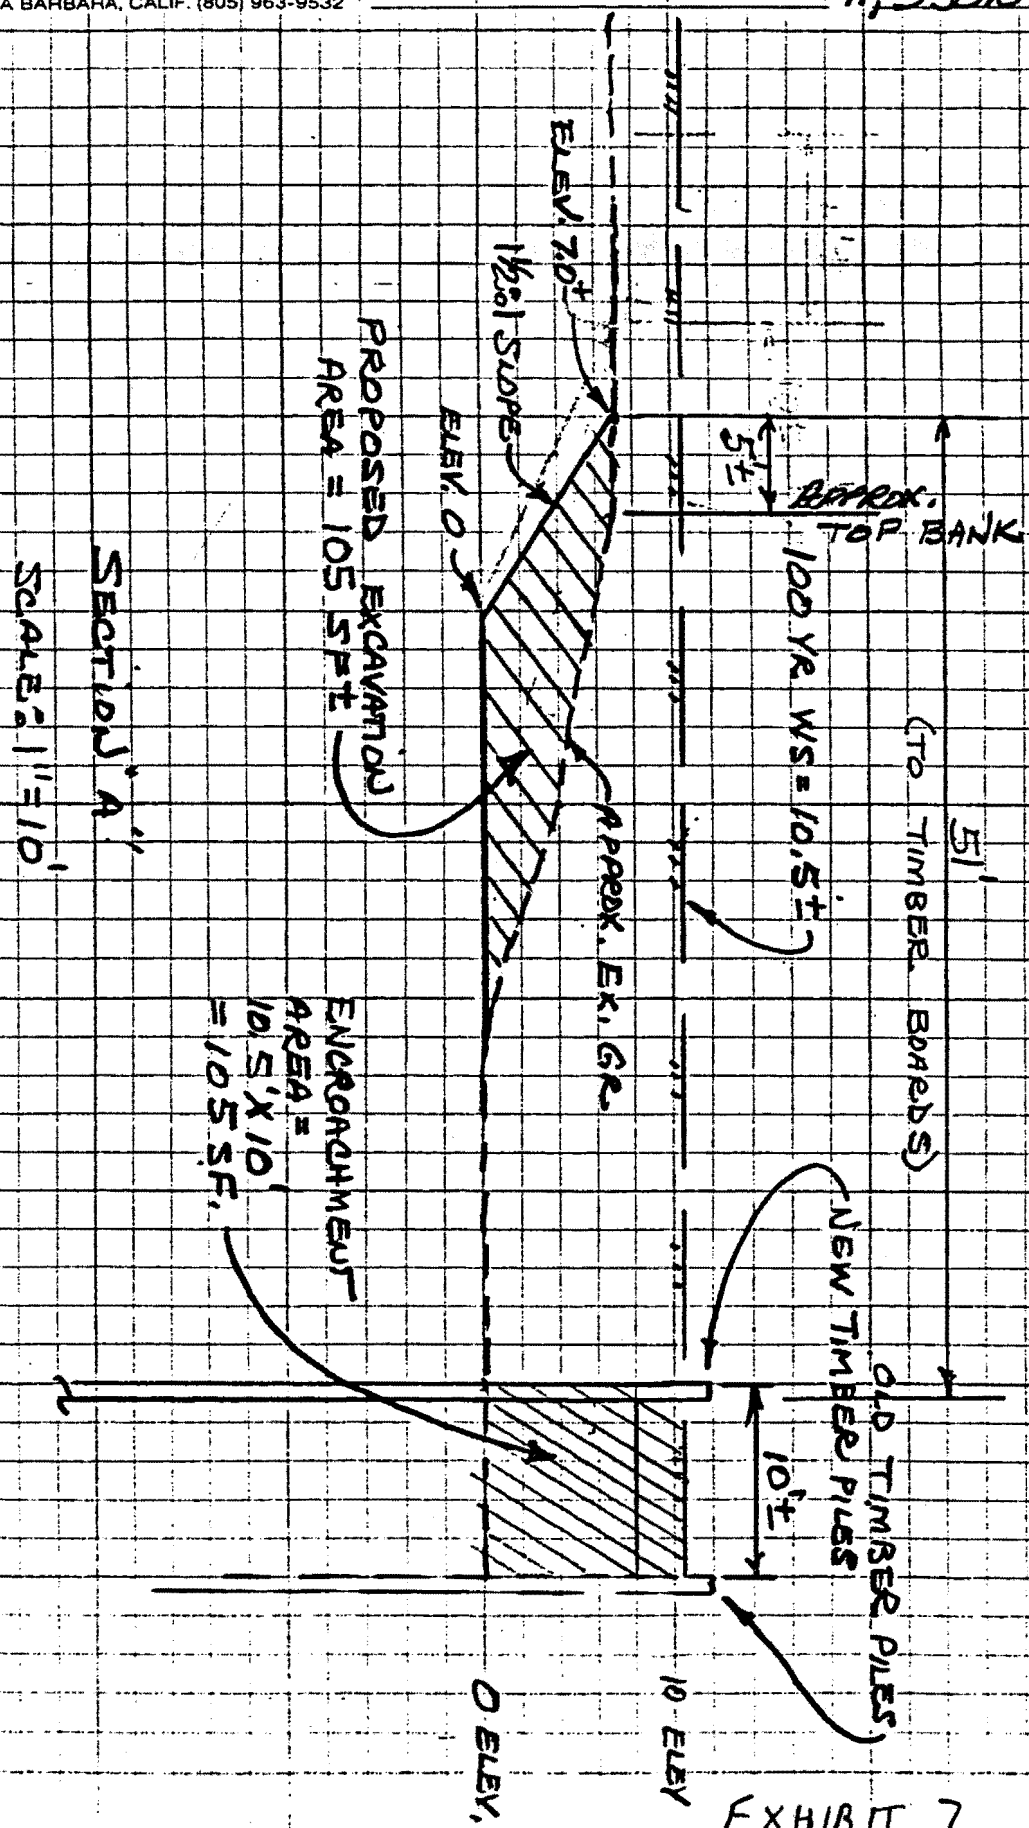
SH 1 OF 2
FLOOD DAMAGE REPAIR DATE 5-24-95

The project area is not therefor considered "floodway." However, we recommend that an area along the opposite side of the creek be excavated to provide approximate equivalent conveyance. Enclosed herewith are a plan and sections defining the proposed excavation. The following are comments regarding the plan.

5. The quantity of material to be excavated is approximately 400 cubic yards.
6. Sections A & B show that the cross sectional area of the proposed excavation will approximately equal the cross sectional area of the encroachment. Both the manning's roughness coefficient and the hydraulic radius for the sections would be approximately the same for the before and after condition. Therefore equivalent conveyance would be achieved.

PROPOSED EXCAVATION
AREA = 105 SF

ENCRAGEMENT
AREA =
10.5' X 10'
= 105 SF.

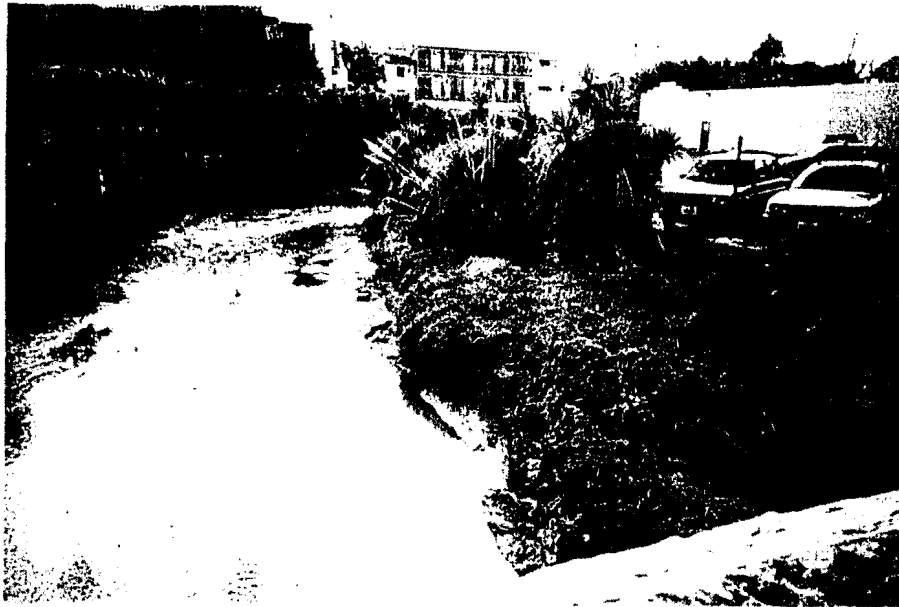
Photo 1 - Looking upstream from State Street Bridge - Feb 17, 1998

- Photographs taken in 1998 after the El Nino events were compared to photographs taken in October 2002, after several years of sub-average rainfall and stream flow. No significant aggradation of the creek was observed. See photos 1 and 2. This combined with the fact that sediment removal at this location in Mission Creek has historically not been required¹ indicates that reduction in creek capacity due to development of a point bar on the inside of the bend curvature is unlikely. In addition, the bulkhead encroachment occurs downstream of the maximum point of inflection of the creek curve, minimizing the hydraulic impacts on sediment deposition.

1. The construction of the post-1995 timber bulkhead has had little if any impact on the physical functionality of the channel and appurtenant structures.
2. The construction of the post-1995 timber bulkhead will likely have little, if any future impact on the physical functionality of the channel and appurtenant structures.
3. Although grading on the northerly creek bank has been proposed to provide equivalent flow conveyance, the grading of this bank along with the consequent destruction of the current vegetation is likely to cause more harm to the channel through sedimentation and disturbance than leaving it in the current condition. The loss of conveyance due to the construction of the timber bulkhead is quite insignificant when compared to the entire adjacent floodplain. Therefore, we recommend that the northerly channel bank be left in its current 2002 condition.

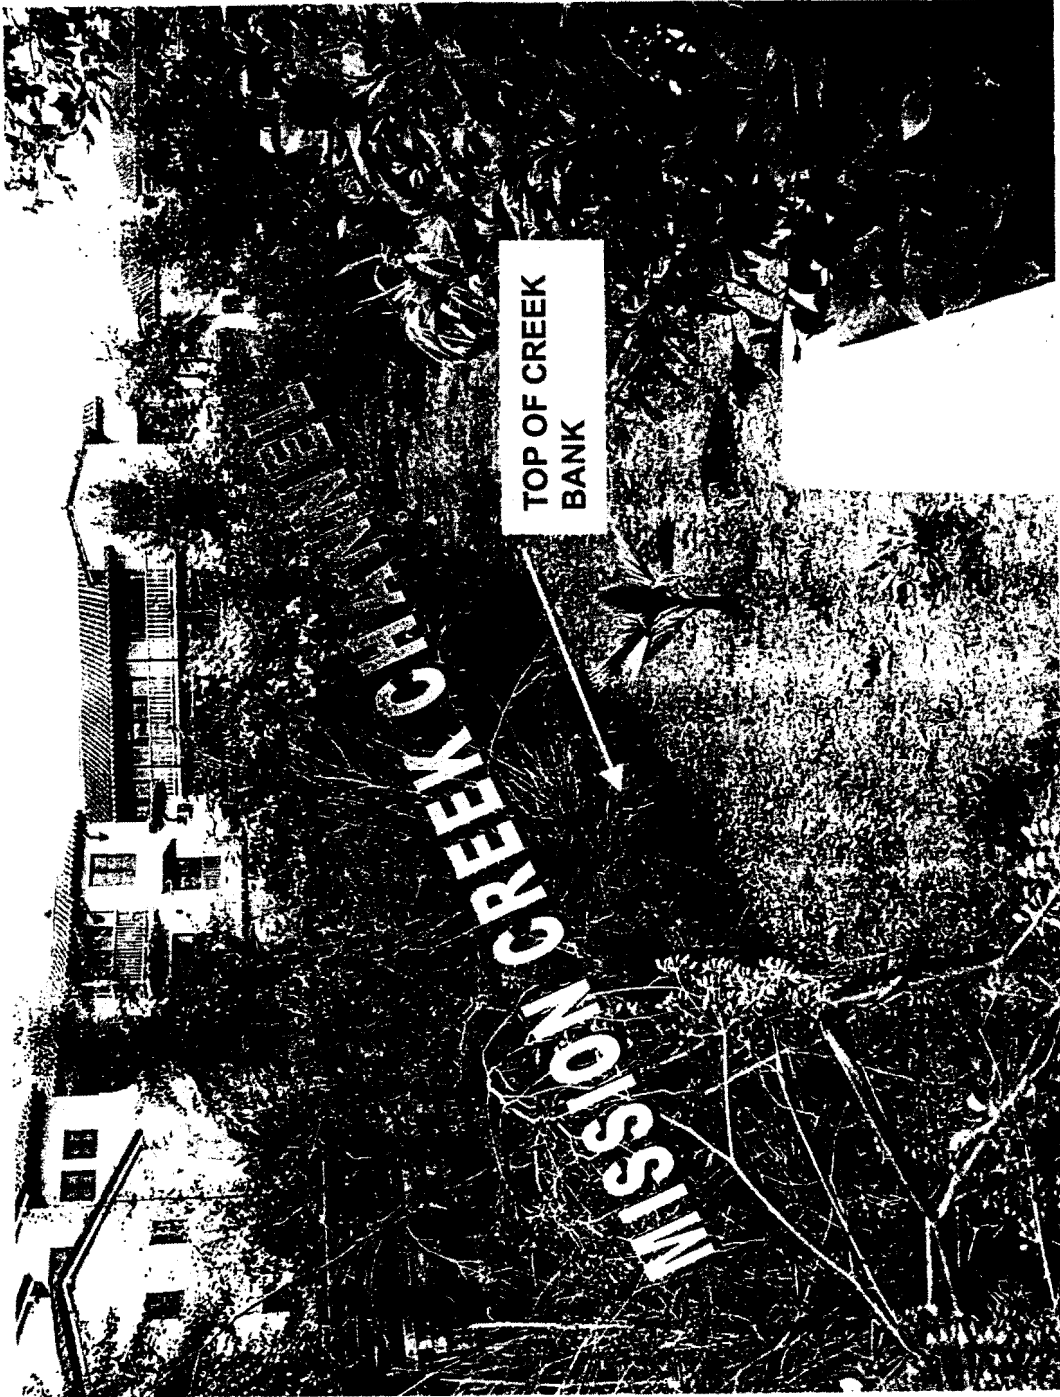
Photo 3 - Northerly Creek Bank

In response to Dr. Johnsson's memorandum, Penfield & Smith submitted a report to the applicant dated October 22, 2002 (exhibit 8). The report notes that the northern creek bank is "heavily vegetated and stabilized with mature plants." (The 1998 Biological Impacts report by Lawrence Hunt notes that the northern bank opposite the retaining wall is "devoid of native vegetation.") The report also notes that "no significant aggradation of the creek was observed" after several years that included the 1998 El Nino storms and several subsequent years of below-average rainfall. Further, the report notes that sediment removal in this area of Mission Creek has historically not been required which indicates that reduction in creek capacity due to development of a point bar on the inside of the bend is unlikely. Based on these observations, the consultant recommends that the construction of the bulkhead has had and will have "little, if any, future impact on the physical functionality of the channel and appurtenant structures." The report also recommends that excavation of the northern creek bank to provide equivalent flow conveyance "is likely to cause more harm to the channel through sedimentation and disturbance than leaving it in the current condition." The report therefore recommends that no excavation take place.

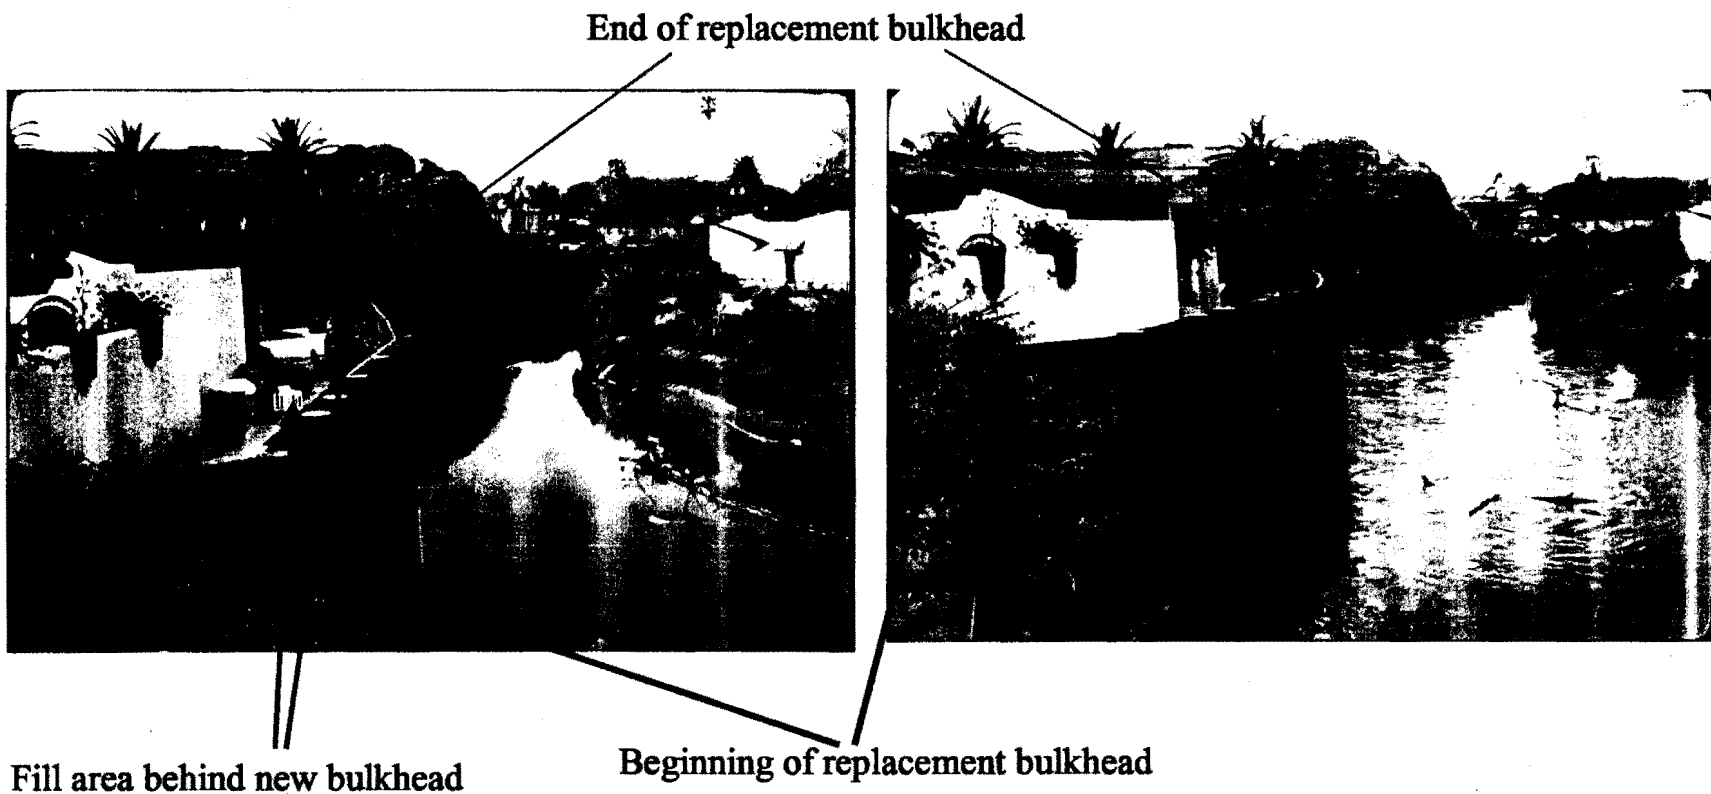
12/3/98 photograph of replacement bulkhead with fill area being used by a restaurant employee to clean screens

Replacement bulkhead during low flow period in 1995

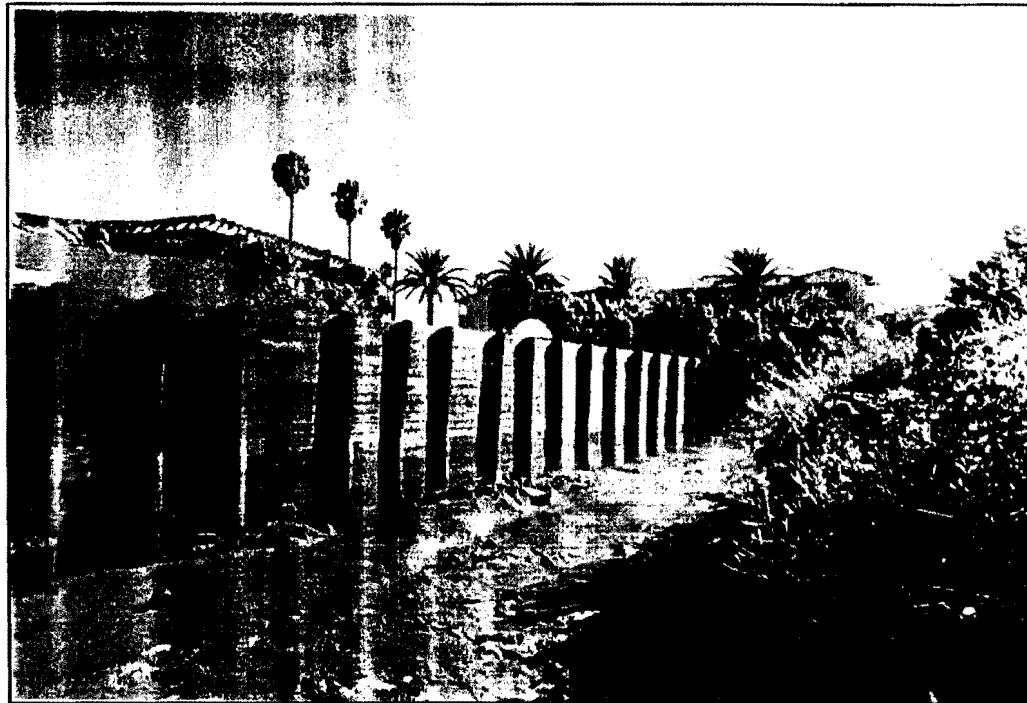
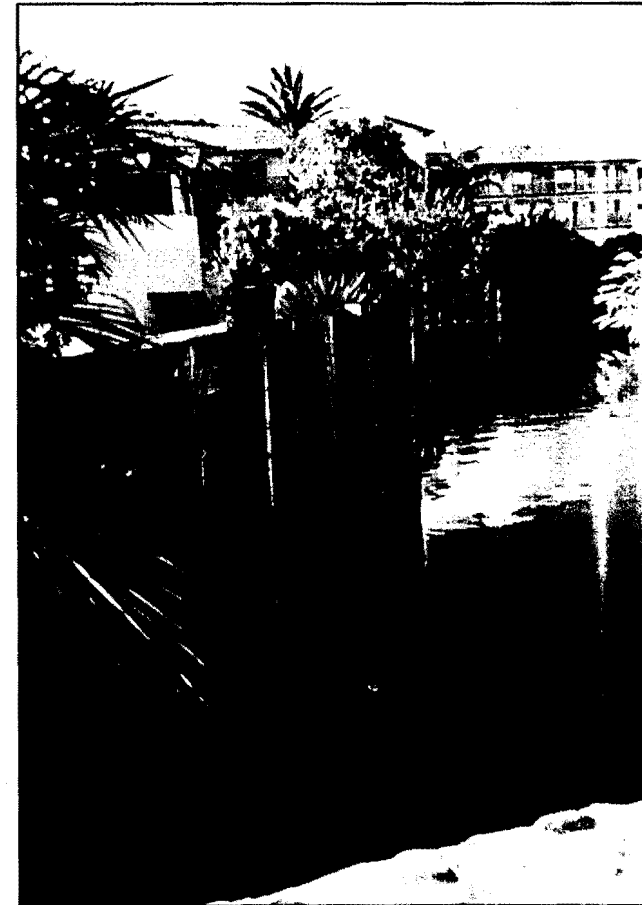
Bulkhead with plywood boards added, presumably to hide views of construction (view from State St. Bridge)

Apparent end of bulkhead replacement and fill area (bulkhead and fill area extend towards bridge in background of photo)

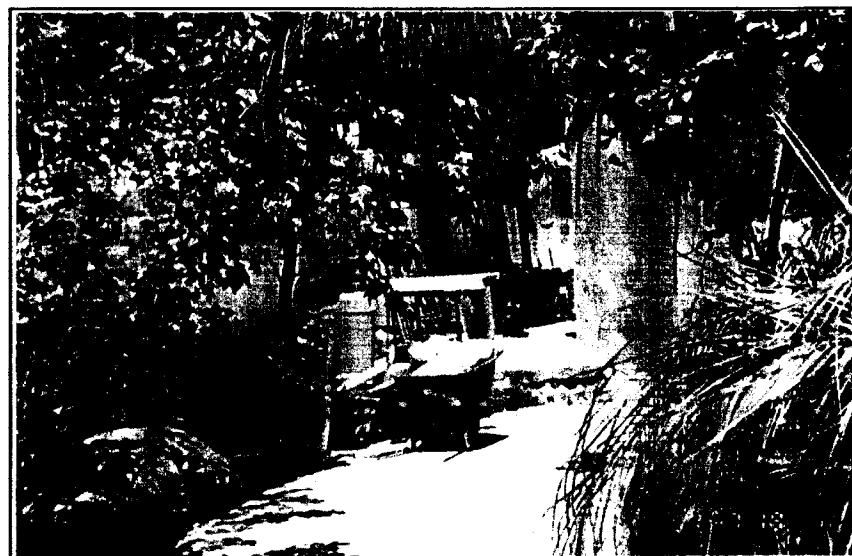
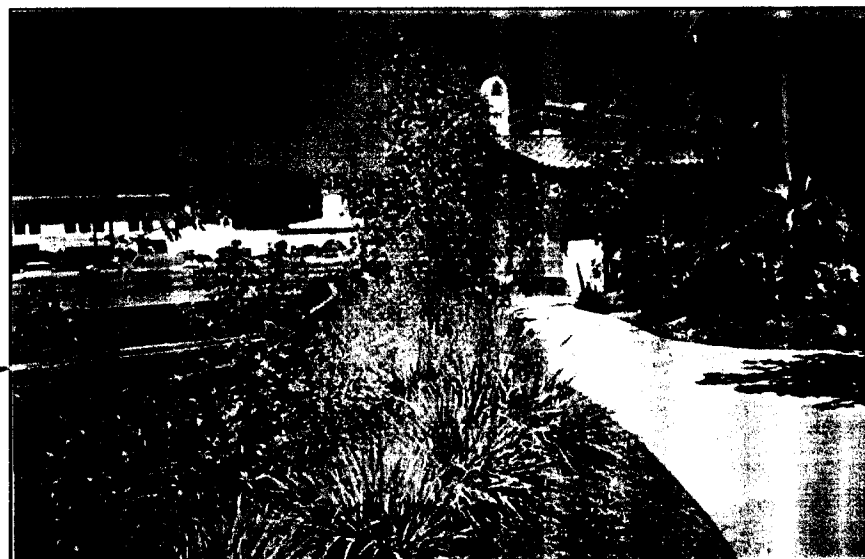
View of vegetation, path behind bulkhead

Area behind bulkhead, subject to on-going construction, and storage of construction materials
