**CALIFORNIA COASTAL COMMISSION**

**COASTAL DEVELOPMENT PERMIT APPLICATION**

**Application number** .....3-03-049 Scenic Road Armoring Repairs

**Project description** .....Repair and augment the existing shoreline armoring in several locations below Scenic Road at Carmel Beach.

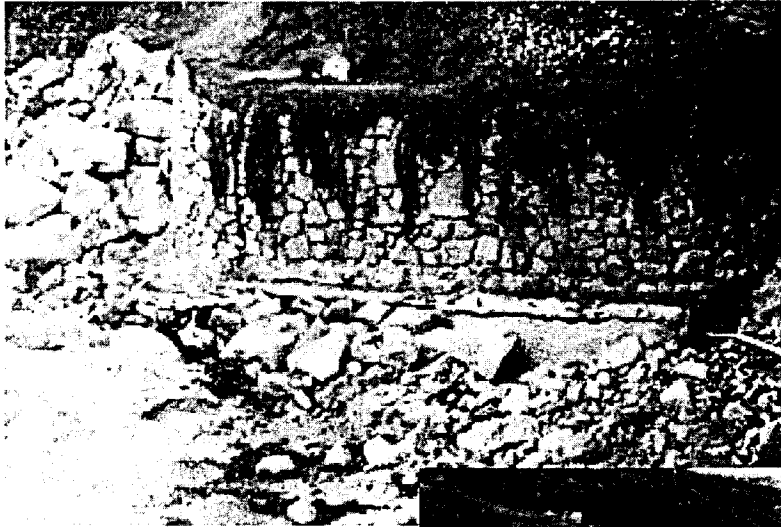
The City repaired the existing permitted rip-rap revetment by resetting displaced large armor stones and filling voids with approximately 50 tons of  $\frac{1}{4}$  to  $\frac{1}{2}$  ton rock at the base of a currently undermined existing golden-granite faced seawall perched atop the sandstone just north of the 13<sup>th</sup> Avenue stairway. Installation of approximately 120 to 180 tons of rip-rap was approved in 2001 at this location (CDP 3-00-140), but due to significant wave action, structural integrity of the revetment had been compromised. The rock is keyed into the underlying bedrock for structural stability and extends roughly 60 linear feet between a natural notch in the sandstone below the existing wall. The rock was placed below the summer sand level and is designed to address ongoing scour that has undermined the existing wall. The rip-rap repair acts as the footing for the existing vertical seawall where erosive scour has removed the sandstone previously supporting this wall segment. Rip-rap was chosen for this repair location because of the scoured configuration of the underlying sandstone (the existing notch) as well to help diffuse wave energy that would otherwise be focused into the walled cove at this location during times of heavy storm driven waves. Repair to the existing revetment was essential to protect the footing of the vertical seawall and prevent a collapse of this structure.

At Site 1 (see Exhibits C and D), the public access stairway is directly connected to the existing seawall that is being undermined. Absent the proposed repair and augmentation of the rip-rap at the base of this seawall to reset the displaced armoring stones and infill the voids in the revetment, the previously approved seawall will be lost, and the stairway itself could be compromised, within the next year or so, if not before.

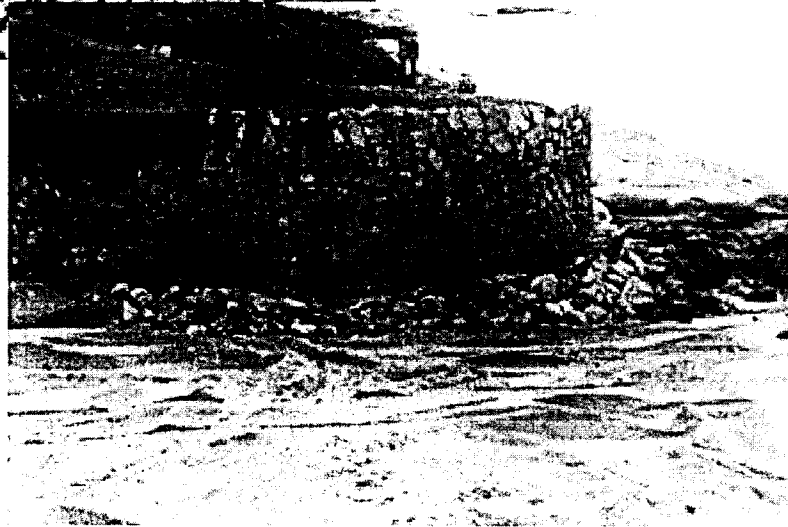
At this location, the City repaired and filled a moderately sized sinkhole behind the existing golden-granite faced seawall just south of the 13<sup>th</sup> Avenue stairway. The settled topsoil was removed from the sinkhole and the sinkhole was filled with 18 inch and 6 inch gabion rock. Filter fabric was placed over the rock and the excavated topsoil replaced. The bluff slope was re-vegetated with drought tolerant native coastal plantings. Without repair, the existing vertical wall may have soon failed.

At Site 2 (see Exhibits C and D), a sinkhole has formed behind an existing vertical seawall that is now susceptible to being undermined. Without placing gabion rock at the bottom of the hole and back filling the void with topsoil, the undercut section of the existing vertical seawall may fail and an even greater portion of the bluff (and public access improvements landward of this location) retained by the wall lost in a very short period of time.

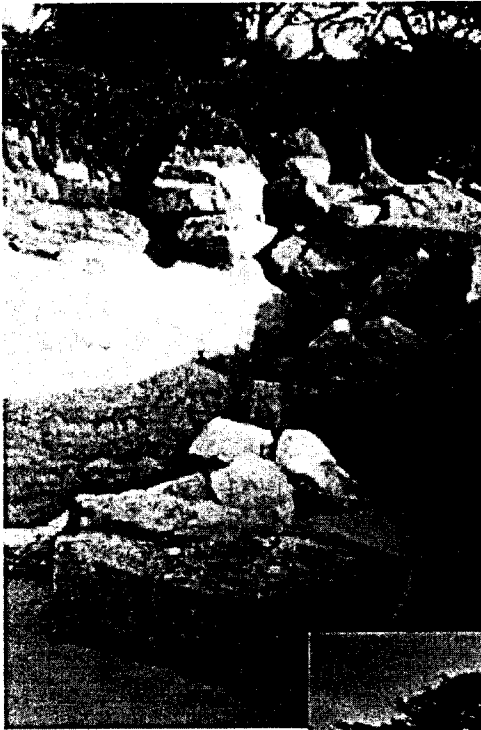
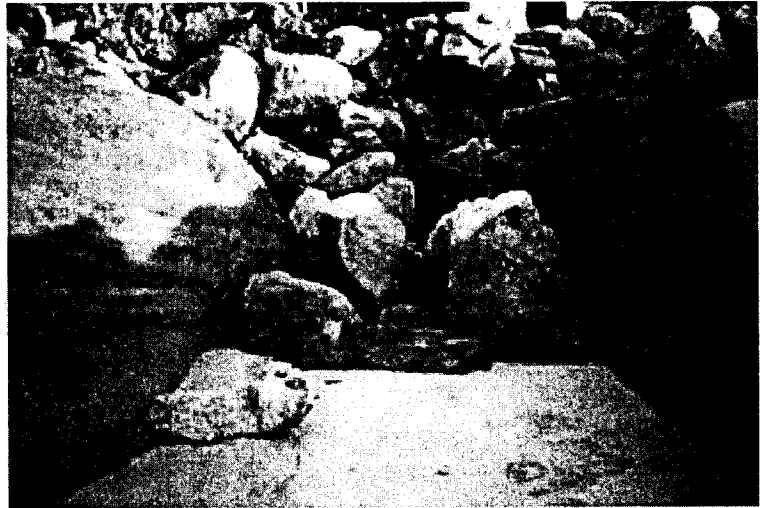
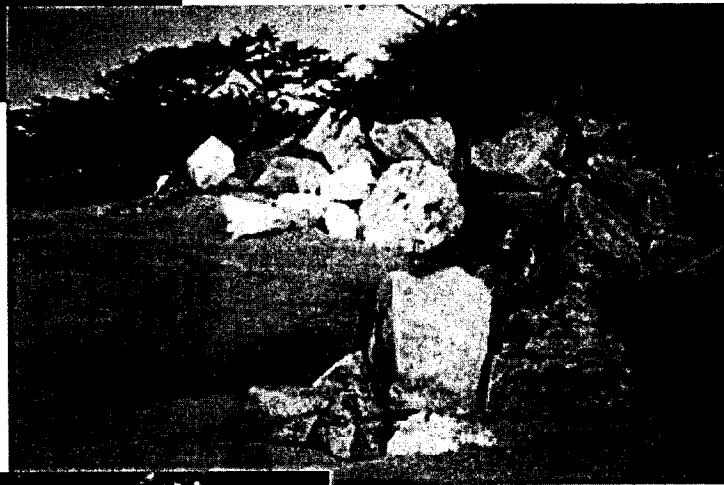
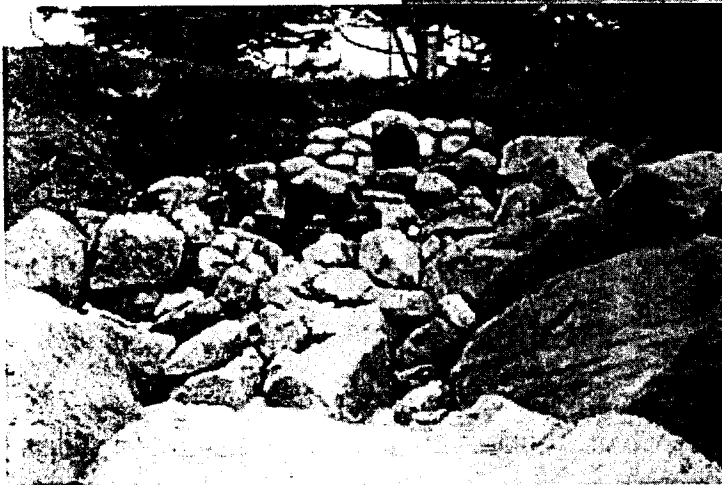
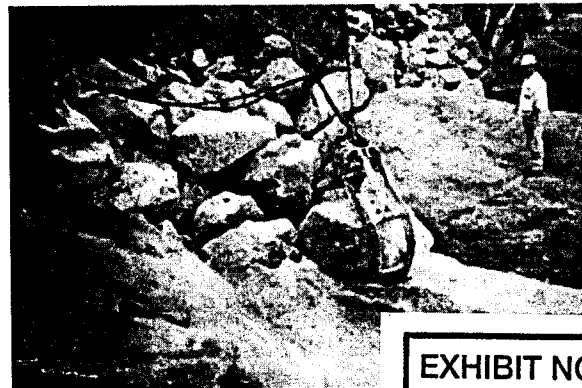
# Site 3

The existing rock revetments at Site 3 were emplaced after the natural disaster declarations and storm damages of 1983.

1. SITE 1 – Reset displaced 3 to 5 ton rip-rap and in-fill voids with 50 ton +/- of imported ¼ to ½ ton rock.
2. SITE 2 – Remove settled topsoil from sink hole behind existing seawall. Backfill with 18 inch minus and 6 inch minus gabion rock and cover with filter fabric. Replace excavated topsoil and re-vegetate from City's approved list of drought tolerant native coastal ground cover.
3. SITE 3 – Reset displaced 3 to 5 ton rip-rap and in-fill voids with 10 ton +/- of imported ¼ to ½ ton rock.

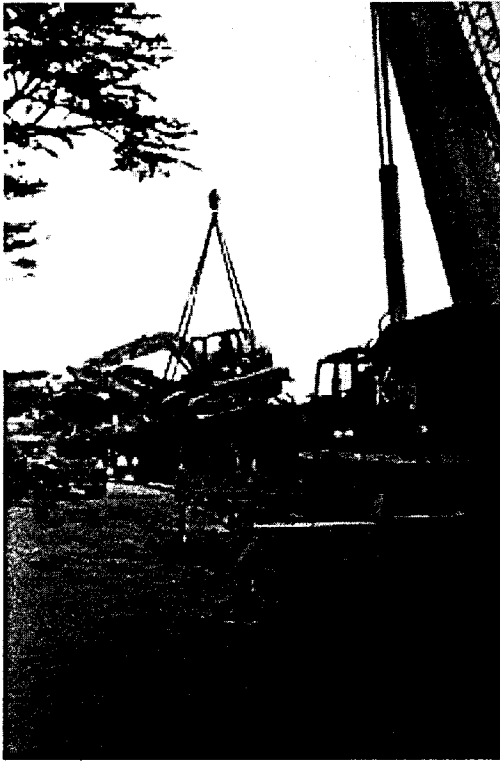
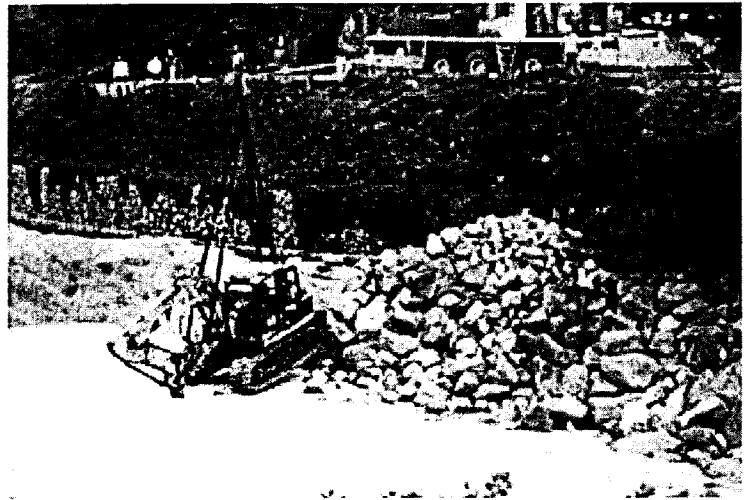
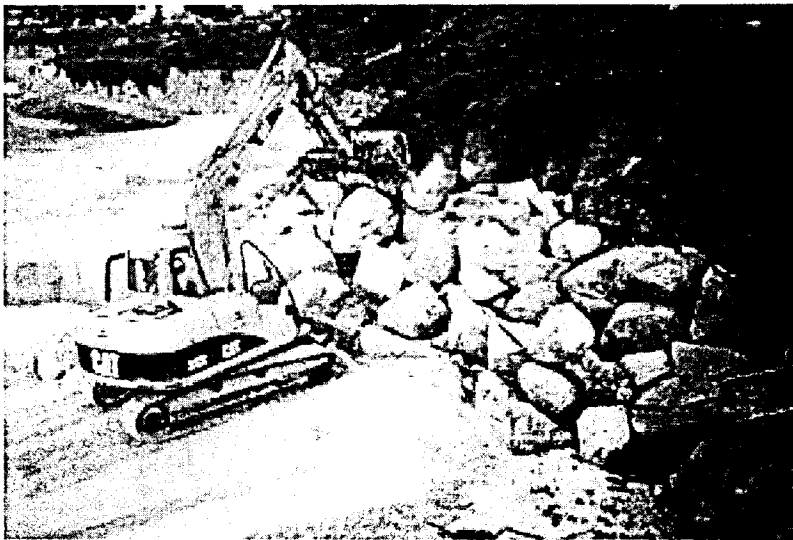
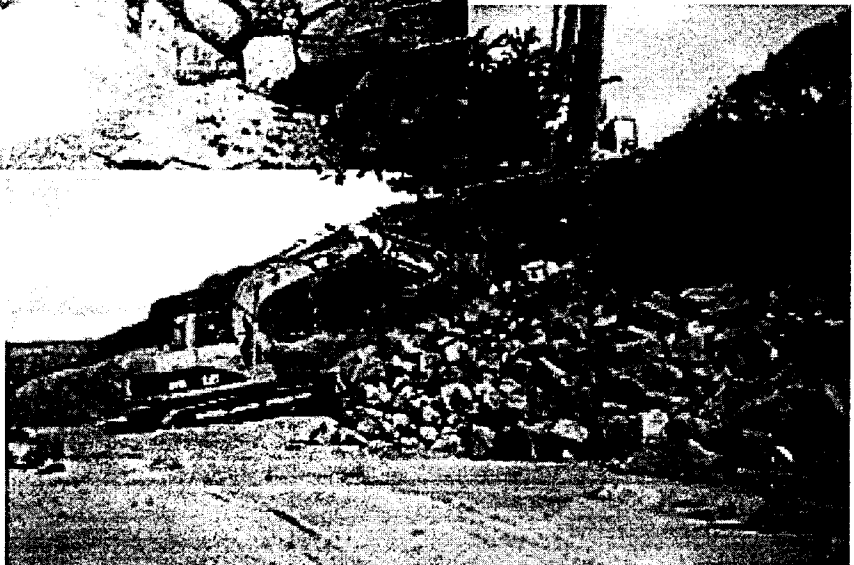
Repair and  
Maintenance  
activity

There are ongoing temporary impacts associated with repair and augmentation of the rip-rap revetment. Rip-rap is a flexible type of shoreline armoring that moves when subject to wave attack. Ultimately, as the armor stones move and migrate from their original positions, repair and maintenance is required to replace/reset the stones so that the revetment continues to function properly. The displaced armor stones must be carefully placed with a large crane or excavator; the armor stones can weigh upwards of 6 tons each. Resetting the armor stones and installation of additional rock onto the revetment can take several days. This activity precludes public access to and use of the beach, prevents use of the blufftop pedestrian path, and eliminates public beach parking in the area of the repair work when the crane is in operation. These repair activities also present visual and noise disturbances in an area that is otherwise relatively serene.
