CLAIM OF VESTED RIGHTS
STAFF REPORT AND RECOMMENDATION

CLAIM NO: 3-04-20-VRC

PROJECT LOCATION: Beach and base of coastal bluff seaward of residence at 4440 Opal Cliff Drive in the Opal Cliffs region of the unincorporated Live Oak area of Santa Cruz County (Assessor's Parcel Number 033-151-08).

DEVELOPMENT CLAIMED: Concrete shoreline protective device (seawall) at base of bluff.

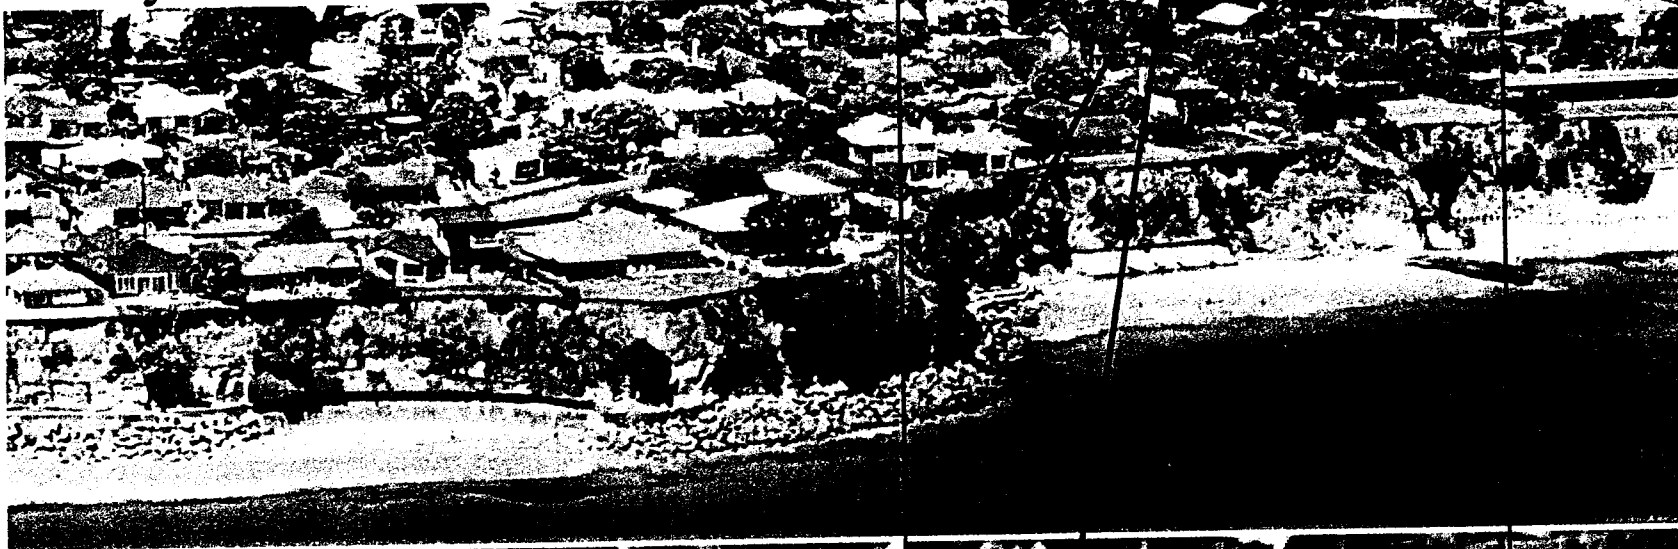
Figure 1. Comparison of December 1972 and July 2002 Aerial Obliques

July 2002

Nov/Dec
1972

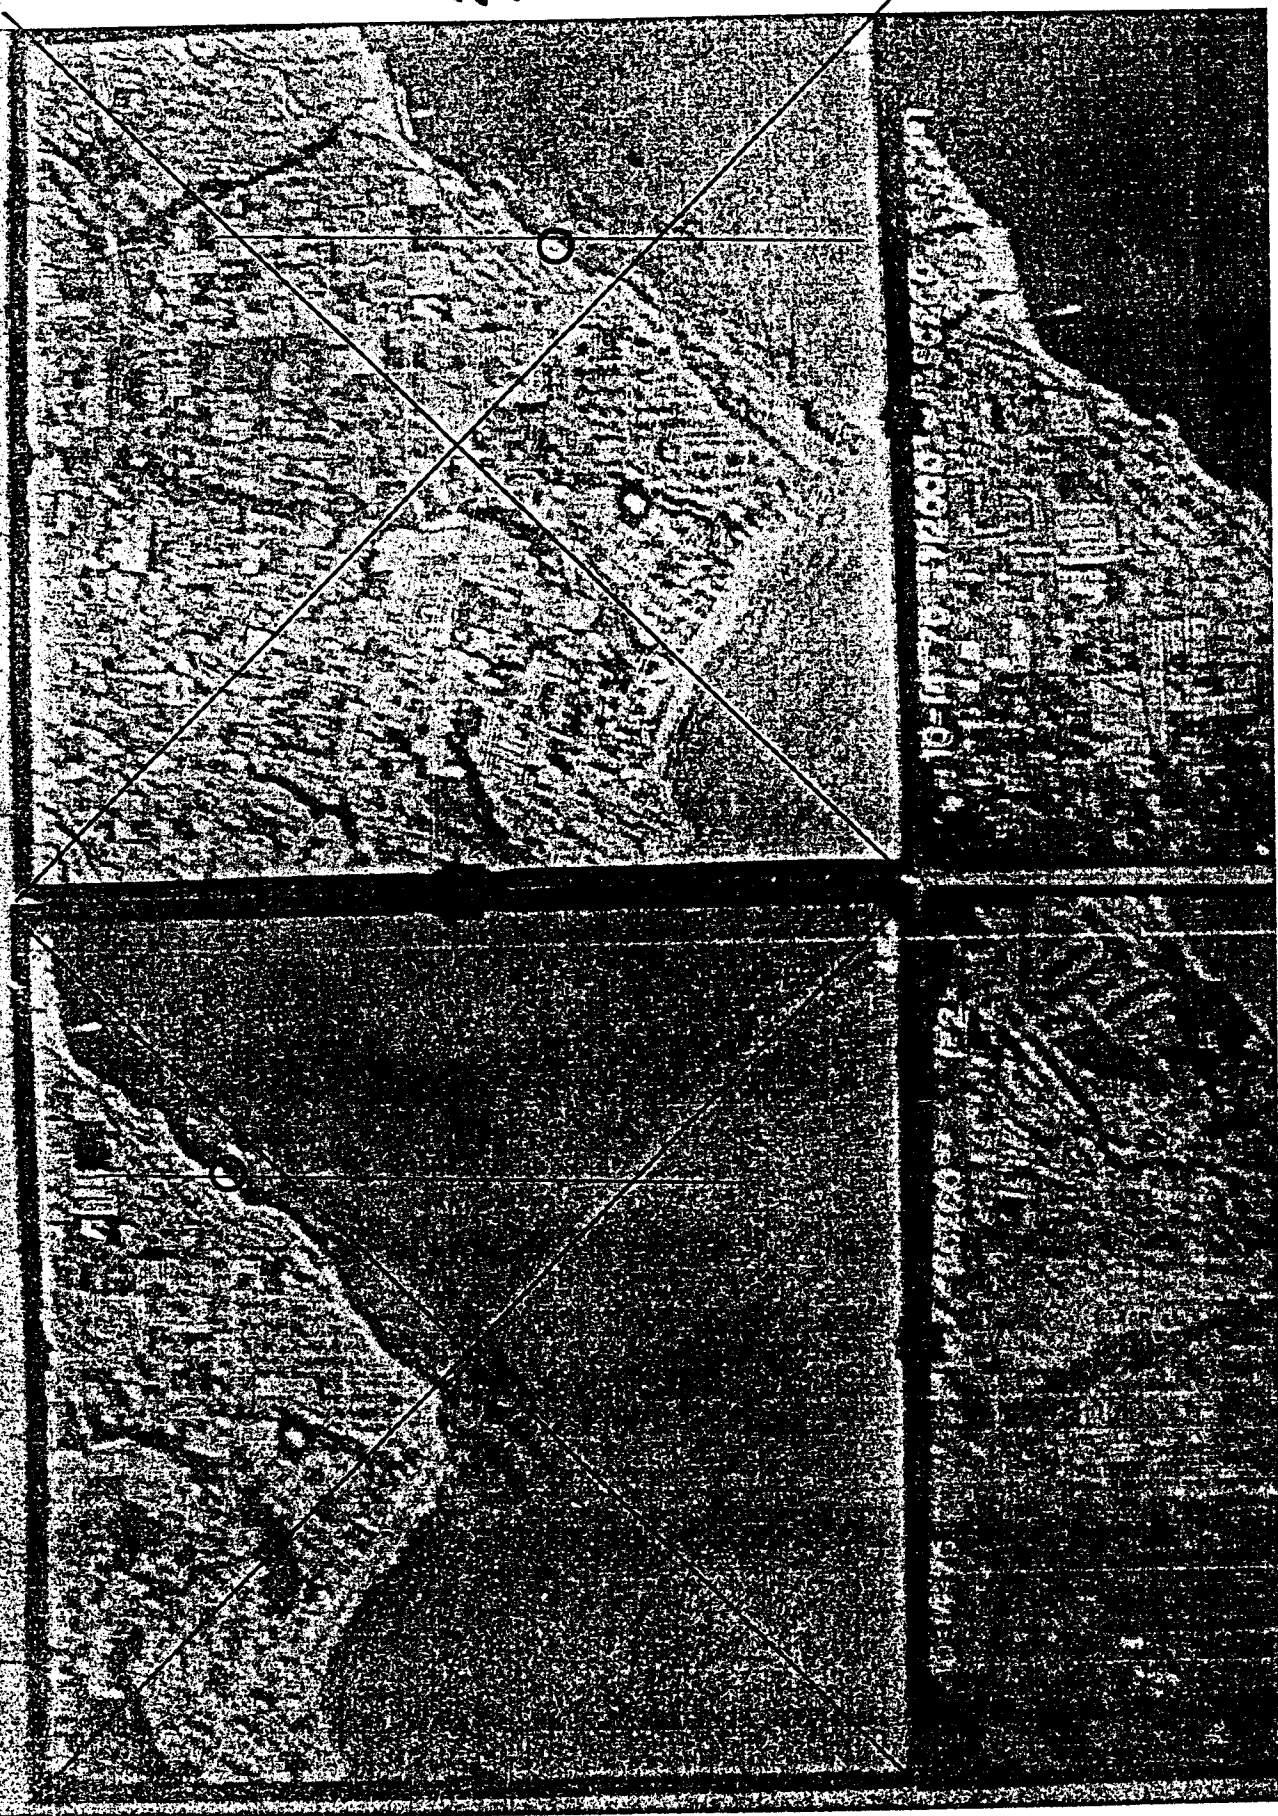
Appendix AG

1975 Aerial Photos (Stereo pair) - f14 line Analyses

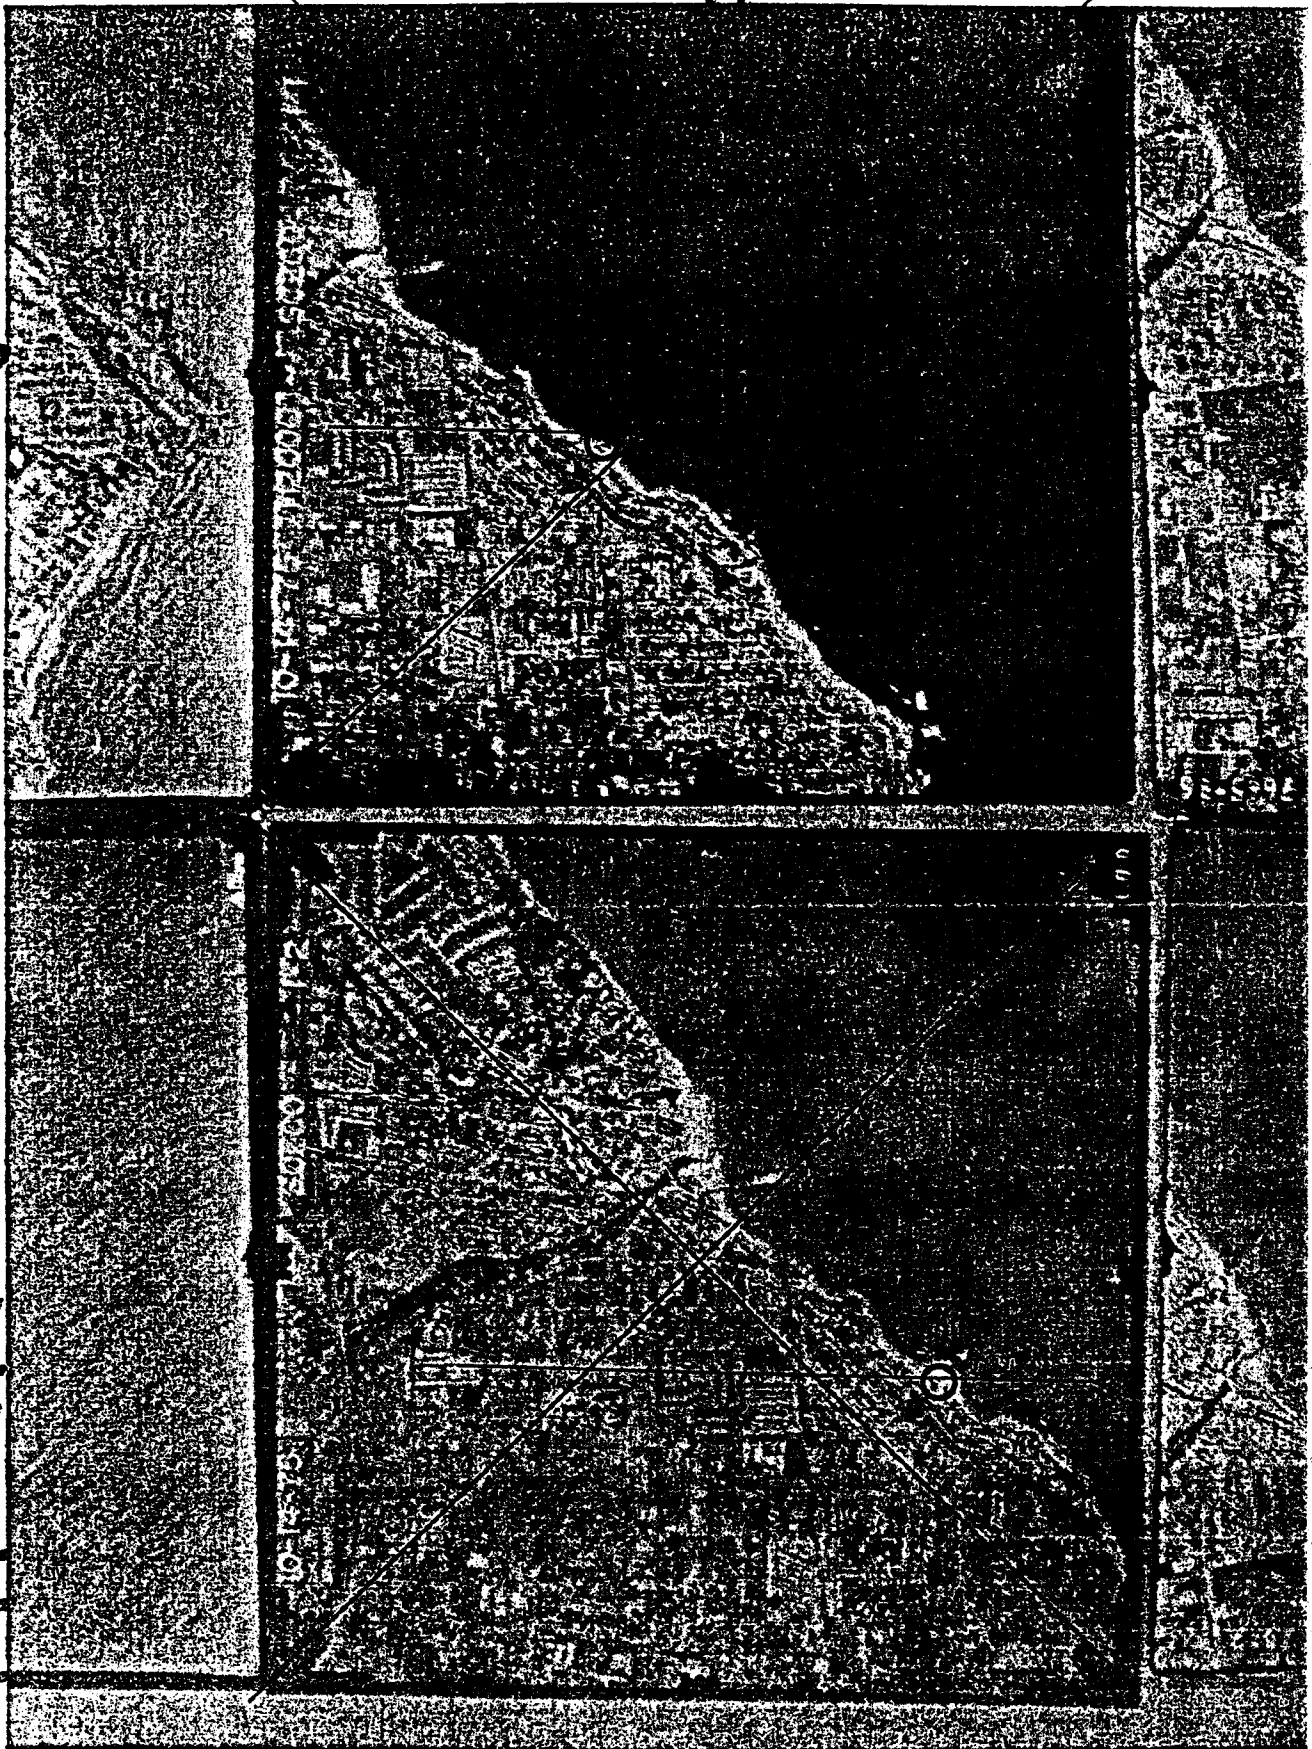
Appendix HG

975 Aerial Photos
(Stereo pair)
Fit line Analysis
