**STAFF REPORT: REGULAR CALENDAR**

**APPLICATION NO.:** 1-03-024

**APPLICANT:** Table Bluff Reservation – Wiyot Tribe

**PROJECT DESCRIPTION:** Place 391 cubic yards of revetment materials along a 400-foot-long segment of the bay shoreline of Indian Island to stabilize and protect the Tuluwat Village Shell Mound Place from further shoreline erosion and help preserve the remaining Tribal artifacts and cultural resources at the site.

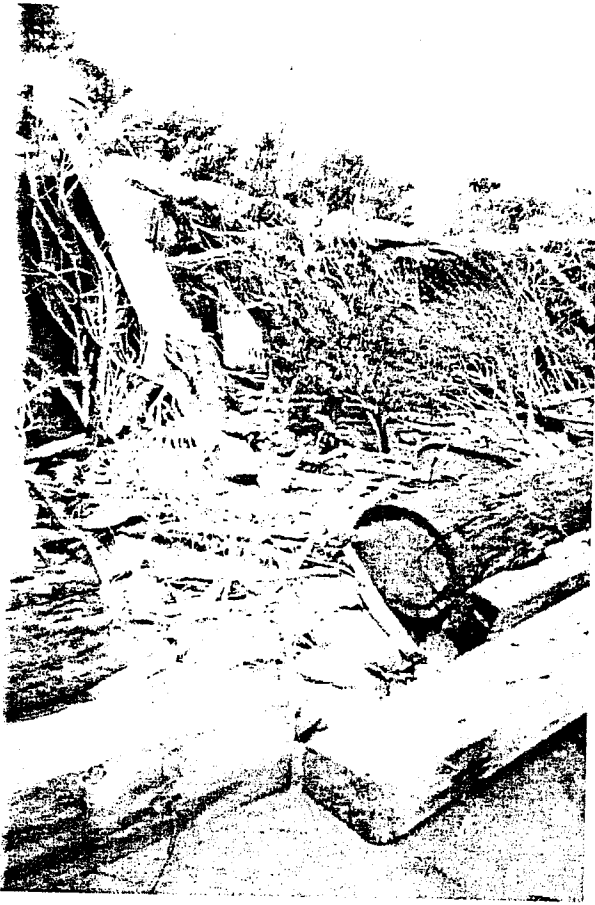
Figure 5. Initial Erosion Control Measures (November 1999).

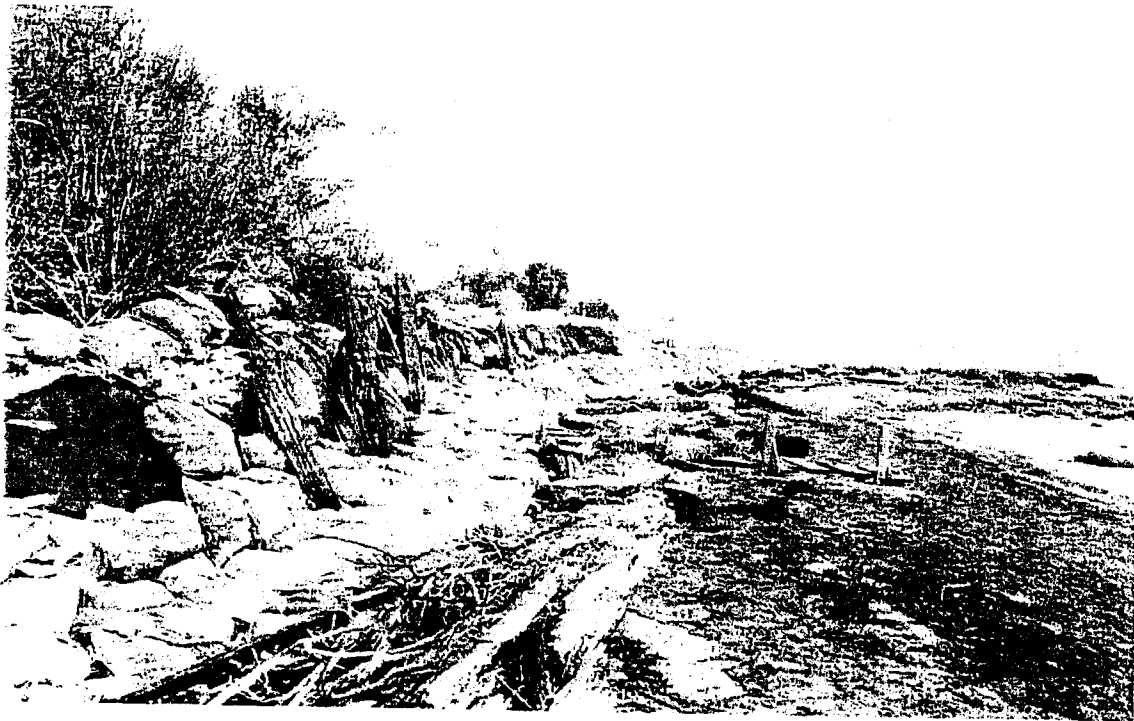
Figure 6. Erosion Control Measures After First Repair (February 2002).

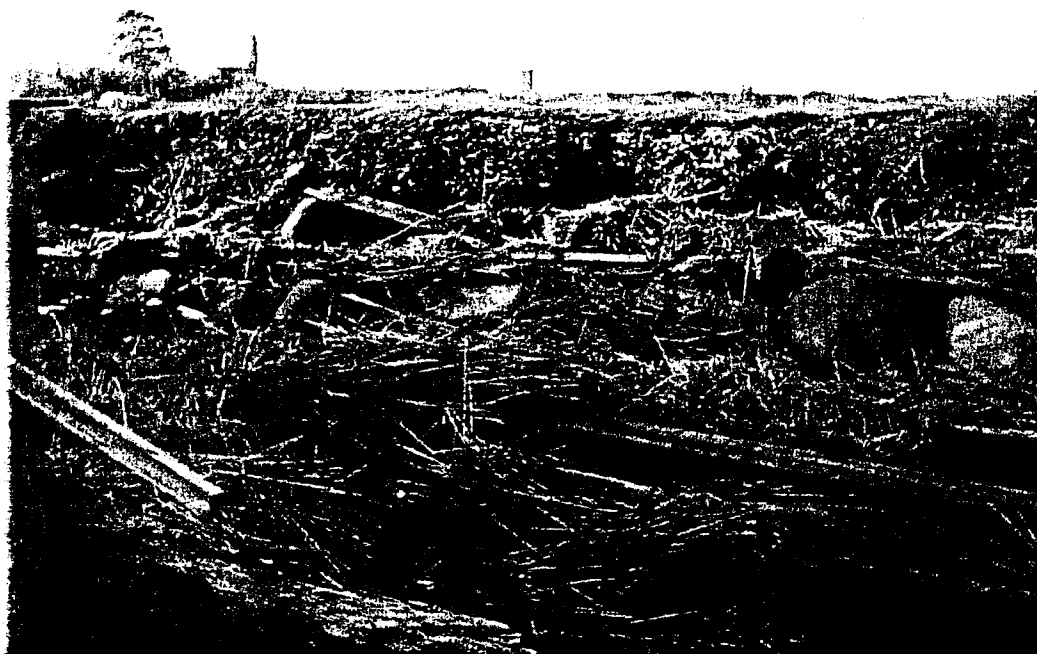
Figure 3. Exposed Midden After Winter Storms and High Tides (November 2003).

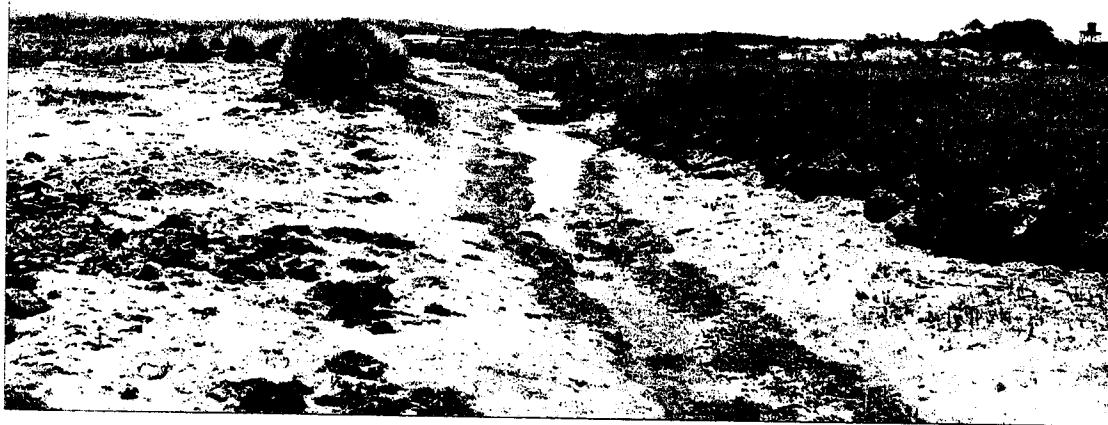
Figure 3 — Drainage canal and dike remnants on northeastern tip of island (photo by Mark Rudo).

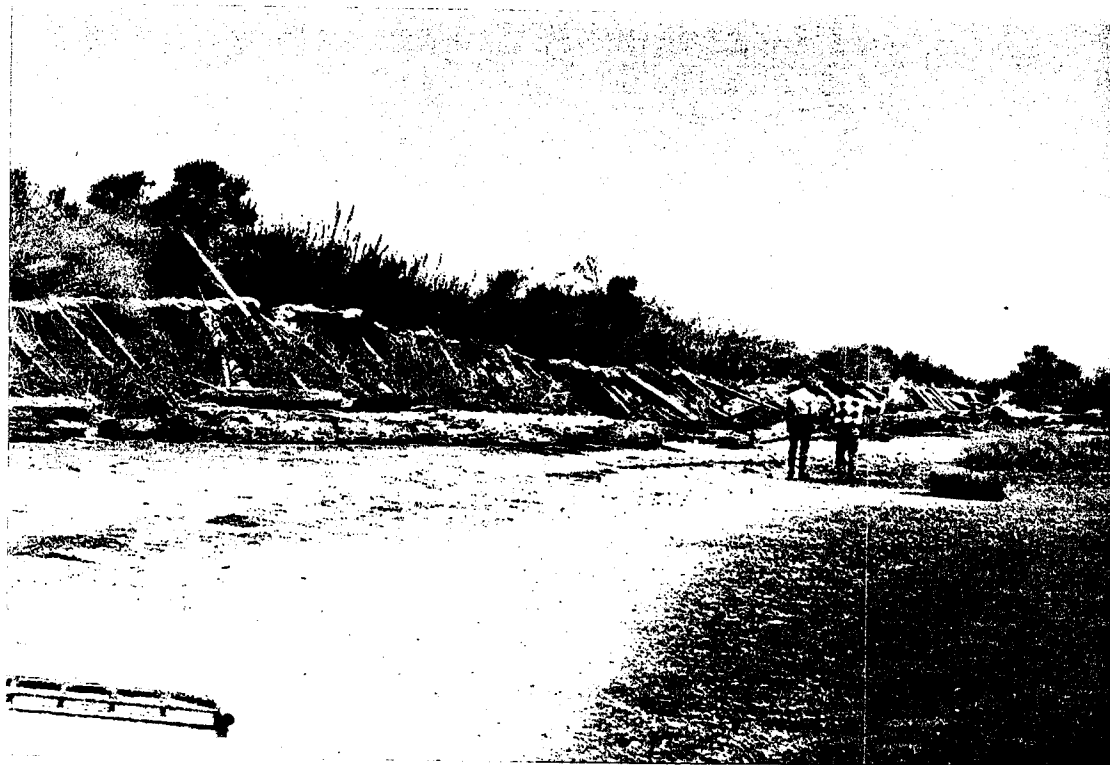
Figure 4 — Beach zone along base of cultural deposit at CA-Hum-67 (photo by Mark Rudo).

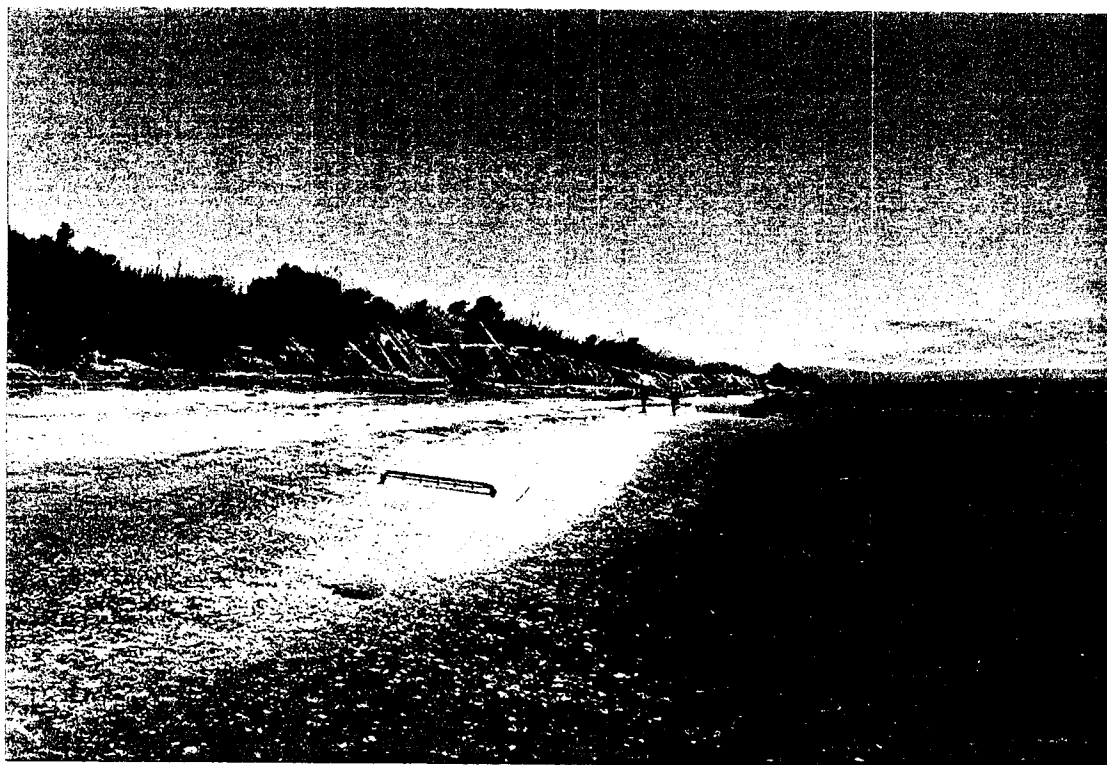
*Figure 5: Beach zone width at maximum low tide at CA-Hum-67 (photo by Mark Rudo).*
