CALIFORNIA COASTAL COMMISSION

STAFF REPORT: REGULAR CALENDAR

APPLICATION NUMBER: 5-04-324

PROJECT LOCATION: 437 Paseo de la Playa, City of Torrance (Los Angeles County)

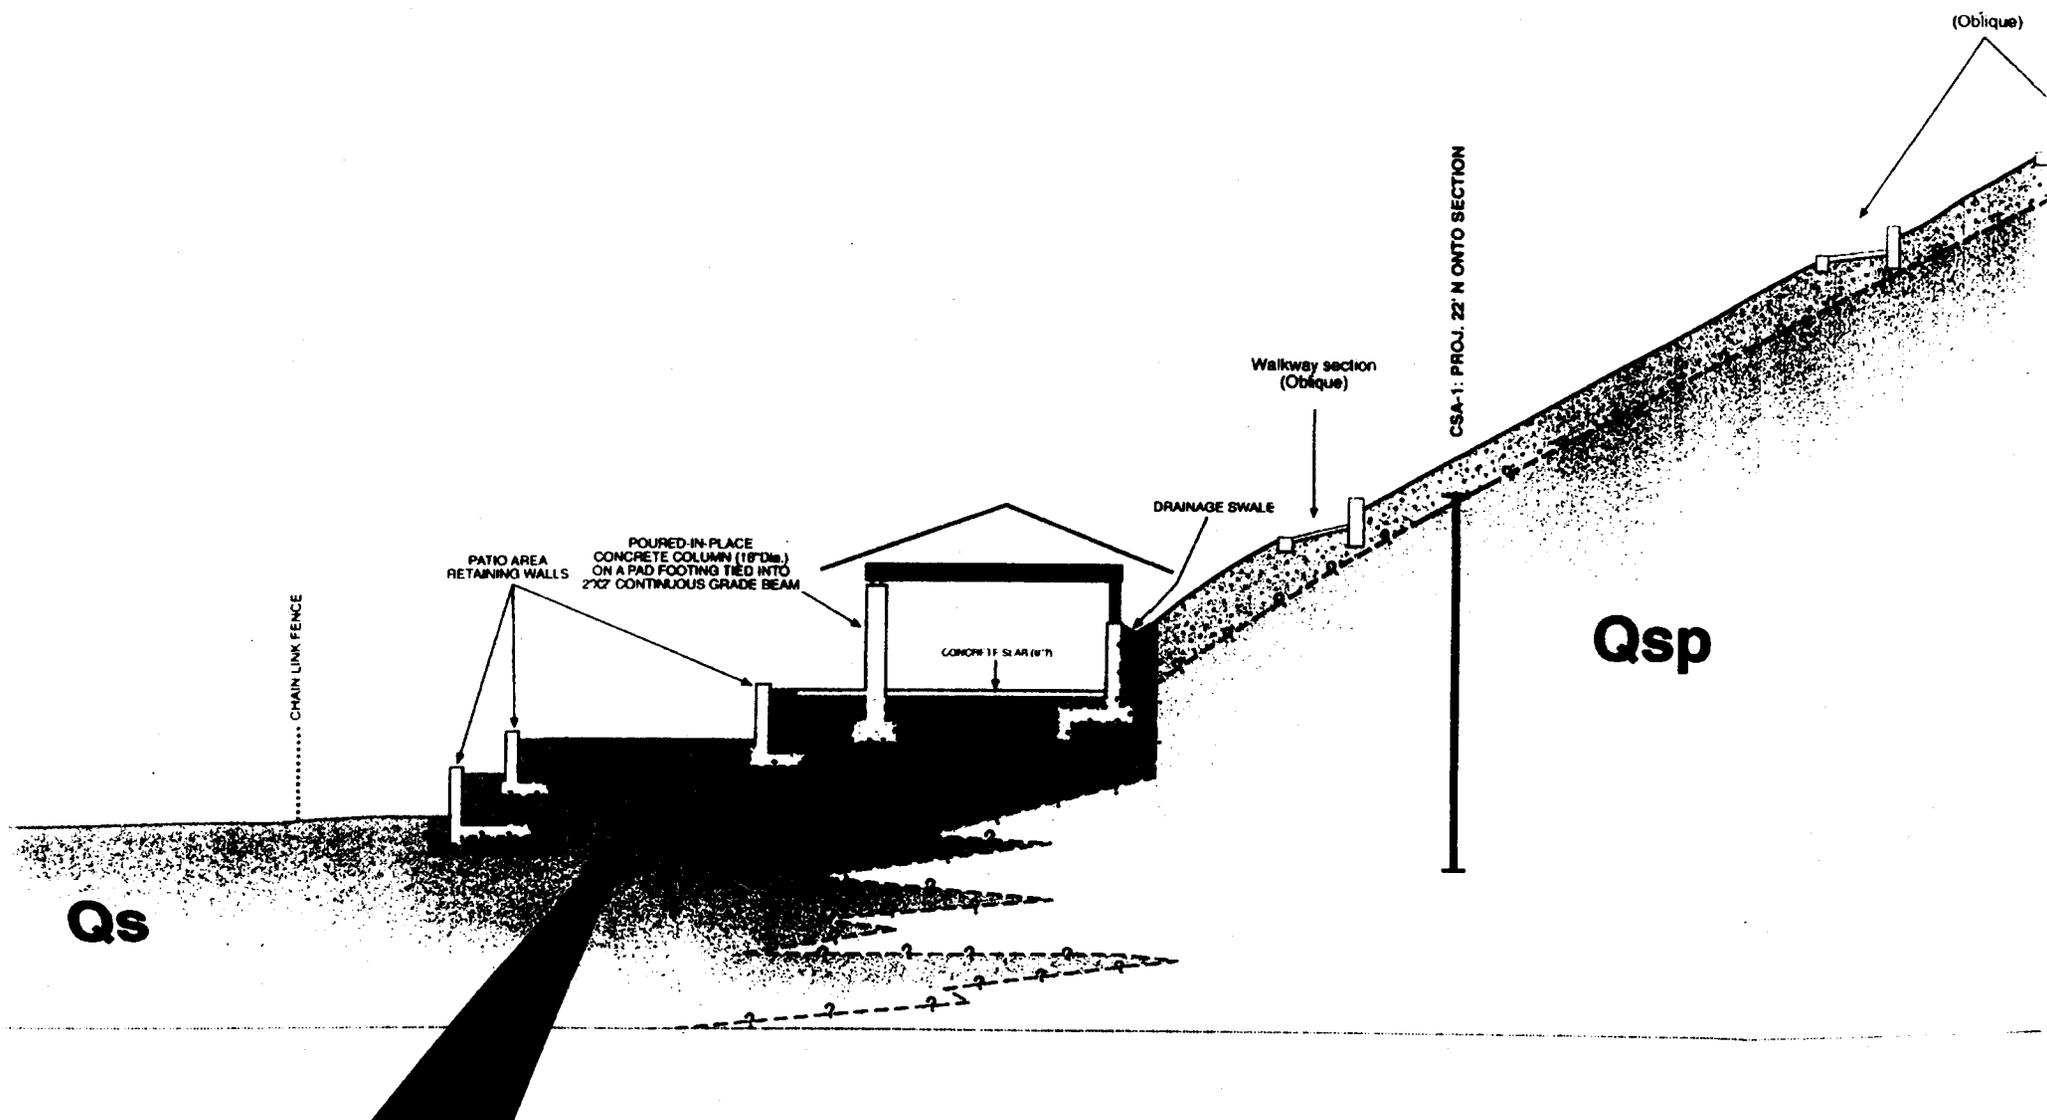
COASTAL COMMISSION
 504.324
 EXHIBIT # 6
 PAGE 1 OF 2
 Section

NOTE: LIMITS OF EXCAVATION FOR CABANA AND PATIO CONSTRUCTION AND FOOTING LIMITS (WHERE DASHED) ARE NOT CONFIRMED. LIMITS SHOWN ARE BASED ON DISCUSSIONS WITH CONTRACTOR ONLY.

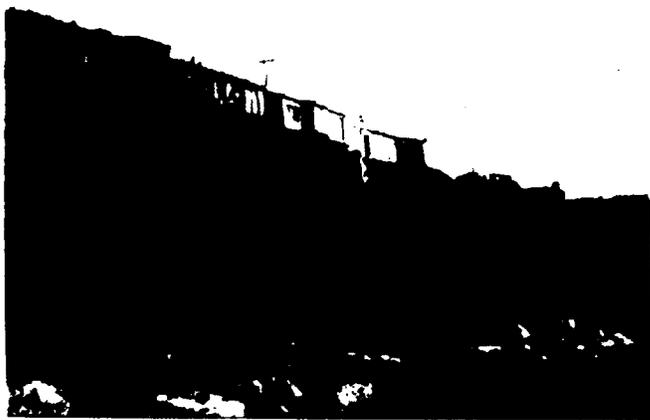
Figure 2. Rapid retreat of this sea cliff in Pacifica, California, caused damage to these houses, which later were declared unsafe and demolished. Compare with the cover photo of the same area, taken about 2-1/2 months previously, before the arrival of the 1997-98 El Niño storms.

has caused damage to structures in many of these places (fig. 2). A common problem along mountain-backed coastal cliffs, which typically are sparsely developed, is damage to or loss of coastal roadways as the coastal cliff retreats (fig. 3).
