**RECORD PACKET COPY****W 8b****STAFF REPORT AND RECOMMENDATION****ON CONSISTENCY CERTIFICATION**Consistency Certification No. **CC-072-05**Staff: **MPD-SF**File Date: **6/2/2005**3 Months: **9/2/2005**6 Months: **12/2/2005**Commission Meeting: **9/14/2005****APPLICANT:** North County Transit District**DEVELOPMENT
LOCATION:**

Emergency repairs, Pier 5, Bridge 208.6, San Onofre Creek
(Exhibits 3-8)

NCTD Bridge 208.6 Emergency Repair

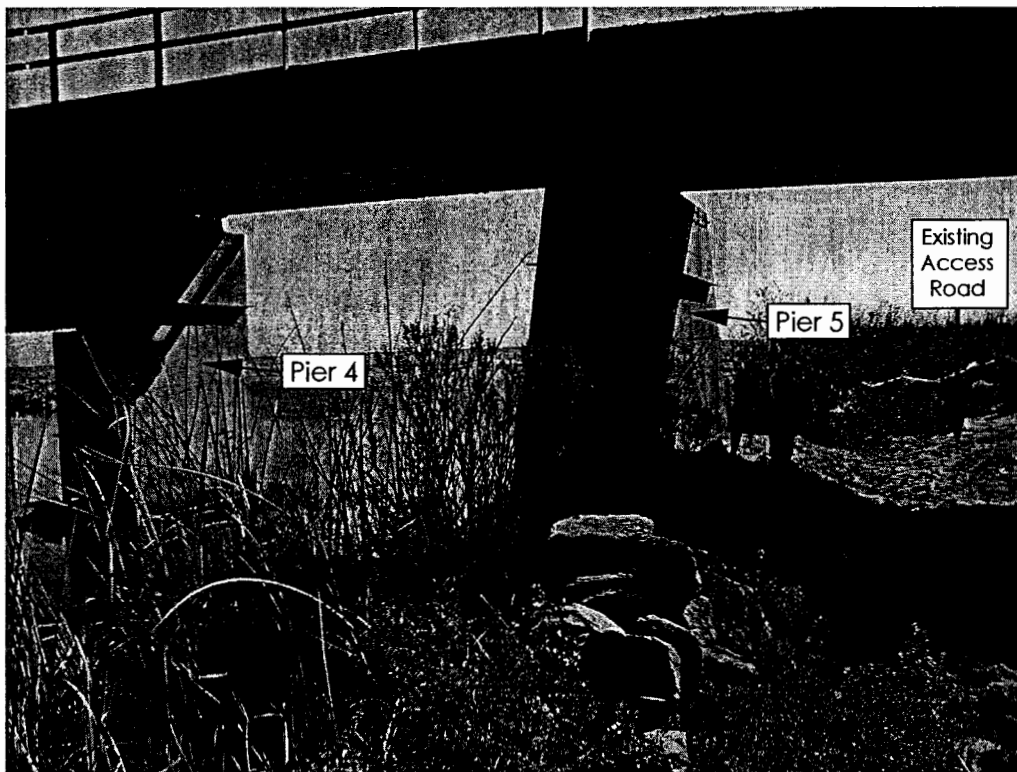
Pre-Repair Site Photographs

Looking West

Figure 5 depicts views of Railroad Bridge 208.6 looking east and west before repair activities. Specifically, the photos depict Piers 4 and 5 and the surrounding area. As described above in Section 2, the emergency repair work was focused on repairing the concrete footing of Pier 5.

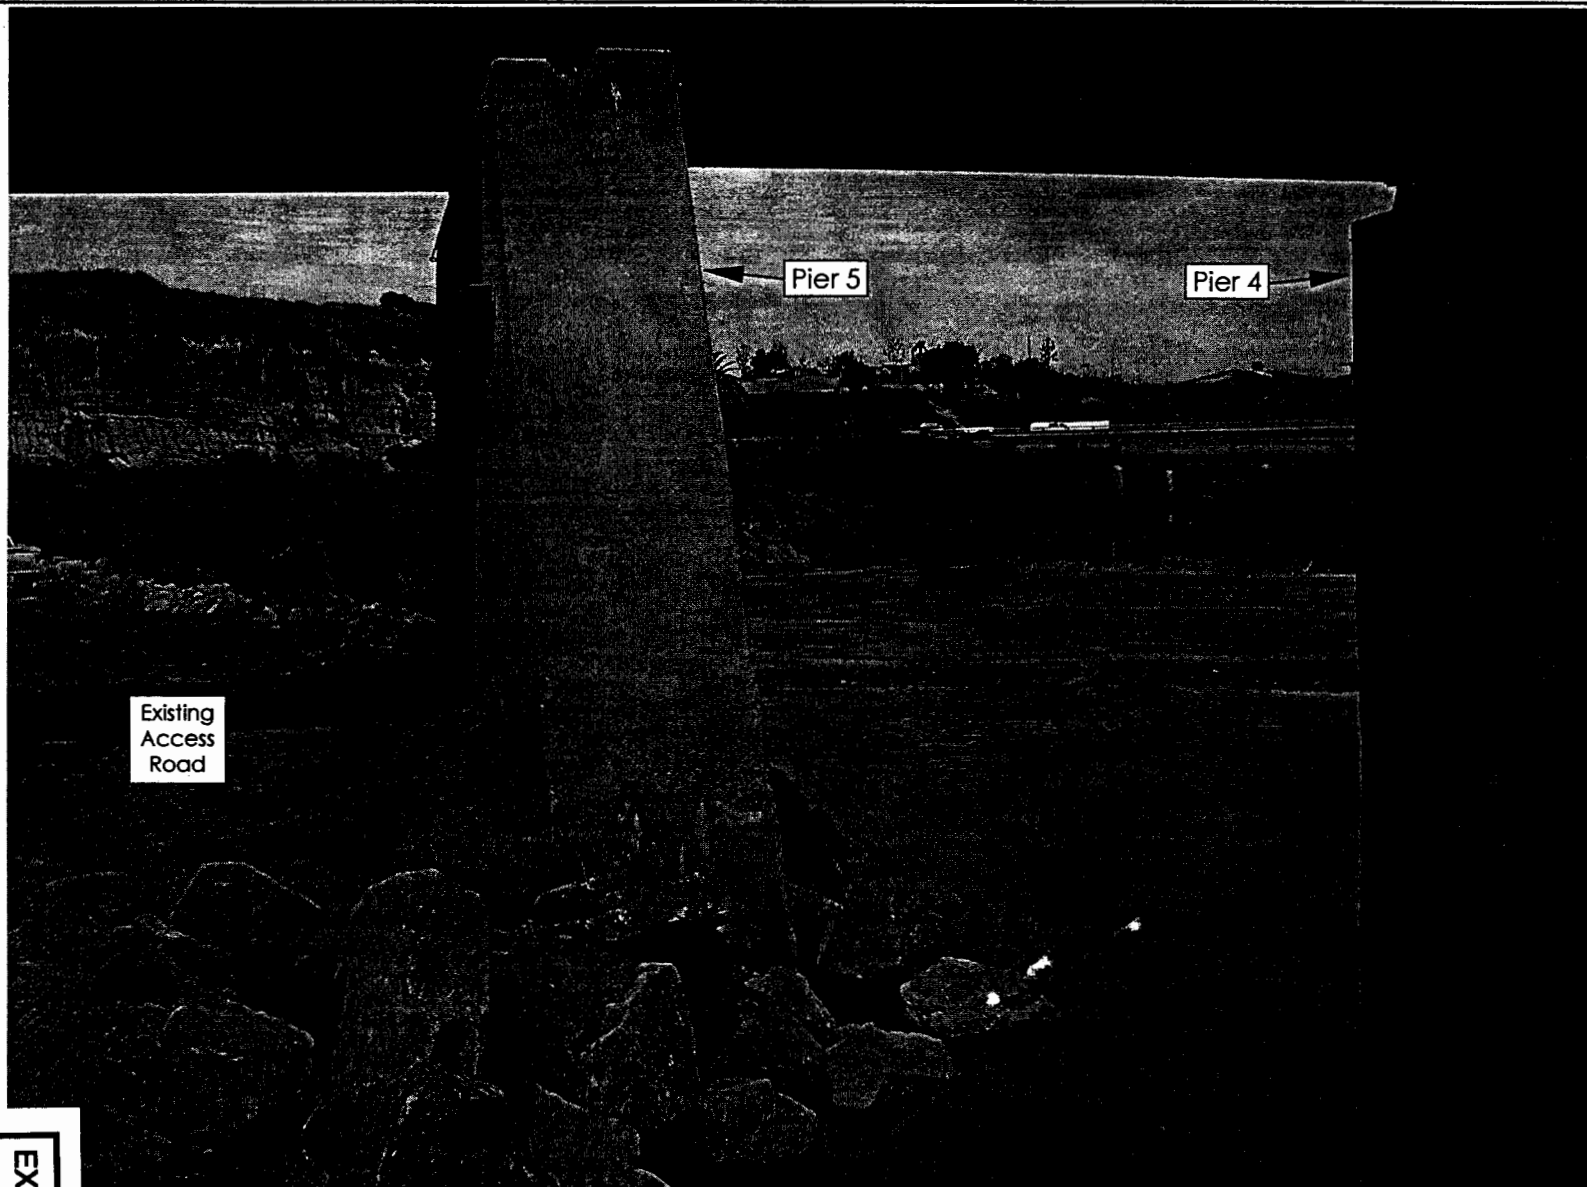
Post-Repair Site Photograph - East View of Pier 5

Figures 6a, 6b, and 6c depict the post-repair photographs of Pier 5 and the surrounding area. Temporary repair impacts to non-wetland waters of the U.S involved the following:

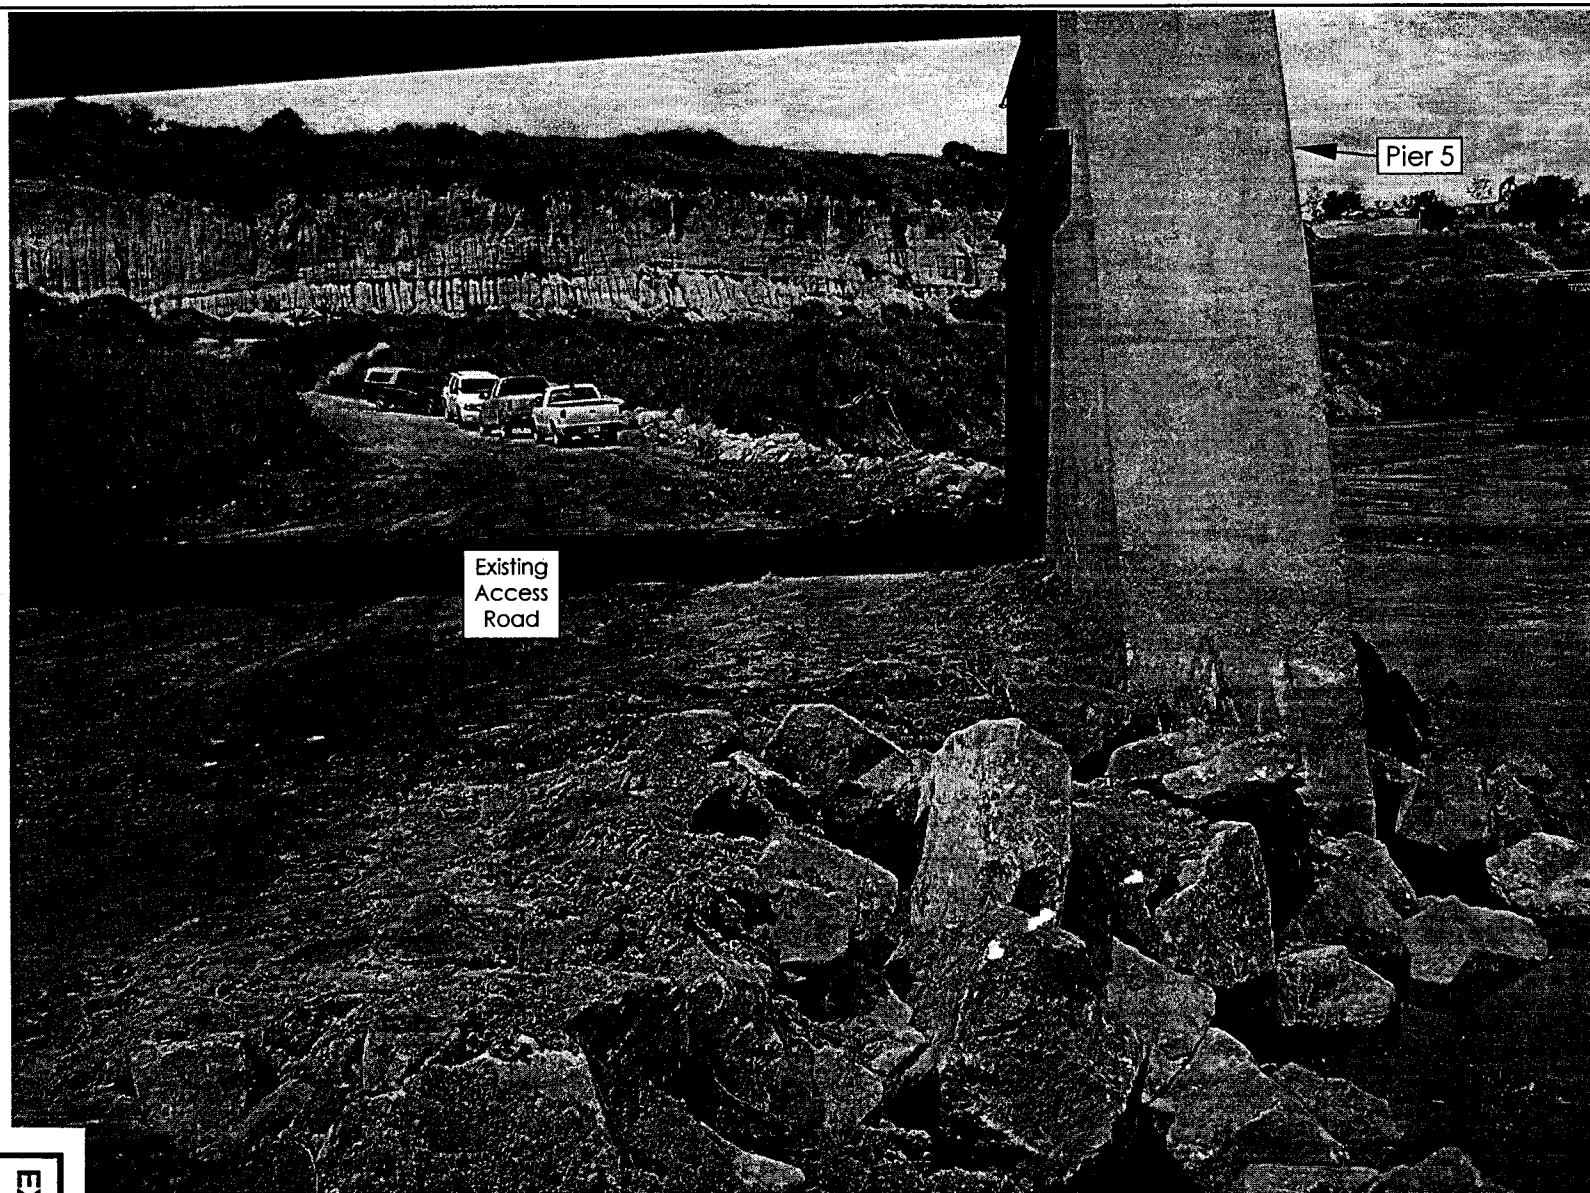
Post-Repair Site Photograph - East View of Access Road

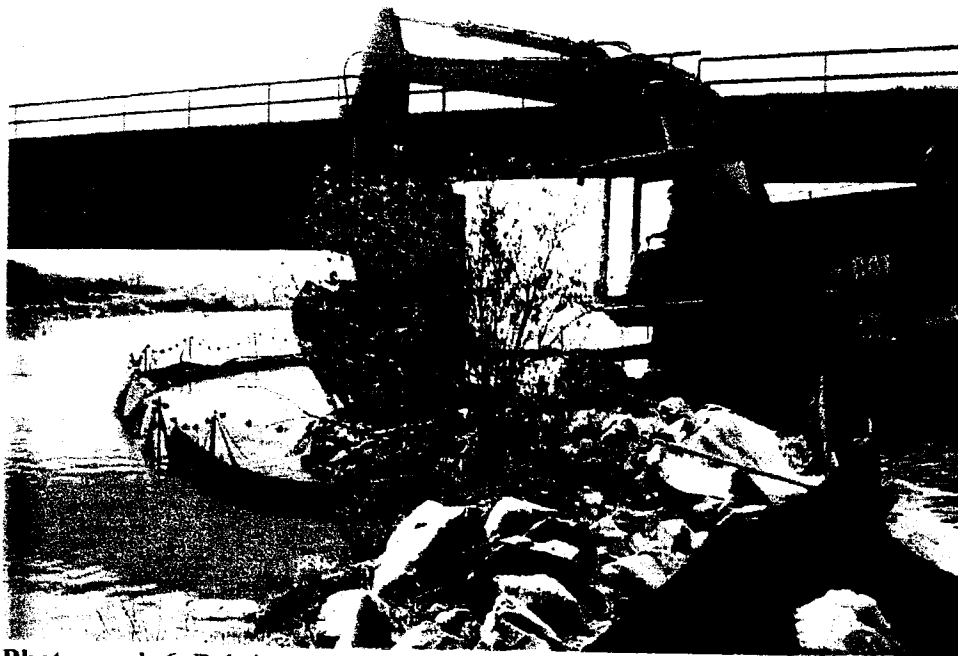
Photograph 6. Debris removal (30 March 2005)

Once the pads were built up, woody debris was removed from around the bridge piers. Work then concentrated on excavating around the inside bridge pier. The road was dug 6 feet down and two of the three concrete form steel plates were placed on the roadside of the pier. No fish or amphibians were observed inside the project area.

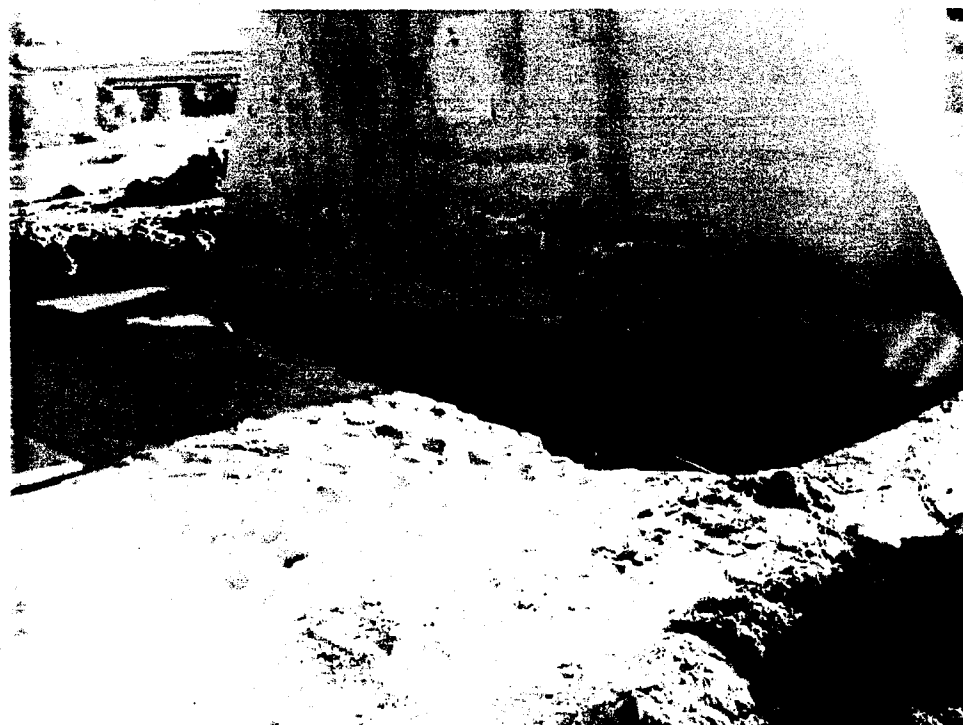
Photograph 8. Excavated area on roadside of bridge pier (31 March 2005)

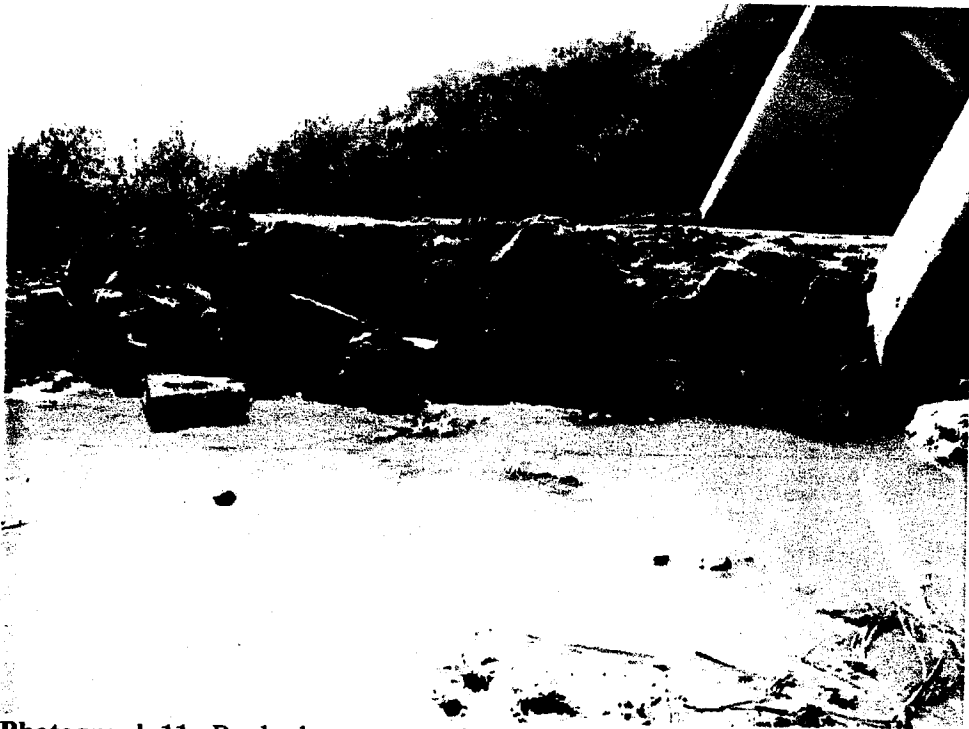
Photograph 11. Rock placement on downstream side of bridge pier (6 April 2005)

The project area was observed for fish or amphibians in the morning. None were observed. The excavator continued placing the quarry rock on the waterside of the pier and the upstream streambank. The upstream berm was removed, and no further

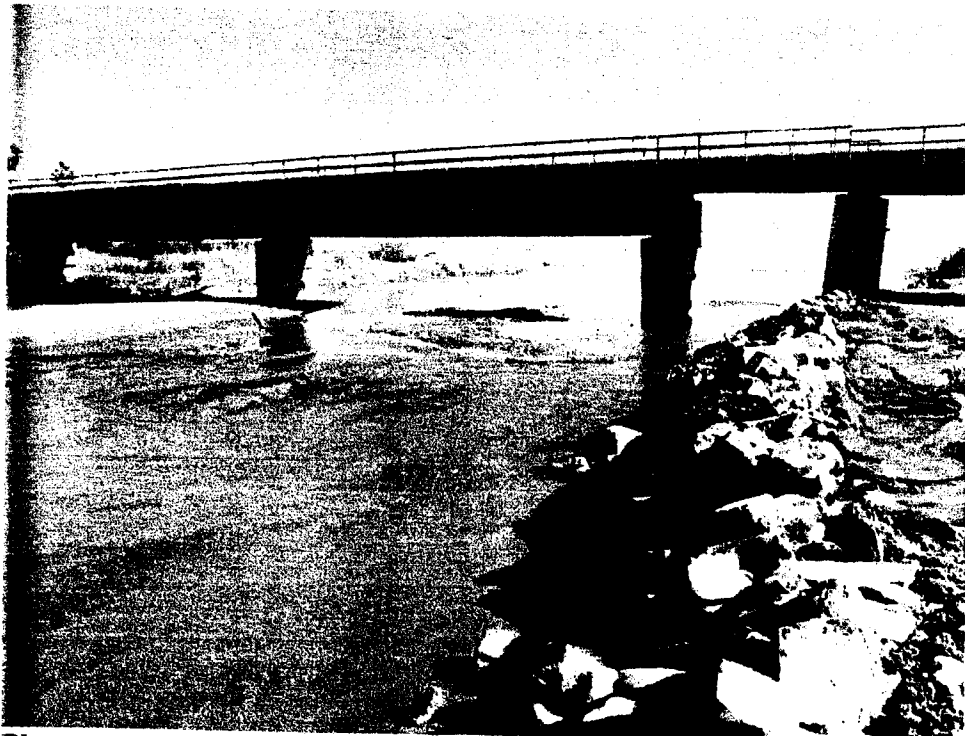
Photograph 12. Post-construction downstream view towards lagoon (6 April 2005)

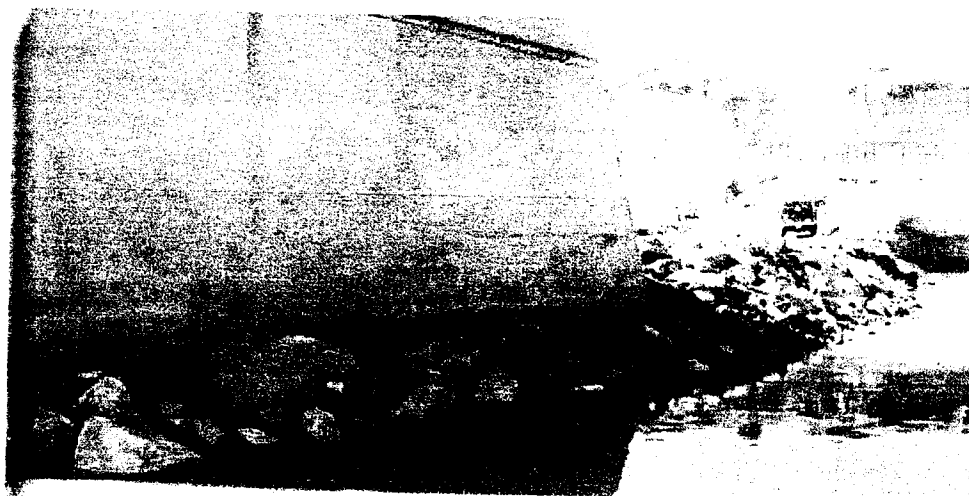
Photograph 14. Post-construction upstream view between the bridge piers and newly placed rock (6 April 2005)
