RE: Huntington Beach/Parkside Estates Local Coastal Plan Amendment 1-06  
Comments on June 29, 2007 Staff Report and Addenda

Ms. Meg Vaughn  
California Coastal Commission  
LCPA 1-06 Staff Report Comment Letter

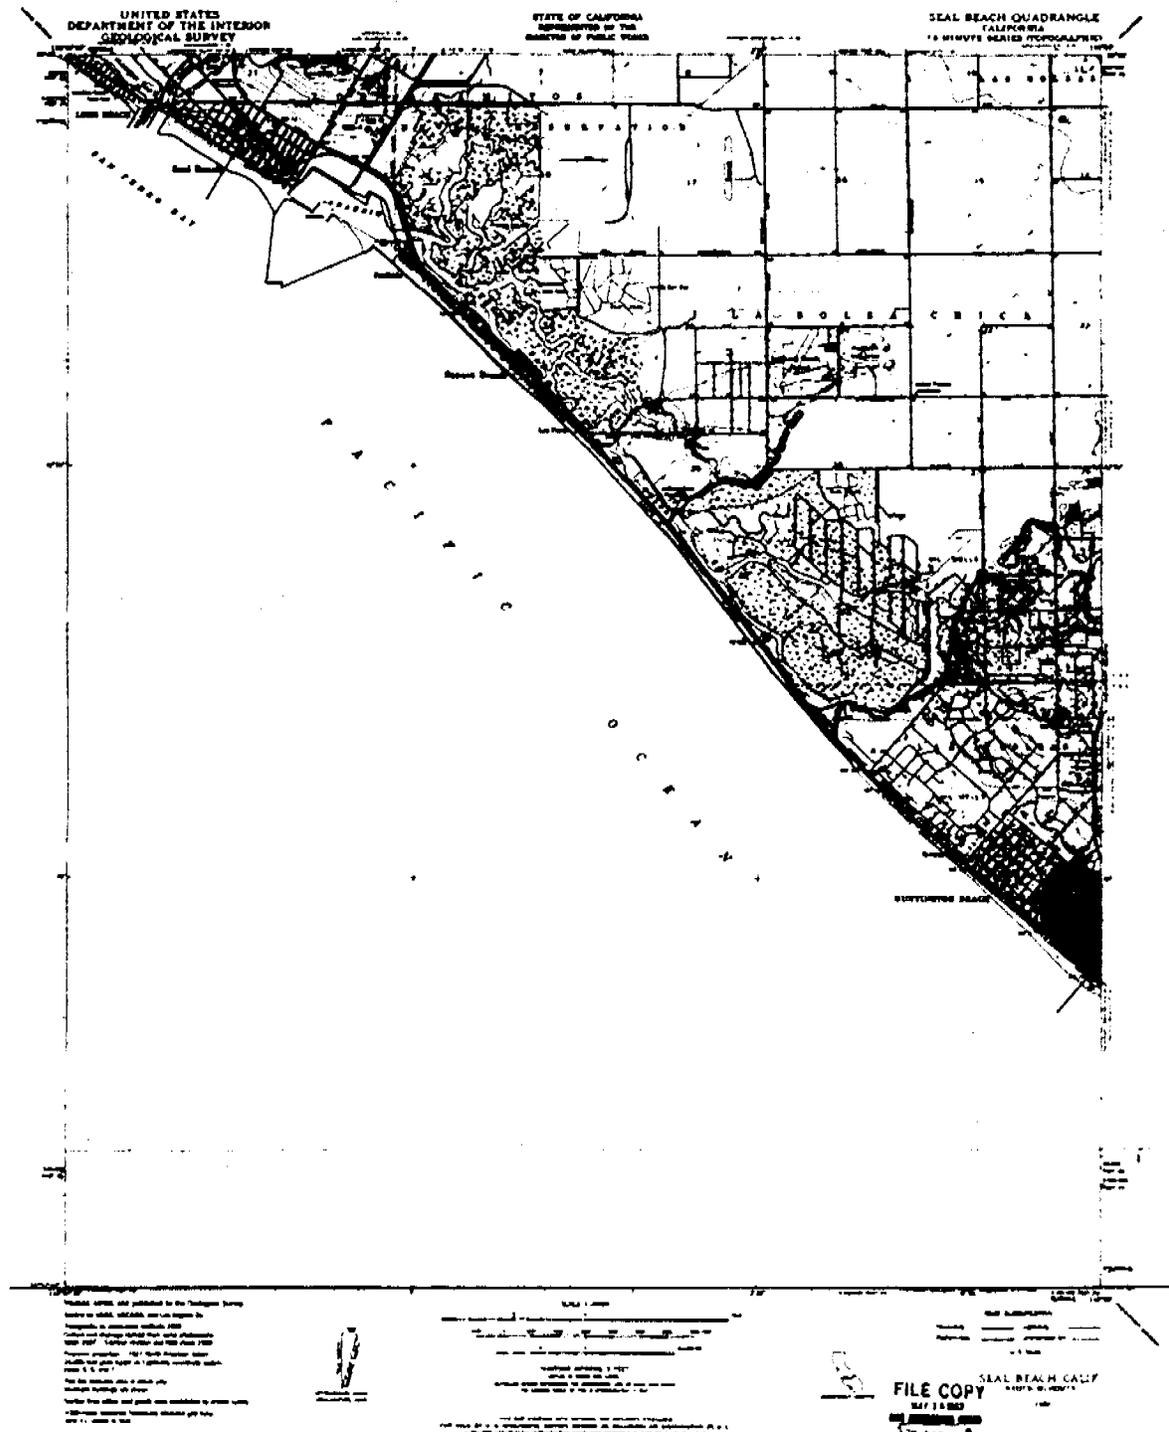
Figure 4. USGS Quad Sheet, 1949. NGVD 29 Datum.

Also, we noted that the illustrations accompanying our letter of September 21 that figures 4, 5 and 6 were presented out of order. We apologize for this error.

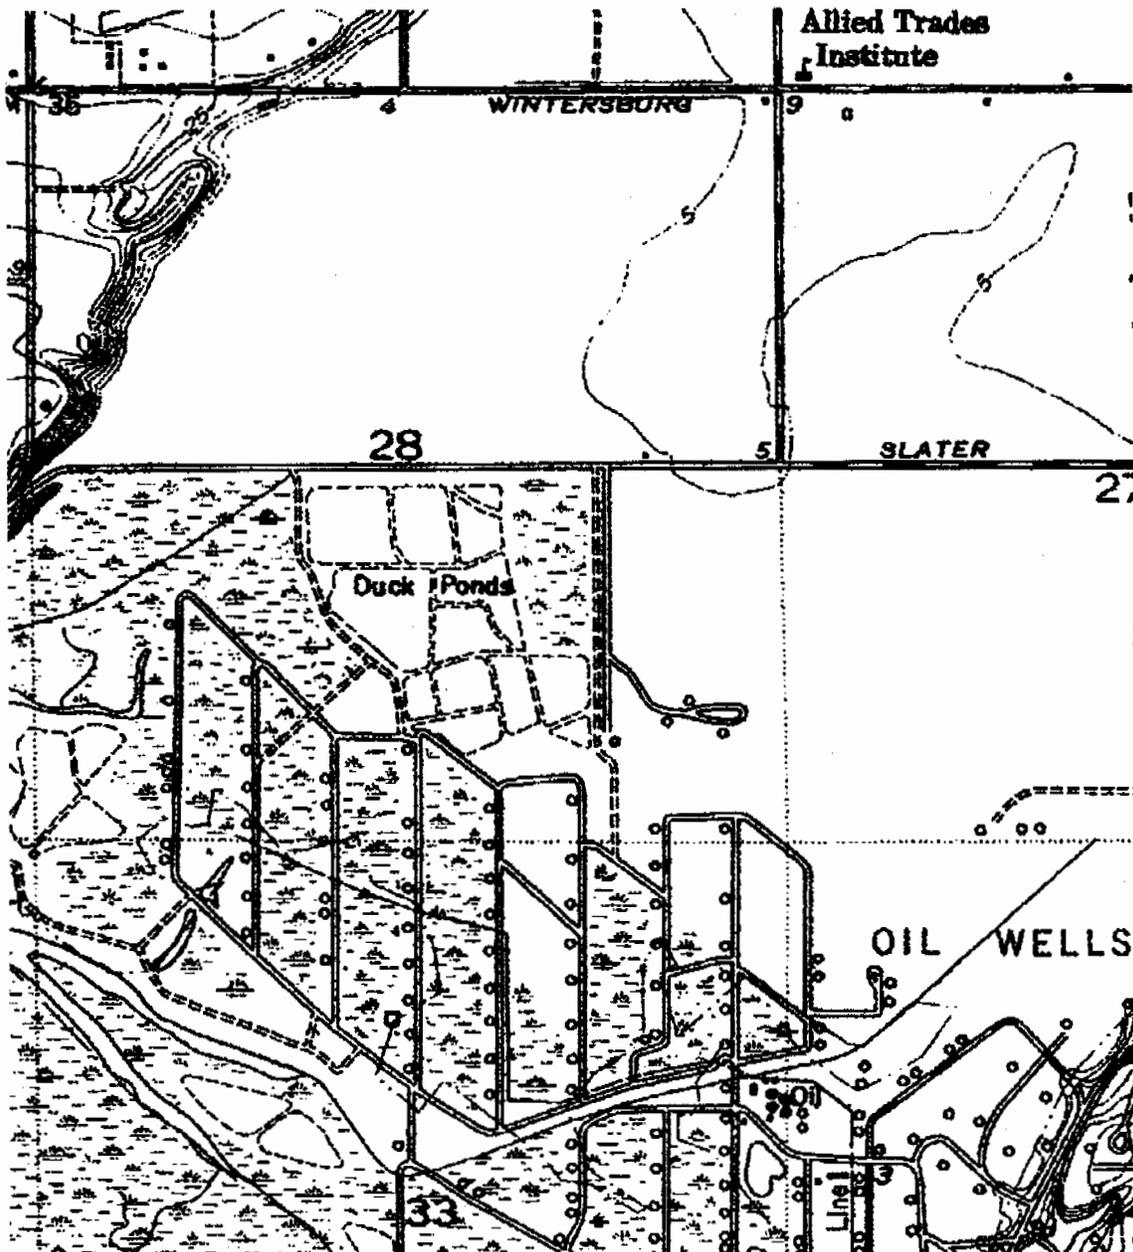
Figure 5. Detail, USGS Quad Sheet, 1949. NGVD 29 Datum.

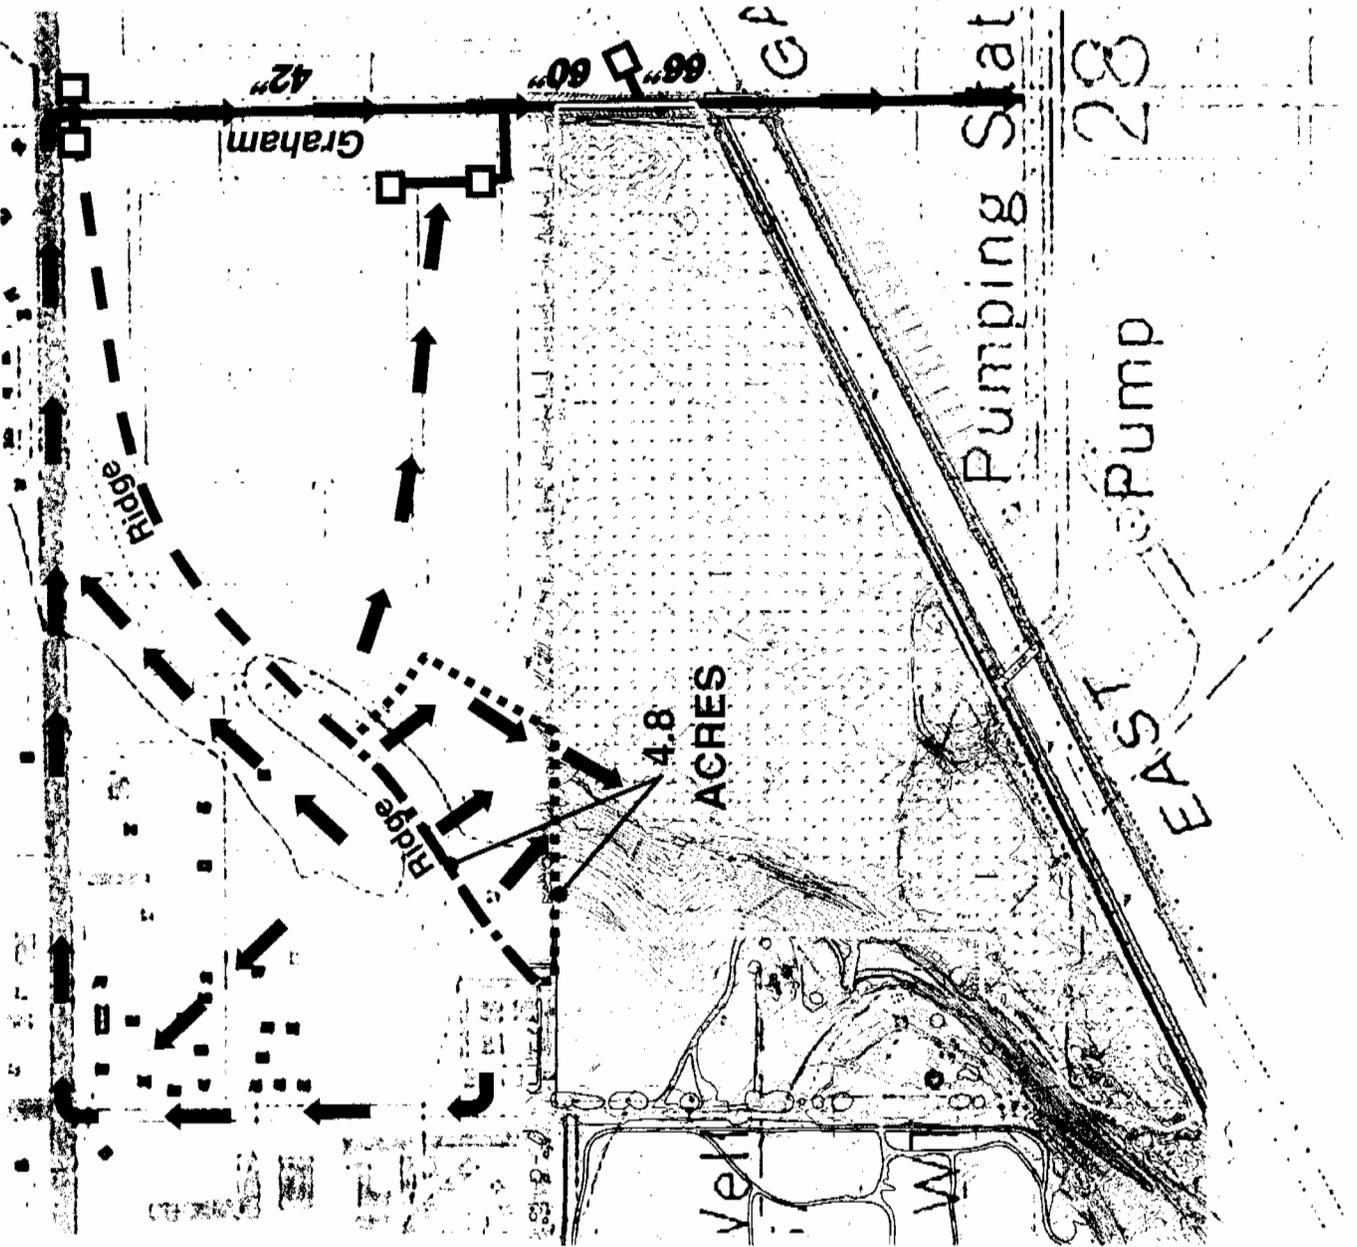
**Figure 1**

**Drainage Before  
Harbor Bluff and  
Cabo Del Mar  
(Pre 1978)**

See Figures #1, #2 and #3 and comment #12 above. The statistical test results imply that roughly the same percentage of years ponded would be observed whether or not the drainage diversion existed. Further, the test results argue that there would be no significant benefit in re-establishing the drainage diversion.

Also see comment #12 above. The objective of a topographic analysis is to estimate the amount of runoff that might have reached the property, but the final result must meet the test of whether the change can be observed in the majority of years. The statistical test results imply that roughly the same percentage of years ponded would be observed whether or not the drainage diversion existed. Further, the test results argue that there would be no significant benefit in re-establishing the drainage diversion.

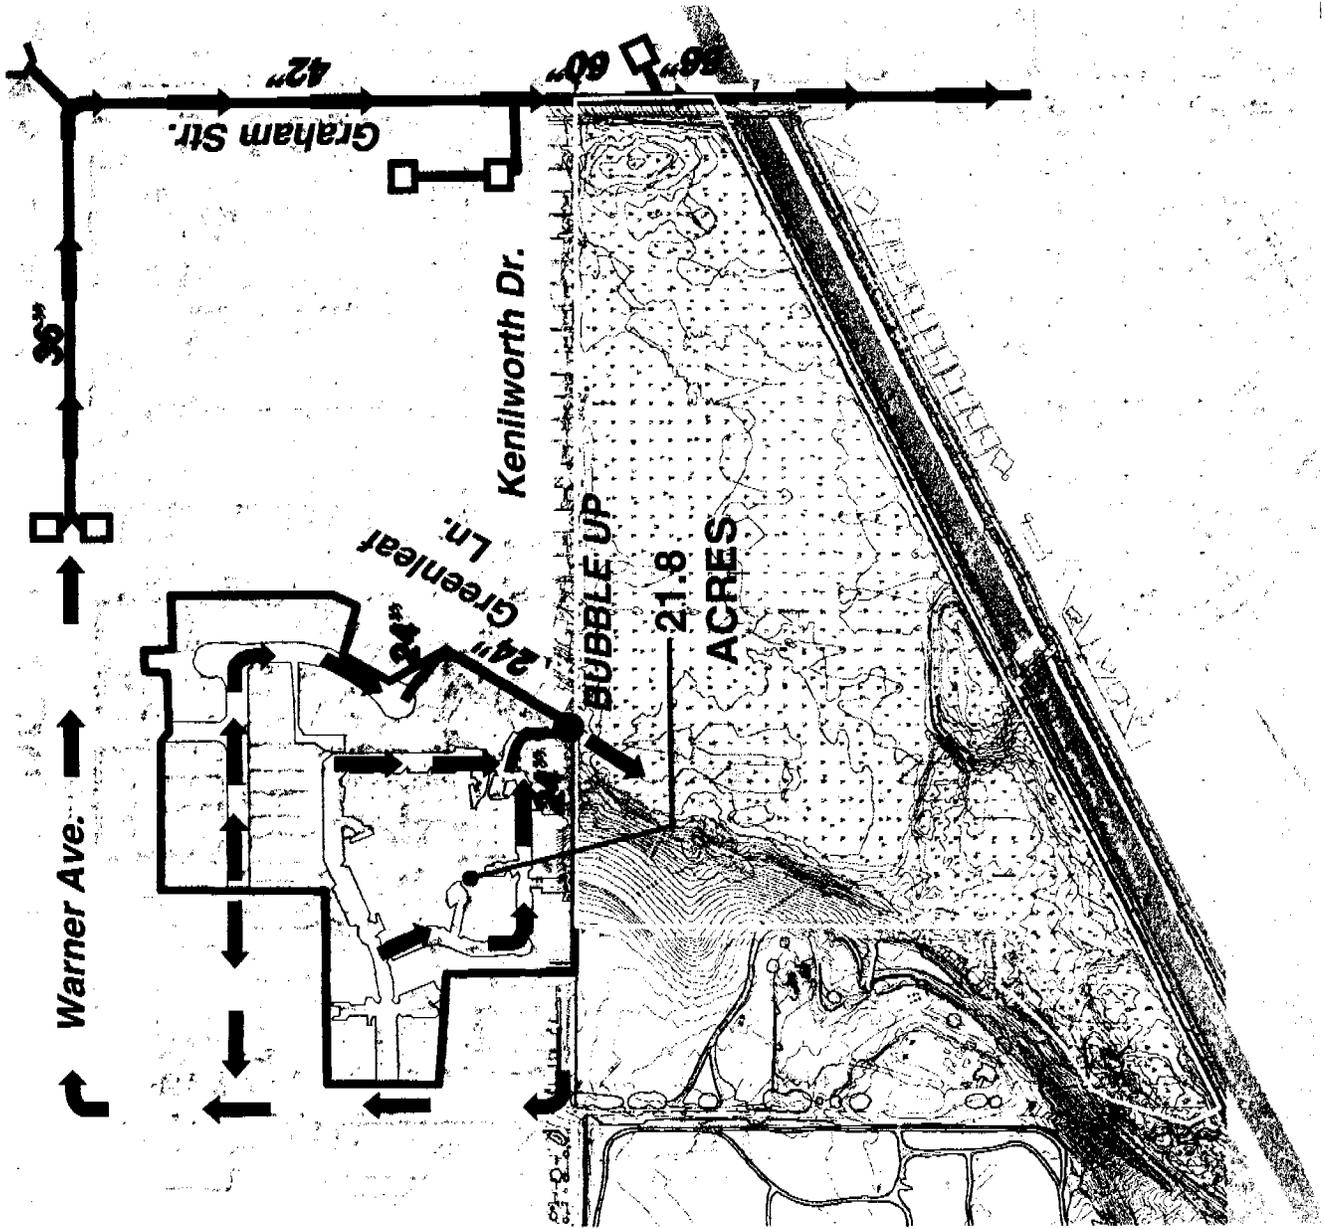
**Figure 2**

**Interim Drainage  
 Pattern From  
 Harbor Bluff and  
 Cabo Del Mar  
 (Before 60" Storm Drain)  
 (Approximately 1978-1985)**

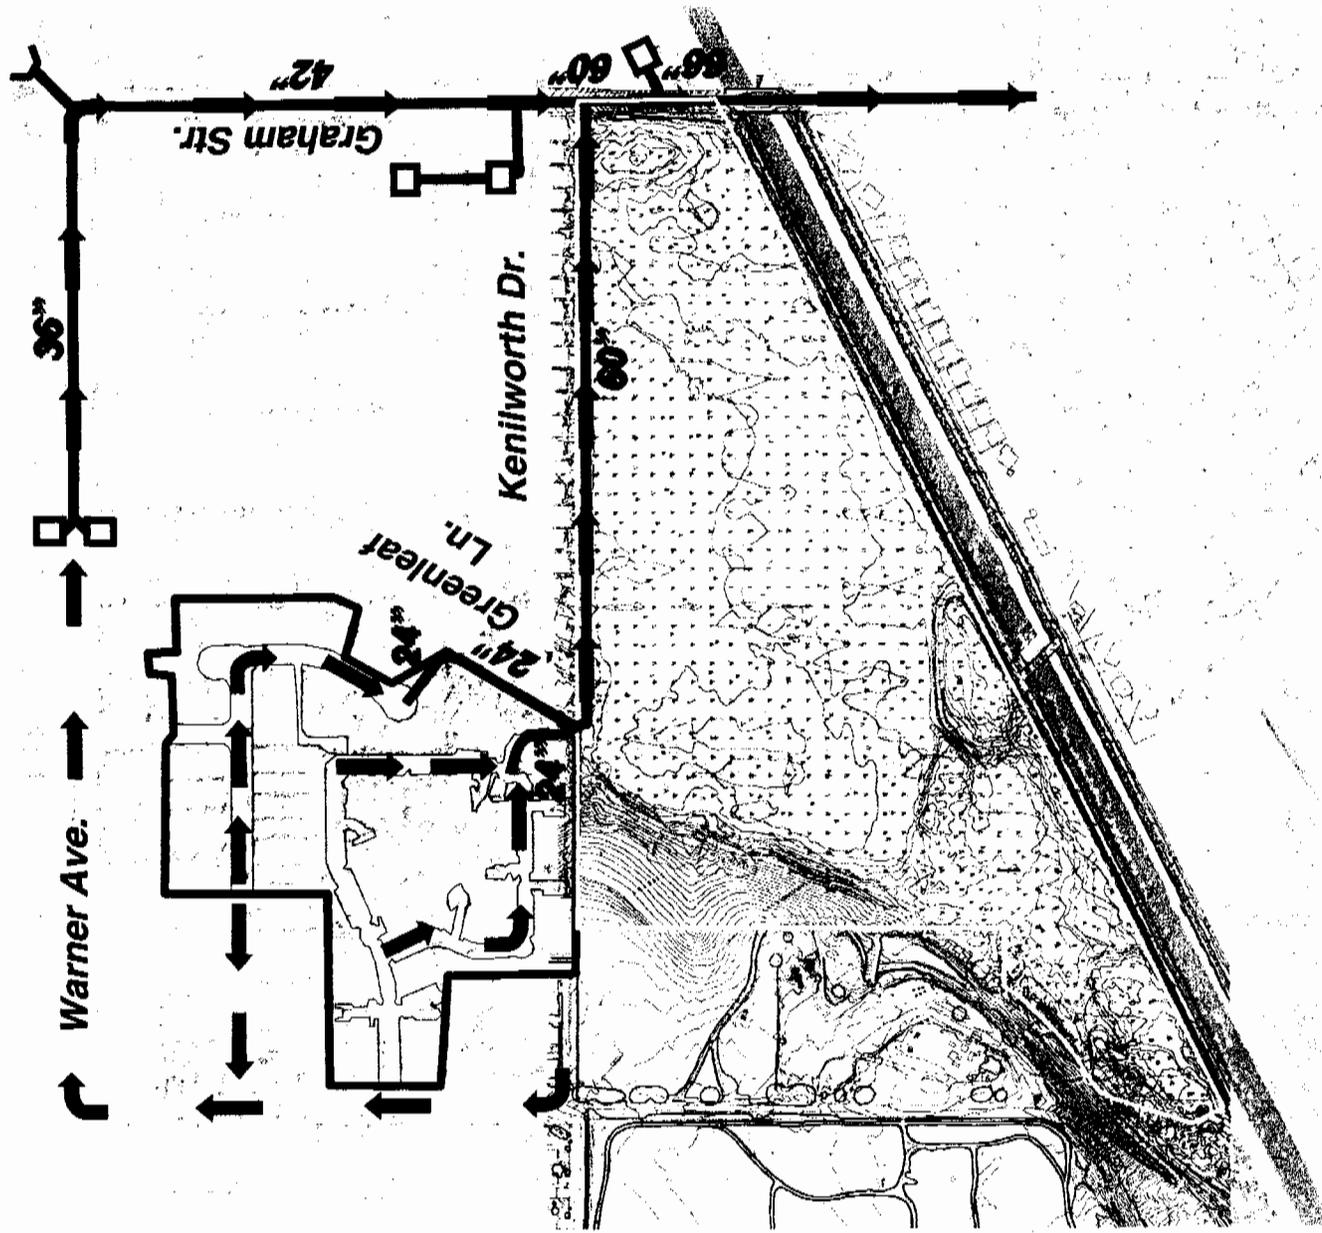
Figure 3

Drainage Today

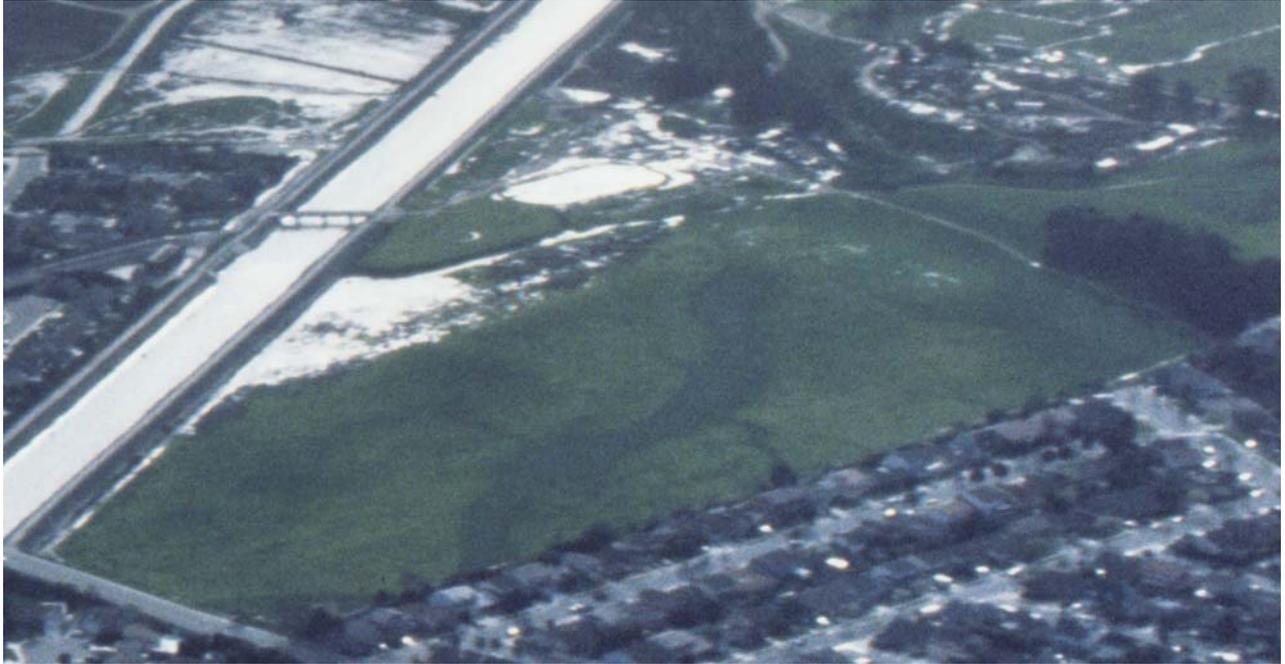
Figure 1. Oblique aerial photograph taken on February 10, 1993. There were about 5.7 inches of rain during the 30 days prior to the photograph and about 18.7 inches for the 1992-1993 rain year. Much of the ponding in the EPA area was probably obscured by vegetation.

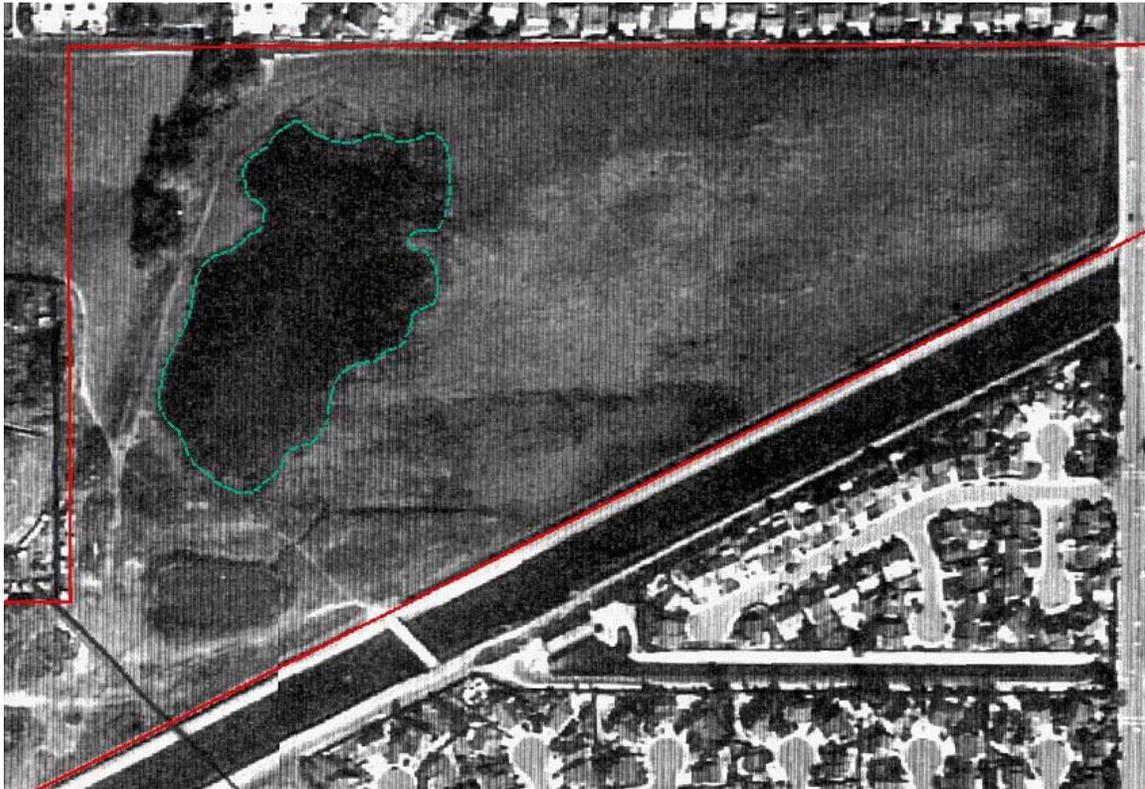
Figure 2. Vertical aerial photograph taken on January 28, 1995. There were about 11.7 inches of rain during the 30 days prior to the photograph and about 18.3 inches for the 1994-1995 rain year. The area estimated to be ponded is contained within the green polygon and comprises about 6.1 acres.

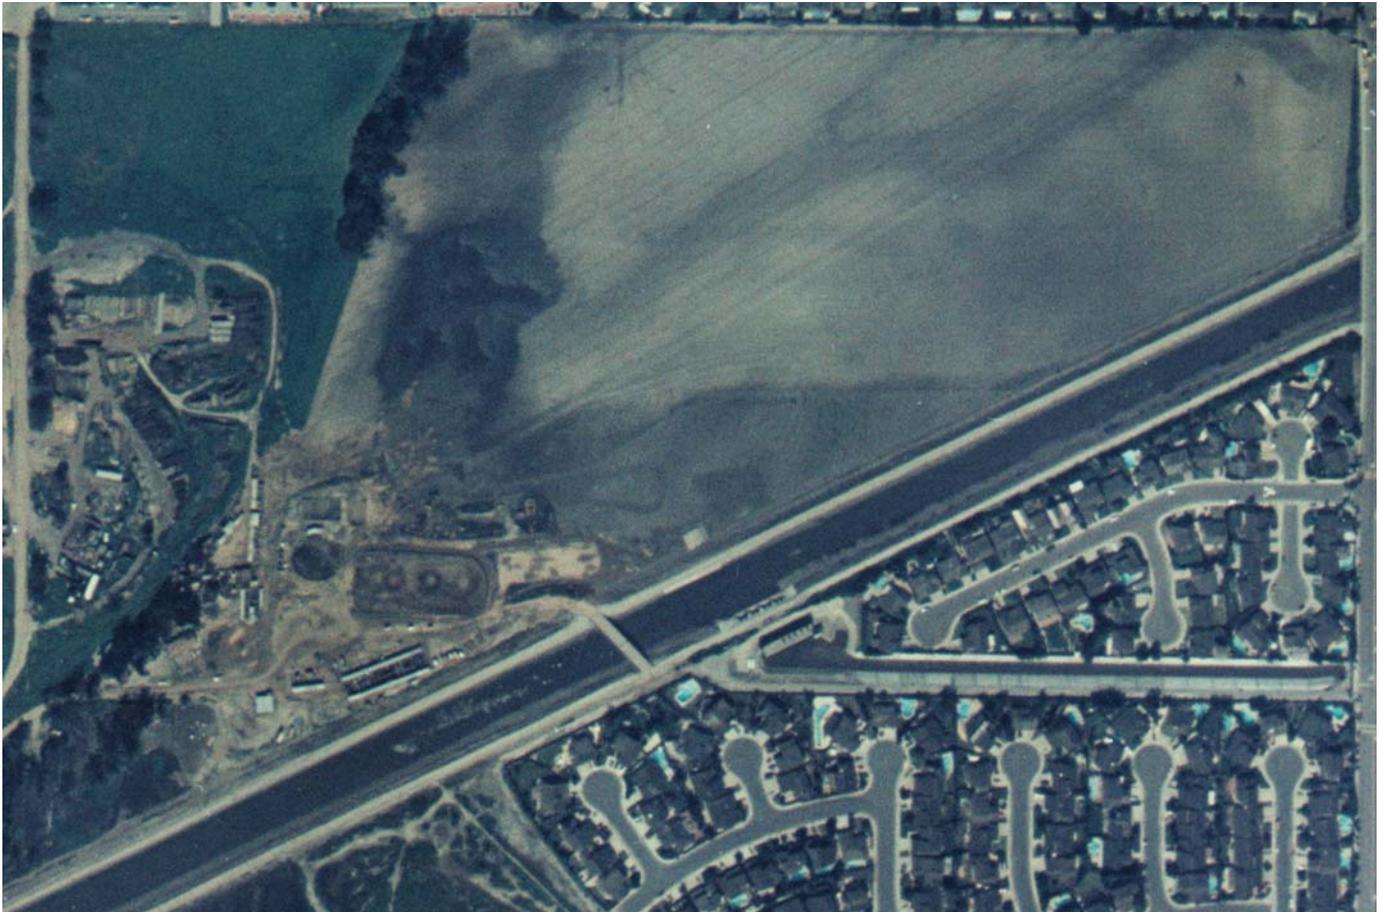
Figure 3. Vertical aerial photograph taken on March 19, 1996. There were about 3.7 inches of rain during the 30 days prior to the photograph and about 7.3 inches for the 1995-1996 rain year. The estimated area of inundation is shown separately in Figure 4 because the polygon obscures some of the surface features seen here.

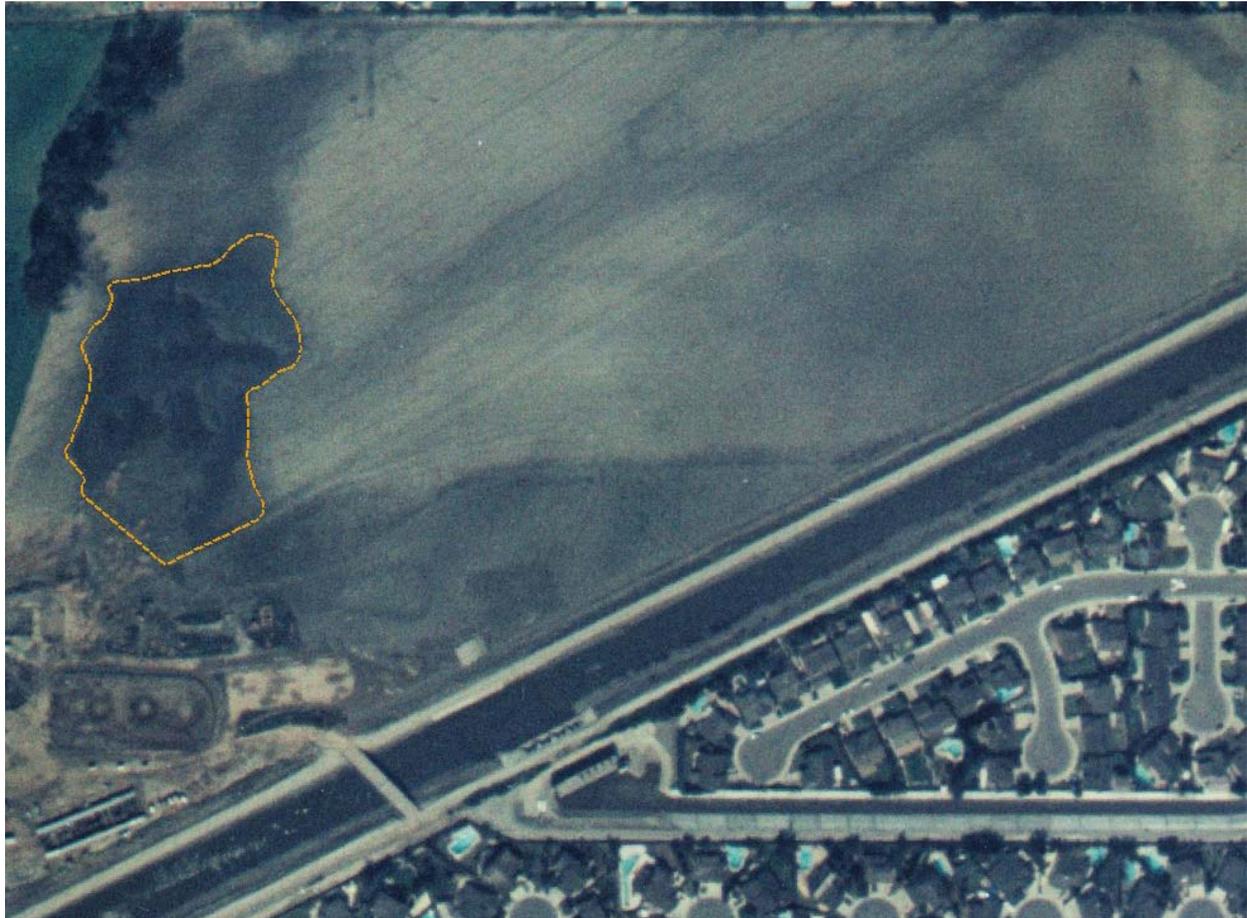
Figure 4. Vertical aerial photograph taken on March 19, 1996. The estimated area of inundation, which is enclosed by the orange polygon, comprises about 2.9 acres.

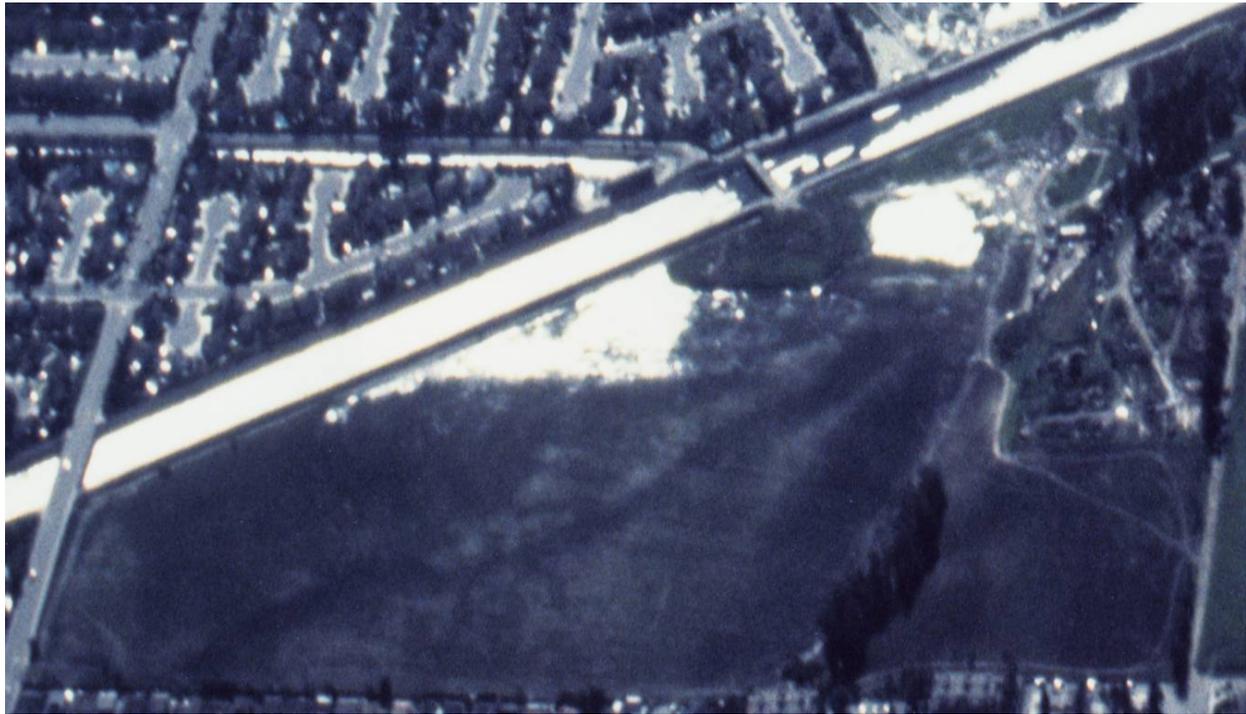
Figure 5. Oblique aerial photograph taken on January 29, 1997. There were about 4.8 inches of rain during the 30 days prior to the photograph and about 10.6 inches for the 1992-1993 rain year. The ground surface in the EPA area is obscured by vegetation. When the riding arena area and the area next to the flood control channel have this much water, it is highly likely that portions of the EPA area were also inundated (see Figure 1).

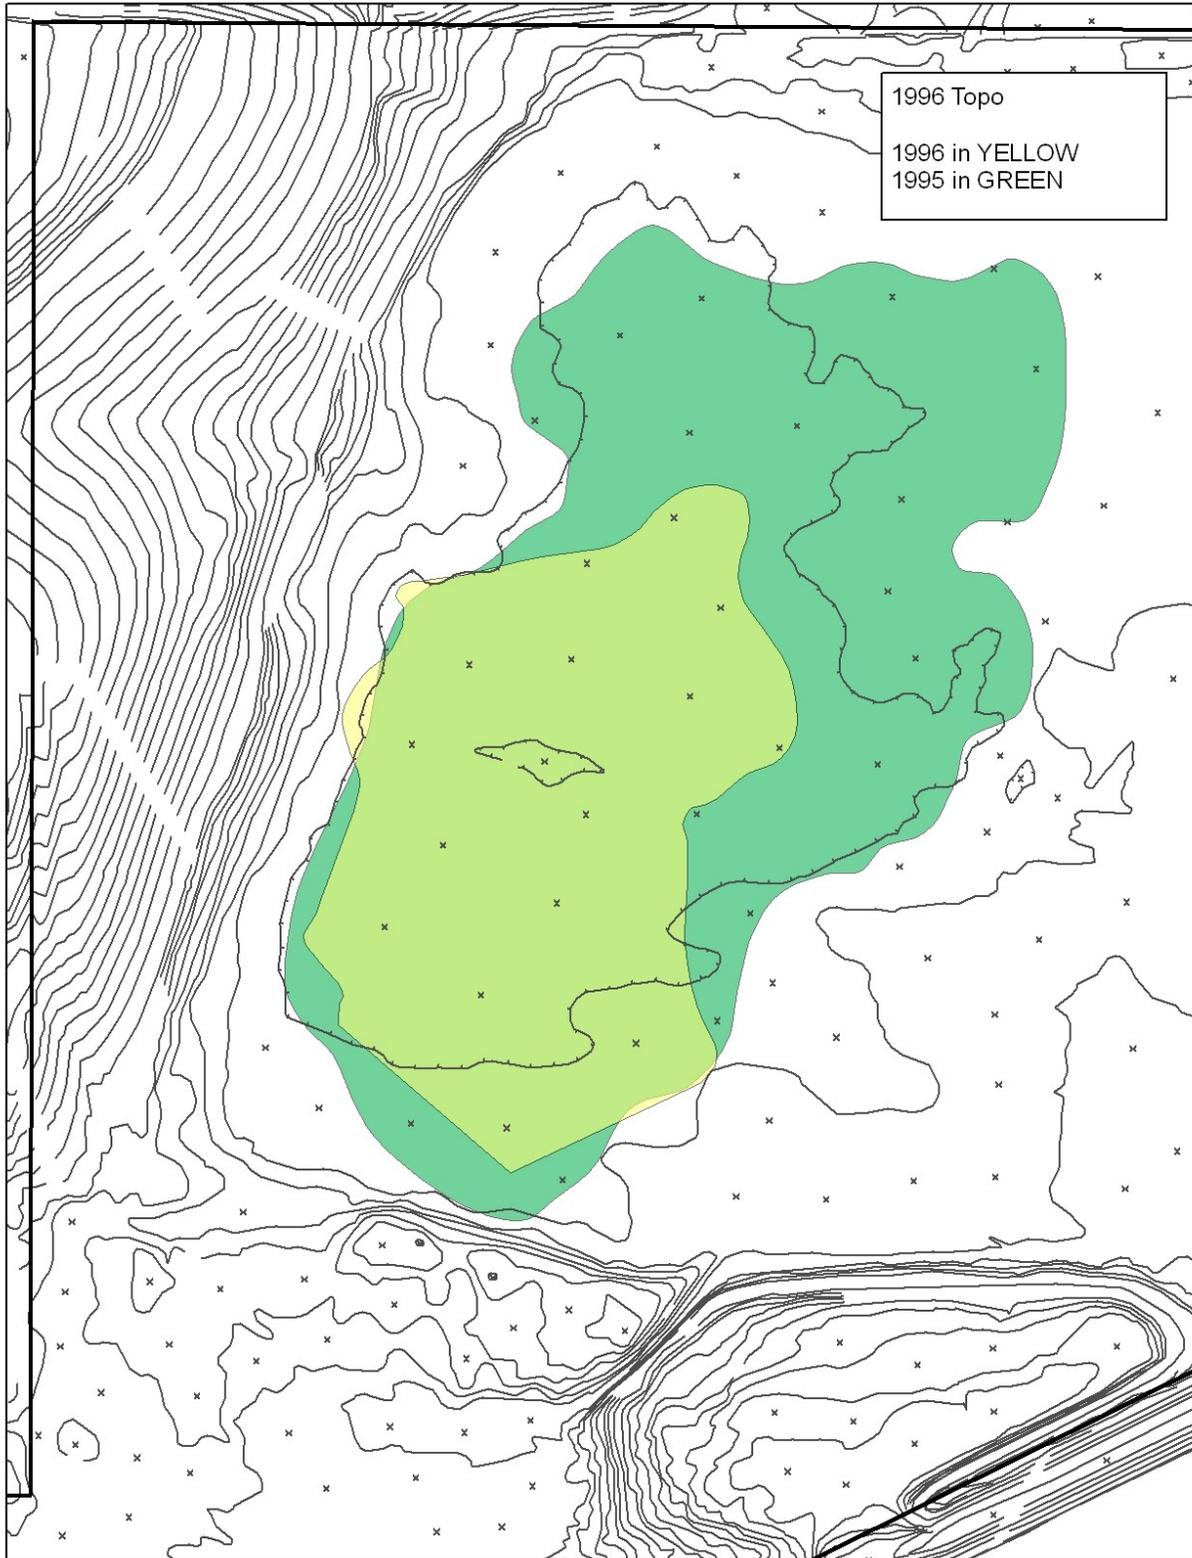
Figure 6. Estimated areas of inundation on January 28, 1995 and on March 19, 1996 overlaid on 1996 elevation contours.

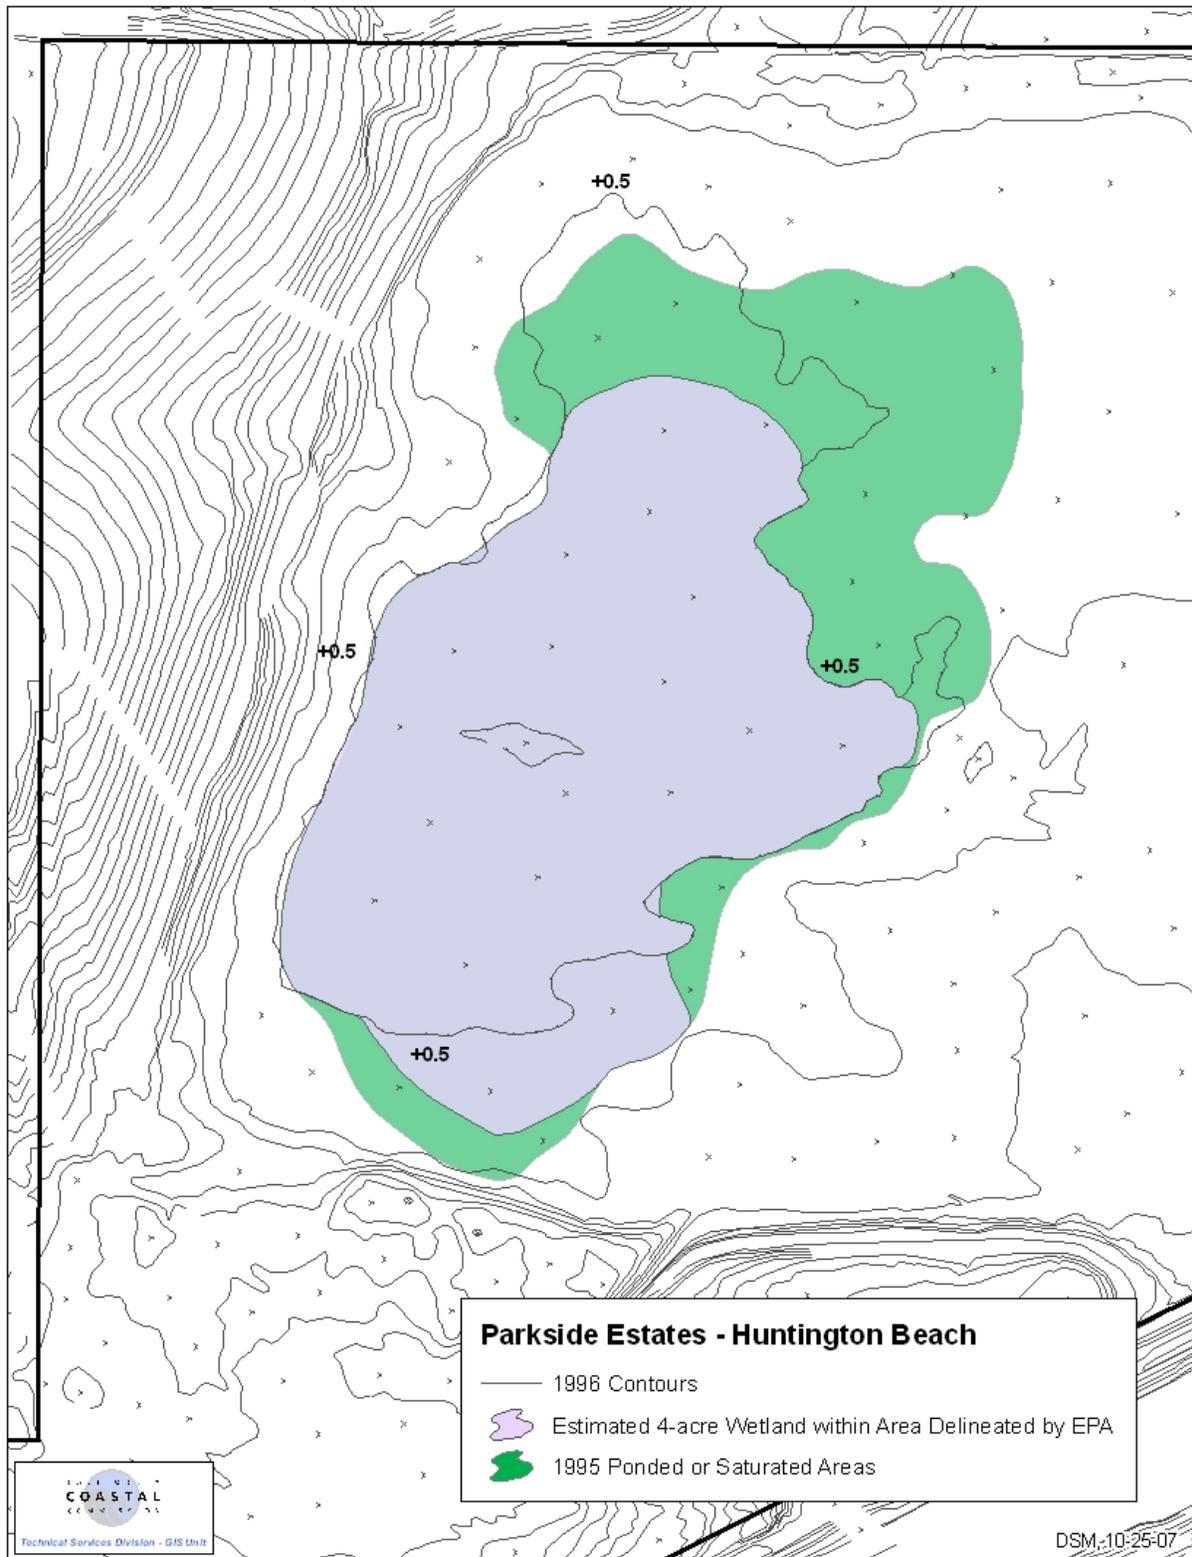
Figure 7. The blue polygon was obtained by expanding the boundary of the area inundated in 1996 (encompassed by the blue polygon) until it intersected the edge of the depression defined by the +0.5-foot contour or the edge of the area inundated in 1995, or until 4-acres was reached.

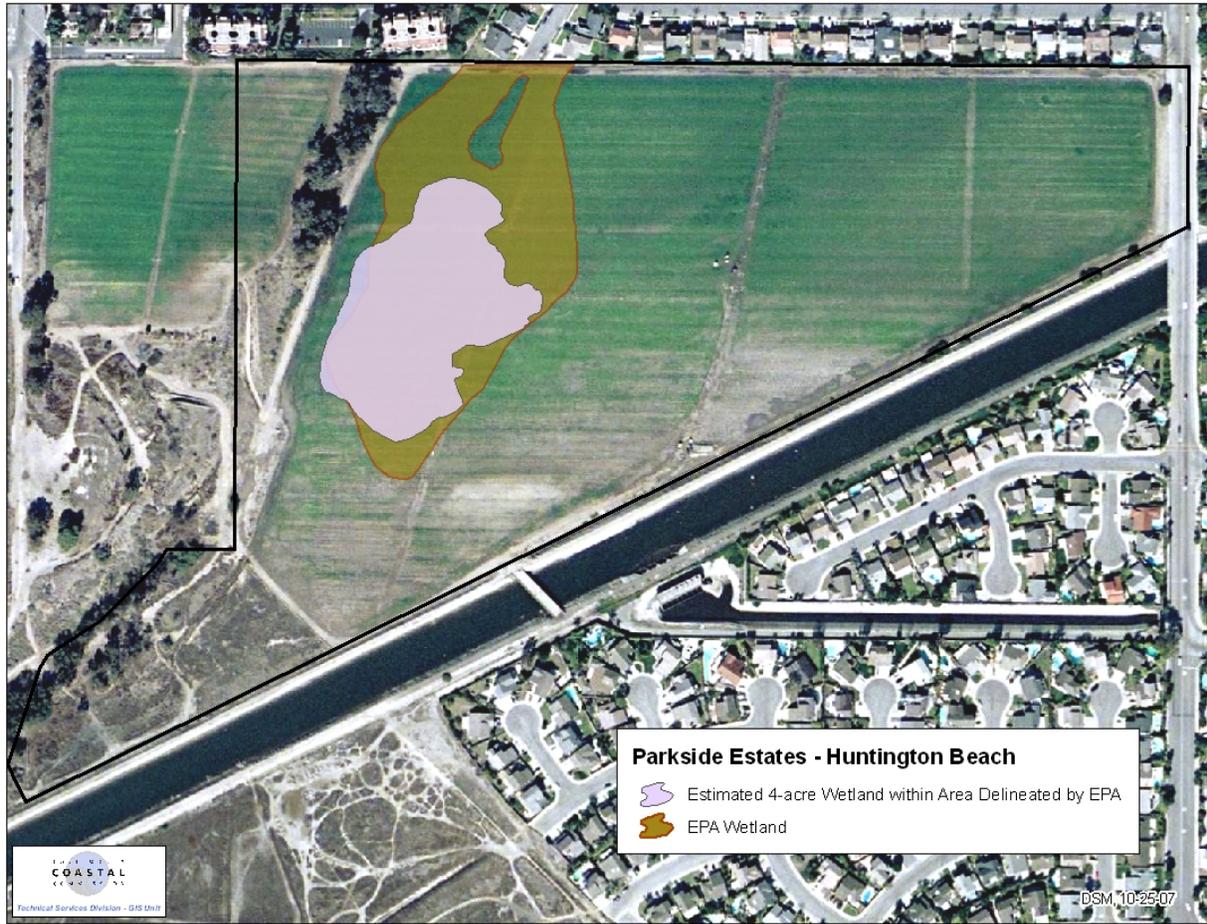
Figure 8. The area delineated by EPA during the construction period for the Cabo del Mar condominiums is shown in tan. Shown in lavender is the 4-acre portion of the EPA wetland that is estimated to have been present before and after the hydrological modifications associated with the construction of Cabo del Mar and before the significant land leveling that took place beginning in 1998.

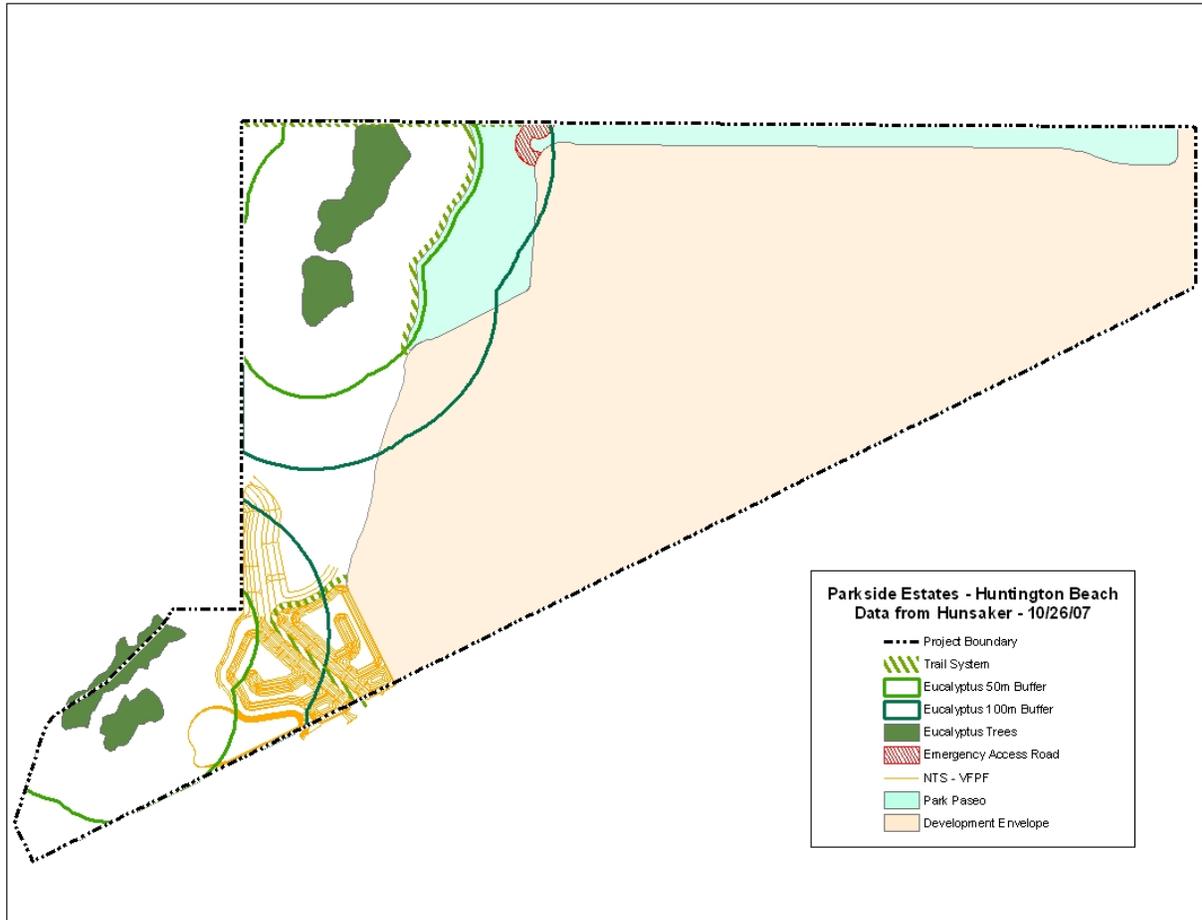
Figure 9. Proposed development plan presented in Homrighausen (2007) with 50-m and 100-m buffers around the northern eucalyptus trees that provide important raptor habitat. In the key, "NTS" is a natural treatment system for urban runoff and "VFPP" is a vegetated flood protection feature or levee.

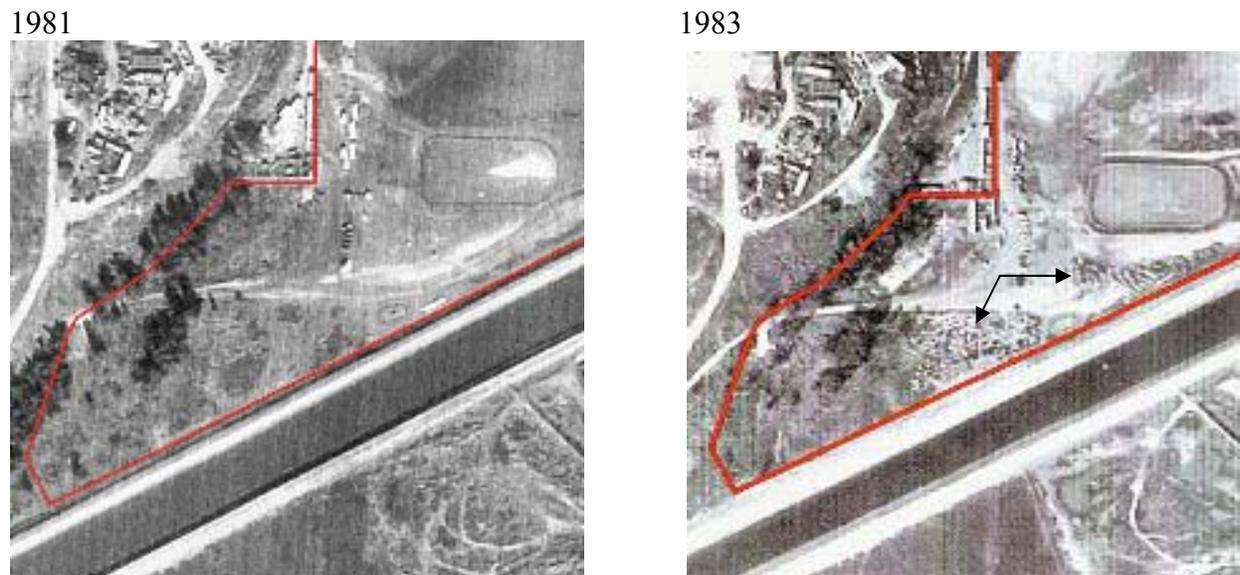
Figure 1, included below, includes portions of the 1981 and 1983 images reviewed in Exhibit MMM clearly showing evidence of elevation change in the form of mounds of fill visible south of the arena and in the central area of this portion of the 1983 image (see arrows). While these photos are not stereopairs, they clearly show that there are mounds of material on the property in 1983 that did not exist in 1981.

Figure 1 – Portions of 1981 and 1983 images

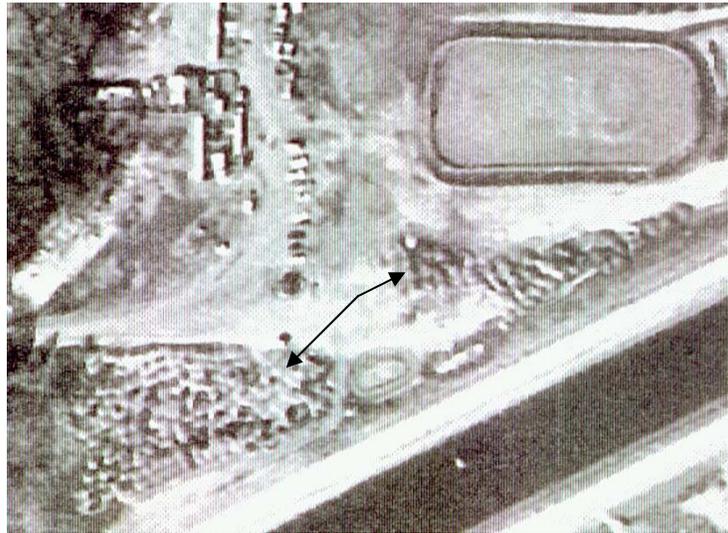
Figure 2, below, is an enlargement of the portion of the 1983 image reviewed in Exhibit MMM clearly showing evidence of mounds of fill visible south of the arena and in the central area of the image (see arrows).

Figure 2 – Enlargement of portion of 1983 image

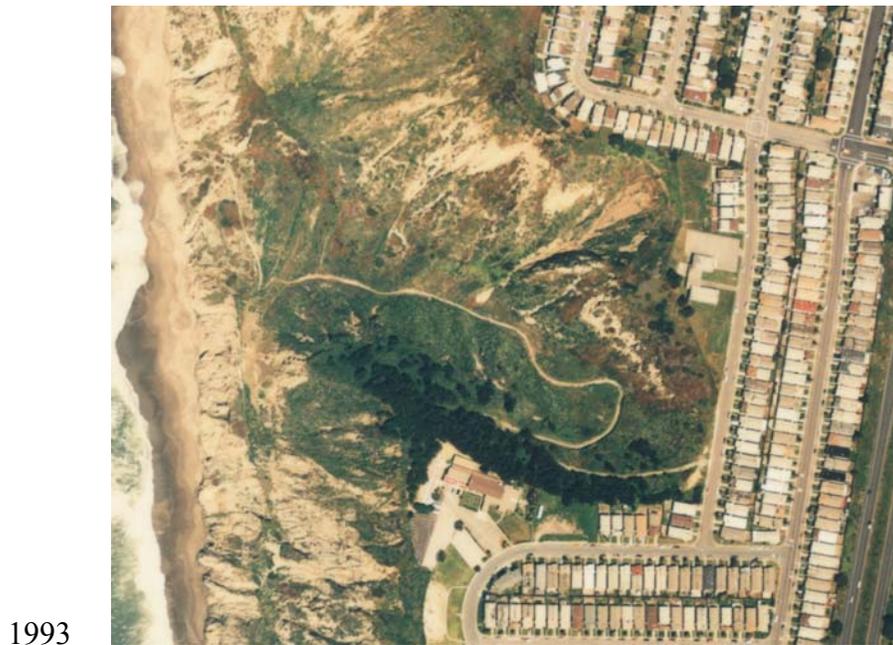
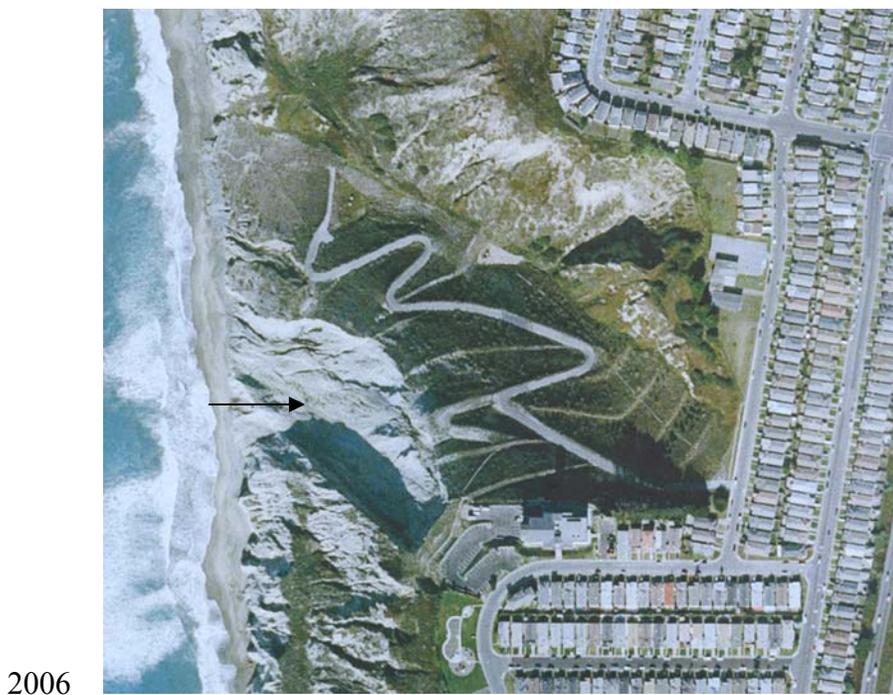
To illustrate this further using a less dramatic coastal example, imagine examining two individual vertical aerial photos from different years that depict an area having an eroding coastal bluff. Figure 3, included on the following page, depicts portions of 1993 and 2006 Coastal Commission vertical aerial photography covering a part of San Mateo County's coastline showing evidence of coastal bluff retreat at the left center of the image (see arrow). The change in topography is clearly discernable, despite the fact that these are not stereopairs. The retreating cliff face (indicating changing elevations) is visible without stereoscopic analysis. Comment 40 is incorrect.

Figure 3 – Portions of 1993 and 2006 images showing coastal bluff erosion in San Mateo County
