RE: Huntington Beach/Parkside Estates Local Coastal Plan Amendment 1-06  
Comments on June 29, 2007 Staff Report and Addenda

Ms. Meg Vaughn  
California Coastal Commission  
LCPA 1-06 Staff Report Comment Letter

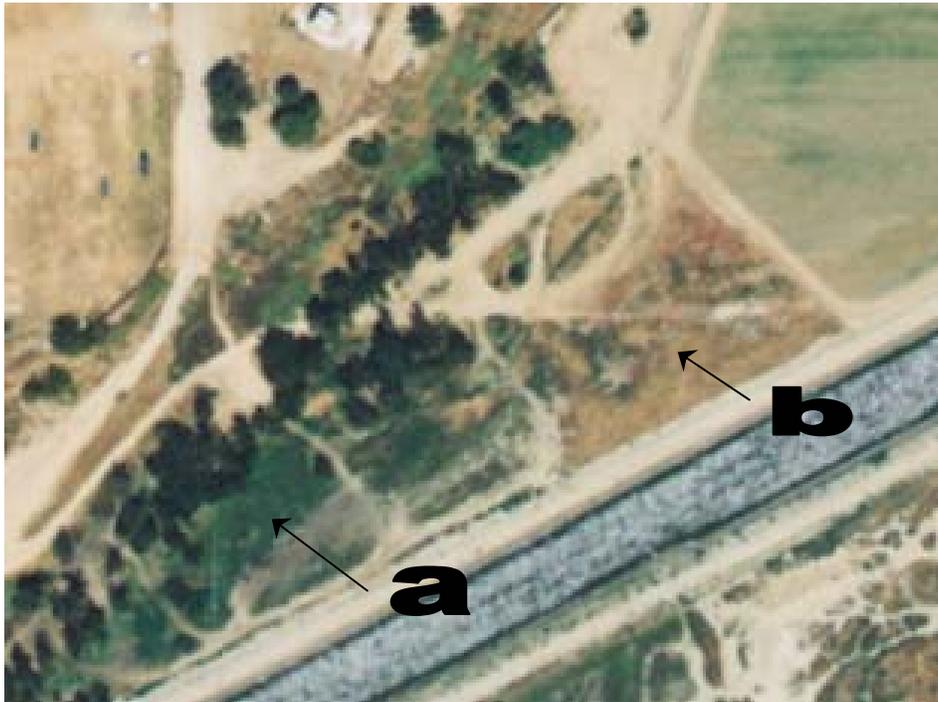
In the portion of the 2001 image included on the following page as Figure 4, which depicts the area of the CP wetland, it is plainly evident that the vegetation color, the color contrast between the vegetation features, and the geometric arrangement of the vegetation shapes in the area support the statement in Exhibit MMM that the area was re-vegetating with both wetland and upland species (see arrows a – wetland vegetation, and b – upland vegetation).

Figure 4 – Portions of June 29, 2001 image showing re-vegetation of CP wetland

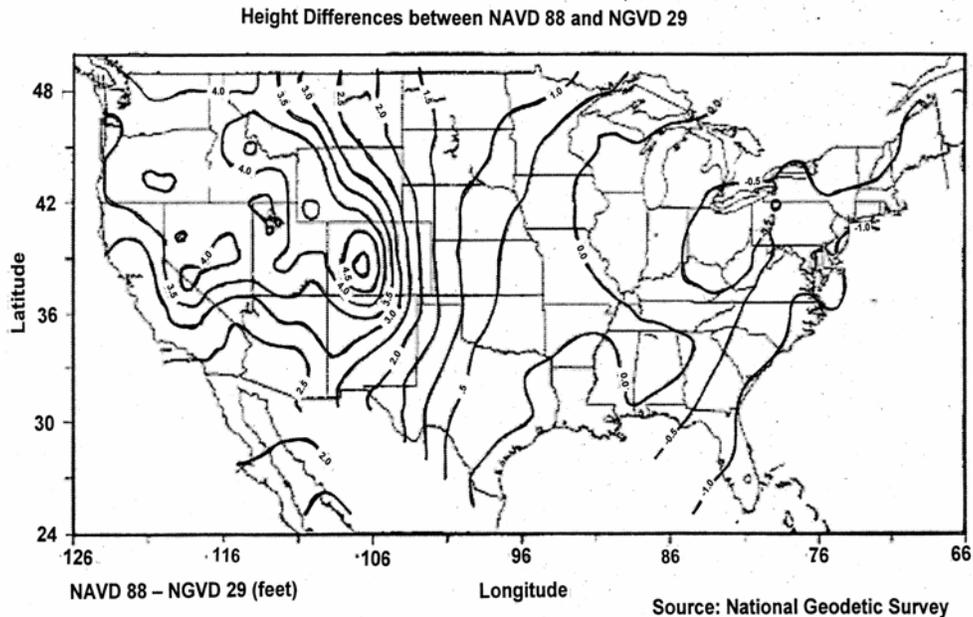
The comments regarding Exhibit MMM, page 6, 4<sup>th</sup> paragraph, line 7 are at first random, and then become misleading and erroneous. They appear to be based partly on using a portion of the sentence I wrote regarding geographic variations of the difference between the NGVD29 and NAVD88 vertical datums out of context. The sentence comment 53 quotes out of context did not state that the vertical datums vary from location to location. Re-reading it one will plainly see that the full statement reads “The *difference* [emphasis added] between the two vertical datums varies from location to location...” which it does (See Figure 5, National Geodetic Survey (NGS) map of height differences between NAVD88 and NGVD29). Orange County’s Geomatics/Land Information Systems Division actually provides the values of 2.3 feet, 2.34 feet and 2.35 feet for the NAVD88/NGVD29 height difference.

Figure 5 – NGS Map showing variations in height differences between NAVD88 and NGVD29

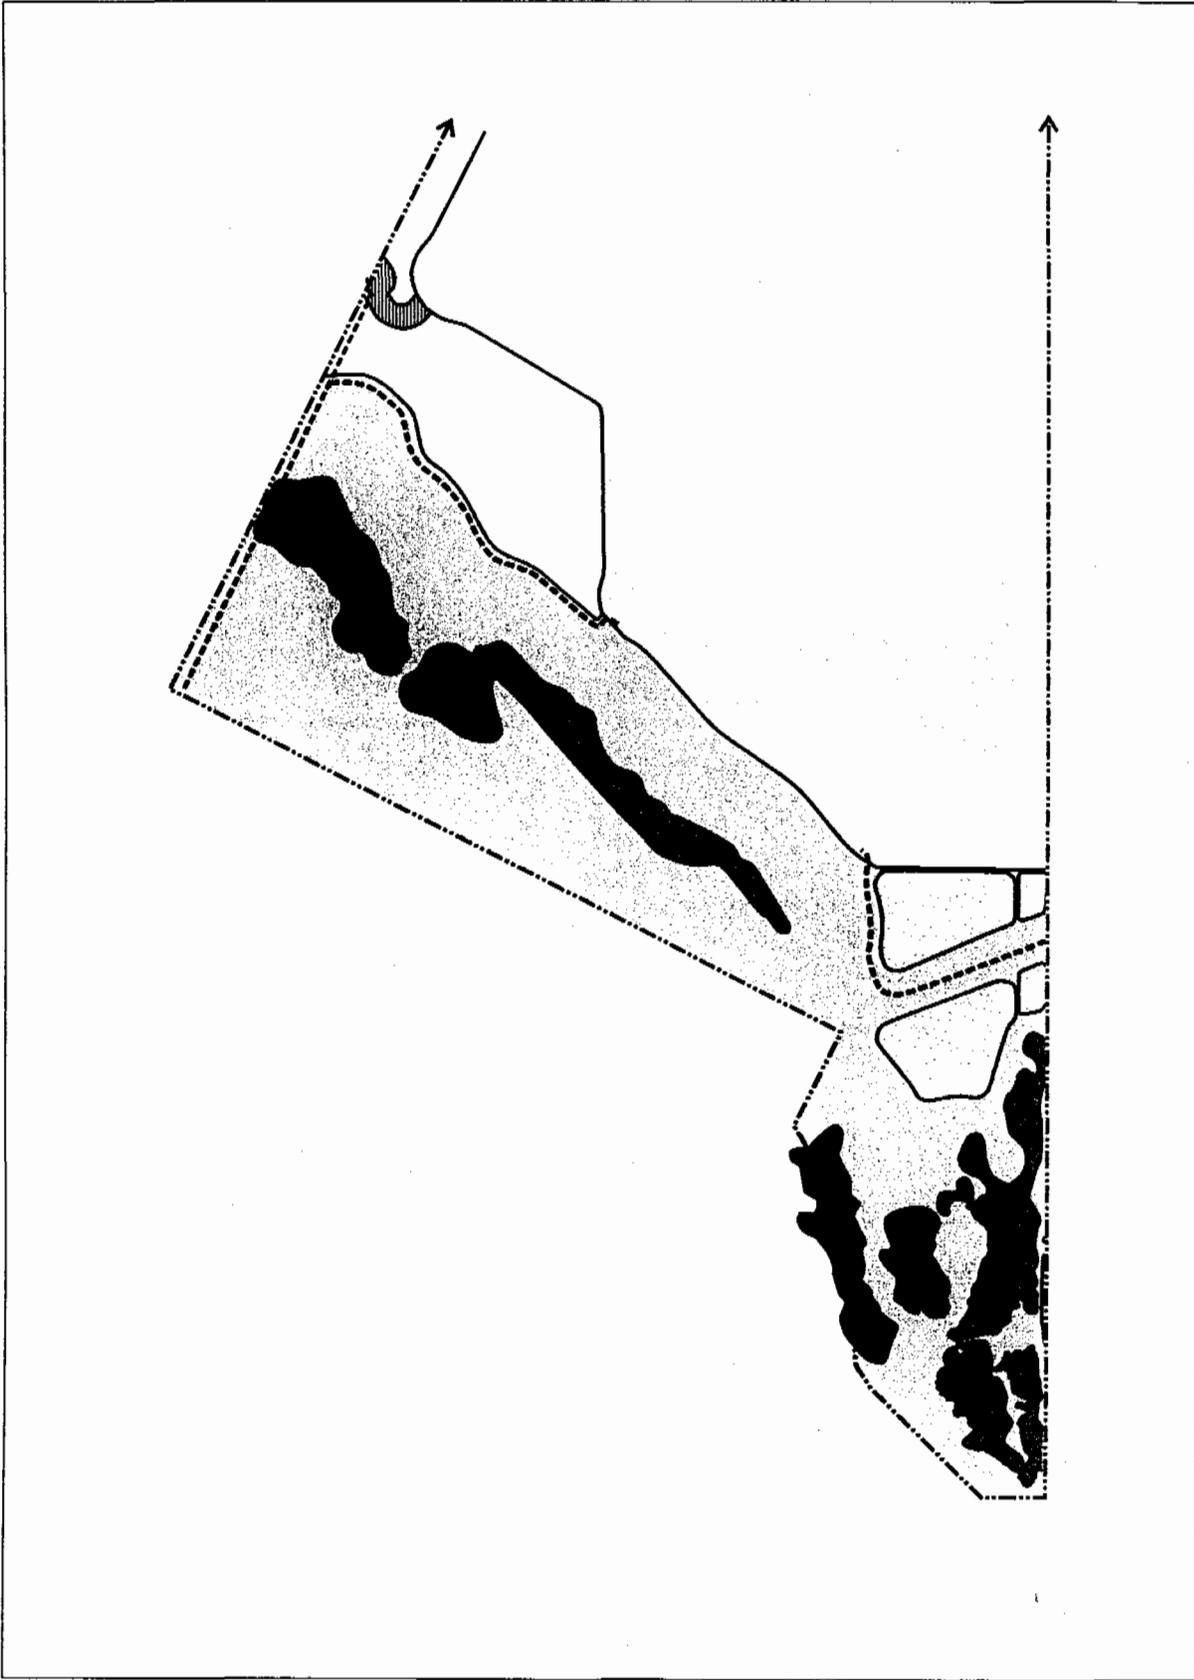
LSA  
 FIGURE 1  
 Parkside Estates  
 Proposed Buffer Concept

SEI-334-07 Buffer Concept (07.7.07)

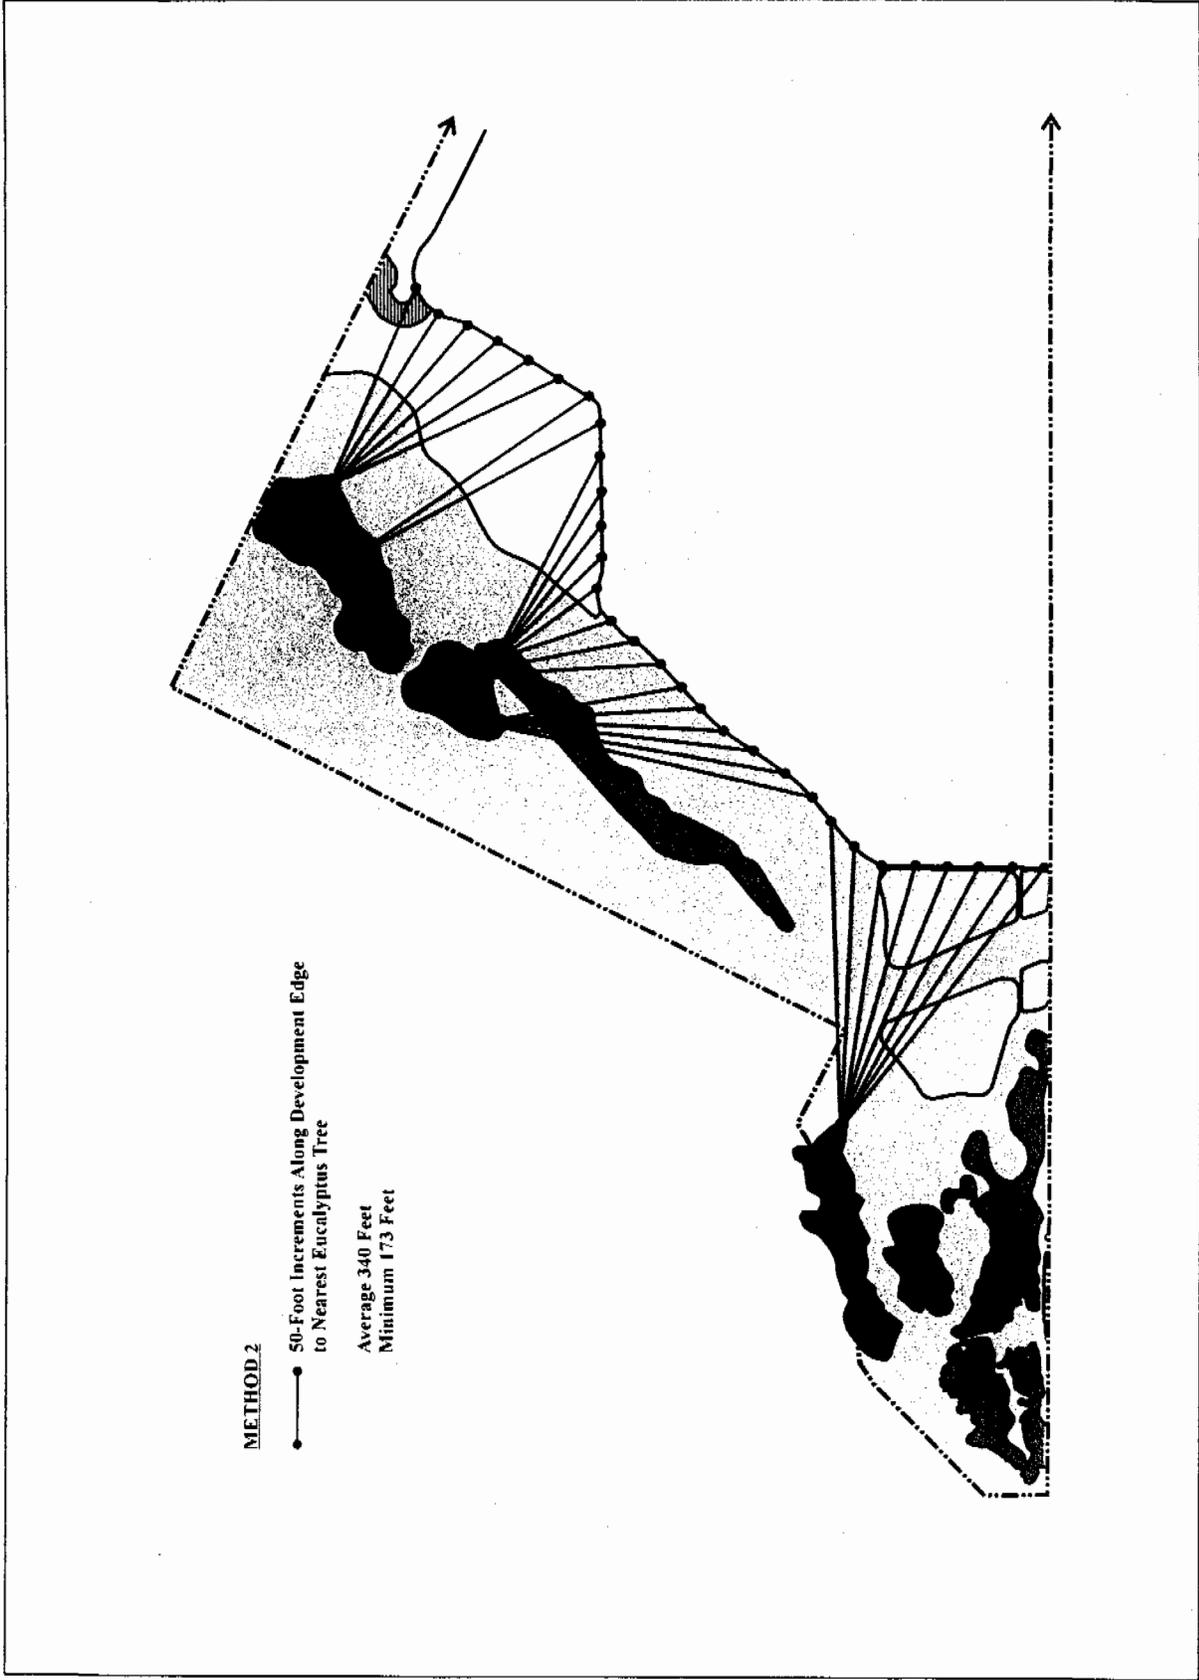
LSA  
FIGURE 3

Portside Estates  
Buffer Distance Calculation -  
Method 2

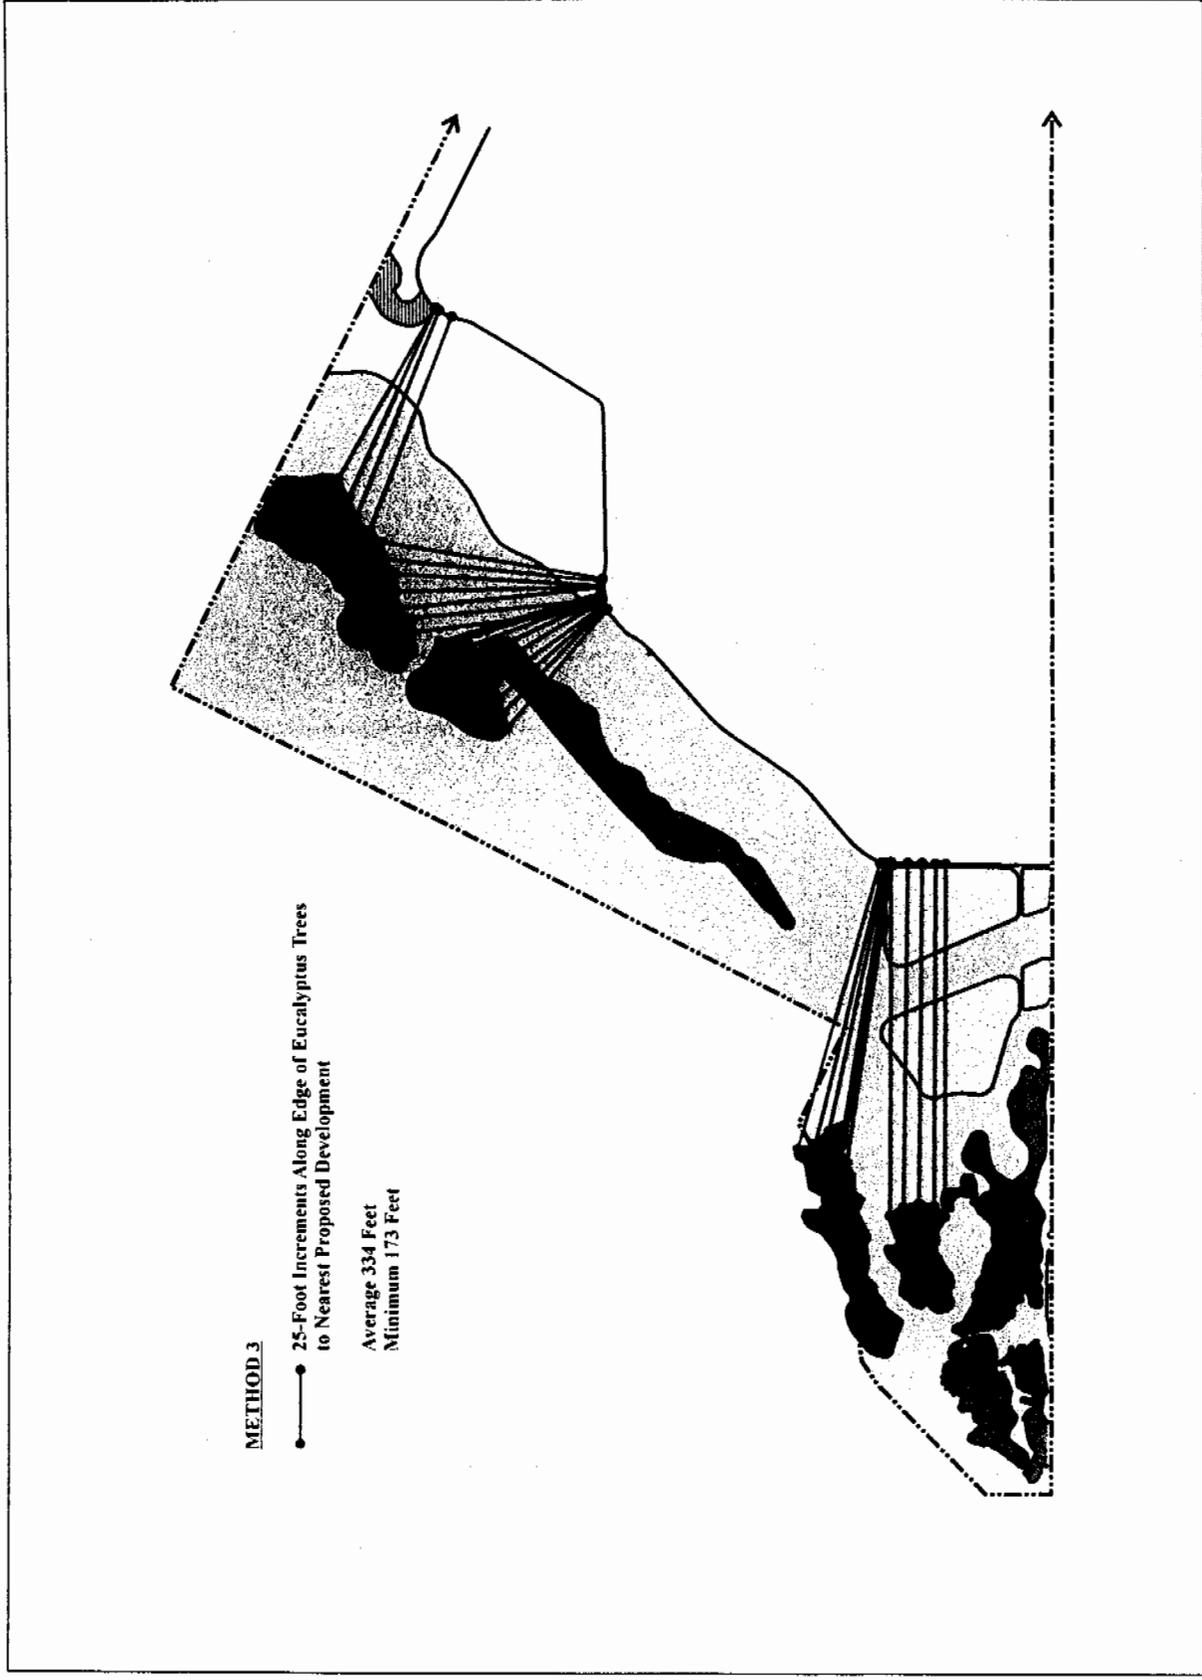
LSA  
FIGURE 4

**METHOD 3**

●—● 25-Foot Increments Along Edge of Eucalyptus Trees to Nearest Proposed Development
