UNITED STATES ENVIRONMENTAL PROTECTION AGENCY

Subject: Terrace Point Wetland Delineation, Santa Cruz County, CA

Attachment 2. March 2007 CORPS Delineation with Additional Areas Identified For CCC Staff Consideration Regarding CMA Status, Terrace Point, Santa Cruz, CA

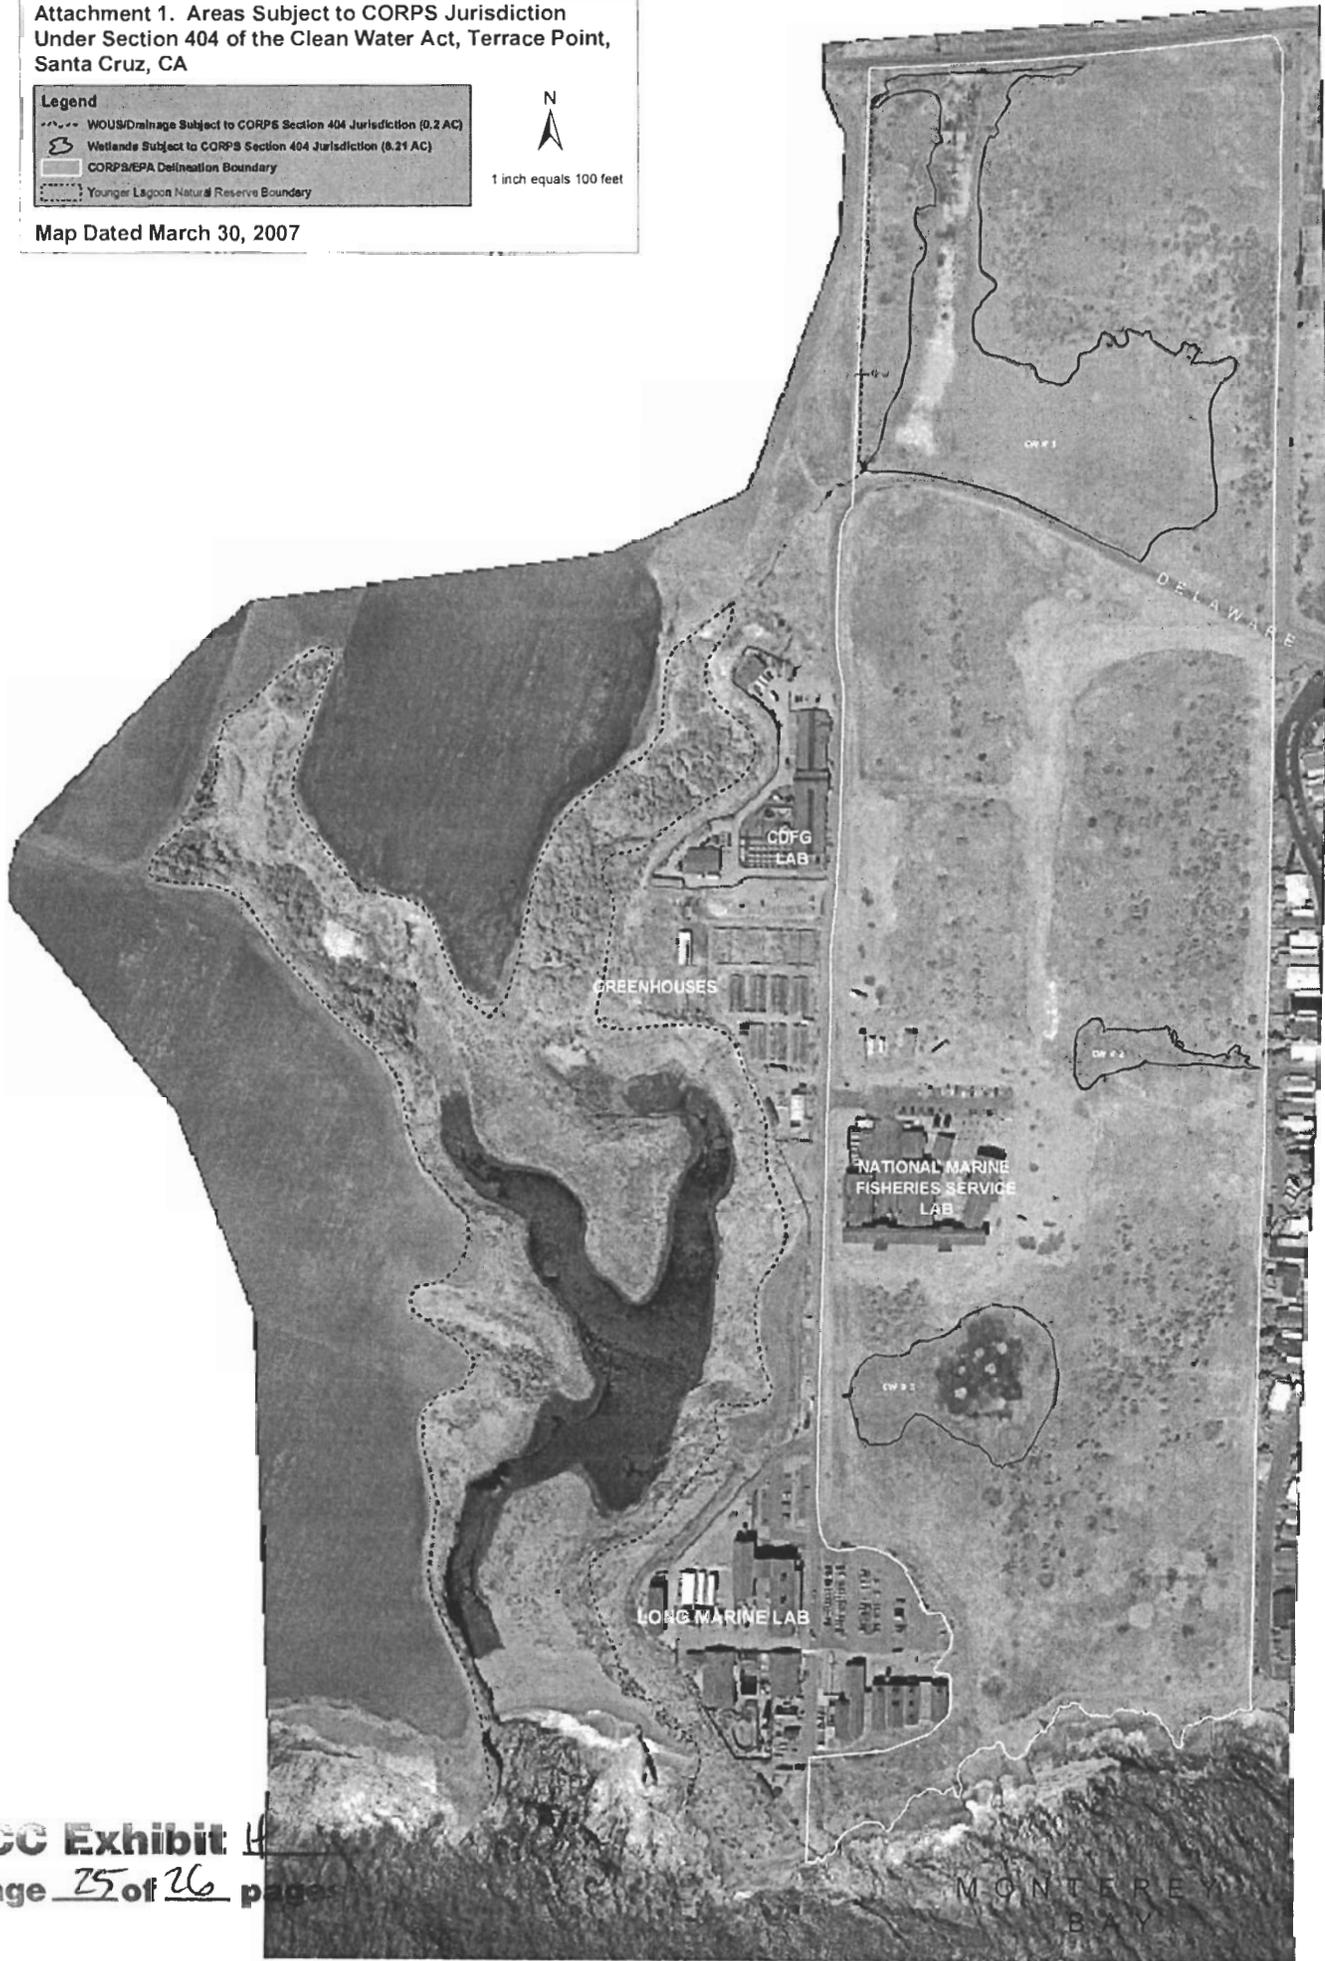
(2) Revise the proposed CCC map to include all previously identified CCC wetlands, and all areas added to the Section 404 wetlands map as federal wetlands, as CCC wetlands. Additionally, we recommended that HBG identify four areas of interest on the proposed map for CCC staff consideration as CCMA wetlands. These areas are identified on the map and legend as Groups A through D.

- **Group A** consists of patches of *Baccharis douglasii* growing within a FAC, FACW, or OBL plant dominated community, with conditions that meet Corps hydric soil and wetland hydrology criteria.

- **Group B** consists of patches of *Baccharis douglasii* not meeting Corps hydric soil and/or wetland hydrology criteria, and in a landscape position, and with soil characteristics unlikely to promote wetland conditions. Group B includes patches of *Baccharis douglasii* scattered throughout the project study area characterized by one or more of the following conditions: (1) *Baccharis douglasii* was no longer present at a location previously identified by HBG; (2) the sample plot at the identified *Baccharis douglasii* patch did not have a hydrophytic plant community (standard Corps 87 Manual routine sample plot) even though there were individuals of *Baccharis douglasii*, which may or may not have been a dominant; (3) the *Baccharis douglasii* patch was within a hydrophytic plant community but lacked observable or inferred hydric soil and/or wetland hydrology, and/or was located in a landscape position comparable to adjacent and obvious upland plant communities. We recovered/observed each identified location of *Baccharis douglasii* on the proposed HBG 2002 delineation map, sampled soil profile conditions at many of these locations, and noted observable hydrology conditions. In general, the soil profiles of condition (3) are characterized by at least 24 inches of soil coarser than fine sandy loam, with no apparent surface or sub-surface hydrologic indicators. Based on our observations of current site conditions, we do not believe plant communities identified in Group B are the result of wetness conditions that are significantly different from those existing in adjacent upland plant communities.

- **Group C** consists of six identified patches of *Baccharis douglasii* not meeting Corps hydric soil and/or wetland hydrology criteria. However, landscape position and/or subsurface wetness associated with a shallow aquitard may support a wetland plant community pursuant to the CCMA definition of wetlands. We refer Group C to CCC staff.

Baccharis douglasii patch C-1 had moist soil below 12 inches and was at a slightly higher elevation than the expanded Corps wetland boundary. *Baccharis douglasii* patch C-2 had a soil textural change at 24 inches consistent with impeded drainage and development of short-to-long- duration seasonal water table, development of faint contrast at 16 inches in the soil, and a relative shallow landscape depression on the soil surface. *Baccharis douglasii* patch C-3 had soil depletions below 15 inches, and abuts a historic drainage way constructed to drain surface water from area W-5. *Baccharis douglasii* patch C-4 has a depleted matrix and shallow aquitard beginning at 15 inches depth, and is likely to have short-to-long-duration perched water tables close enough to the surface to cause periodic wet soil conditions. *Baccharis douglasii* patch C-5 has conditions similar to C-4. *Baccharis douglasii* patch C-6 (identified as C-7 on the CCC map) was in a low topographic landscape position, had moist soil conditions, and supported wetter-end plant species.

- **Group D** consists of two relatively large areas with plant communities dominated by FAC, FACW, or OBL plant species other than *Baccharis douglasii* that do not meet the Corps hydric soil and wetland hydrology criteria. However, landscape position and subsurface wetness associated with a shallow aquitard may support a wetland plant community pursuant to the CCMA definition of wetlands. We refer Group C to CCC staff. Area D-1 was adjacent to an expanded area of federal wetlands characterized by a sample point with a depleted soil matrix at 15 inches and saturated soil between 3 and 15 inches. D-1 was at a slightly higher elevation than the federal wetland and sloped, but was still dominated by FAC grasses and likely to have seasonally wet soil conditions. D-1 also included a *Baccharis douglasii* patch. Area D-2 was a large patch of FAC dominated grasses with a depleted soil matrix at 16 inches, and saturated soil at 24 inches depth. D-2 is immediately upslope (1%) of area C-4 and is likely to have seasonal wet soil conditions.

(1) Please revise the proposed CWA Section 404 WOUS map to enlarge the geographic extent of federal wetlands associated with areas W-2, W-3, W-4 and W-5. This revision extends federal wetland areas into some of the *Baccharis douglasii* patches, especially those patches associated with the fringe of the previously identified federal wetlands. With proper revisions, the Section 404 WOUS jurisdictional verification request can be finalized without further site evaluation.

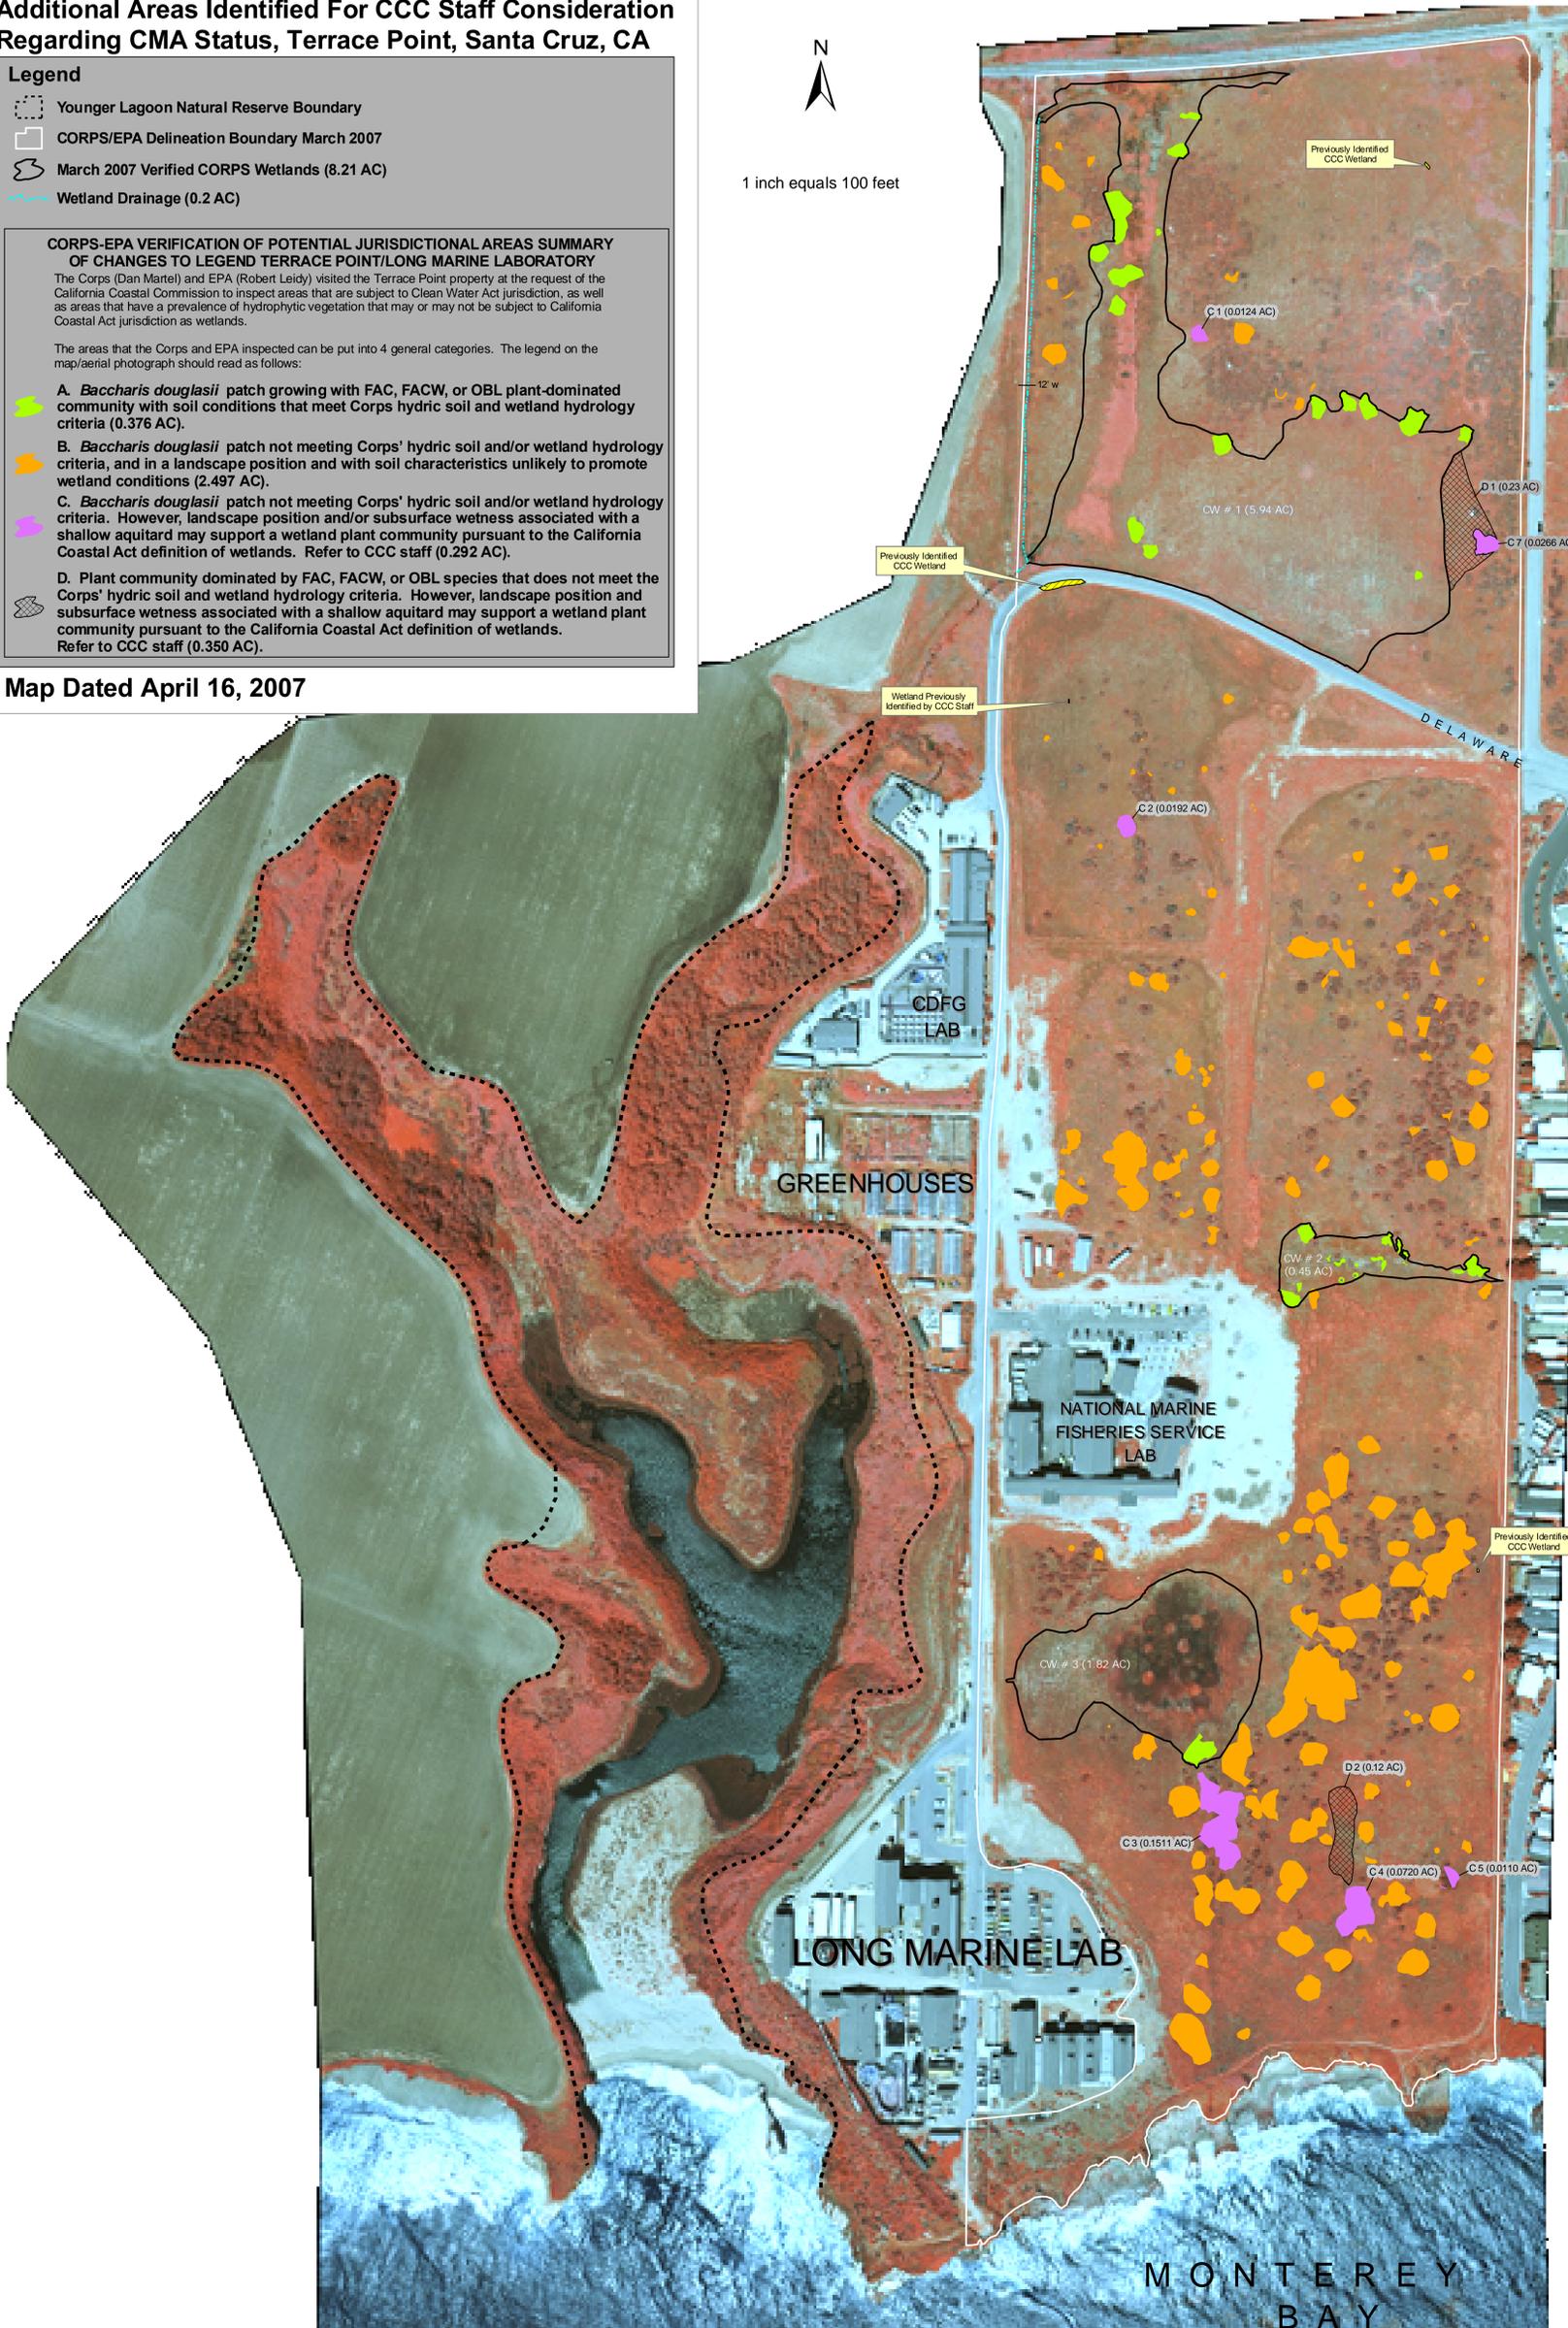
Map Dated April 16, 2007

**A. *Baccharis douglasii* patch growing with FAC, FACW, or OBL plant-dominated community with soil conditions that meet Corps' hydric soil and wetland hydrology criteria (0.376 AC).**

**B. *Baccharis douglasii* patch not meeting Corps' hydric soil and/or wetland hydrology criteria, and in a landscape position and with soil characteristics unlikely to promote wetland conditions (2.497 AC).**
