**CALIFORNIA COASTAL COMMISSION**

**DATE:** October 5, 2009  
**TO:** Commissioners and Interested Parties  
**FROM:** South Central Coast District Staff  
**SUBJECT:** Agenda Item Th11a, Thursday, October 8, 2009, Coastal Development Permit No. 4-07-094 (LACDPW)

**PROJECT DESCRIPTION:** Repair of a damaged public road, including the removal of debris from Dry Canyon Creek, re-compaction of approximately 33 cubic yards of unstable slope by creating a bench at the toe of the slope, and through the placement of approximately 85 tons of light rock and soil over a geo-fabric layer and planted with native vegetation.

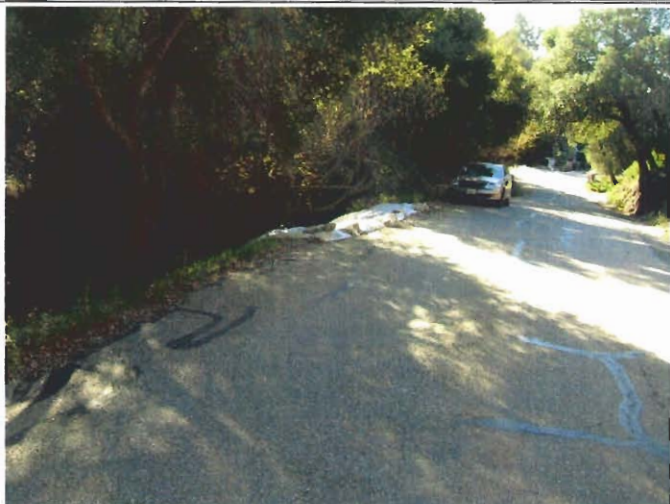
<p><b>Photograph:</b> 1</p> <p><b>Photo Date:</b> December 21, 2005</p> <p><b>Location:</b> Seabreeze Drive, 130 ft. north of Mile Marker 0.20.</p> <p><b>Direction:</b> Facing south along Seabreeze Drive.</p> <p><b>Comment:</b> Rip rap placed over Project site on the east side of Seabreeze Drive.</p>

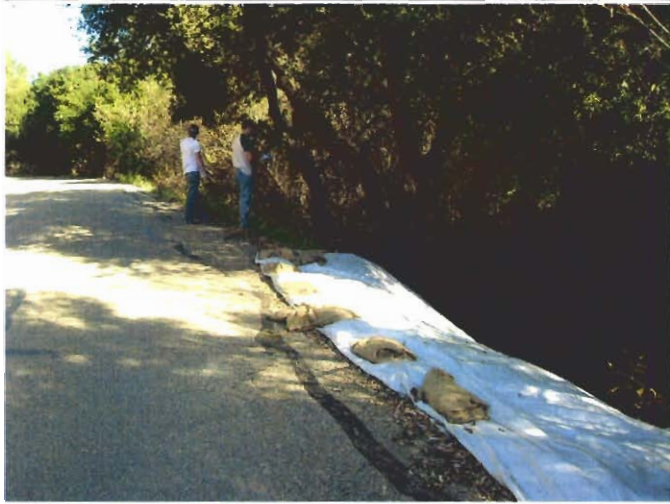
<p><b>Photograph:</b> 2</p> <p><b>Photo Date:</b> December 21, 2005</p> <p><b>Location:</b> Seabreeze Drive, 130 ft. north of Mile Marker 0.20.</p> <p><b>Direction:</b> Facing north along Seabreeze Drive.</p> <p><b>Comment:</b> General work area showing road and implemented rip rap.</p>

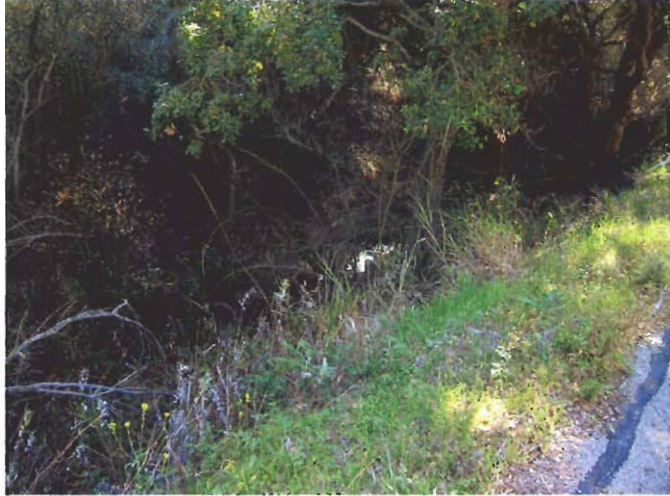
<p><b>Photograph:</b> 3</p> <p><b>Photo Date:</b> December 21, 2005</p> <p><b>Location:</b> Seabreeze Drive, 130 ft. north of Mile Marker 0.20.</p> <p><b>Direction:</b> Facing east down into drainage.</p> <p><b>Comment:</b> General work area showing oak woodland habitat and drainage water.</p>

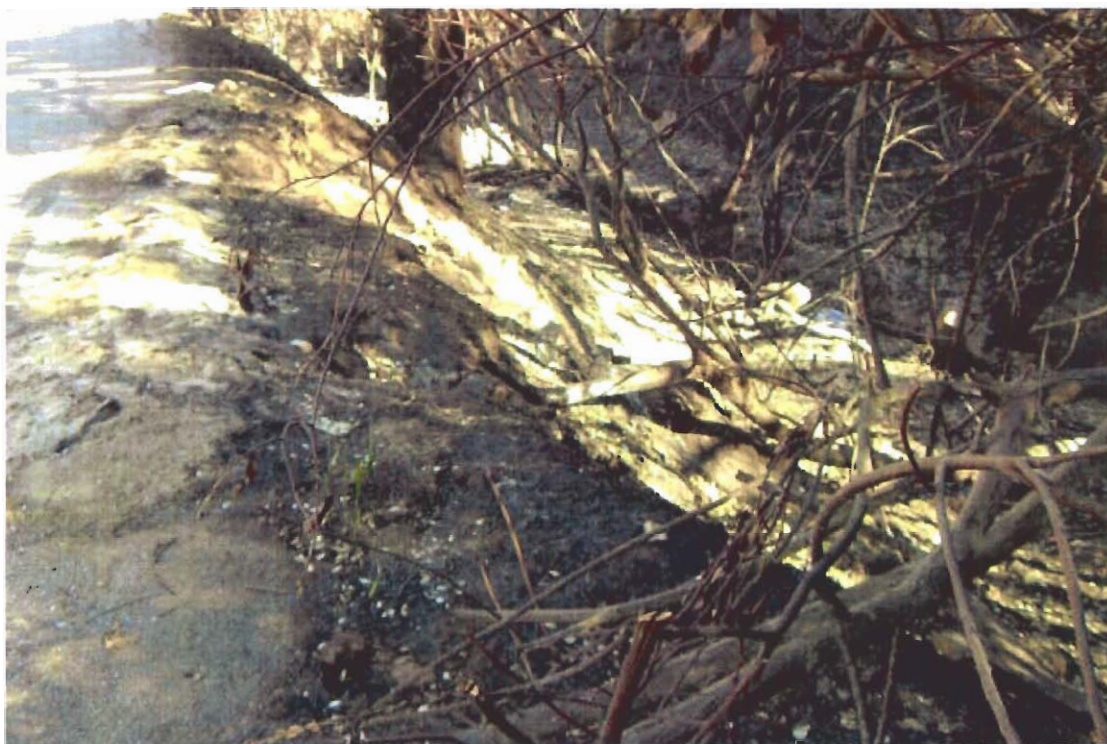
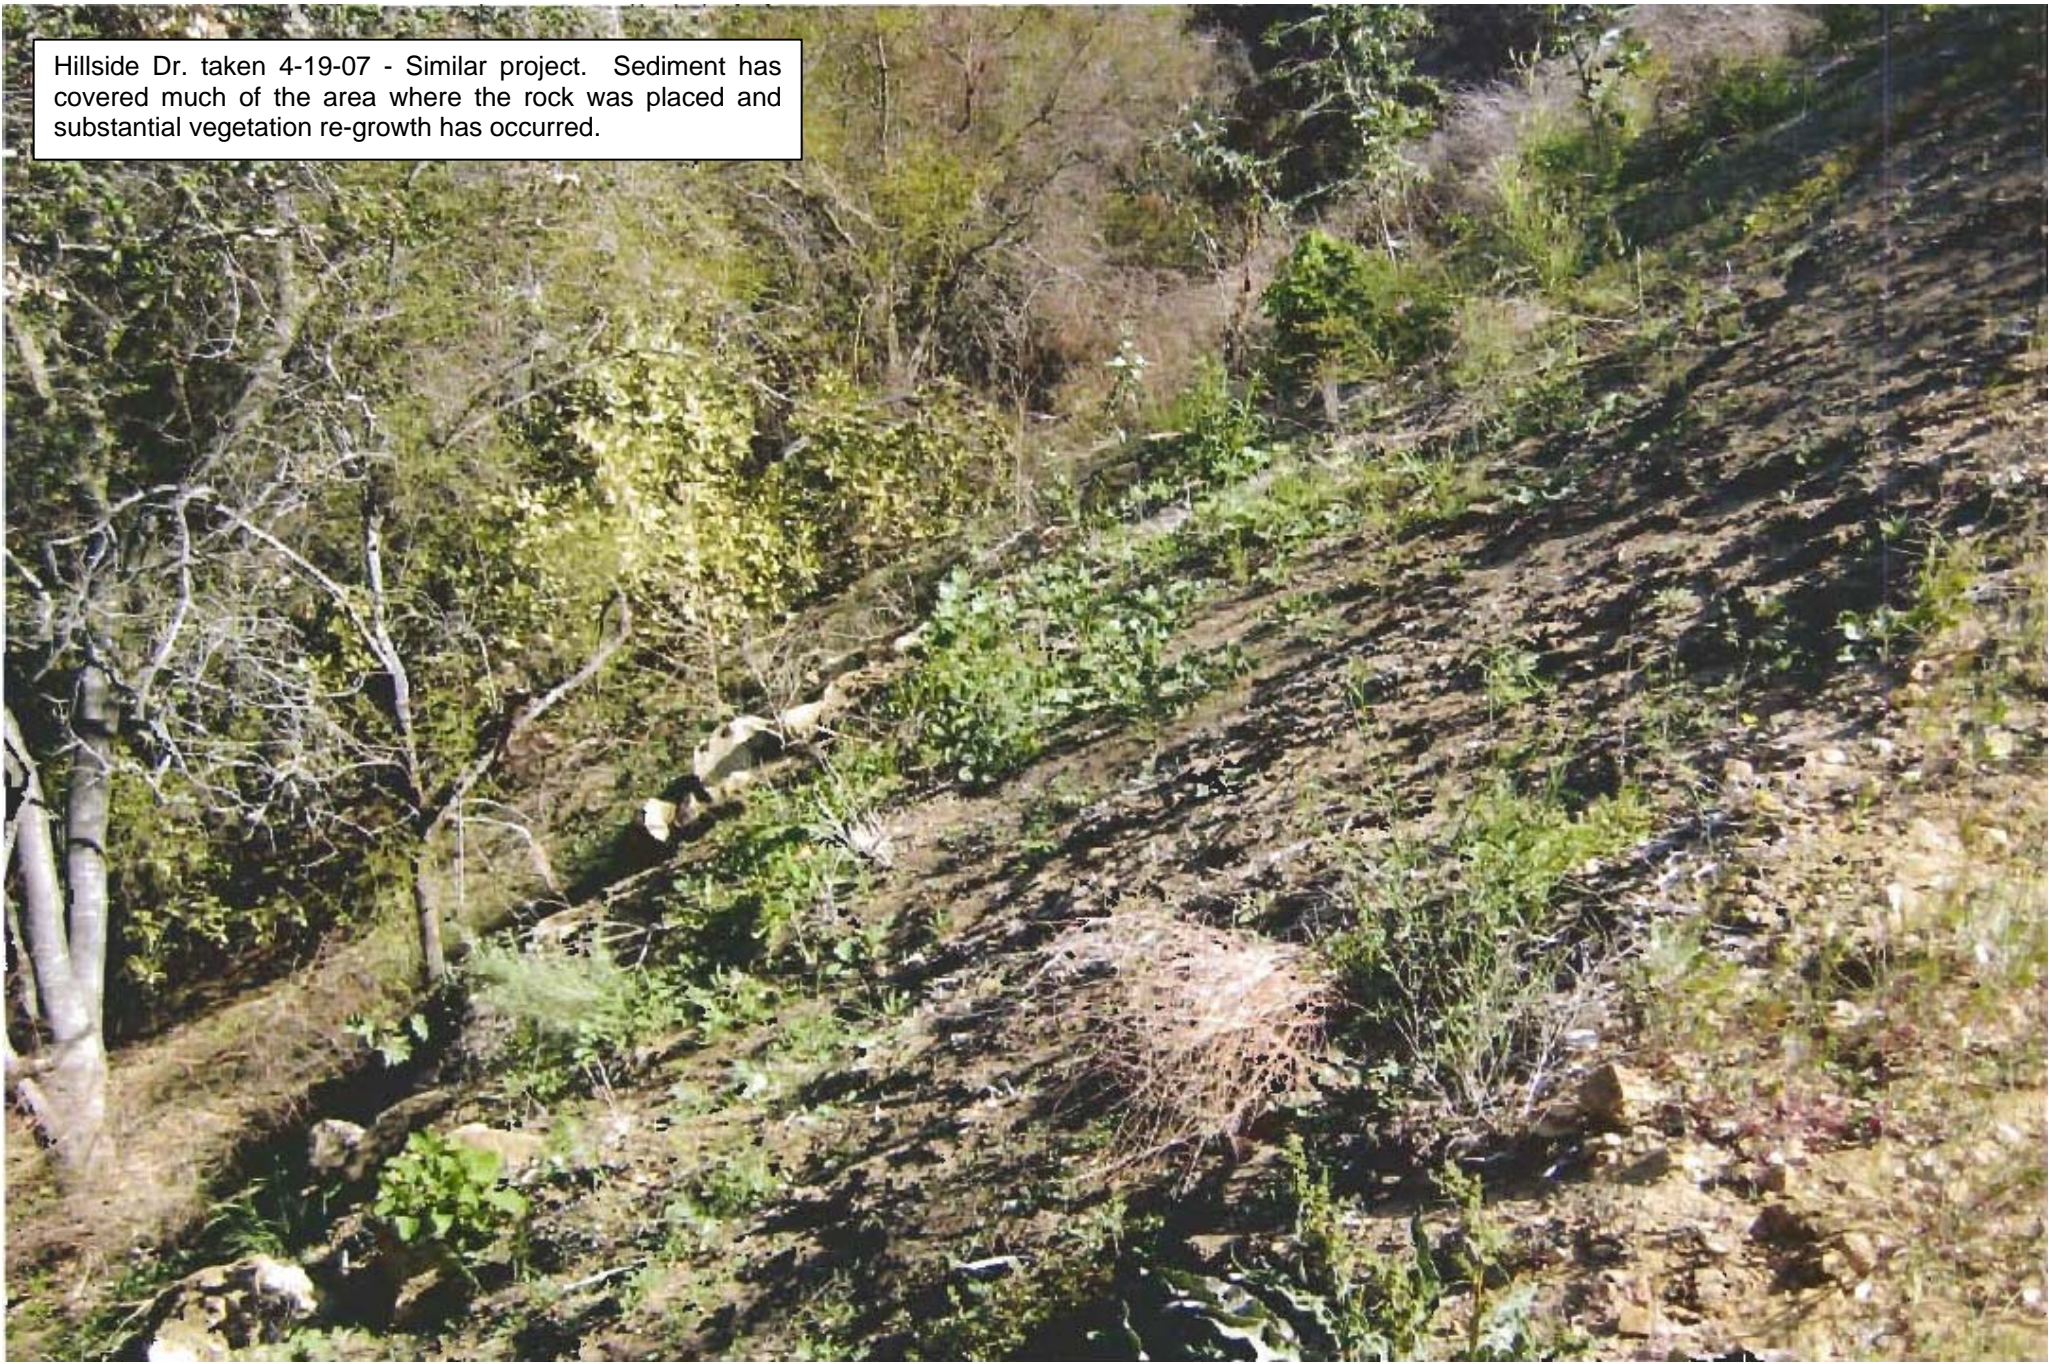
Exhibit No. 7

Hillside Dr. taken 4-19-07 - Similar project. Sediment has covered much of the area where the rock was placed and substantial vegetation re-growth has occurred.

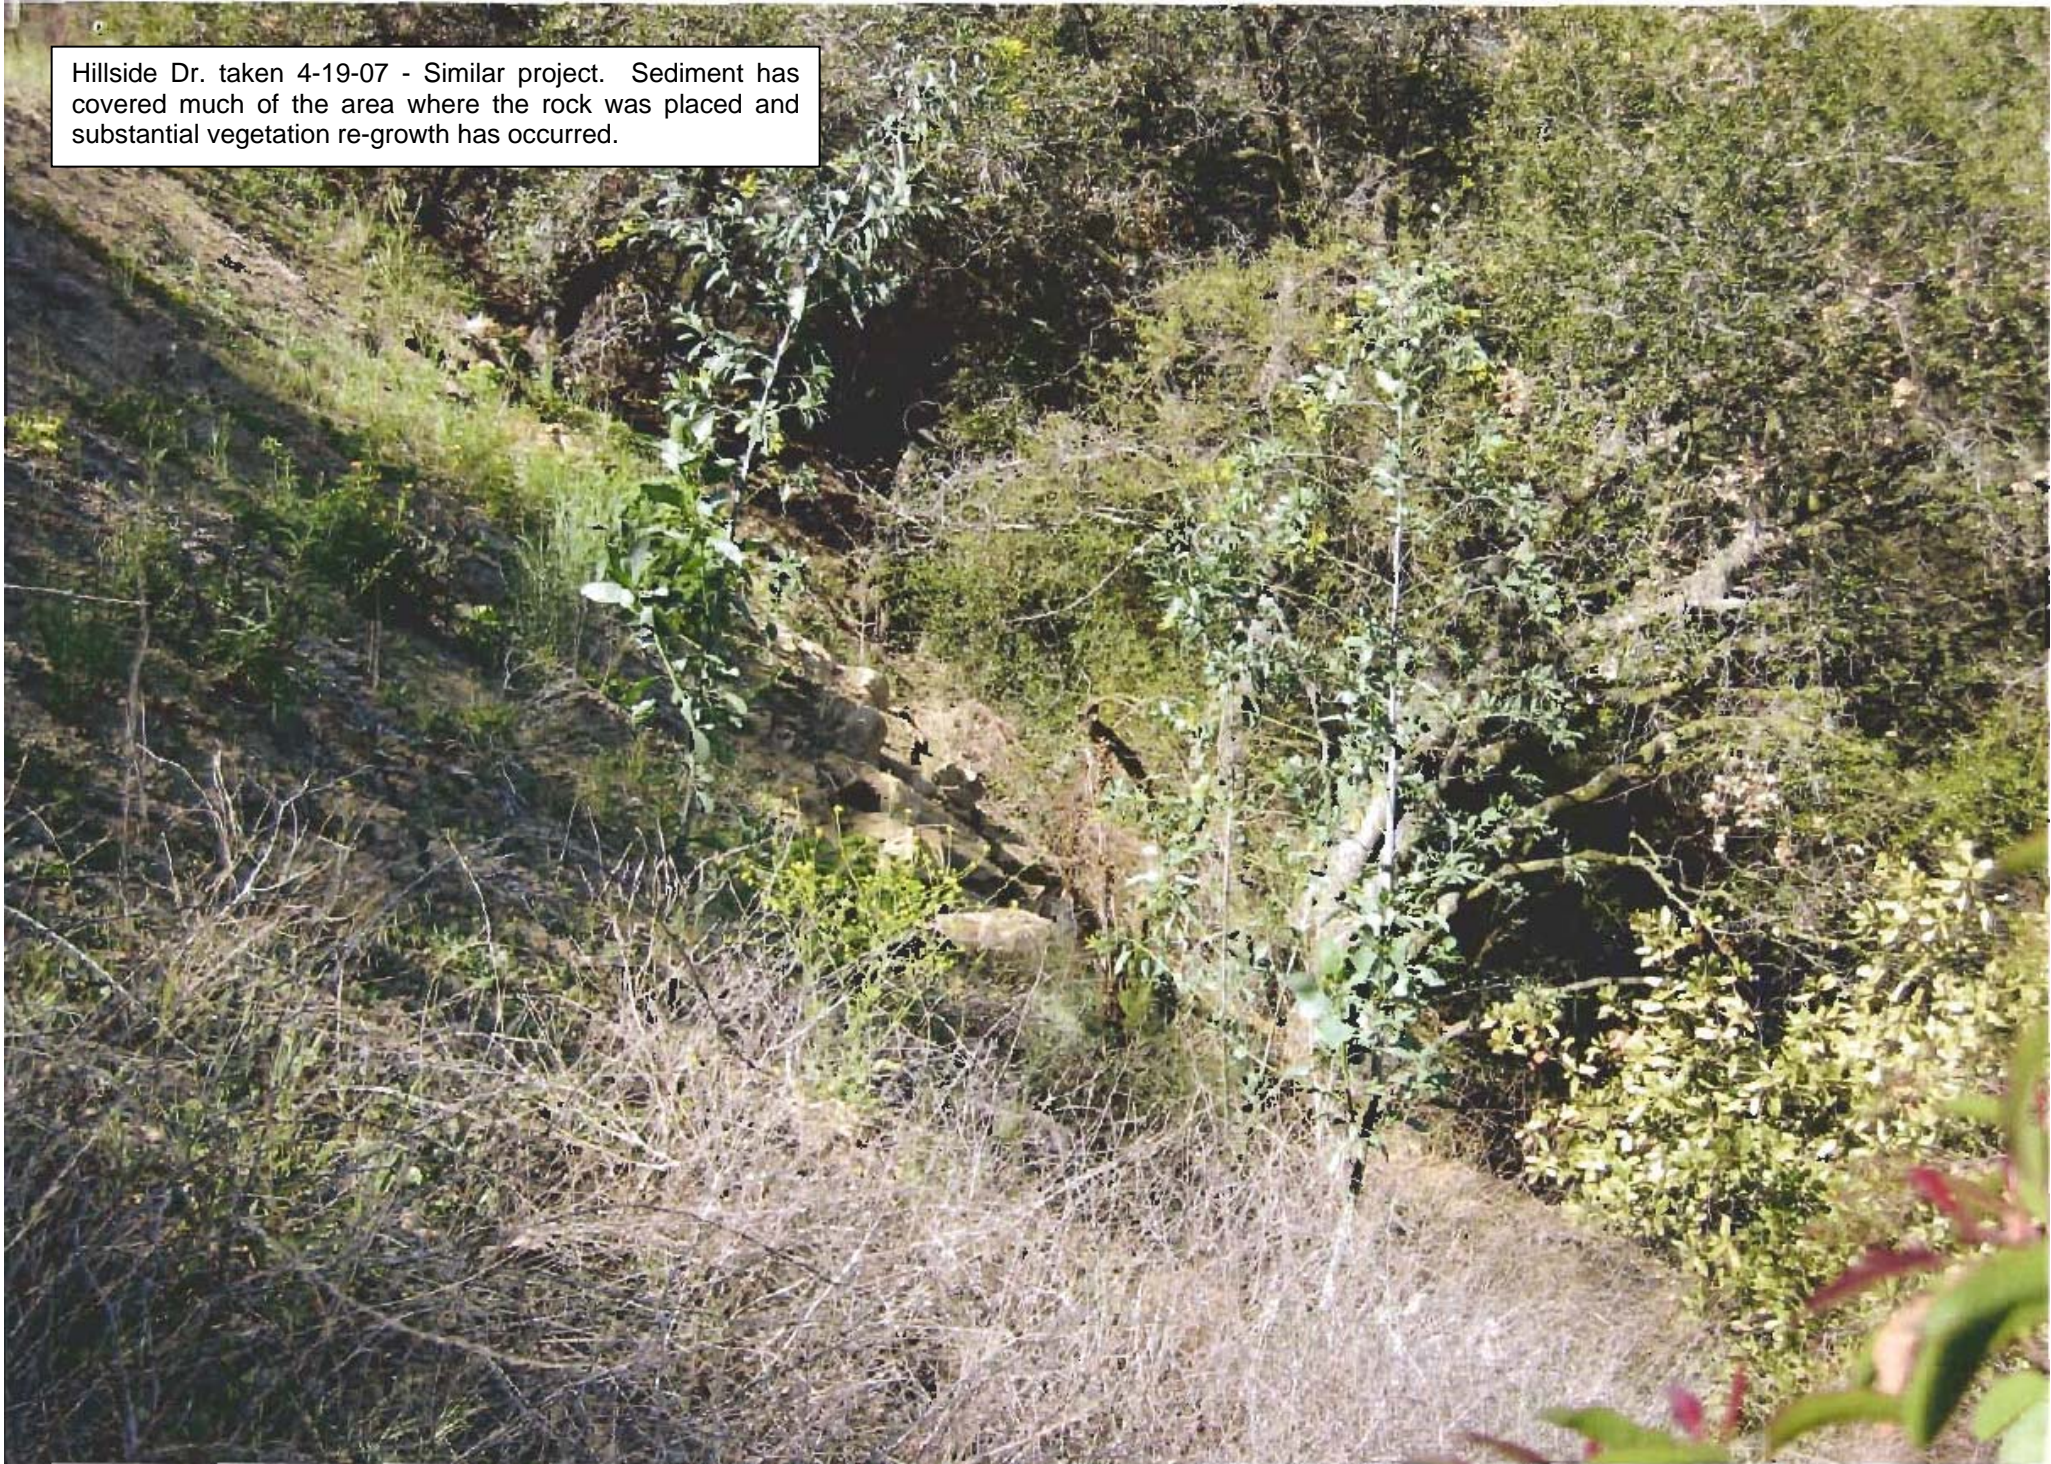
Exhibit No. 7

Hillside Dr. taken 4-19-07 - Similar project. Sediment has covered much of the area where the rock was placed and substantial vegetation re-growth has occurred.

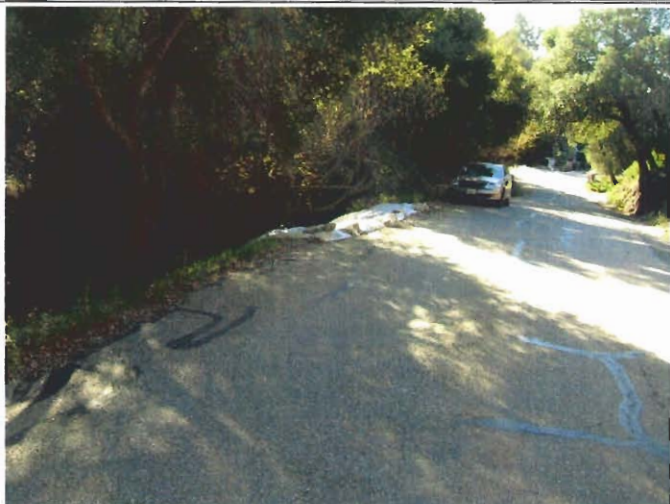
<p><b>Photograph:</b> 1</p> <p><b>Photo Date:</b> December 21, 2005</p> <p><b>Location:</b> Seabreeze Drive, 130 ft. north of Mile Marker 0.20.</p> <p><b>Direction:</b> Facing south along Seabreeze Drive.</p> <p><b>Comment:</b> Rip rap placed over Project site on the east side of Seabreeze Drive.</p>

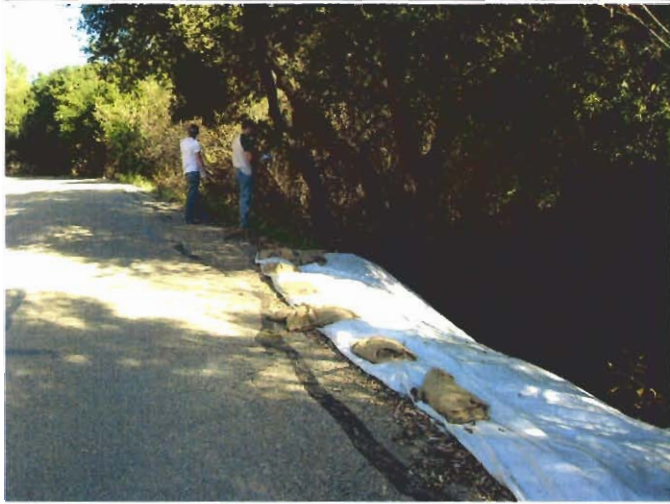
<p><b>Photograph:</b> 2</p> <p><b>Photo Date:</b> December 21, 2005</p> <p><b>Location:</b> Seabreeze Drive, 130 ft. north of Mile Marker 0.20.</p> <p><b>Direction:</b> Facing north along Seabreeze Drive.</p> <p><b>Comment:</b> General work area showing road and implemented rip rap.</p>

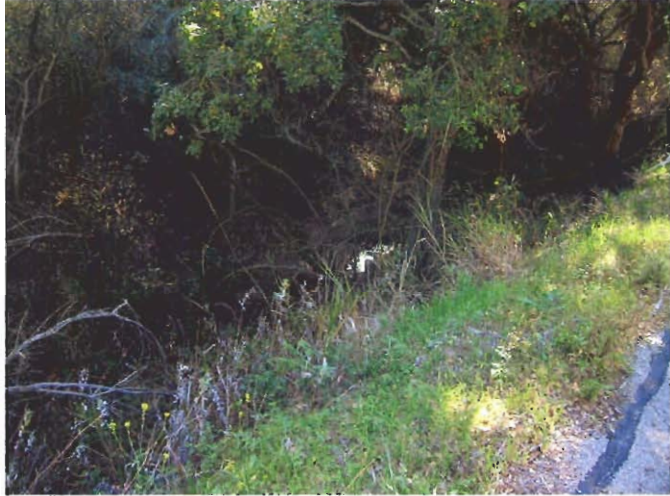
<p><b>Photograph:</b> 3</p> <p><b>Photo Date:</b> December 21, 2005</p> <p><b>Location:</b> Seabreeze Drive, 130 ft. north of Mile Marker 0.20.</p> <p><b>Direction:</b> Facing east down into drainage.</p> <p><b>Comment:</b> General work area showing oak woodland habitat and drainage water.</p>
