**ANALYSIS OF COASTAL BLUFF MORNING-GLORY
(*CALYSTEGLIA PURPURATA* SSP. *SAXICOLA*)
POPULATION**

GUALALA, MENDOCINO COUNTY, CALIFORNIA

EXHIBIT NO. 14
APPEAL NO. A-1-MEN-05-037 (PIETY/PANELLI) JUNE 2004 ANALYSIS OF COASTAL BLUFF MORNING- GLORY HABITAT

**47021 Pirates Drive
Gualala, Mendocino County, California**

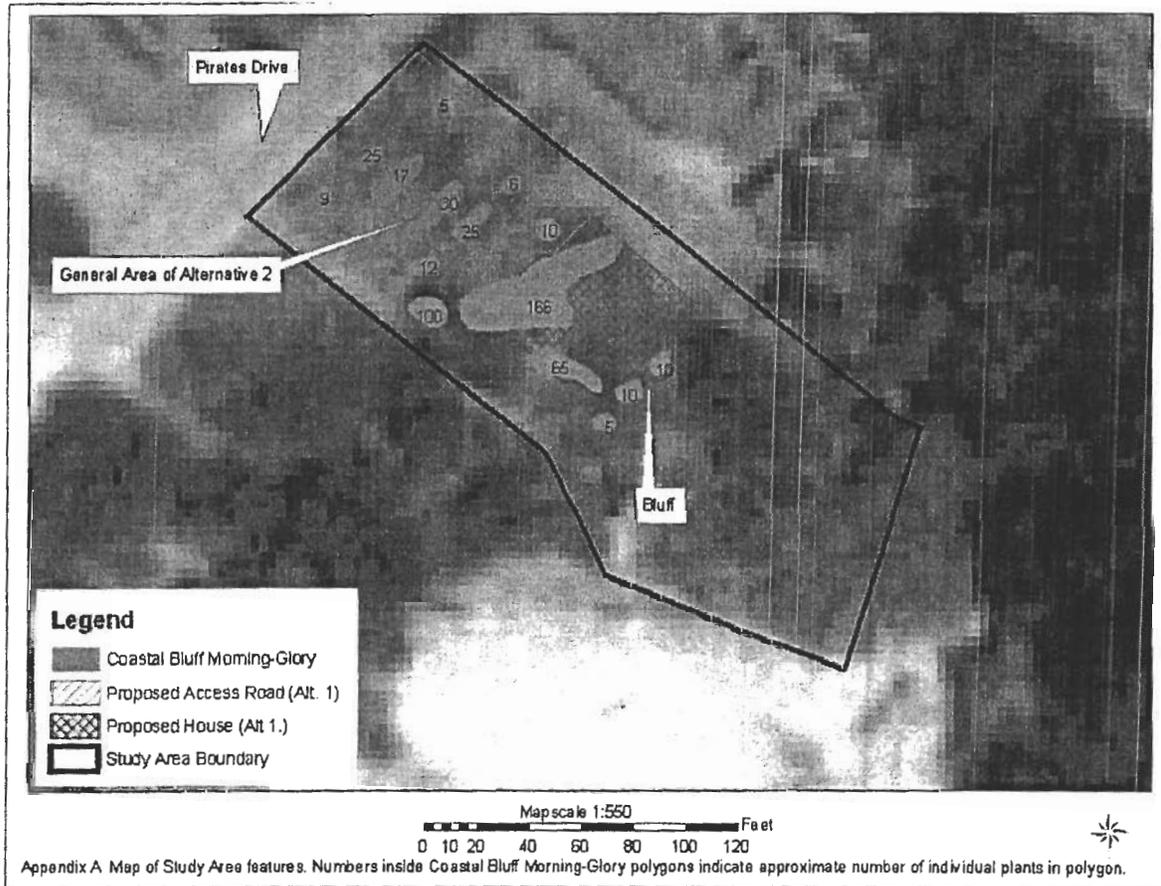
Figure 1. Map showing property, location of proposed Alternative 1 building area, and several patches of coastal bluff morning-glory mapped on the site in June, 2004 (Albion Environmental, Inc.).

The areas on the north side of the property near Pirates Drive where the plant has recolonized after disturbance (Figure 1), demonstrates that this plant can recover after a major disturbance, (and may actually benefit from some disturbance). Though the plant was found in higher densities toward the center of the property (Figure 1), this may be a reflection of the disturbance that occurred on the north side, and the lack of any disturbance on the center of the property. It is possible that with at least some management (i.e. weed control/ mowing), the colonies of coastal bluff morning-glory on the north side will expand, and possibly reach density levels observed in the undisturbed central portion of the property. Weed control will be a critical component of protecting the species, since in some areas that were heavily disturbed, weeds have become dominant (Figure 6). It should also be noted that plant distributions are dynamic and should be expected to vary in their abundance and distribution at a particular site due to changes in physical (e.g. annual and seasonal rainfall and temperature) and biological factors (predation and competition). Plant distributions on a particular site can therefore have dramatic shifts in abundance and distribution over the course of a single year. For this reason, it is important to protect, when possible, contiguous areas that consist of high quality habitat and marginal habitat, since these habitats will fluctuate over time.

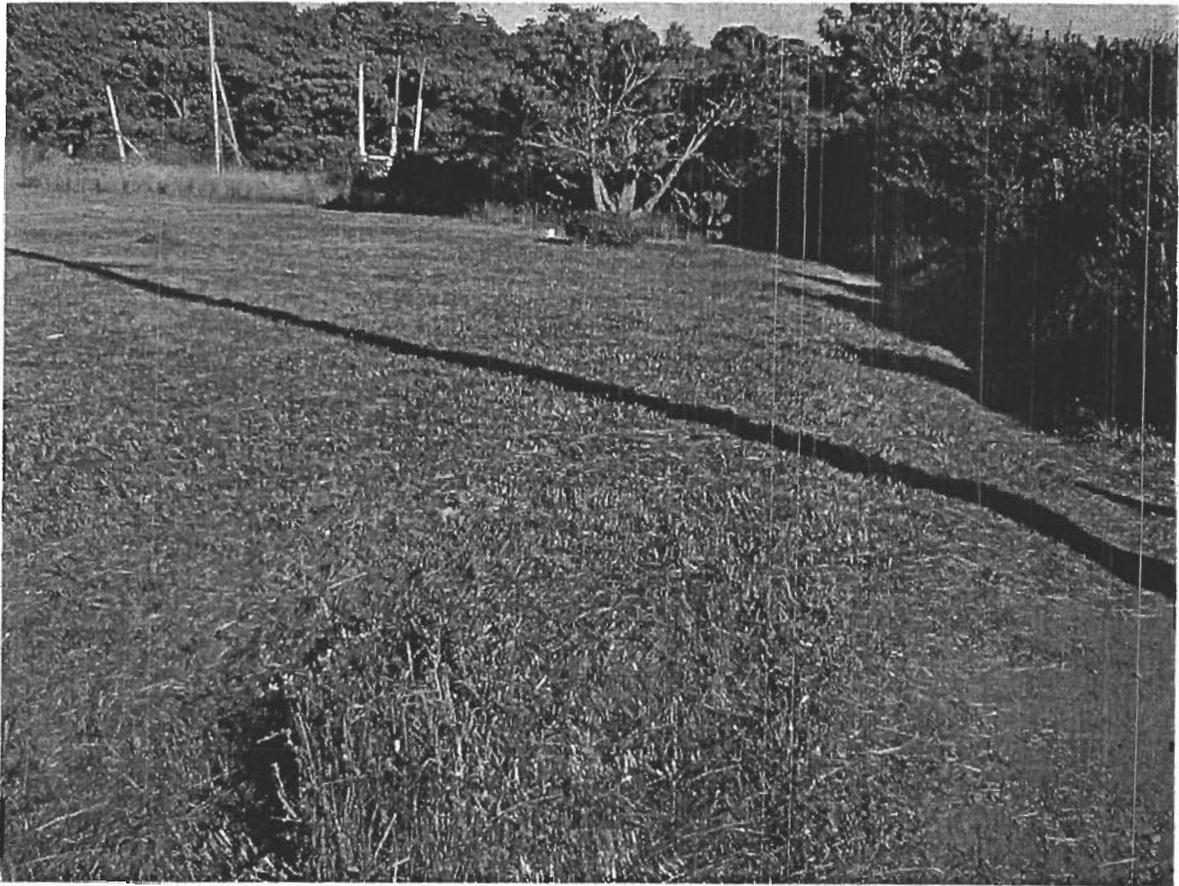
Figure 2. View of property at 47021 Pirates Drive, Gualala. View is looking southeast. Story poles in background represent the Alternative 1 building location and are near the grassland/scrub boundary. Photo date: 09/03/04. See Figure 7 for a comparative view of the site in 2001.

The site was mowed just prior to a field visit on September 3, 2004. The coastal bluff morning-glory on site was found to be easily observable within the mowed areas, and was leafing out and growing back vigorously (Figure 2). For the first three years of the project, the site should be mowed 3 times per year. Twice in the early spring, and once in the fall. Care should be taken to mow above the height of the prostrate coastal bluff morning-glory, when possible. Mowing will also help control the expansion of brush into the grassland on site. Brush expansion is a problem especially in grasslands in populated areas, where fire is no longer a component of the ecosystem.

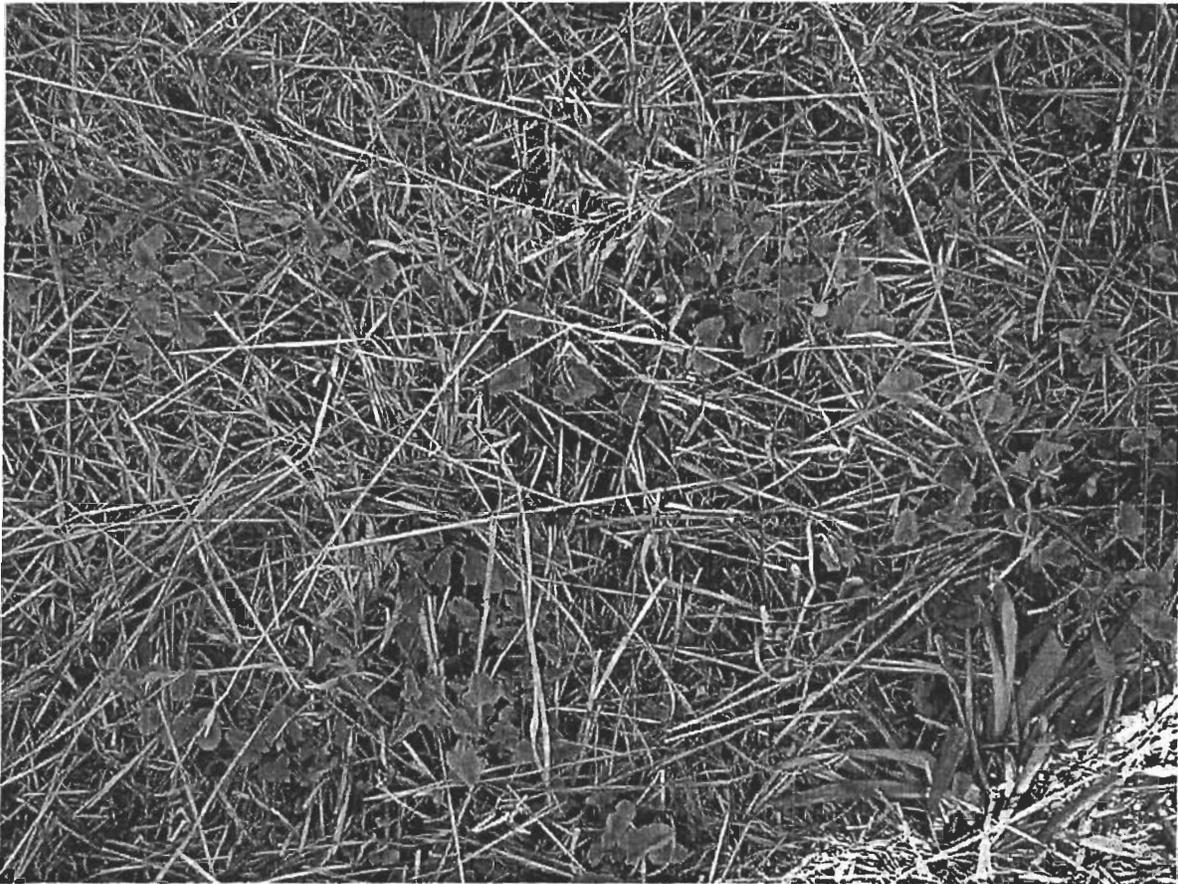
Figure 3. Close up view of the coastal bluff morning glory (*Calystegia purpurata* ssp. *saxicola*) on site. Plants appear to be responding well to the recent mowing (photo date: 09/03/04).

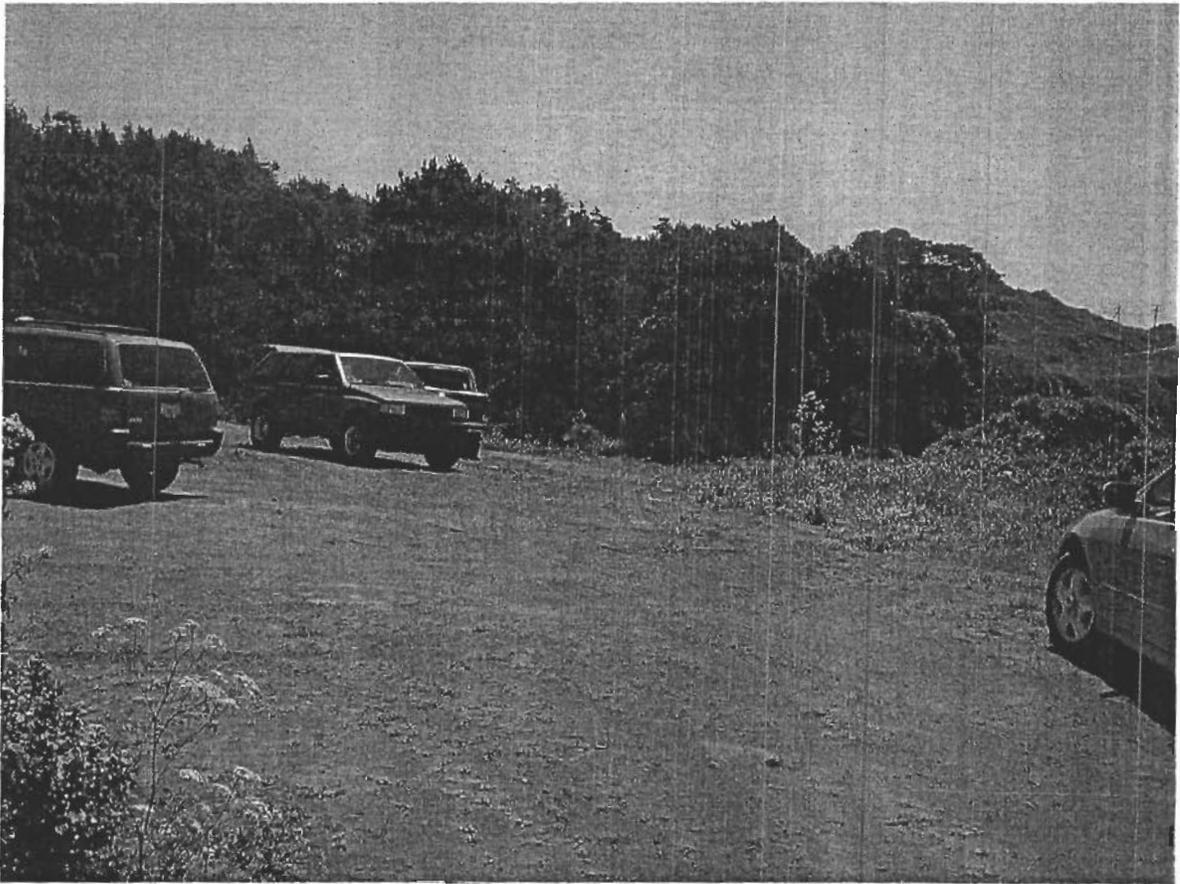
Figure 4. Northern side of property was scraped of vegetation and used as a parking area in 2002. View is looking southeast. Photo date: 06/11/02.

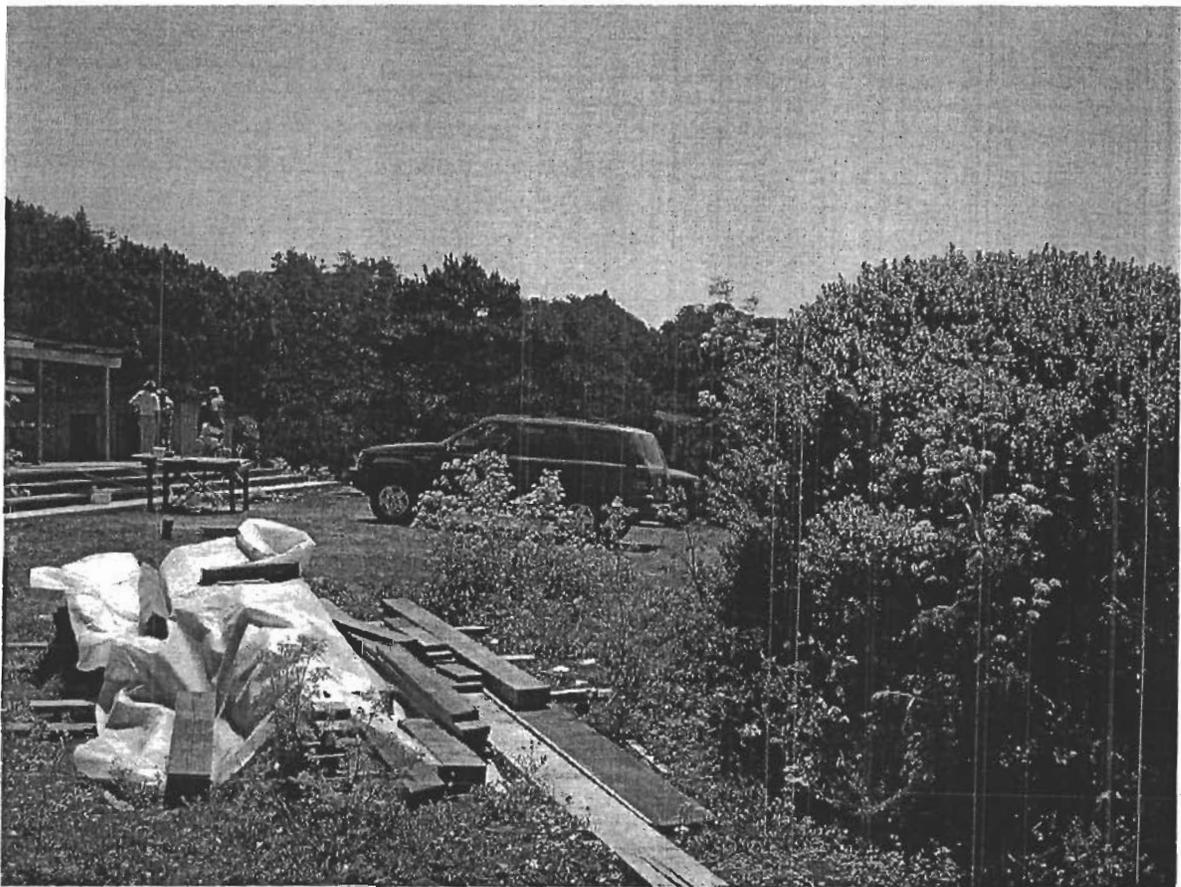
Figure 5. Vehicle usage and construction materials stored on the northern side of the property by work crews during work on an adjacent property in 2002. View is looking southeast. Photo date: 06/11/02.

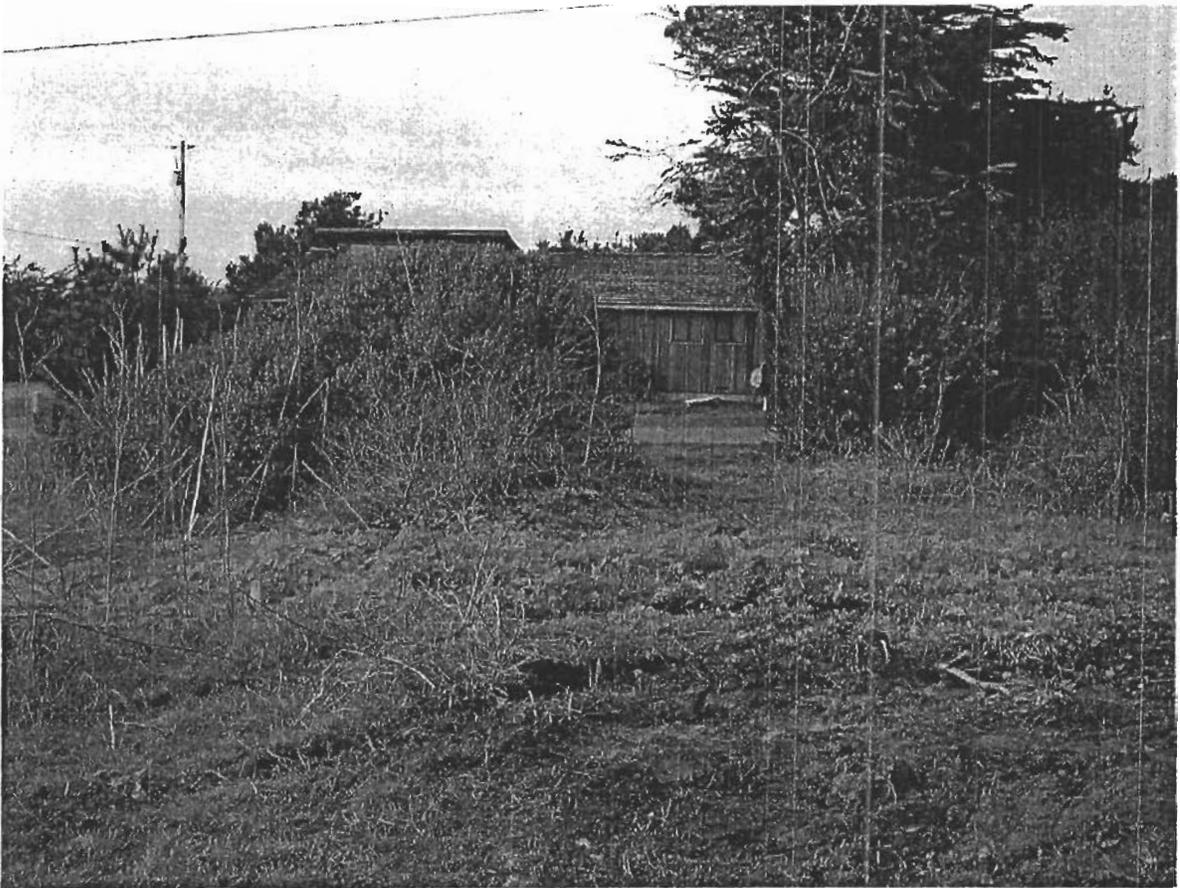
Figure 6. Northern portion of site where vehicles have disturbed the soil (tire tracks) and non-native mustard has invaded the site. View is looking northwest. Photo date: 12/15/01.

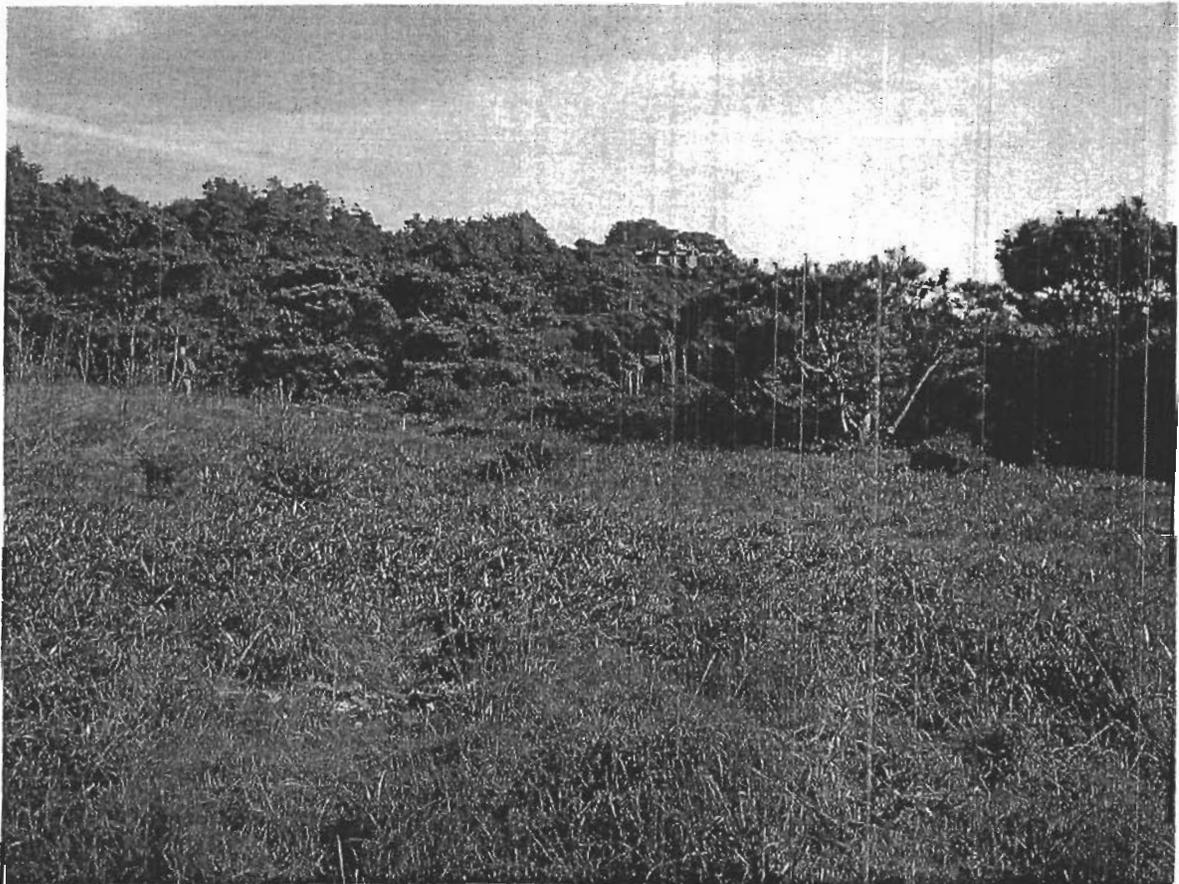
Figure 7. Coastal prairie vegetation on site, prior to clearing work in June, 2002. View is looking southeast. Photo date: 01/13/02.

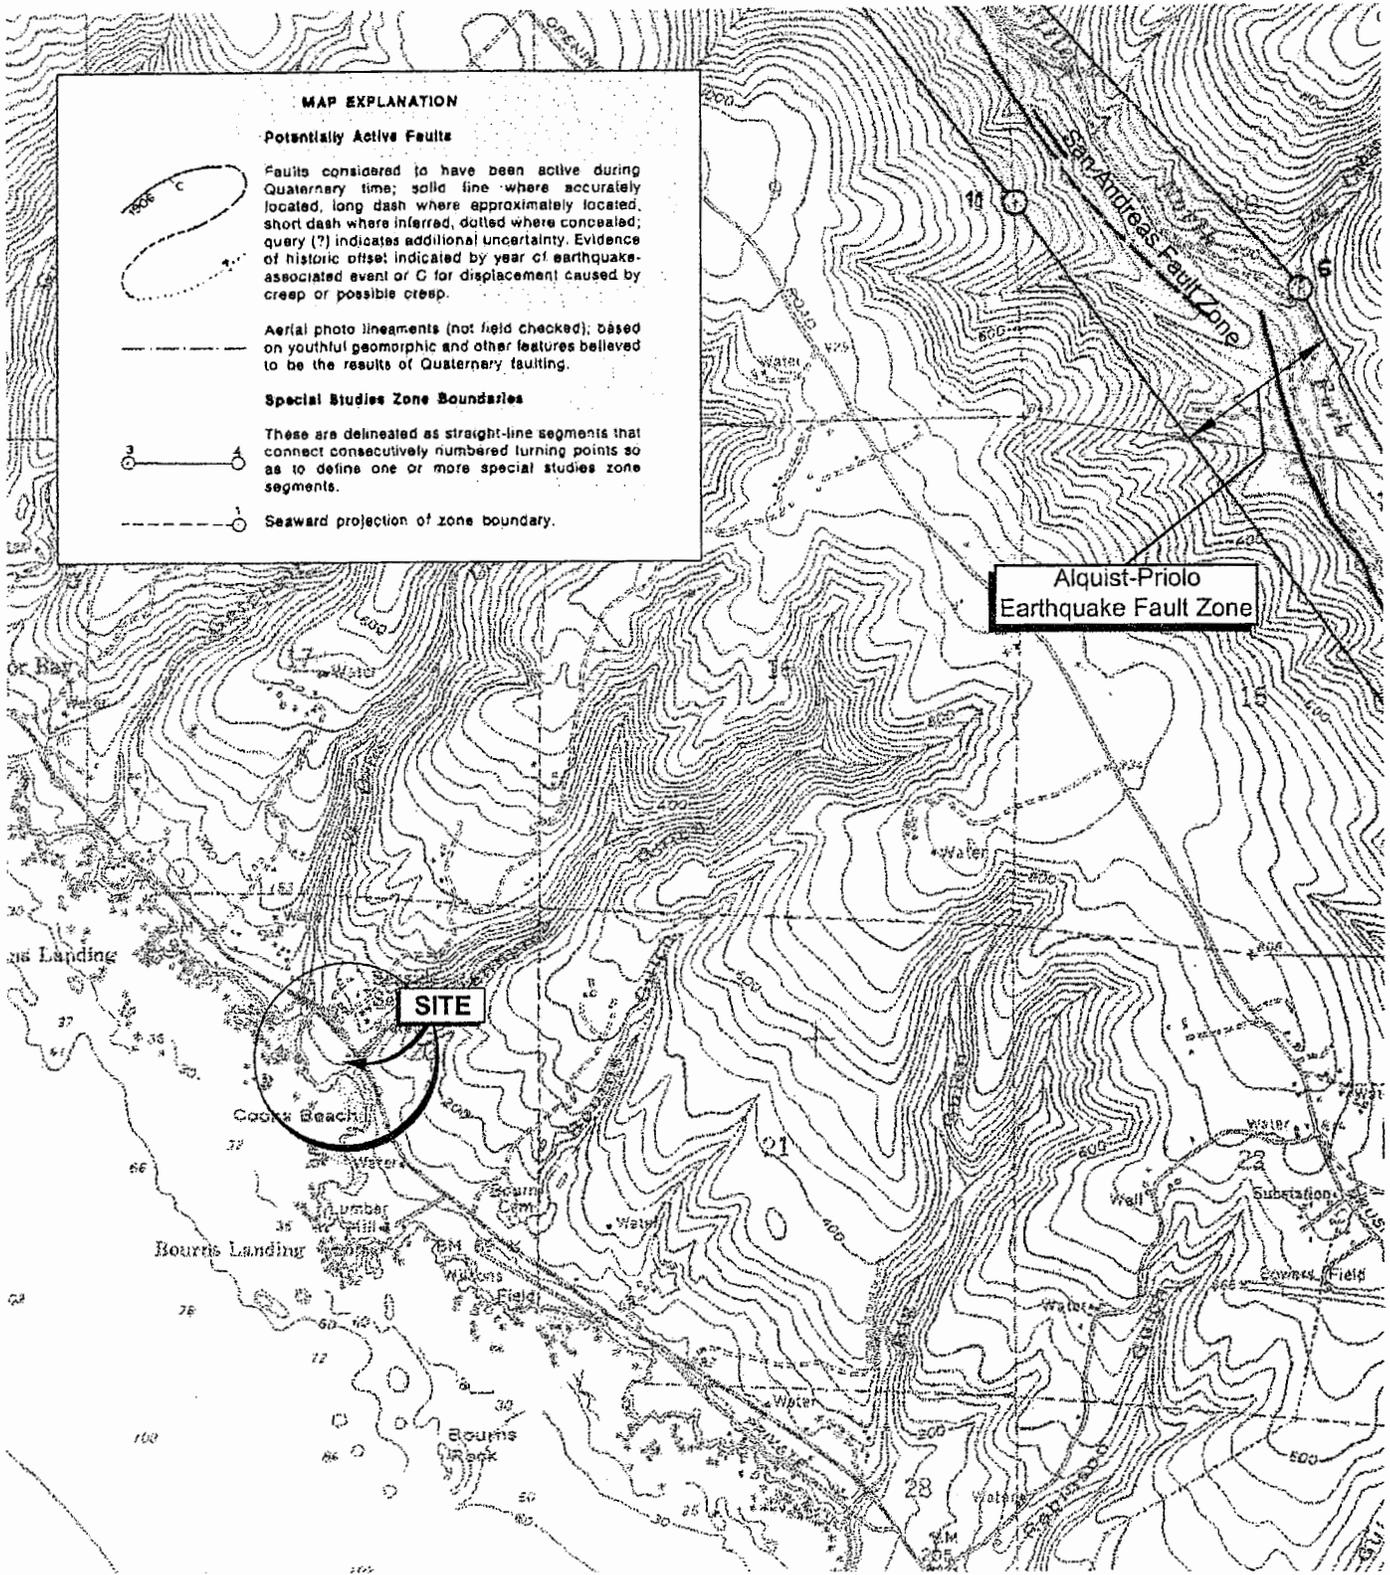
PLATE
1

Reference:
Gualala, 1983, 7.5 Minute Quadrangle
Earthquake Fault Zone Map, CGS.

VICINITY FAULT MAP
PLANNED PIETY RESIDENCE
47021 Pirates Drive
Gualala, California

No landslides were observed at the site except for some relatively minor sloughing on the outer bluff face. No evidence of faulting was observed in the property vicinity and none of the published references that we reviewed show faults on, or trending towards the property. The active San Andreas Fault is located within the canyon of Little North Fork of the Gualala River approximately 2-1/2 miles to the northeast, as shown on Plate 1.

Mendocino County is within a zone of seismic activity associated with the San Andreas Fault. The main trace (1906 movement) of the San Andreas Fault is located approximately 2-1/2 miles northeast of the site. Since the San Andreas Fault is 2-1/2 miles away, and no evidence of faulting was observed at the site, nor shown on the geologic maps and reports that we reviewed, we consider the potential for fault rupture at the site to be very low.

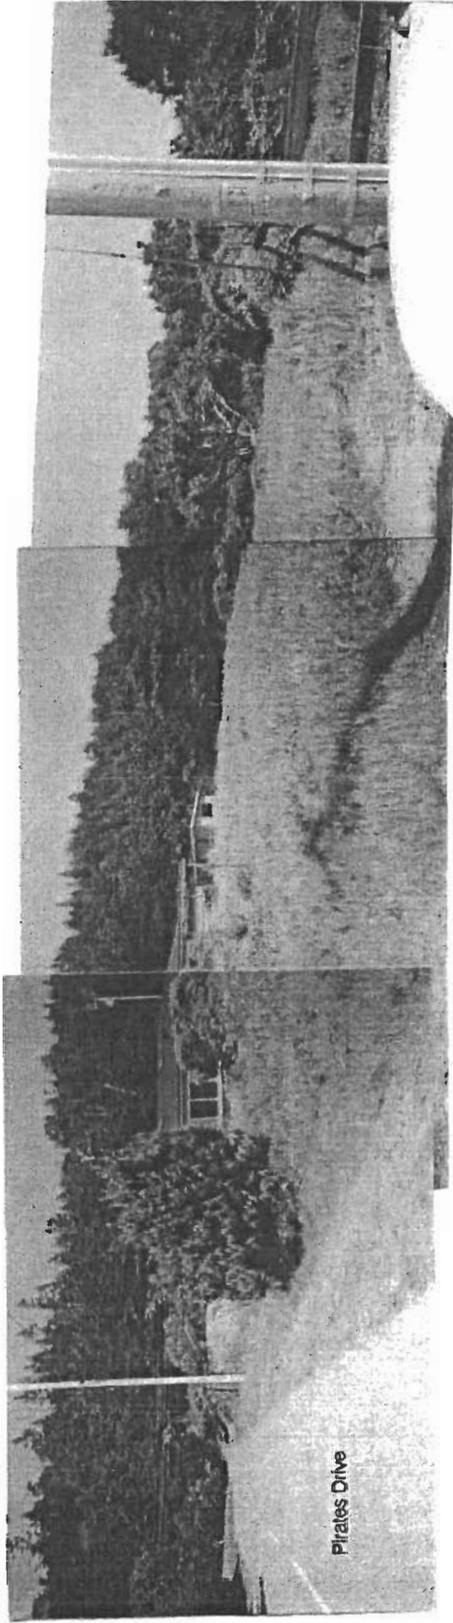
Photograph "A"
Property looking East

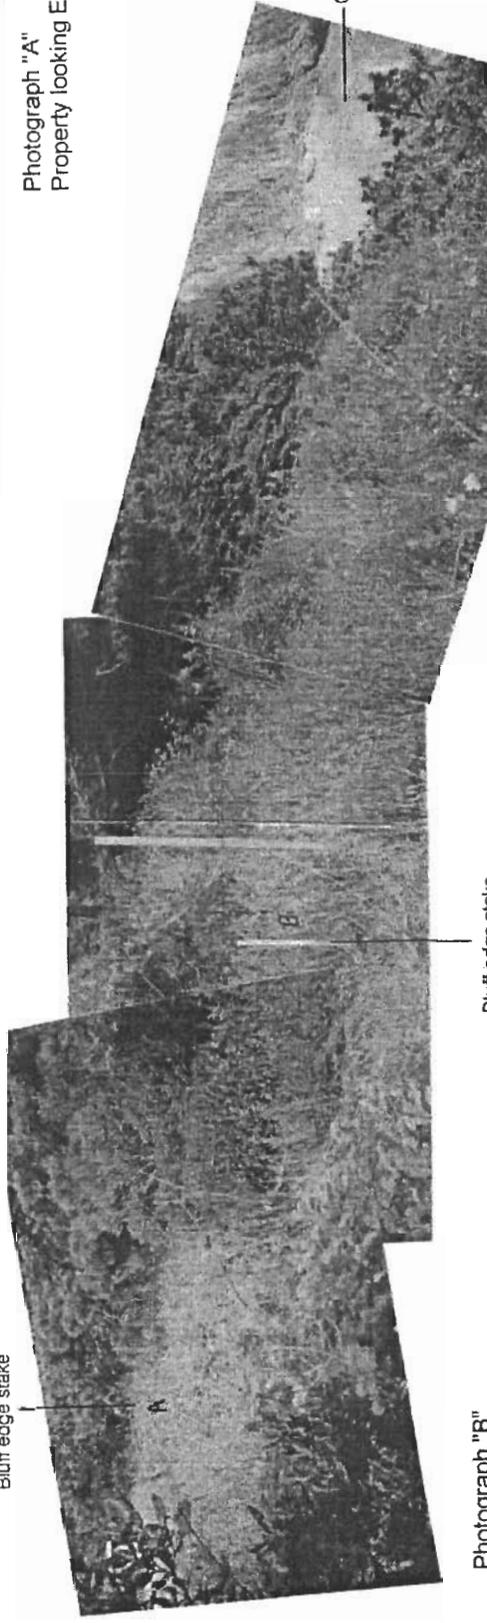
Photograph "B"
Upper bluff looking East

On June 10, 2003, BACE transmitted to you a topographic map showing our staked bluff edge and recommended building setback. Two of the bluff edge stakes are shown in Photograph B, Plate 2. Stake locations are shown on the Site Plan, Plate 3. No building plans have been prepared yet, but according to your preliminary plan sketches, the proposed one-story house will have an attached garage at the north end of the structure. The leach field will be on the northwest side of the structure. We understand that site grading will be limited to minor, if any, cuts or fills for drainage around the structure, and reprocessing of weak soils for support of slab-on-grade floors in the garage and/or elsewhere within the structure.

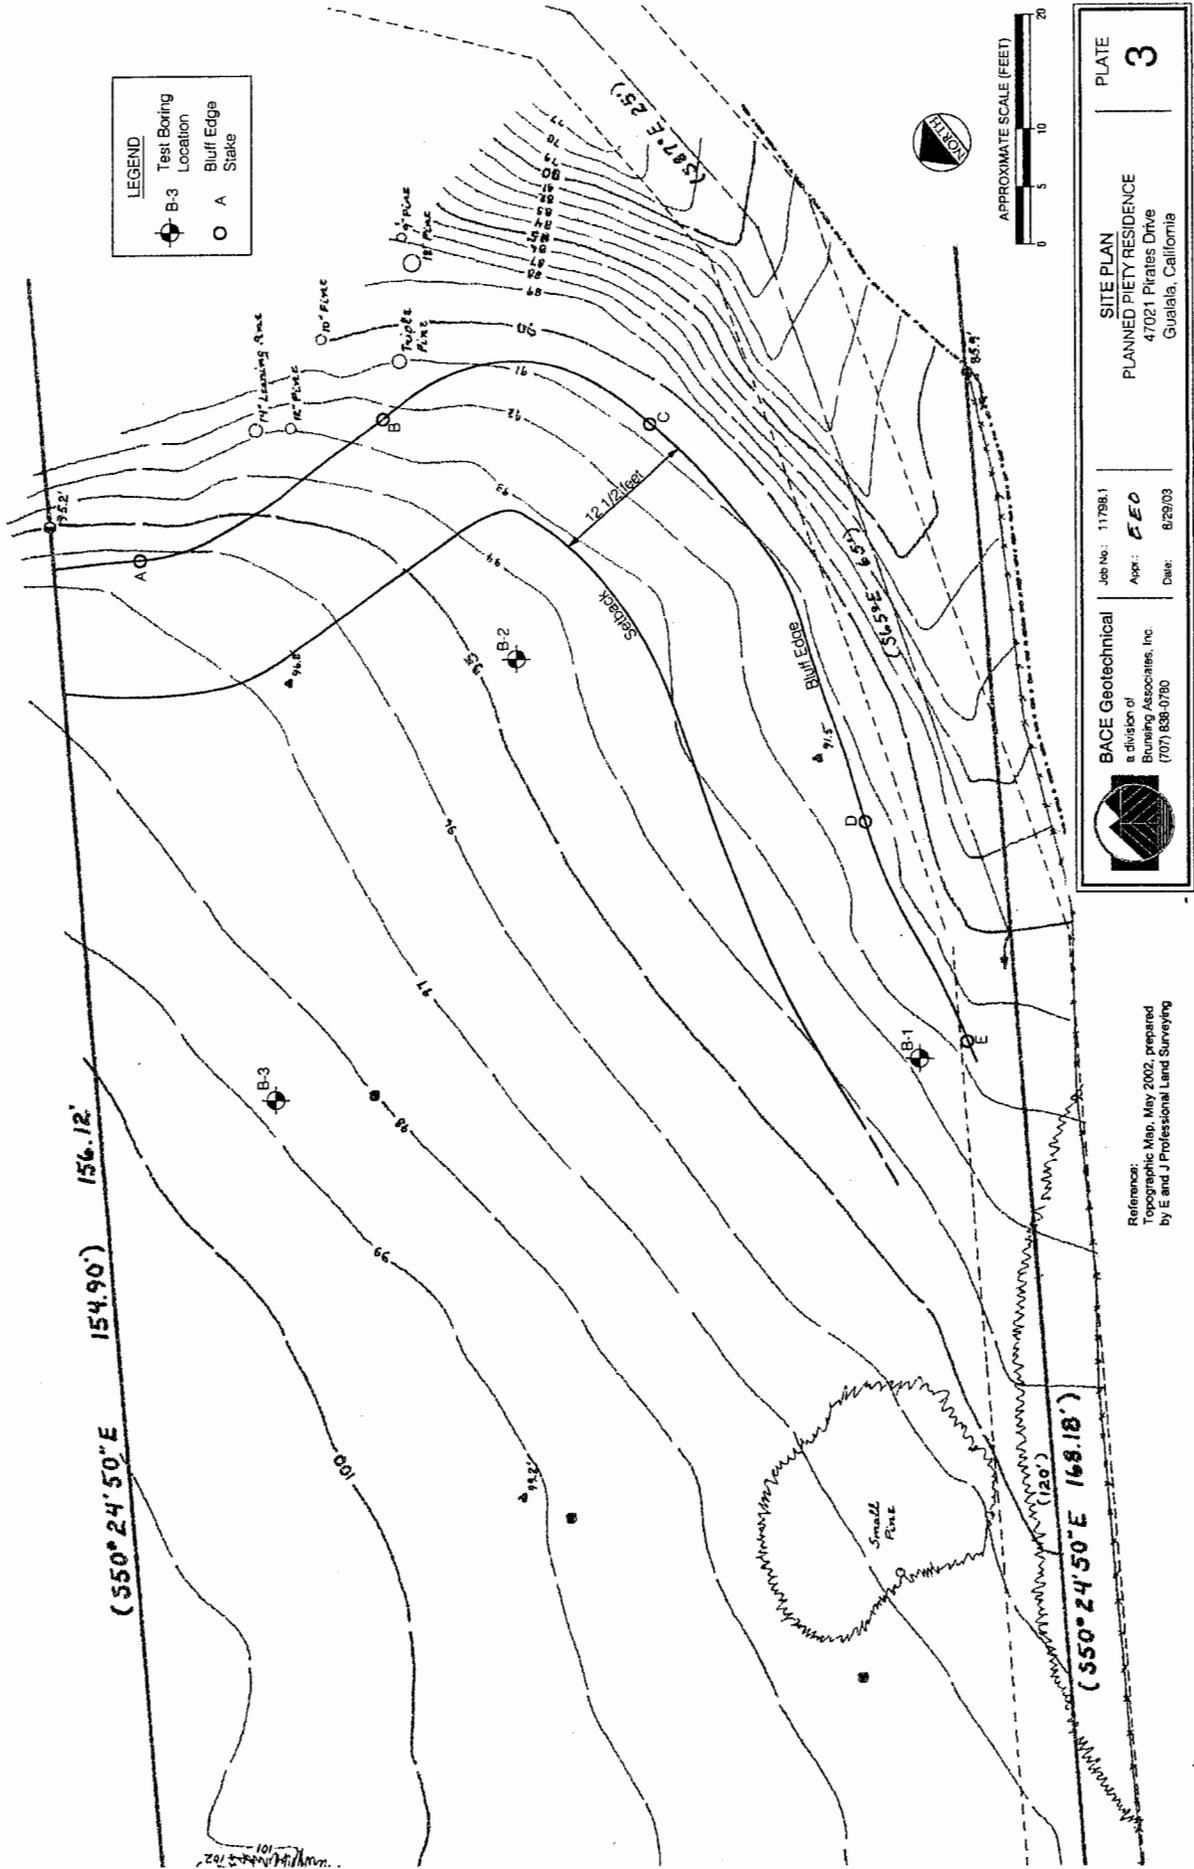
- Test Boring Location
- Bluff Edge Stake

The field exploration consisted of the drilling, logging, and sampling of three test borings within the planned building area. The borings were drilled on June 12, 2003, with a track-mounted all-terrain drill rig utilizing flight auger equipment. The test borings, B-1 through B-3, were 10, 12, and 13-1/2 feet in depth, respectively. Our Project Geologist logged the borings and obtained both relatively undisturbed tube and loose bulk-samples of the materials encountered for visual classification and laboratory testing. The approximate boring locations are shown on the Site Plan, Plate 3.

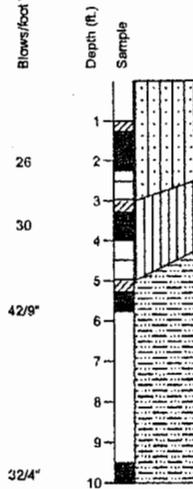
Moisture Content (%)
Dry Density (pcf)
Blows/foot *

25.6 96

NOTES:
(1) No caving
(2) No free water encountered
(3) Practical drilling refusal at 10 ft.

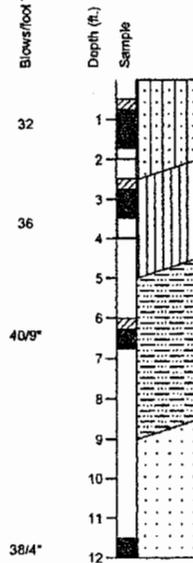
Moisture Content (%)
Dry Density (pcf)
Blows/foot *

12.9 110

NOTES:
(1) No caving
(2) No free water encountered
(3) Practical drilling refusal at 12 ft.

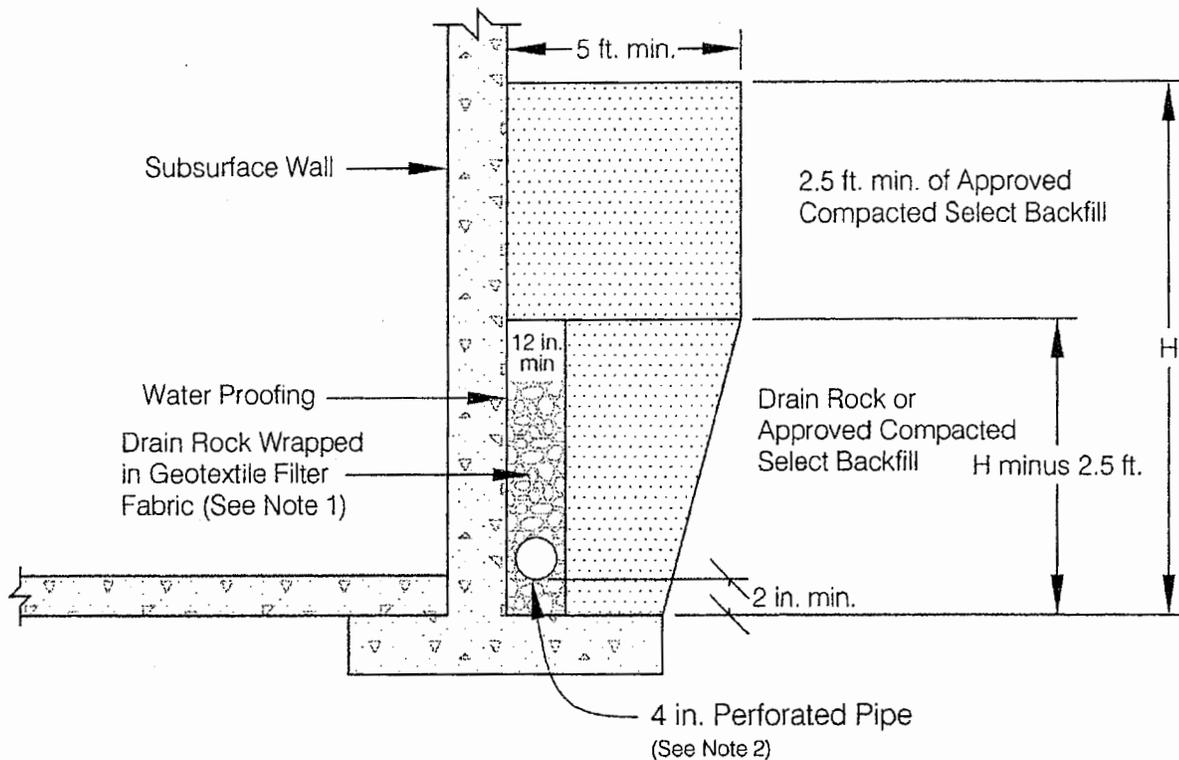
PLATE
10

SUBSURFACE WALL DRAINAGE DETAIL
(Not to Scale)

- (1) Drain rock should be clean, free-draining and meet the requirements for Class 1, Type B, Permeable Material, Section 68, Caltrans Standard Specifications, latest edition, and should be wrapped in geotextile filter fabric (Mirafi 140 or equivalent).
- (2) Pipe should conform to the requirements of Section 68 of Standard Specifications, placed with perforations down, and sloped at 1% to drain to gravity outlet or sump with automatic pump.
- (3) A Clean-out pipe with cap should be installed at the up-slope end of perforated pipe.

RETAINING WALL DRAINAGE DETAIL
PLANNED PIETY RESIDENCE
47021 Pirates Drive
Gualala, California

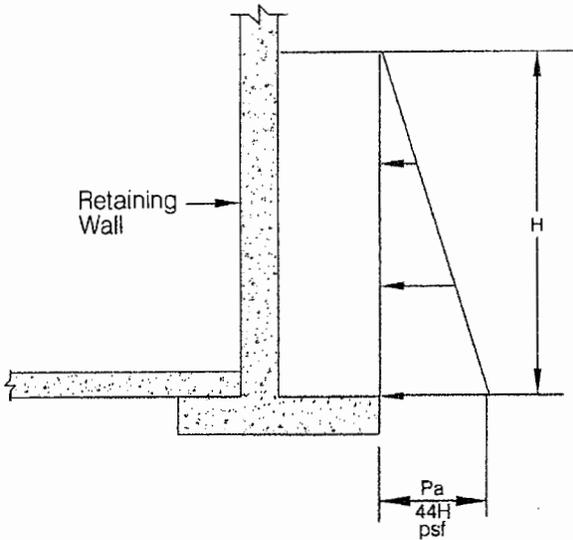
ACTIVE SOIL PRESSURE DIAGRAM

For walls that are free to yield slightly (See Note 2)

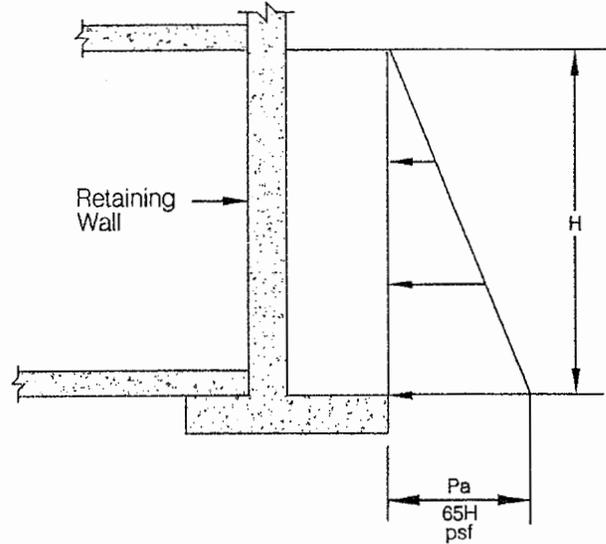
AT-REST SOIL PRESSURE DIAGRAM

For braced walls of substantial rigidity (See Note 2)

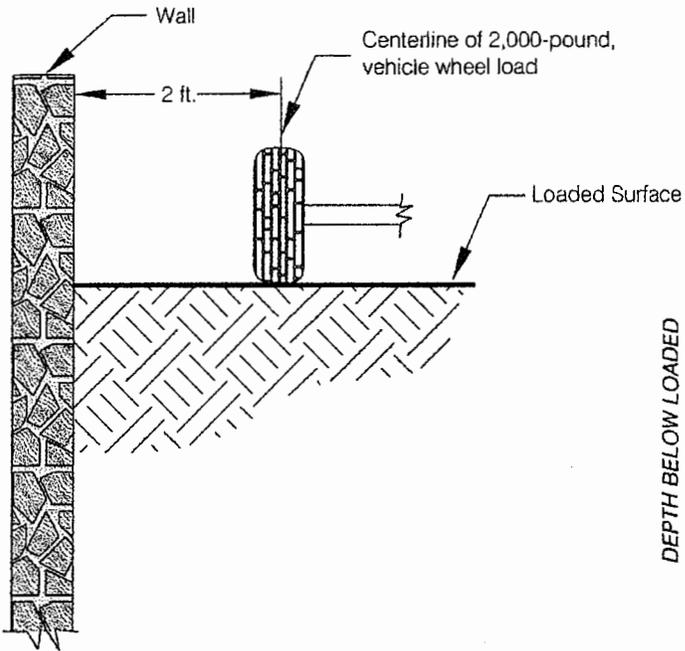
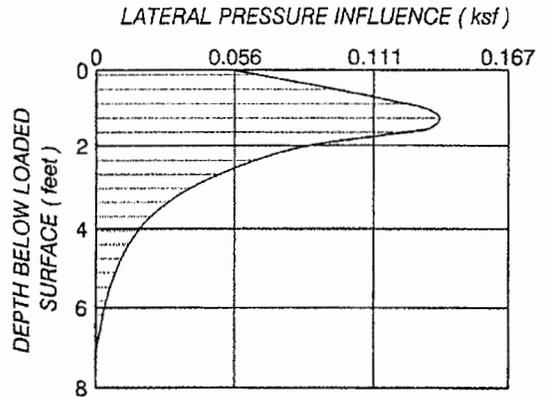
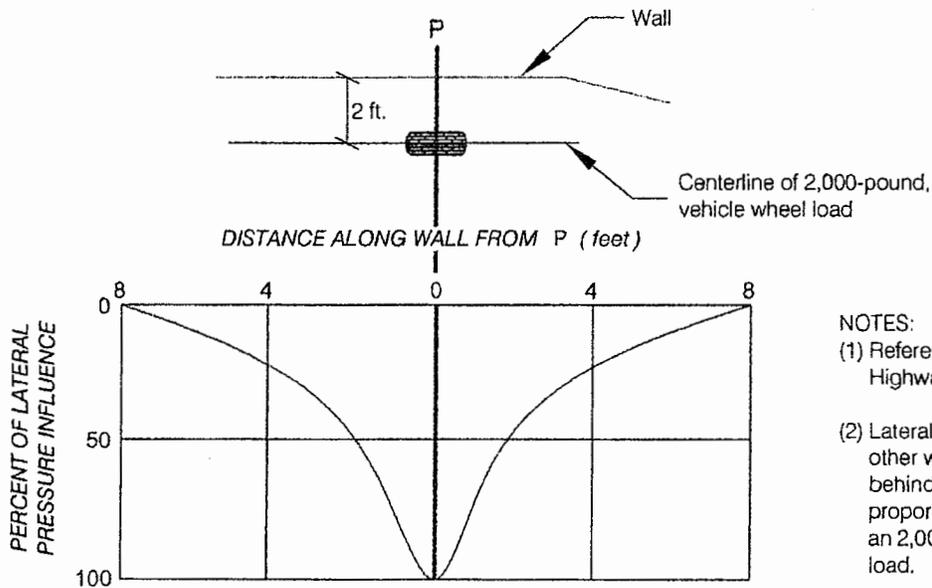
- NOTES:
- (1) Reference: Highway Research Bulletin 141.
 - (2) Lateral pressures influence for other wheel loads located behind a wall would be linearly proportion to those shown for an 2,000-pound, vehicle wheel load.

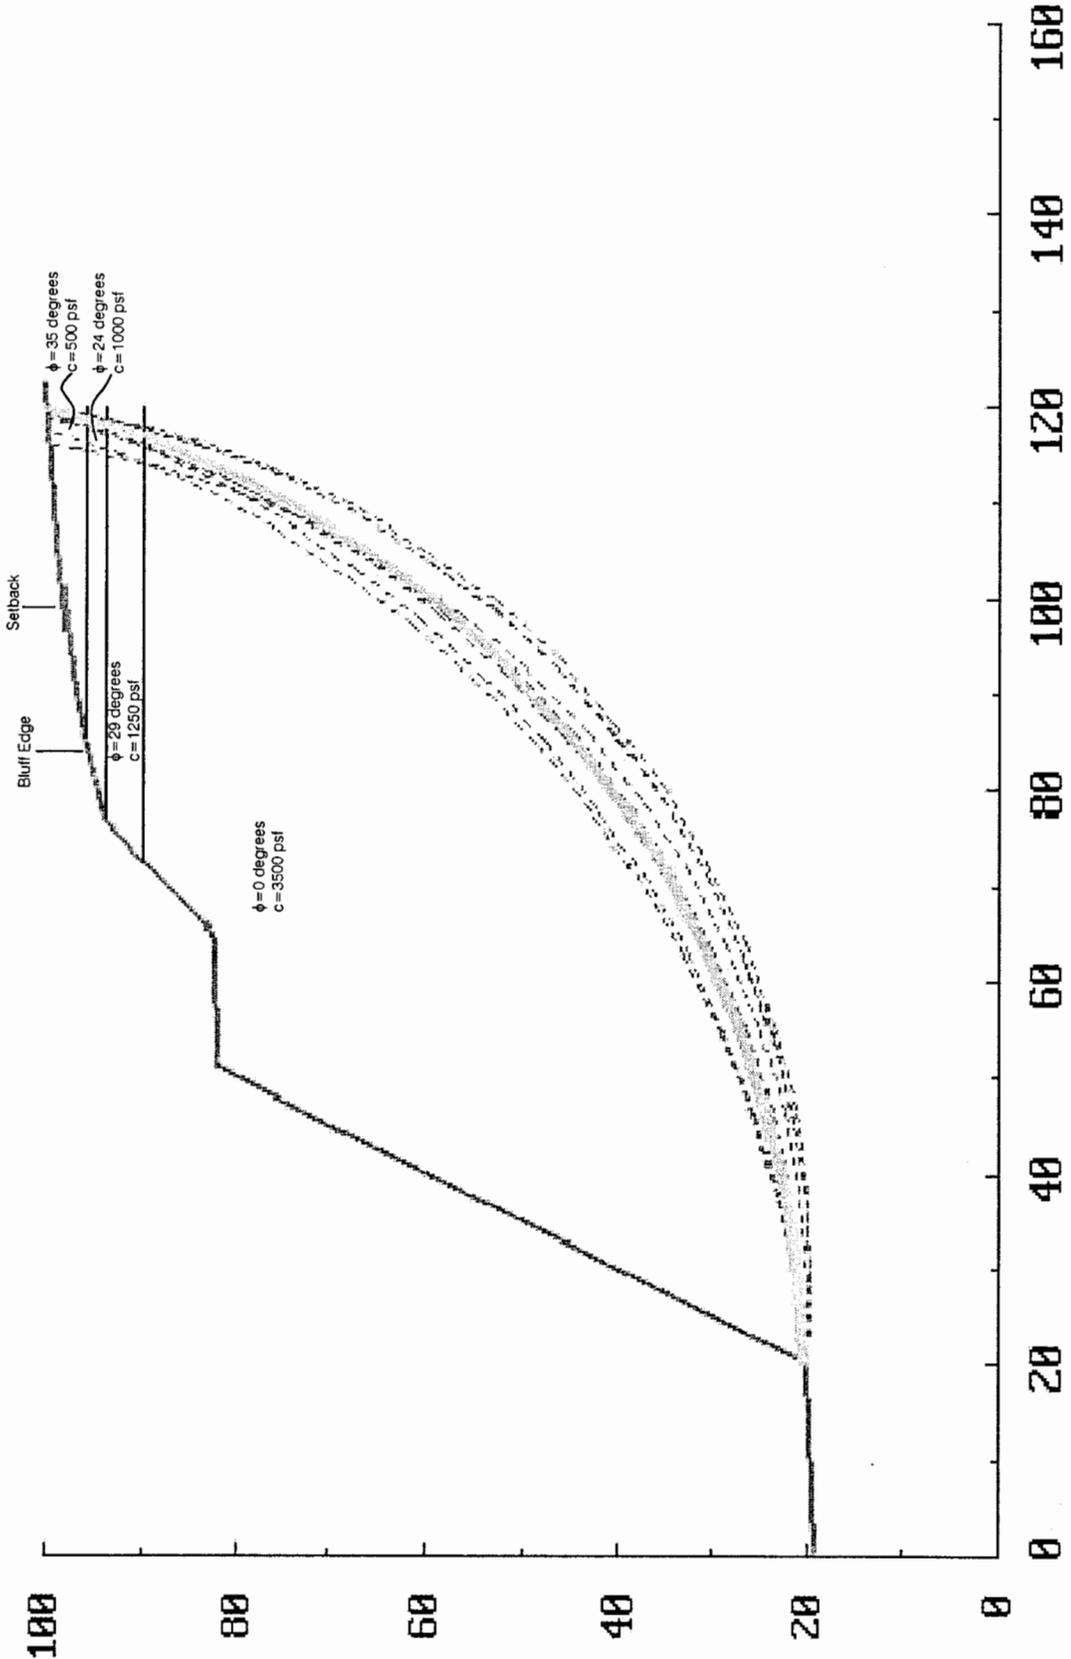
**Piety Static
10 most critical surfaces, MINIMUM BISHOP FOS = 1.730**

SLOPE STABILITY STATIC
PLANNED PIETY RESIDENCE
47021 Pirates Drive
Gualala, California

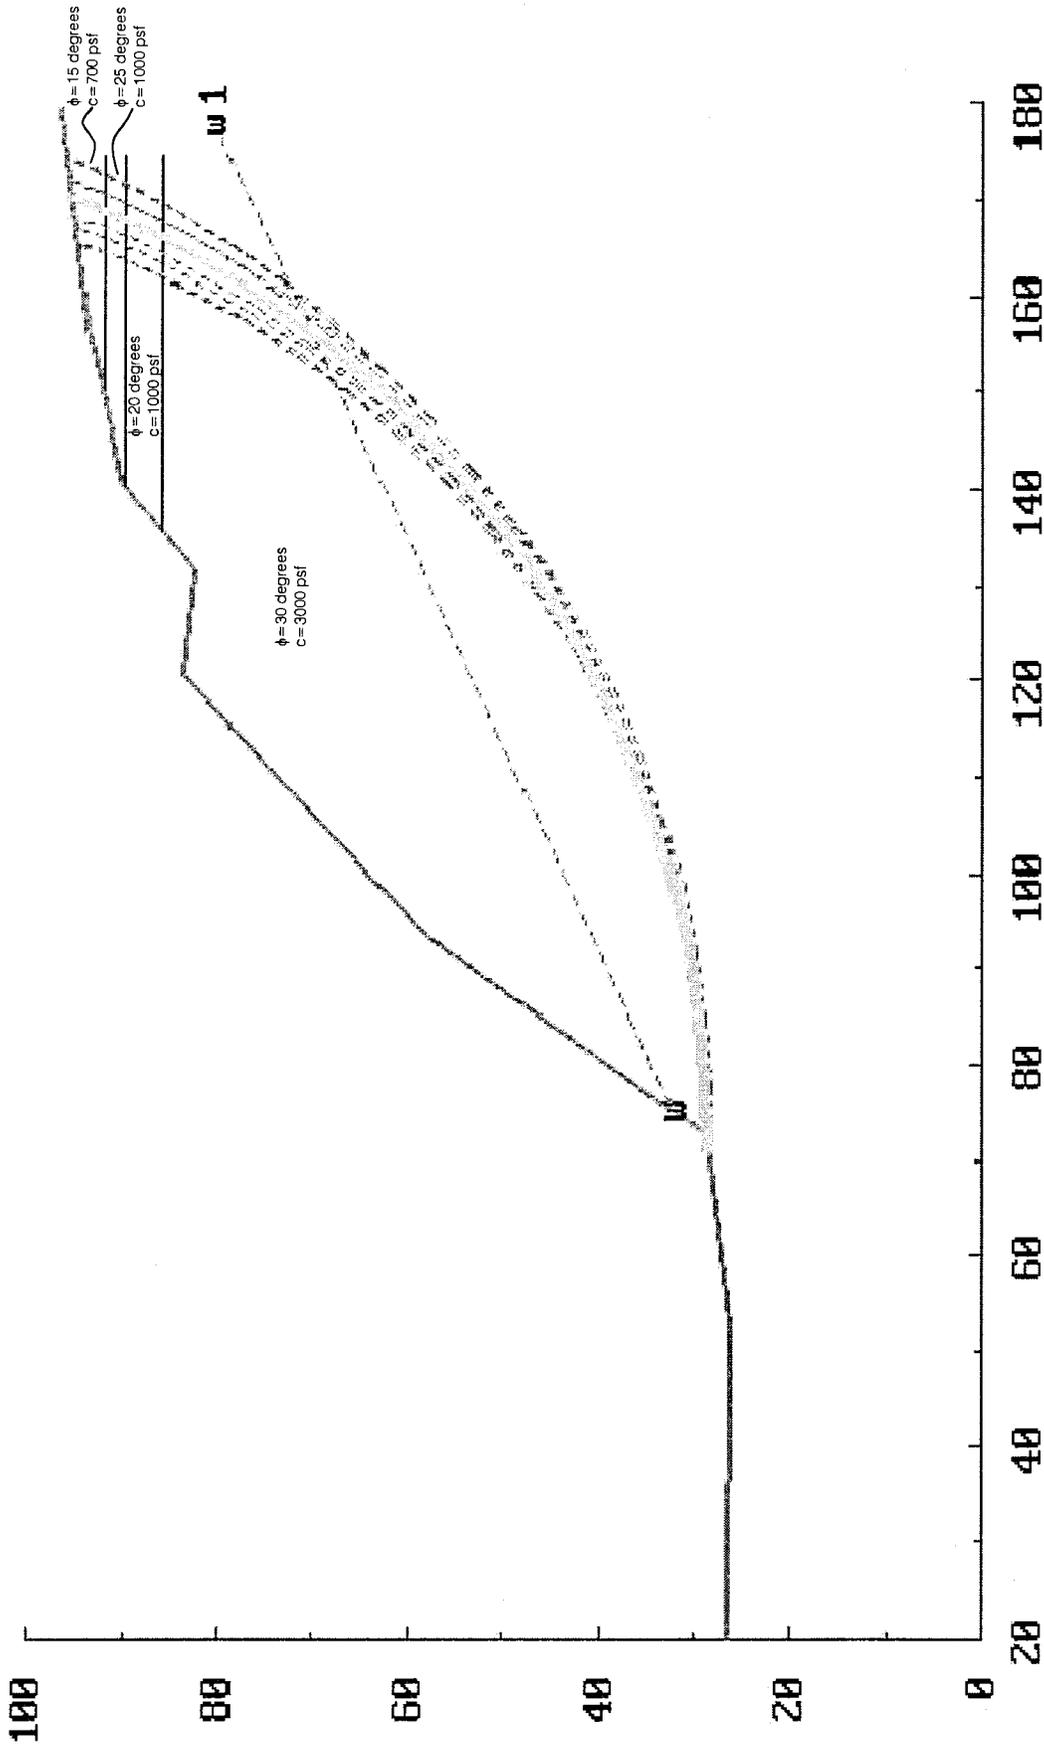
PIETY STATIC
10 most critical surfaces, MINIMUM BISHOP FOS = 3.164
