STAFF REPORT: REGULAR CALENDAR

Application No.: 1-12-014

Location: 98 Rayipa Lane, approximately two miles south of the City of Trinidad, Westhaven area, Humboldt County (APN 514-181-63).

Project Description: (1) Construct a new retaining wall structure to replace and stabilize the remains of two existing retaining walls recently damaged by a fallen tree (one critically damaged and the other with soil undermining) that protect an existing pre-Coastal Act single family residence, and (2) replace a stairway access along the north side of the house also critically damaged by the fallen tree that is necessary for access to the west side of the house.

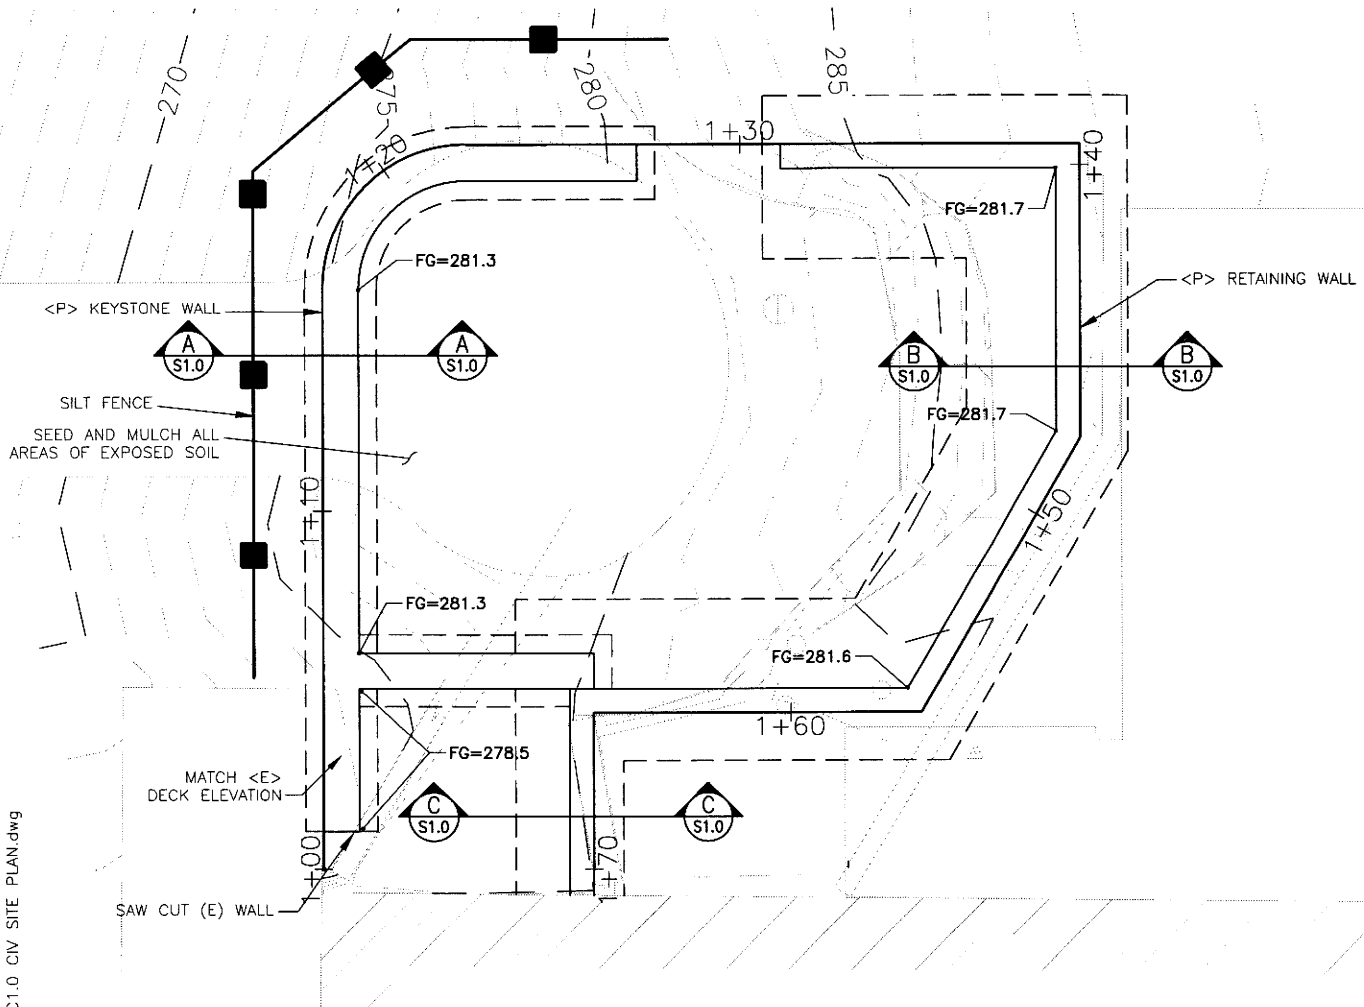
**WALL PLAN**
SCALE: 1"=5'

PROJECT	RETAINING WALL REPAIR	BY	JDB	FIGURE	C1.0A
CLIENT	QUILLMAN CONSTRUCTION	DATE	7/18/12	JOB NO.	7584.00
LOCATION	98 RAYIPA LANE, WESTHAVEN, CA	CHECK	NKT		
	WALL PLAN	SCALE	AS SHOWN

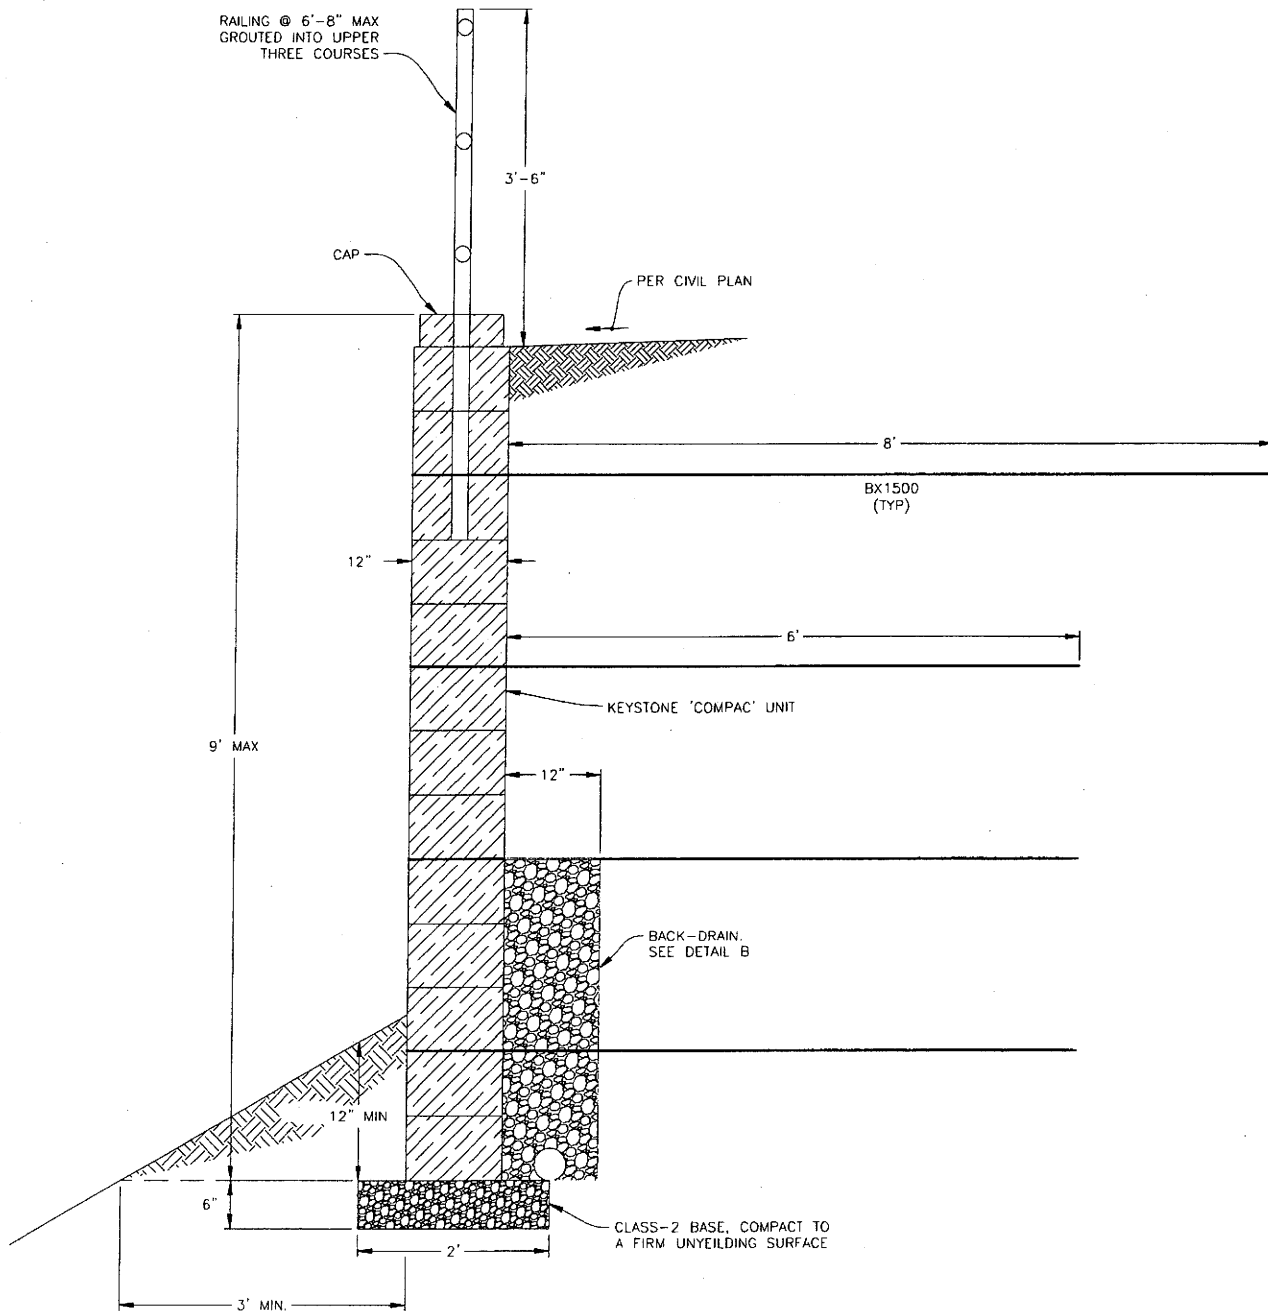
PROJECT	RETAINING WALL REPAIR	BY	JDB	FIGURE	S1.0A
CLIENT	QUILLMAN CONSTRUCTION	DATE	7/18/12		
LOCATION	98 RAYIPA LANE, WESTHAVEN, CA	CHECK	NKT	JOB NO.	7584.00
	KEYSTONE WALL DETAIL	SCALE	AS SHOWN

The new retaining wall structure would consist of a lower (down the hillside) keystone wall with a 120-square-foot exposed face area to replace the existing lower critically damaged retaining wall and an upper 8-foot-tall cantilevered concrete wall with a 220-square-foot exposed face area to stabilize the existing upper retaining wall with undermined soil. A portion of the ground between the two new walls will be excavated then backfilled and compacted in layers within a geogrid system to increase stability (see project plans, **Exhibit 4**, and site photos, **Exhibits 5 and 6**). The existing lower retaining wall serves to stabilize the soil immediately around the western and northern sides of the existing house foundation. The existing upper retaining wall serves to stabilize the soil immediately adjacent to the existing landing that provides primary entry access to the house.

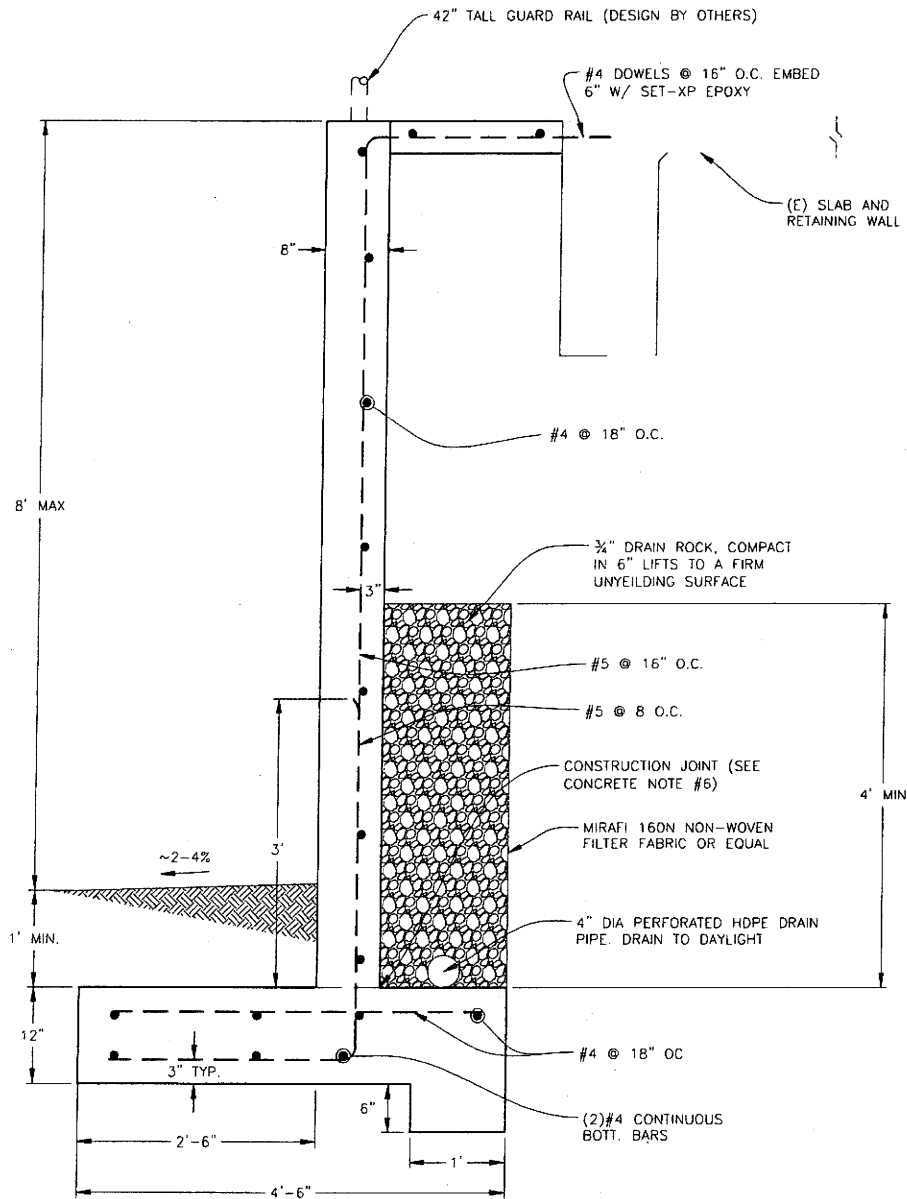
**CANTILEVER RETAINING WALL****1/2"=1'**

PROJECT	RETAINING WALL REPAIR	BY	JDB	FIGURE	S1.0B
CLIENT	QUILLMAN CONSTRUCTION	DATE	7/18/12		
LOCATION	98 RAYIPA LANE, WESTHAVEN, CA	CHECK	NKT	JOB NO.	7584.00
	CANTILEVER RETAINING WALL DETAIL	SCALE	AS SHOWN

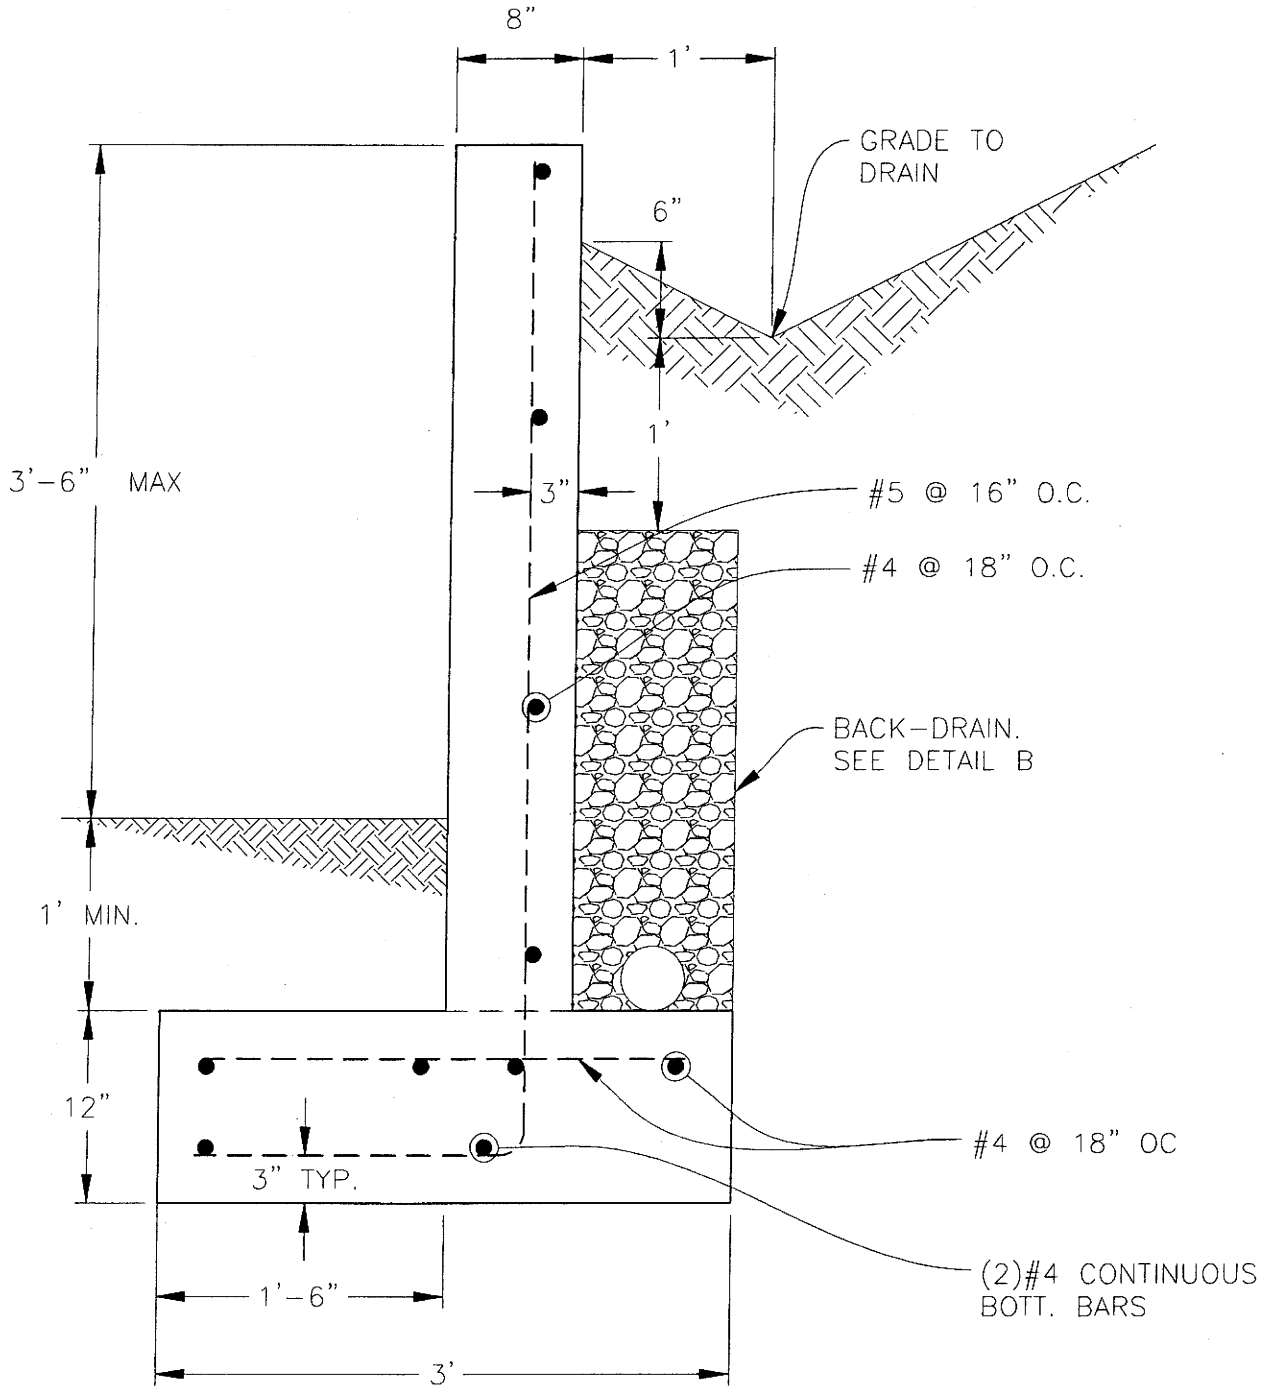
**CANTILEVER RETAINING WALL**

FIGURE	S1.0C
JOB NO.	7584.00

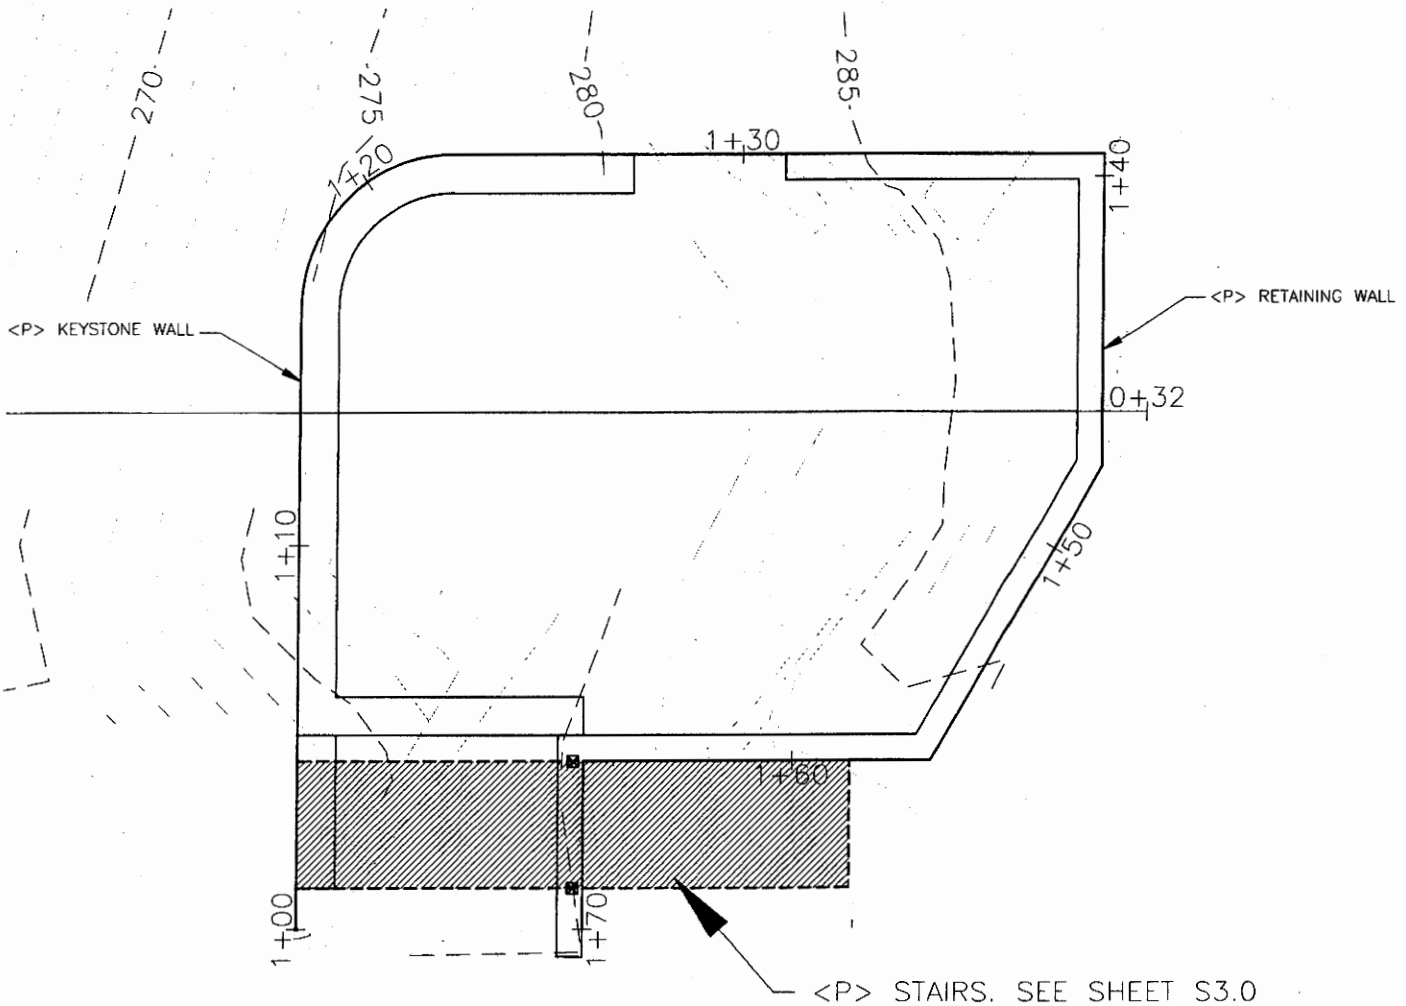
**STAIR PLAN**
SCALE: 1"=5'

PROJECT	RETAINING WALL REPAIR	BY	TAM	FIGURE	
CLIENT	QUILLMAN CONSTRUCTION	DATE	7/18/12		S2.0A
LOCATION	98 RAYIPA LANE, WESTHAVEN, CA	CHECK	NKT	JOB NO.	
	STAIR PLAN	SCALE	AS SHOWN		7584.00

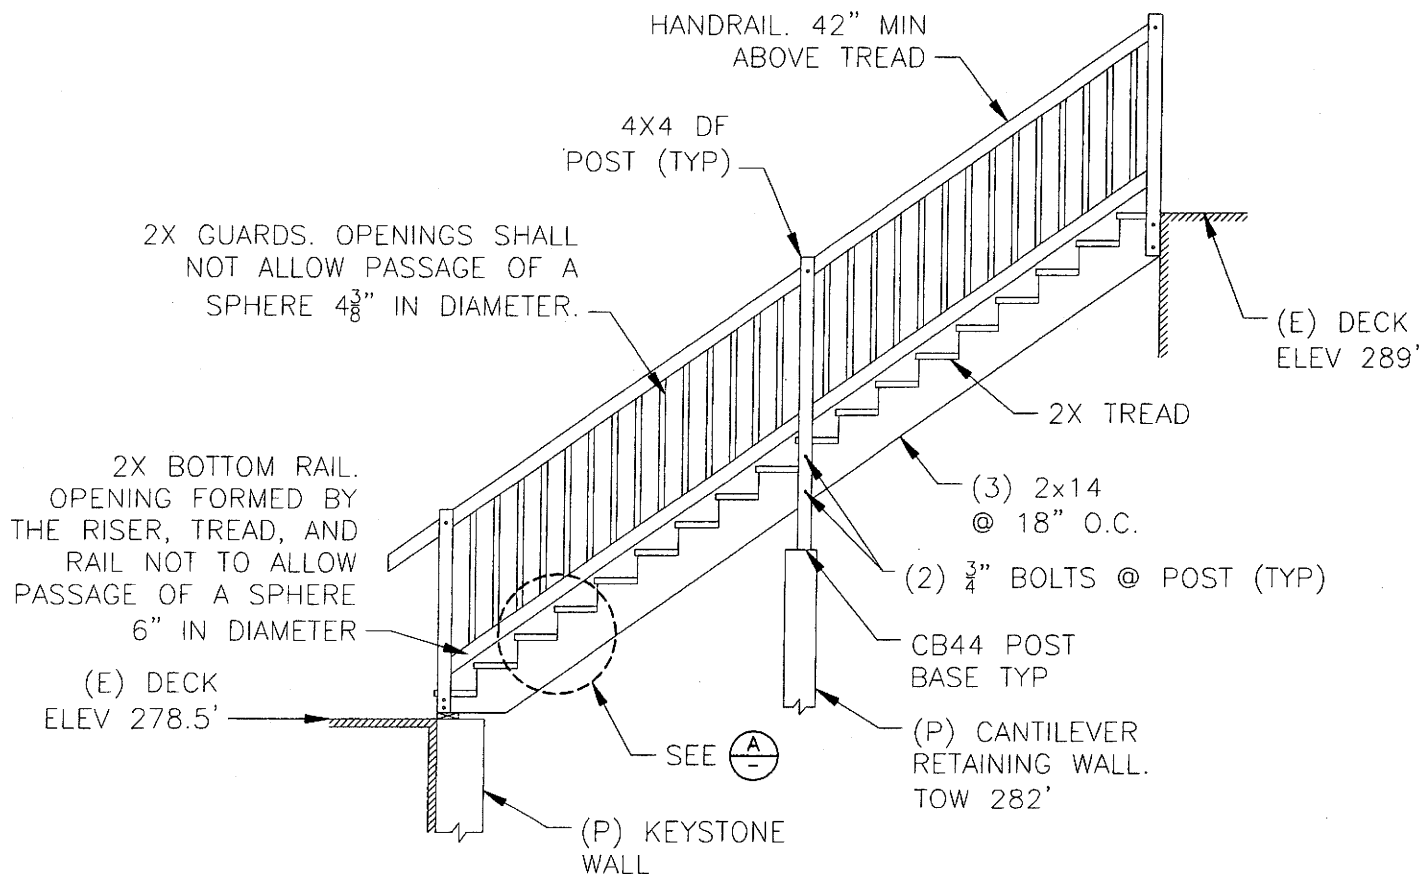
**STAIR PROFILE**
SCALE: 1/4"=1'

PROJECT	RETAINING WALL REPAIR	BY	TAM	FIGURE	S2.0B
CLIENT	QUILLMAN CONSTRUCTION	DATE	7/18/12		
LOCATION	98 RAYIPA LANE, WESTHAVEN, CA	CHECK	NKT	JOB NO.	7584.00
	STAIR DETAILS	SCALE	AS SHOWN

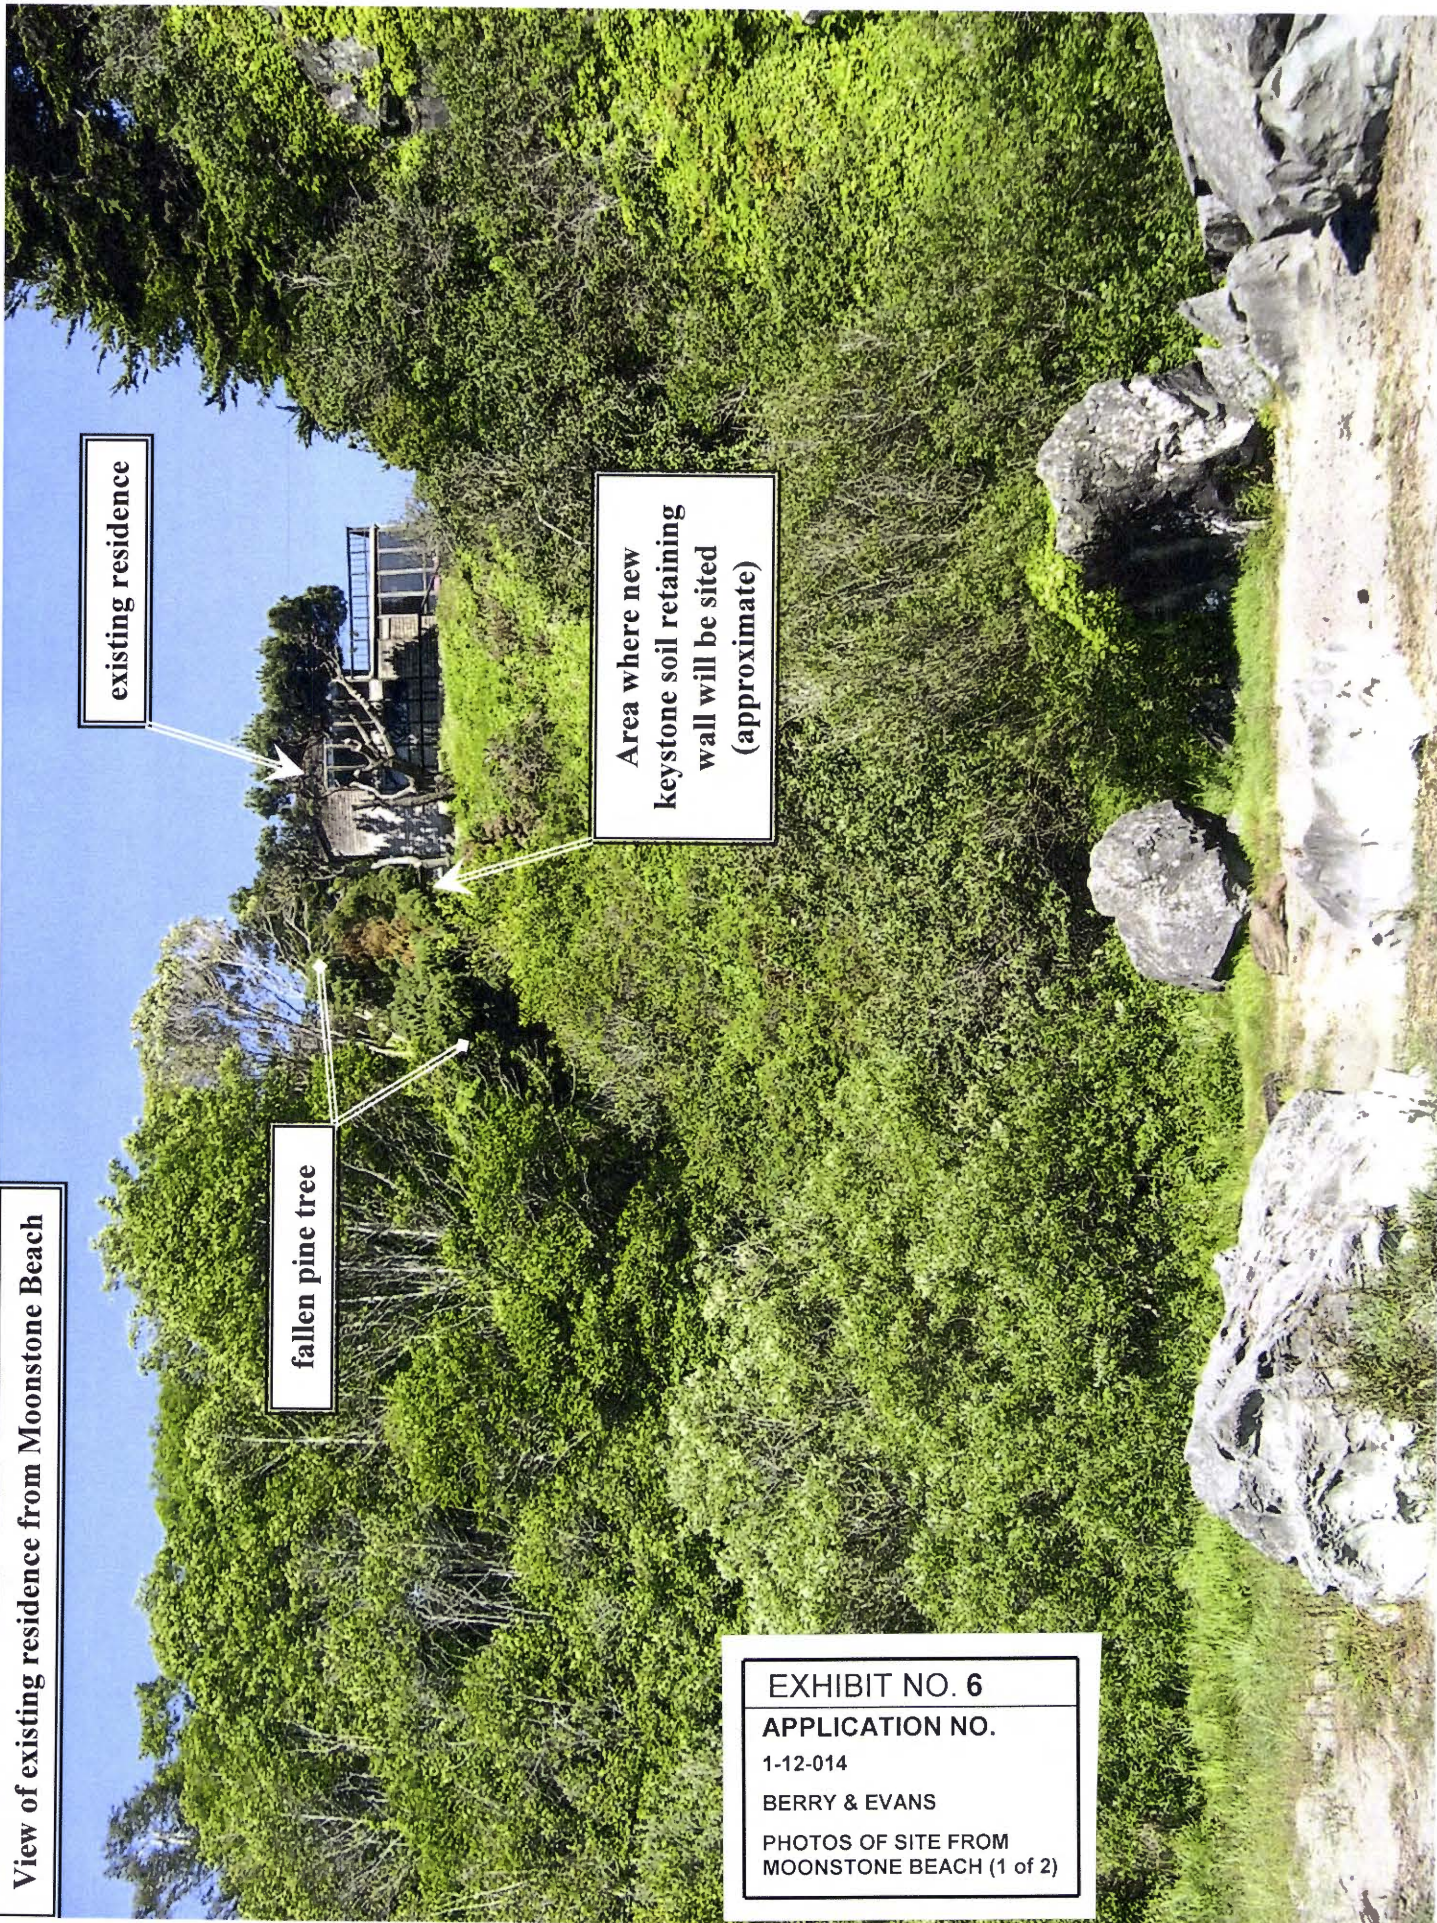
View of existing residence from Moonstone Beach

existing residence

fallen pine tree

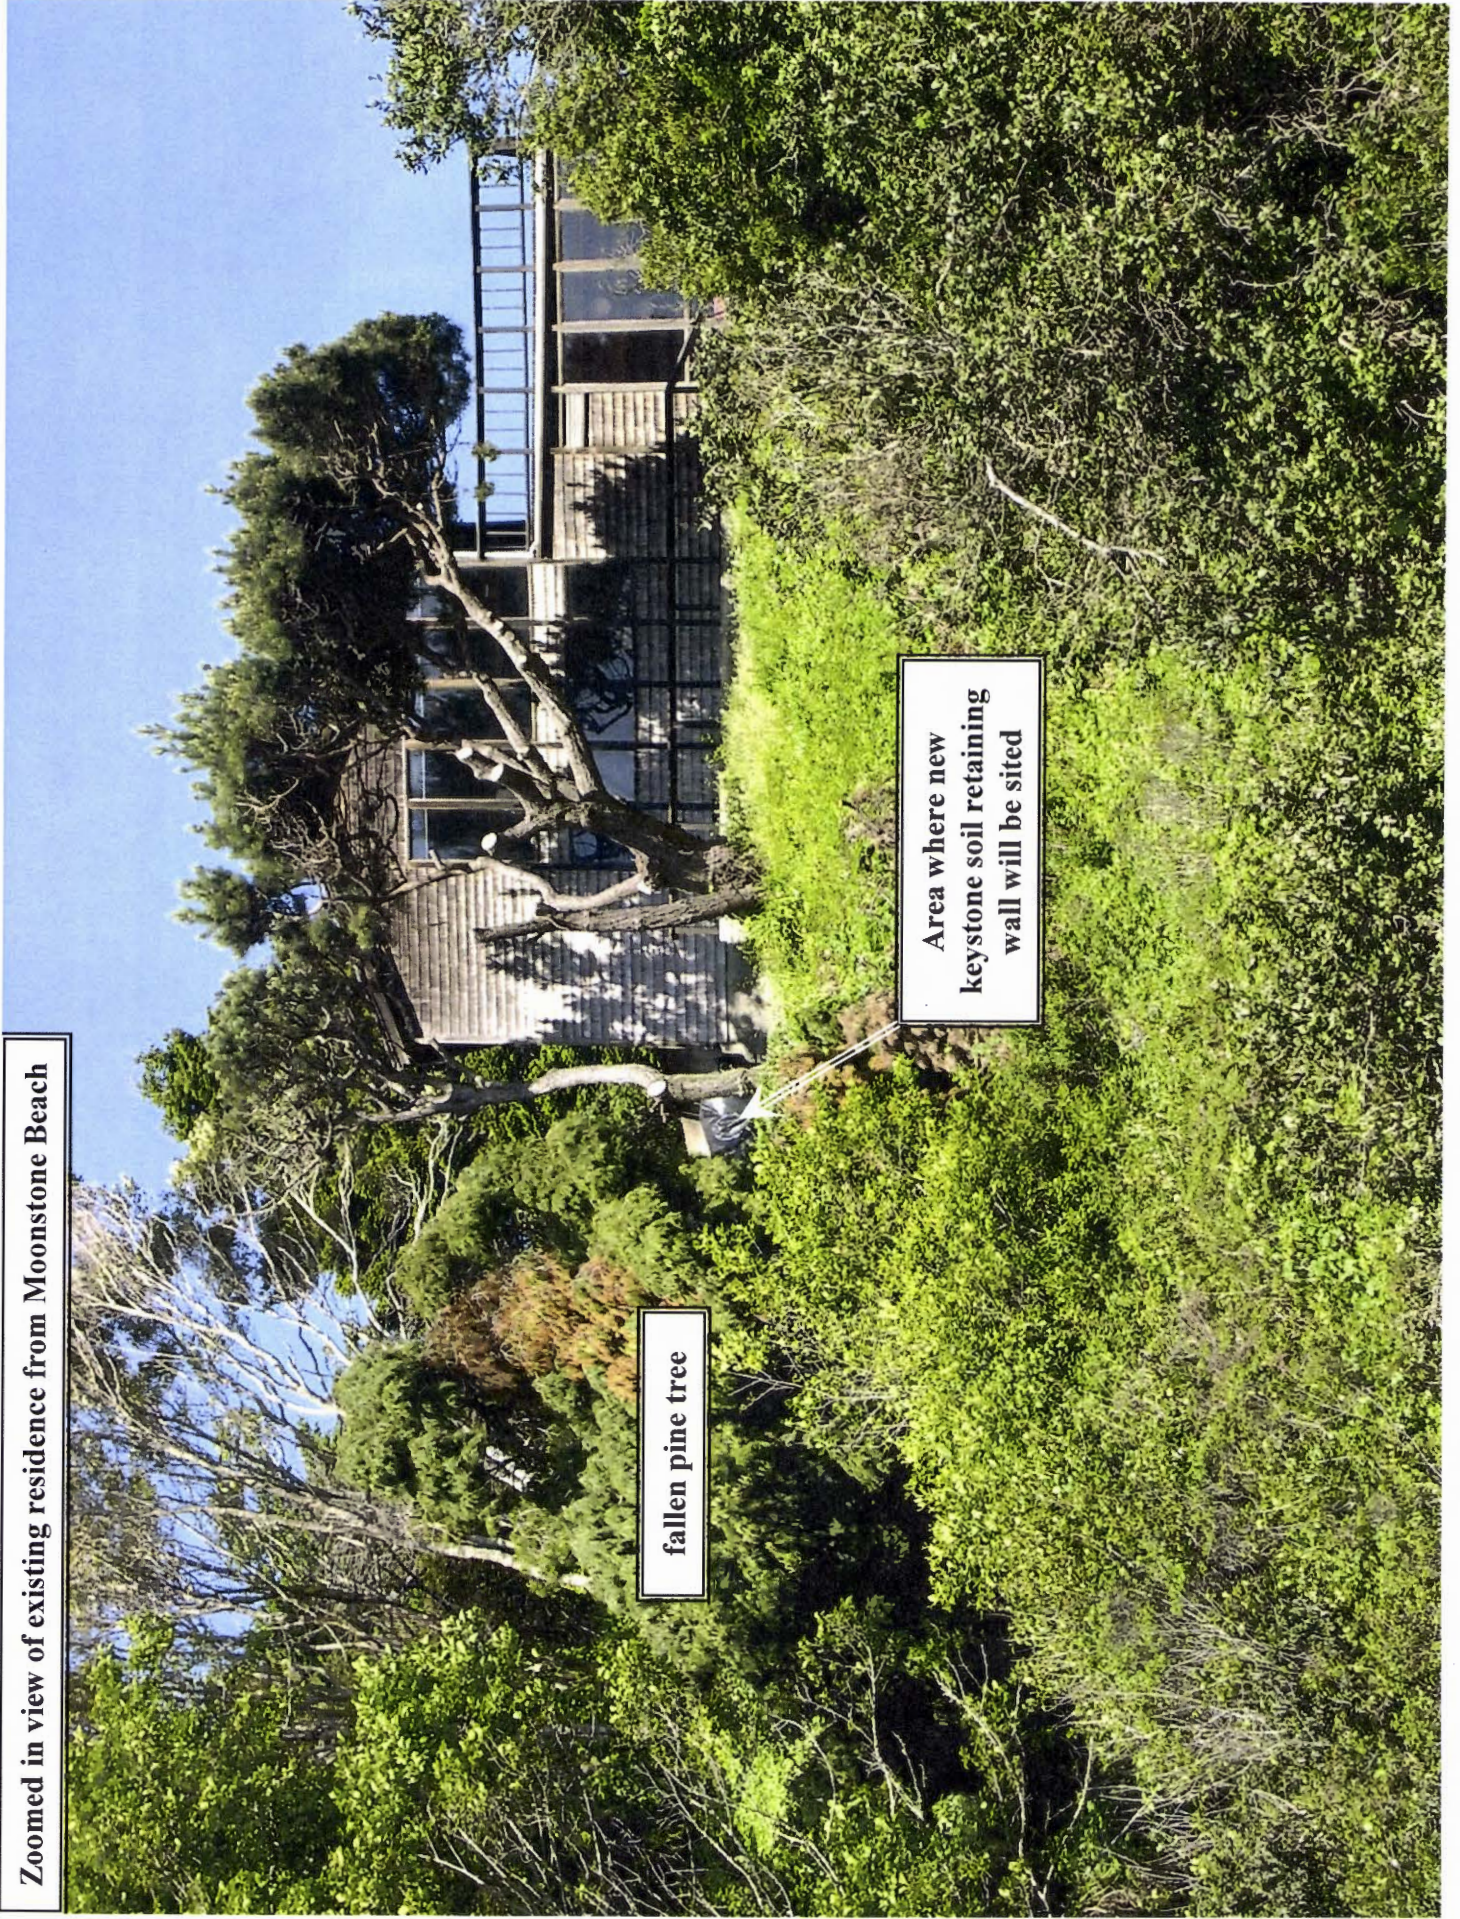
Zoomed in view of existing residence from Moonstone Beach

fallen pine tree

Area where new
keystone soil retaining
wall will be sited

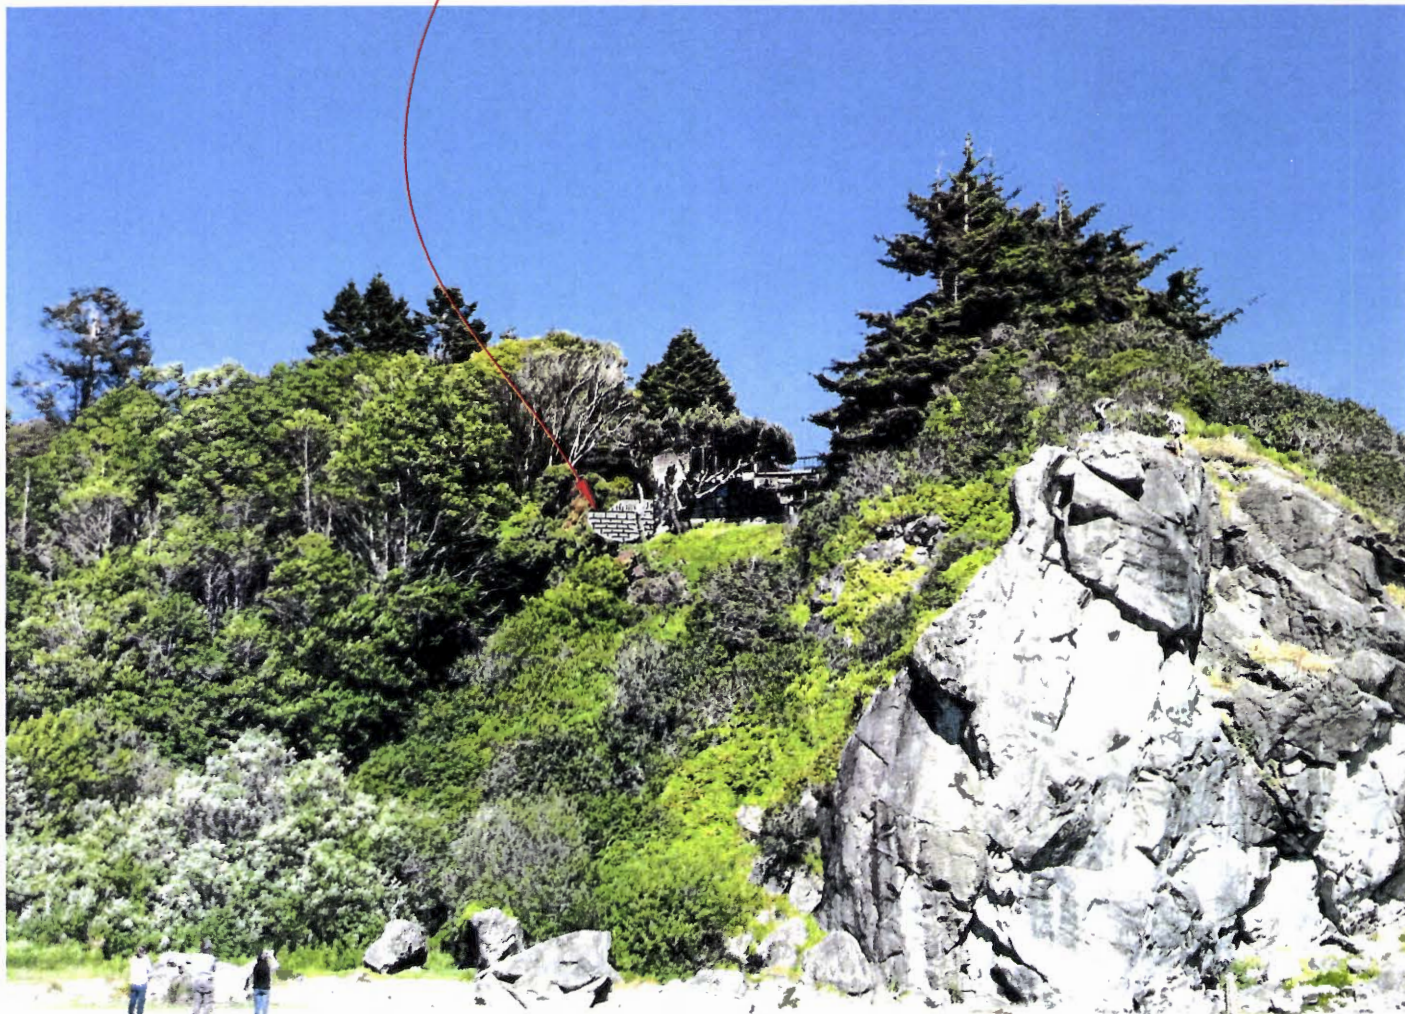
CALIFORNIA
COASTAL COMMISSIONPROPOSED RETAINING WALLS (LANDSCAPING, DECK,
AND STAIRWAY NOT SHOWN FOR CLARITY)

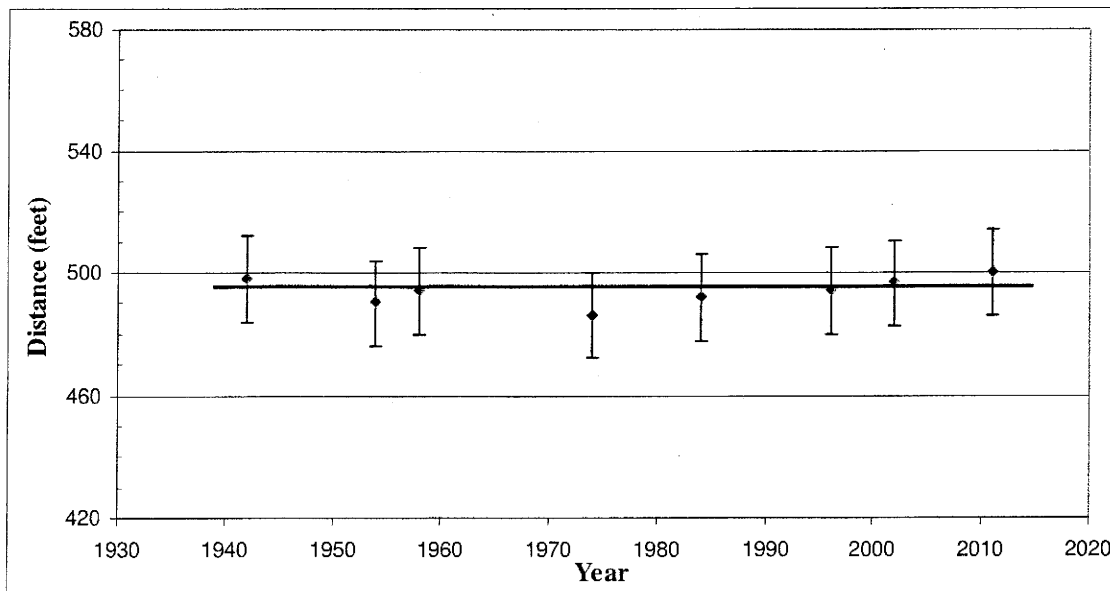
Graph A: Historic Bluff Retreat Rate

The bluff edge adjacent to the project site has not had any discernable retreat between 1942 and 2011, which results in the assumption that the site bluff is not actively retreating (rate=0.0 feet/year). The long-term historic retreat rates were determined by dividing the total amount of coastal retreat measured by the total length of time spanned by the aerial photographs reviewed (69 years). To address scaling limitations and reproduction distortions of the photographs, an error bar (± 14 feet) was included in our aerial photograph measurements. Graph A below presents the results and interpretations of the bluff retreat rate as determined by historic aerial photographs (with error bars).

Note: "Distance" refers to the distance between the bluff crest and Scenic Drive.

The results of the slope stability evaluation indicate a relatively stable slope at the project site (Factor of Safety, $F=1.41$ for static conditions and 1.07 for seismic conditions). The geotechnical analysis also evaluated bluff retreat and erosion rates for the area. According to the results of this analysis, there was no discernable retreat rate of the bluff adjacent to the project site between 1942 and 2011 (and see **Exhibit 9**). The absence of bluff retreat in this area is attributed to the site’s protection from environmental factors such as wind and wave action, which are controlled by the presence of heavy vegetation across the terrace face and the surrounding bedrock outcroppings. Rainfall events and the lack of efficient drainage systems on site and on the surrounding developed residential properties, rather than storm wave action or sea level rise, are more important factors in hillside erosion in the area.

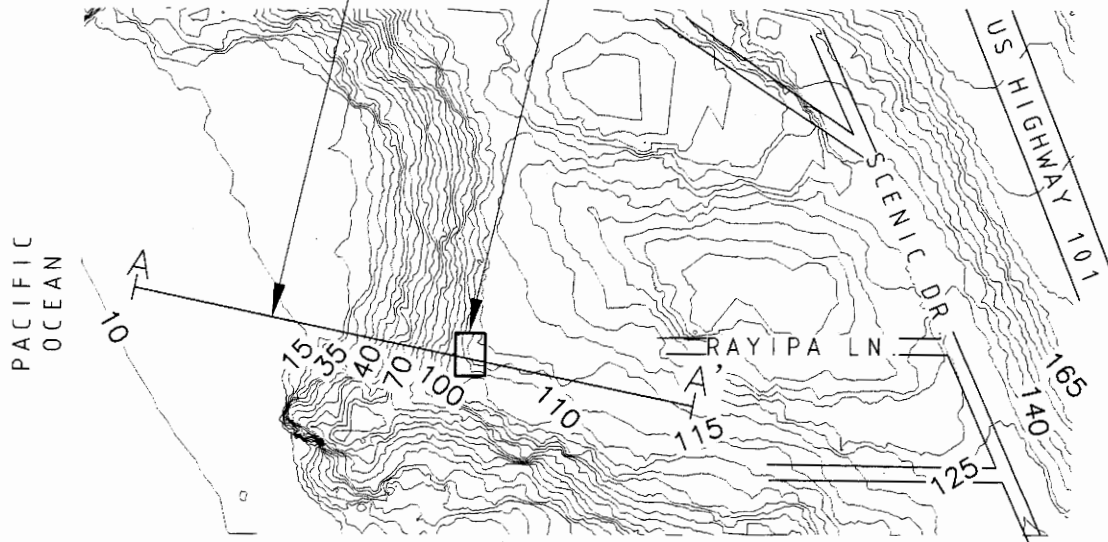
SLOPE PROFILE USED IN
FACTOR OF SAFETY
ANALYSIS (APPENDIX C)

APPROXIMATE LOCATION
OF PROPOSED
DEVELOPMENT AREA

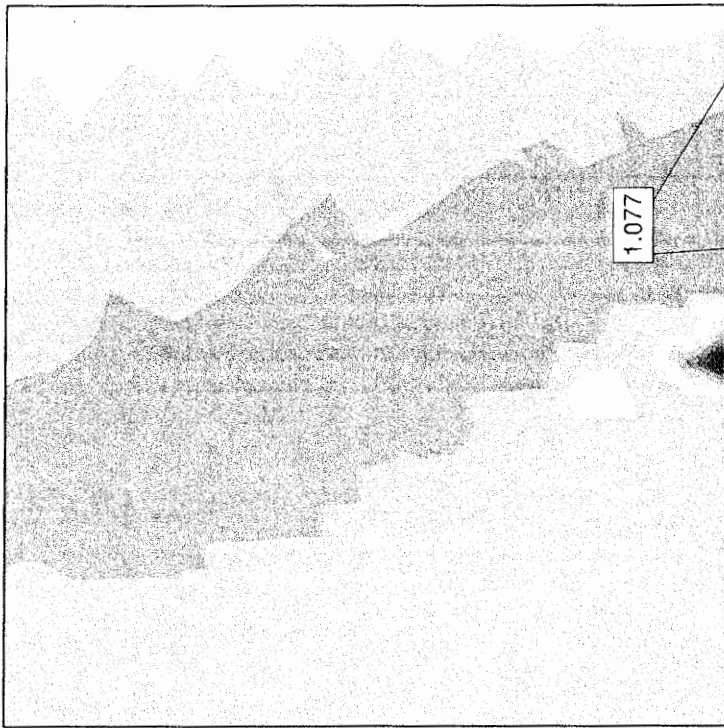
Safety Factor

SLOPE INSTABILITY REPORT SEISMIC CONDITIONS

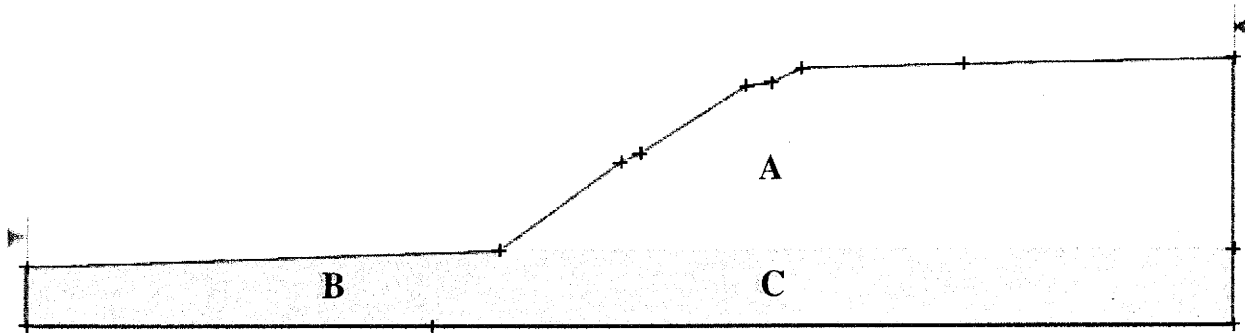
SLOPE STABILITY - KEY TO SOIL LAYERS AND MATERIAL DESCRIPTIONS

Layer	Material	Dry Unit Weight (pcf)	Sat. Unit Weight (pcf)	Friction Angle (degrees)	Cohesion (psf)
A	SM: Weakly Cemented Silty Sand	95.0	110.0	31.7	330
B	Bluff Colluvium/Alluvium	90.0	110.0	29.0	0
C	Bedrock	150.0	---	---	---
