Prepared April 10, 2013 for April 11, 2013 Hearing

Subject: STAFF REPORT ADDENDUM for Th14a Appeal Number A-3-SLO-11-064 (Lewis SFD)

Application Number:	A-3-SLO-11-064
Applicant:	Dr. Marshall Lewis
Project Location:	709 Lucerne Road in Cayucos, San Luis Obispo County (APN 064-281-09).
Project Description:	Demolition of an existing 2,810 square-foot, one-story single- family dwelling and accessory structures, construction of a new 4,555 square-foot, two-story SFD with a 2,377 square-foot underground garage/basement, and removal of eight Monterey cypress trees.
Staff Recommendation:	Approval with Conditions

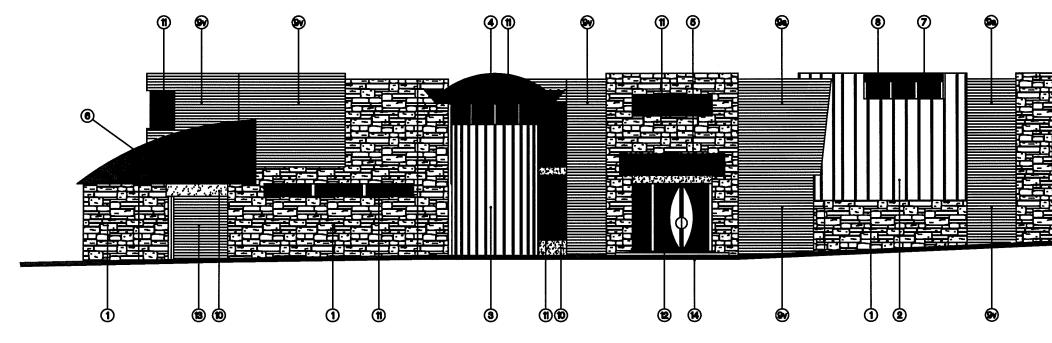
FRONT ELEVATION (facing Lucerne Road)

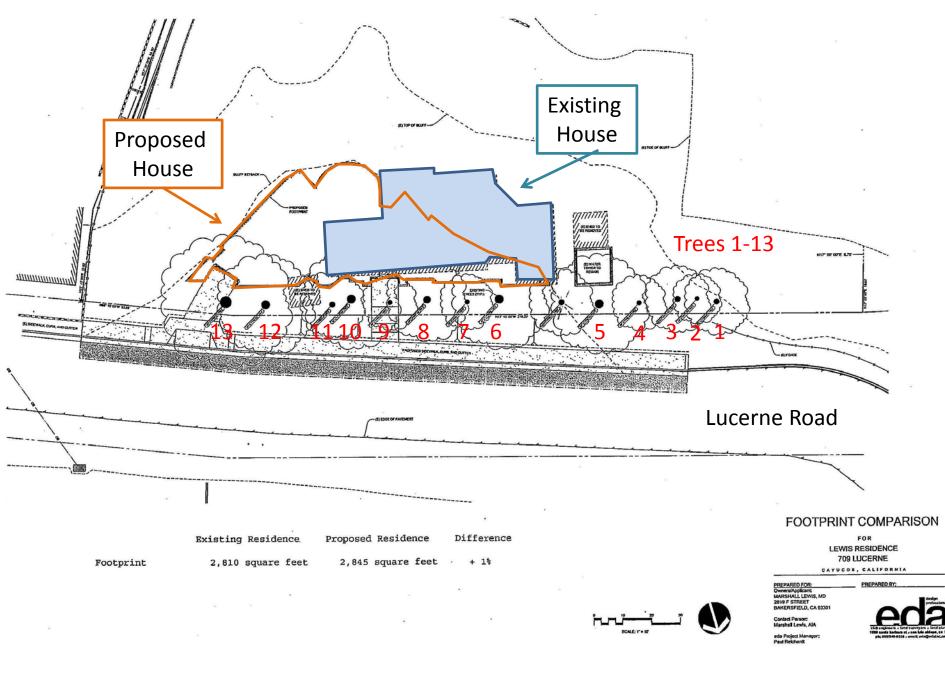
Exhibit 5 Page 1 of 2

TREE MITIGATION PLAN

Every attempt to limit tree removals and impacts will be made. However, in order to fully mitigate the potential impact of the project, the following mitigation strategy shall be implemented:

- Trees 1 through 5 will be protected in place to the greatest extent feasible during construction, and will be replaced at a 2:1 ratio when they eventually expire.
- An arborist will monitor all trees on the site throughout construction.
- Trees will be pruned and removed only at the direction of the project arborist, based upon a thorough evaluation of each tree's health and hazard.
- All replacement Monterey Cypress trees will be generously sized to achieve significant screening immediately and are anticipated to reach 24' to 26' height within ten years.
- All replacement trees shall be monitored by the project arborist for a period of not less than five (5) years.

- 1. **Retention.** The Monterey cypress trees numbered 1 through 5 (see Exhibit 5) shall be retained and shall be maintained in good growing condition for as long as it is feasible to do so.
- 2. **Pruning.** All cypress pruning shall be monitored by a certified arborist. Trees 1-5 shall be pruned and reduced in weight, thereby reducing branching defects and deadwood, and reducing the pull of the trees over the blufftop edge. Pruning for trees 1 and 2 shall remove approximately 50% of the branch weight to reduce the pull of these trees over blufftop edge. Pruning for trees 3, 4, and 5 shall remove no more than 25% of the living canopy of these trees.

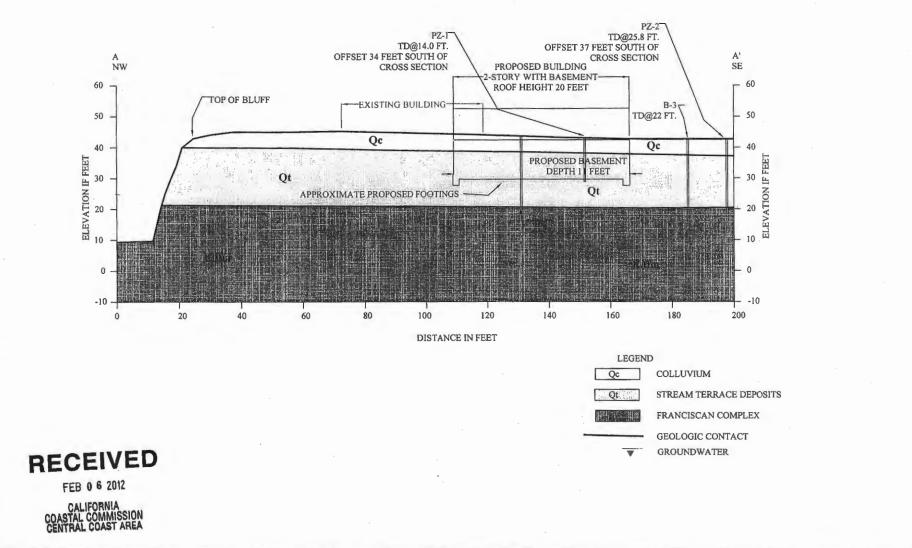
PLATE 1β PROJECT SI.07701-3

GEOLOGIC CROSS SECTION

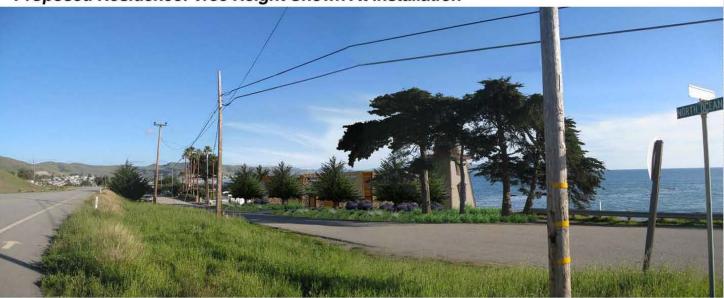
Exhibit 7 Page 1 of 3

Proposed Planting Design: Tree Height Shown At 10 Year Growth (24'-26' tall)

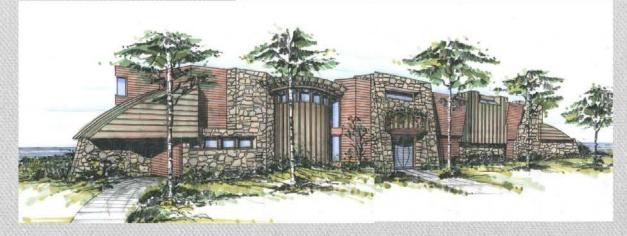
Elevation Proposed by Applicant

Height = 20' max Footprint = 2,845 sf

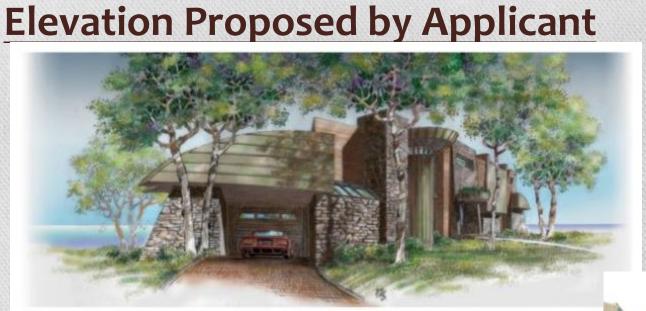
Height = 20' max Footprint = 2,845 sf

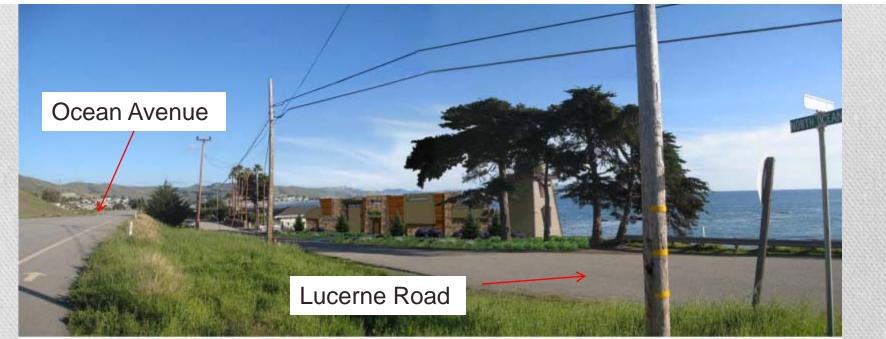
Proposed Residence: Tree Height Shown At Installation

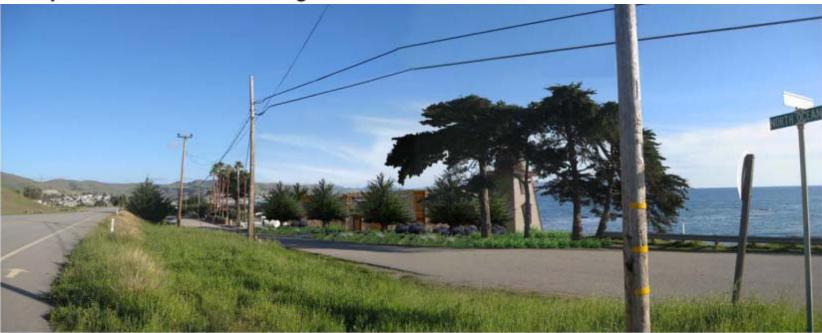
Exhibit 8 Page 18 of 42

Proposed Planting Design: Tree Height Shown At 10 Year Growth (24'-26' tall)

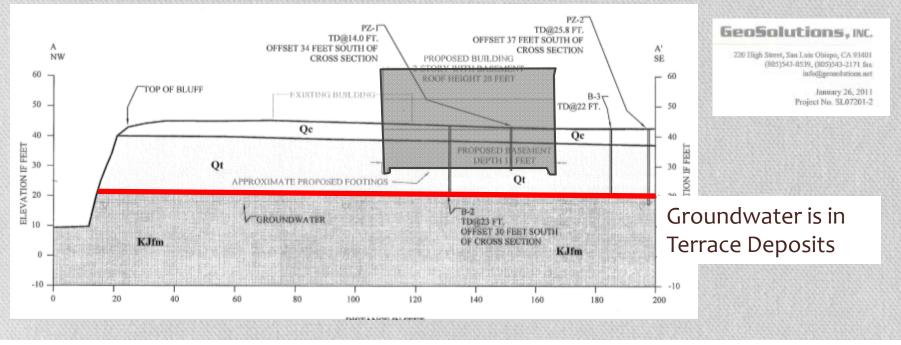
Exhibit 8 Page 31 of 42

- **Piezometers** were **installed** to determine presence of groundwater
 - Groundwater encountered at 24.5 feet bls
 - 13 feet below bottom of the garage
- Slope Stability Analysis and Construction
 Recommendations ASSUMED presence of Groundwater
