**CALIFORNIA COASTAL COMMISSION**

## STAFF REPORT: REGULAR CALENDAR

**Application No.:** 1-12-023

**Project Description:** (1) Develop a 0.33-acre vacant, undeveloped bluff-top lot with a new ~1,200-square-foot, one-story, single-family residence, gravel driveway and parking area, on-site sewage disposal system, water line, drainage swale, and landscaping; and (2) remove approximately 22 Sitka spruce trees.

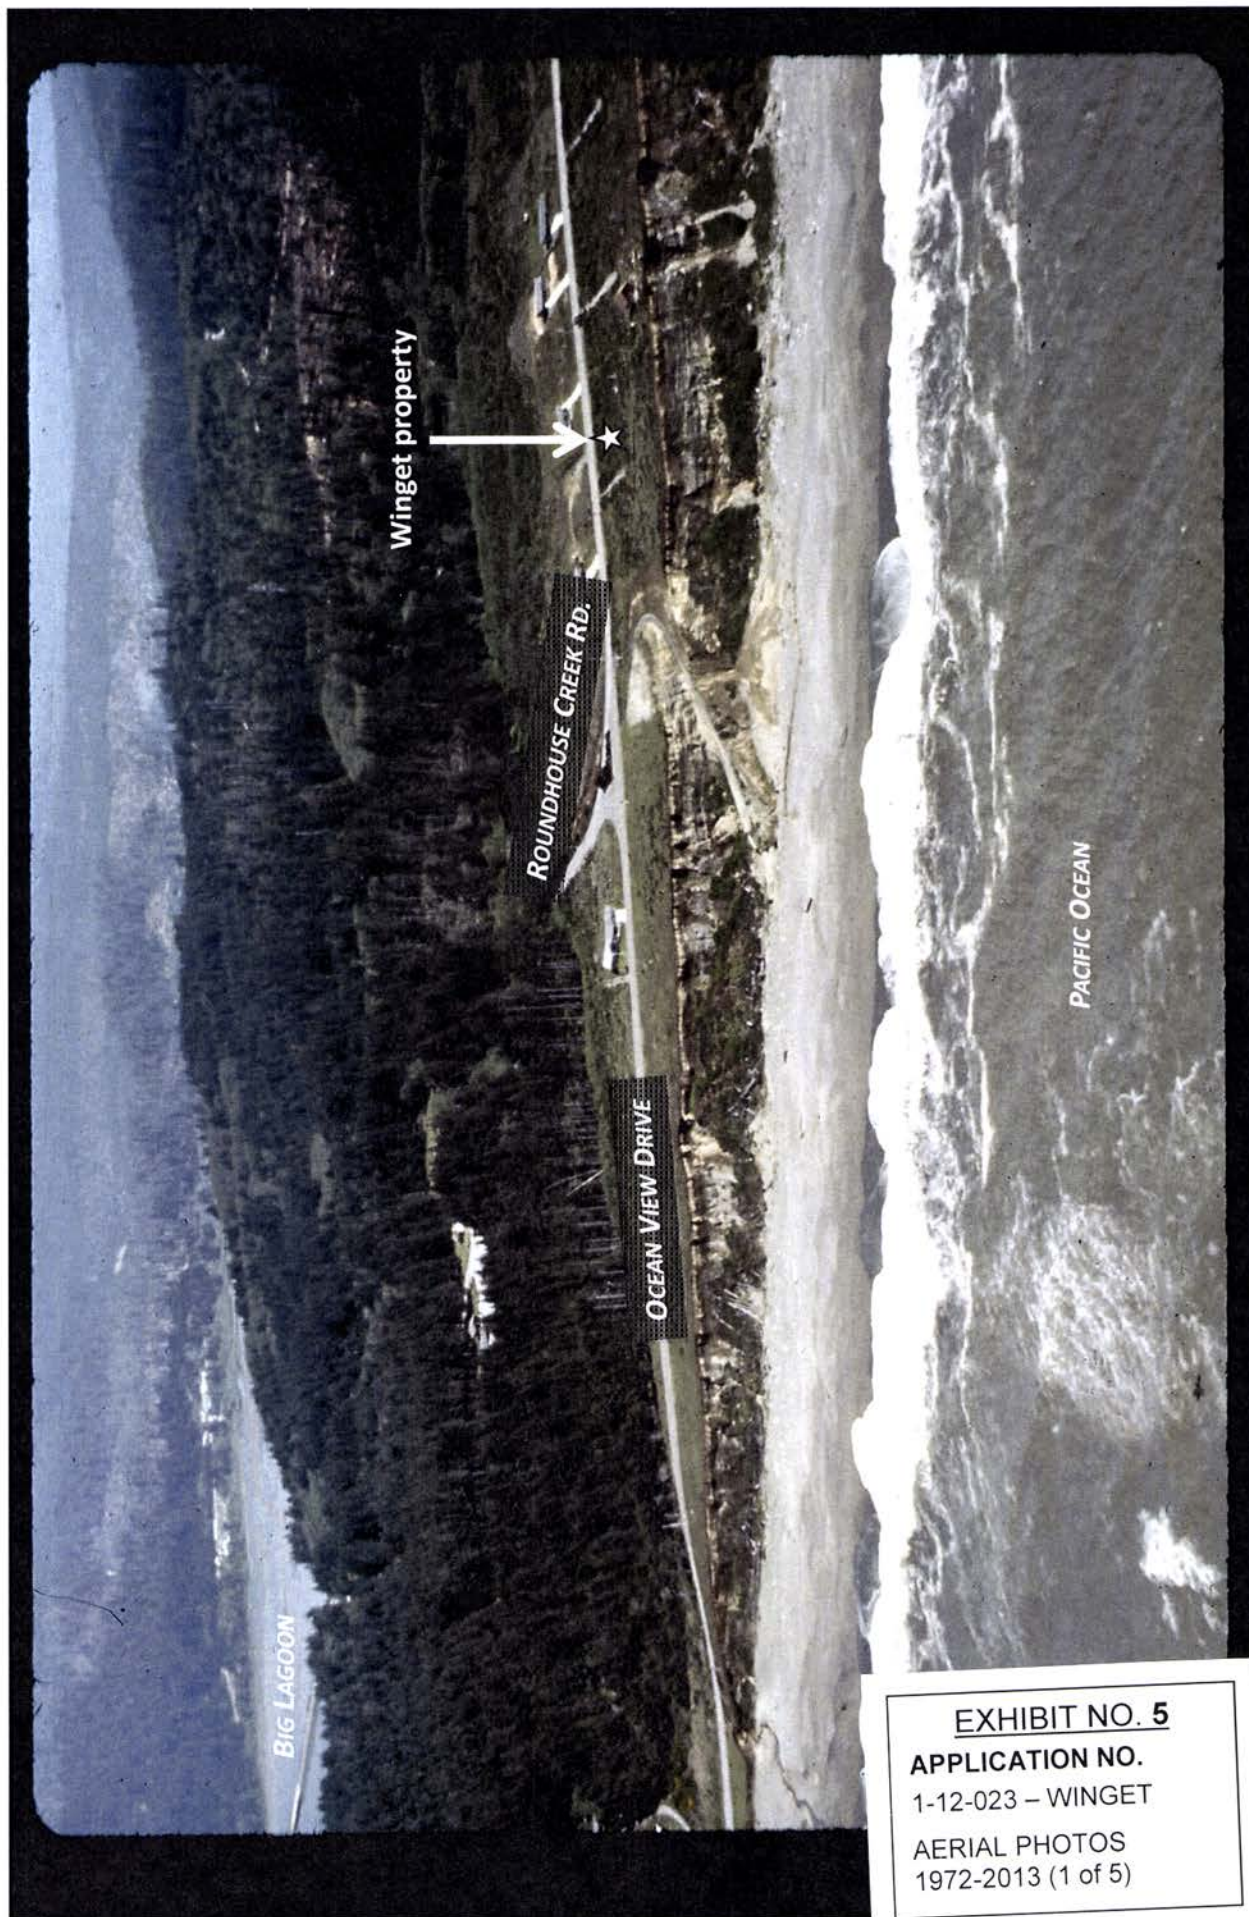
**EXHIBIT NO. 5**  
**APPLICATION NO.**  
1-12-023 - WINGET  
**AERIAL PHOTOS**  
1972-2013 (1 of 5)

**Photo Year:**  
**1972**

NCR-78-CC-942 (Stanley) authorized a new single family home 58 feet from the bluff edge. By 2002, the home had been removed due to bluff retreat hazards (though no permit records for removal could be found).

NCR-74-CC-344 (Rohner) authorized a new single family home 50 feet from the bluff edge in 1974. In December of 2003, the Commission authorized a follow-up CDP (1-03-028) to an emergency permit (1-03-027-G) to merge the lot with the adjacent lot to the east and to relocate the existing home 85 feet eastward due to bluff retreat hazards.

NCR-74-CC-322 (Rochlin/Lewis) authorized a new single family home 56 feet from the bluff edge in 1974. CDP 1-83-164 (Lakin) authorized a 300-sq.-ft. addition to the existing home in 1983. By 2002, the home had been removed due to bluff retreat hazards (though no permit records for removal could be found).

This single family home was constructed prior to 1972. CDP 1-98-075 (Wall), approved in January of 1999, authorized the relocation of the existing home 85 feet eastward on the lot due to bluff retreat hazards.

NCR-77-CC-257 (Headington) authorized a new single family home 80 feet from the bluff edge in July of 1977. The home had to be removed and rebuilt on a lot across the street in 1998 (under County CDP 60-97) due to bluff retreat hazards.

1-87-230 (Kavich) authorized a new single family home over 100 feet from the bluff edge in January of 1988. The home had to be removed (under de minimis waiver 1-99-066-W) in 1999 and rebuilt on a lot inland and down the street (under County CDP 99-35) due to bluff retreat hazards.

NCR-74-CC-322 (Rochlin/Lewis) authorized a new single family home 56 feet from the bluff edge. CDP 1-83-164 (Lakin) authorized a 300-sq.-ft. addition to the existing home in 1983. By 2002, the home had been removed due to bluff retreat hazards (according to aerial photos; no permit records are on file regarding the removal).

**APN 517-241-03:**  
NCR-78-CC-942 (Stanley)  
authorized a new single family home 58 feet from the bluff edge. The home was removed due to bluff retreat hazards some time between 1987 and 2002 (according to aerial photos; no permit records are on file regarding the removal).

**APN 517-241-24:**  
NCR-77-CC-257 (Headington)  
authorized a new single family home 80 feet from the bluff edge. The home had to be removed and rebuilt on a lot across the street in 1998 (under County CDP 60-97) due to bluff retreat hazards.

**APN 517-241-22:**  
CDP 1-87-230 (Kavich) authorized a new single family home over 100 feet from the bluff edge. The home had to be removed and relocated due to bluff retreat in 1999 (de minimis waiver 1-99-066-W).

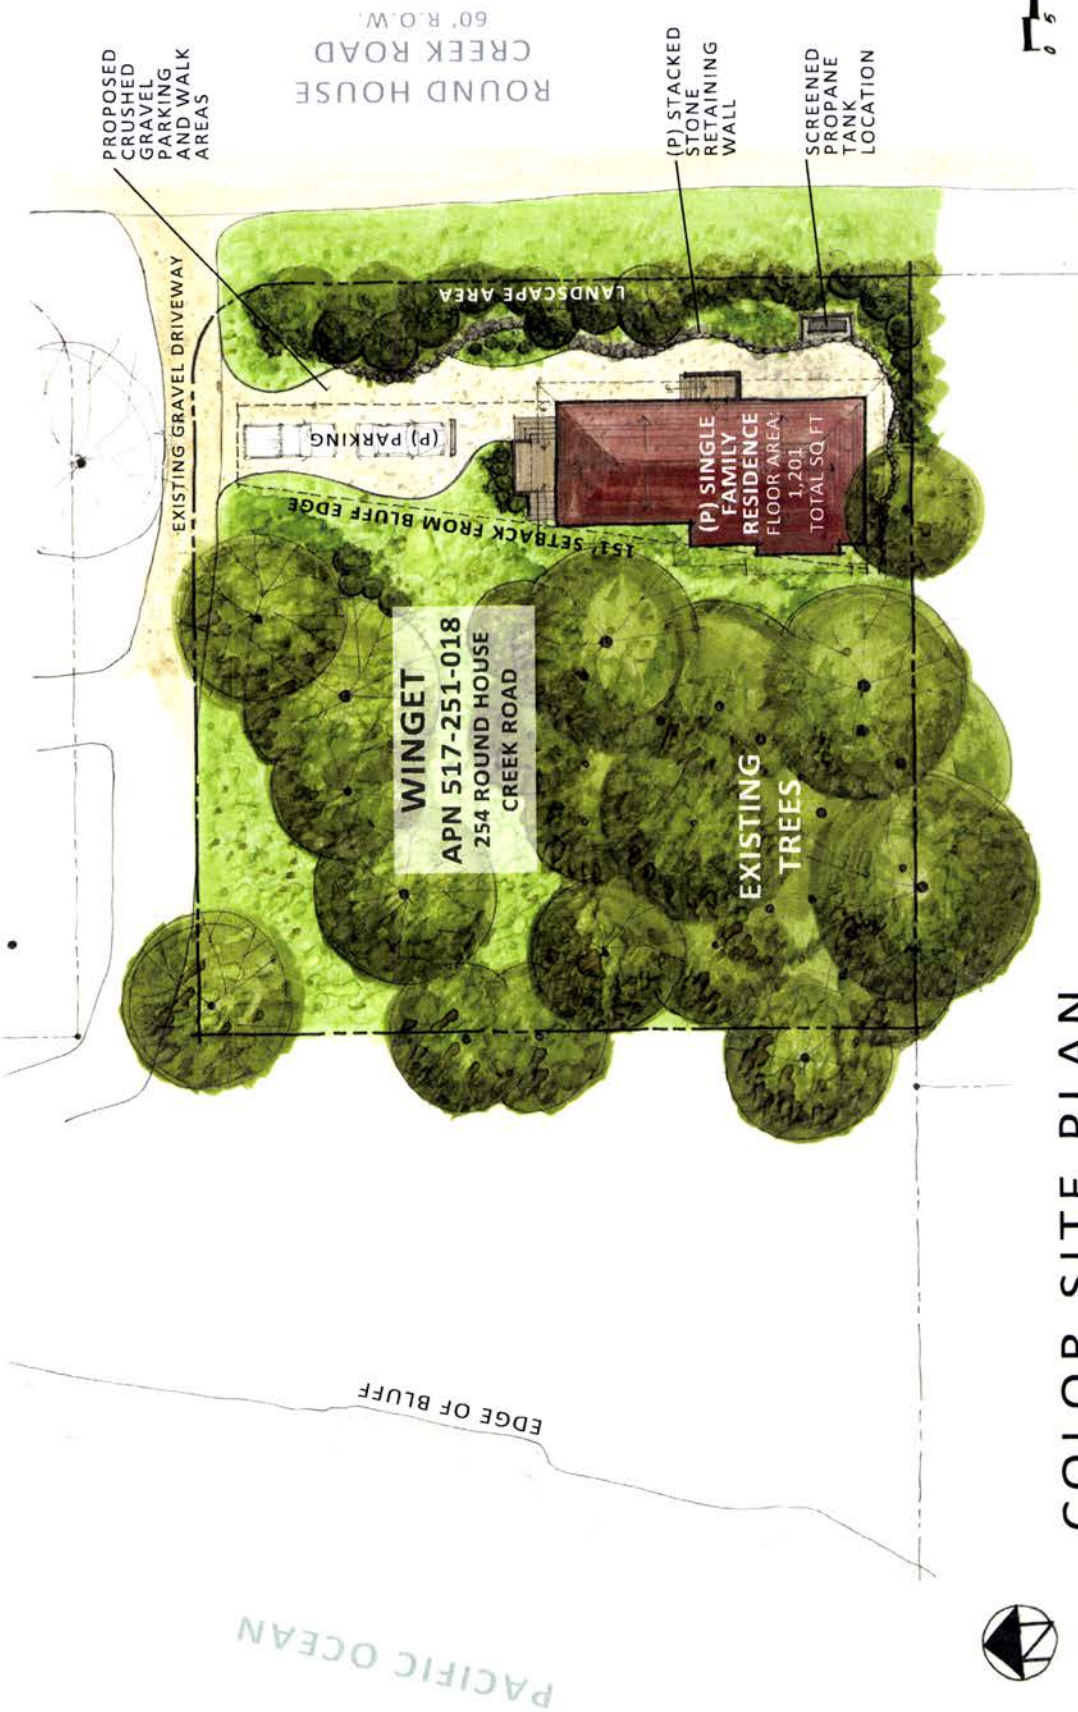
# COLOR SITE PLAN

WINGET RESIDENCE  
254 ROUND HOUSE CREEK ROAD  
BIG LAGOON, CALIFORNIA

The proposed new development would be located a minimum of 151 feet back from the existing bluff edge (**Exhibit 6**). Although the subject site is located on the west side of Roundhouse Creek Road, it is not the westernmost lot. An undeveloped, partially eroded lot owned by the County is located between this property and the bluff edge (**Exhibit 3**). The County's lot was purchased from private ownership with funds awarded under a FEMA hazard mitigation grant in response to severe storm damage to the bluff in 1999, as discussed below.

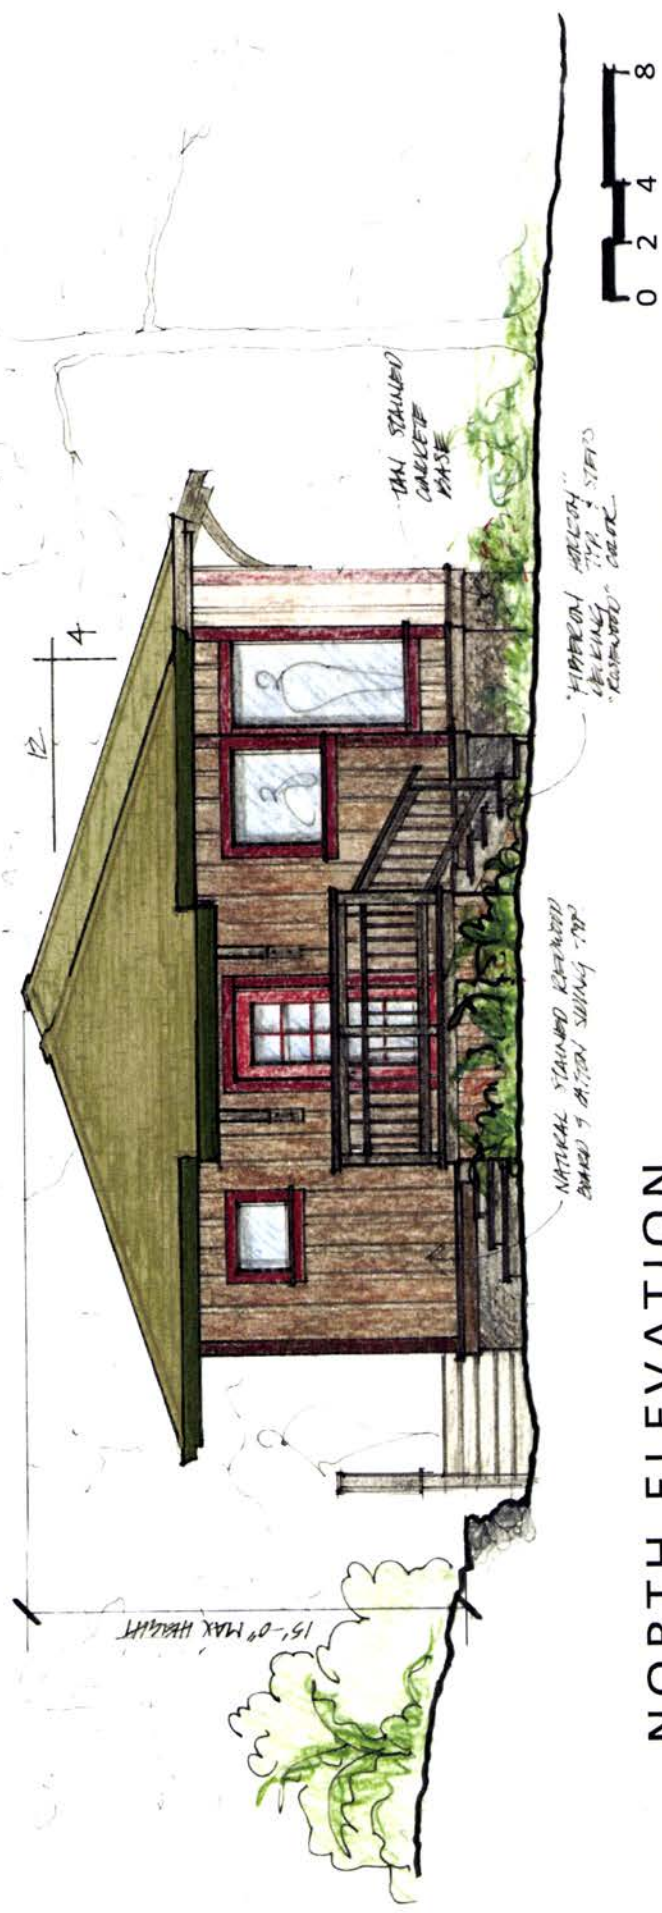
# NORTH ELEVATION

WINGET RESIDENCE  
254 ROUND HOUSE CREEK ROAD  
BIG LAGOON, CALIFORNIA
