CALIFORNIA COASTAL COMMISSION

ADMINISTRATIVE PERMIT

Application No.: 1-15-0246

Project Description: Removal of earthen fill placed in wetlands without the benefit of a coastal development permit and restoration of the wetlands.

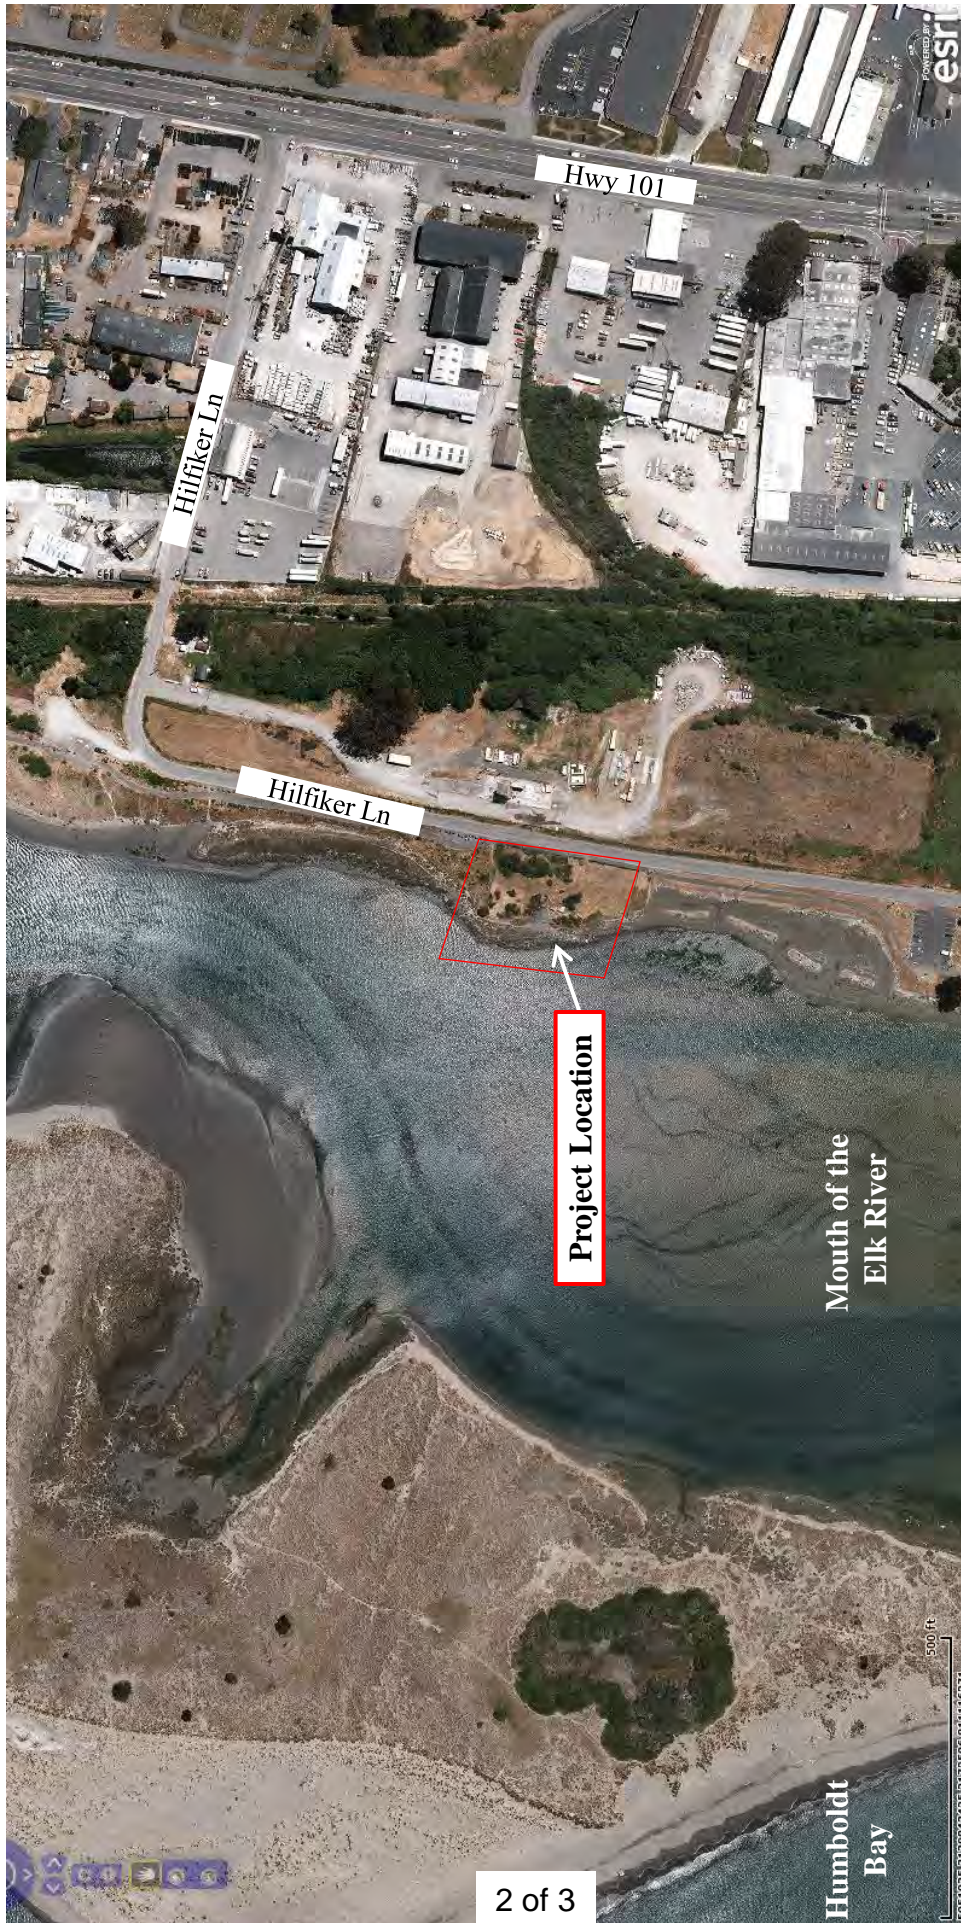
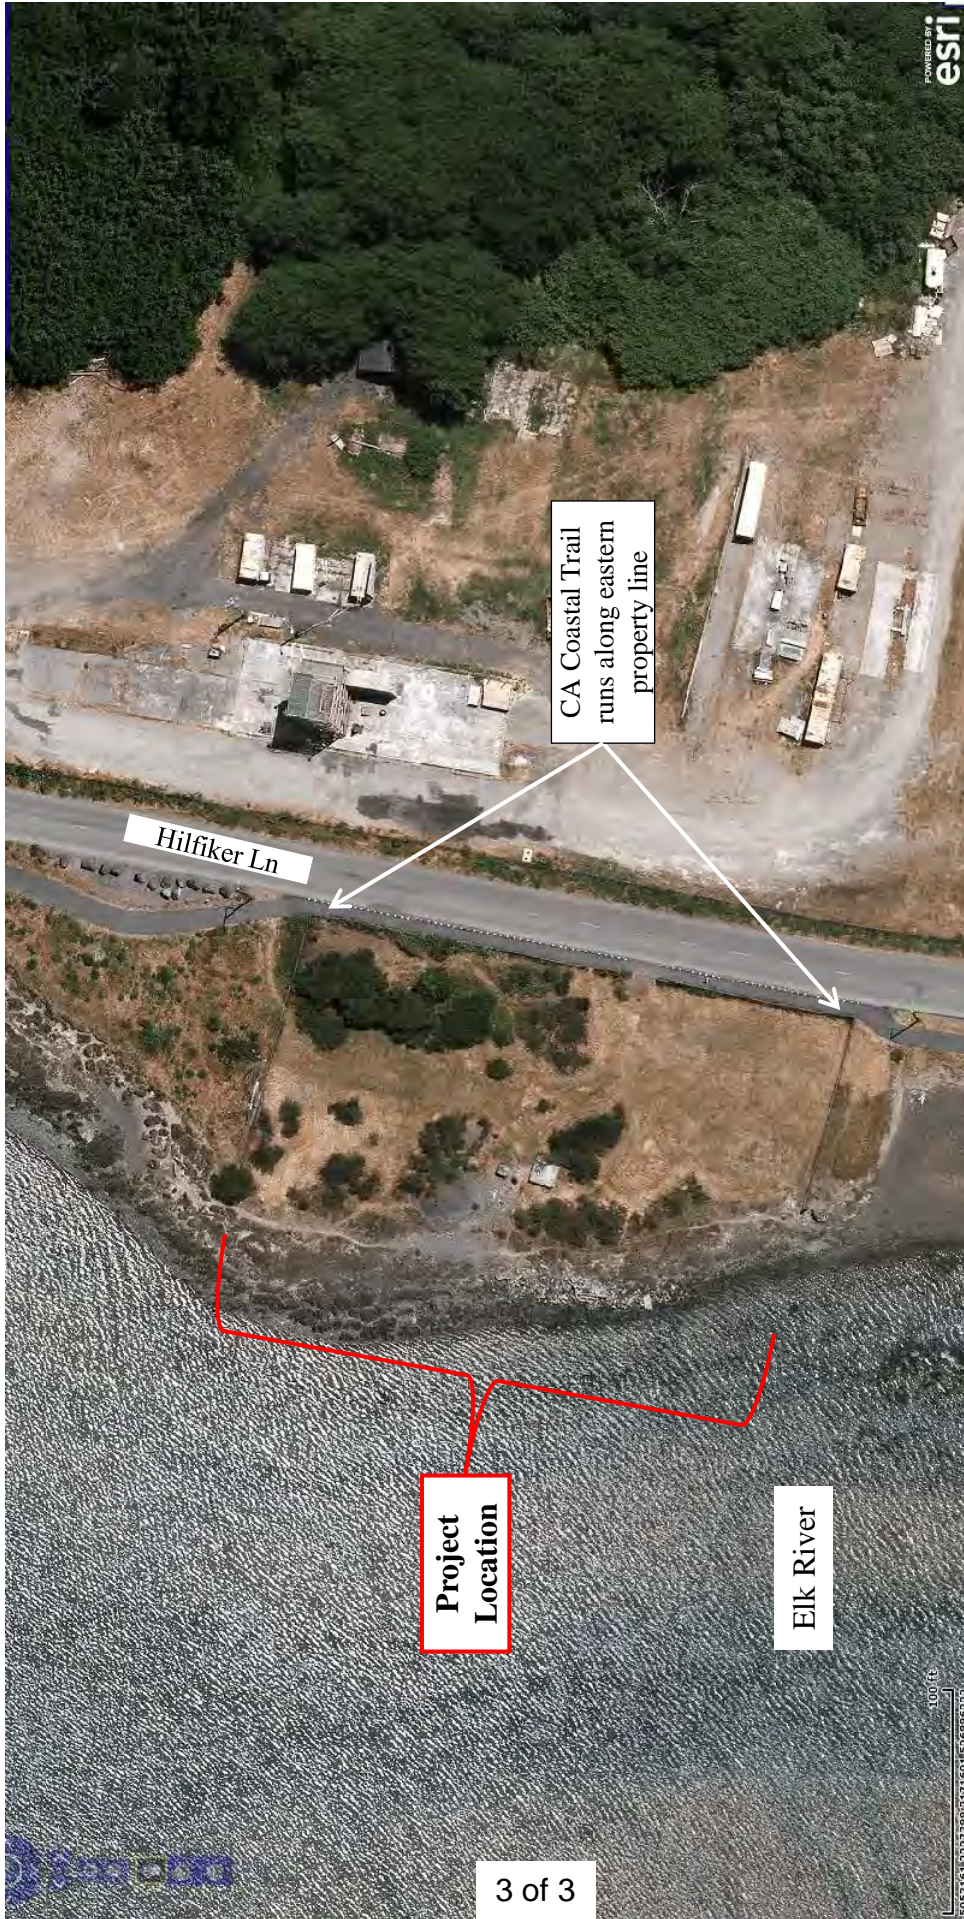
Shwaika Property

Site during fall of 2014 with stockpiled fill. (Photographs taken by Commission staff)

Commission staff subsequently visited the coastal trail to observe and photograph the fill, and then alerted the City of Eureka to the alleged violation. In response, the City of Eureka posted a stop-work order at the subject property on October 1, 2014, indicating that both a coastal development permit (CDP) and a grading permit were required. Photographs taken by the City's code enforcement staff show that at the time the stop-work order was posted, the unpermitted fill material was stockpiled in over a dozen small piles (See [Exhibit 3, pg. 1](#)). Commission staff then became aware that despite the stop-work order, the piles of unpermitted fill had since been leveled (See [Exhibit 3, pg. 2](#)).

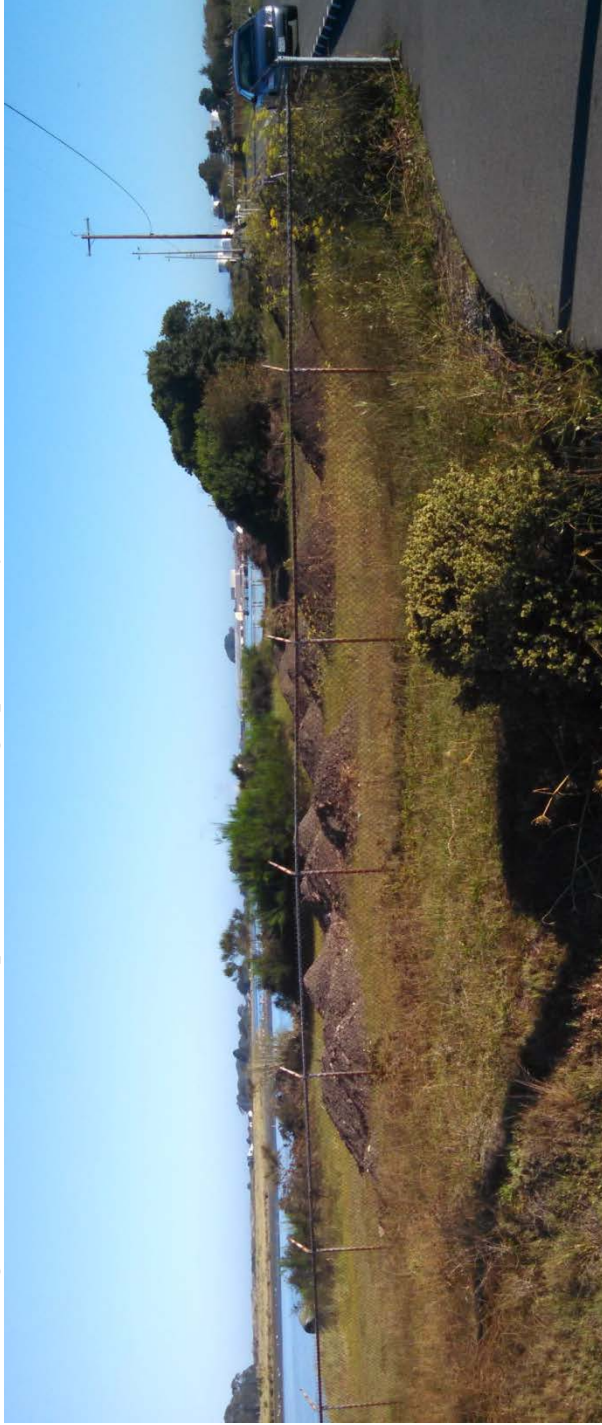
Shwaika Property

Site during fall of 2014 after stockpiled fill was leveled.

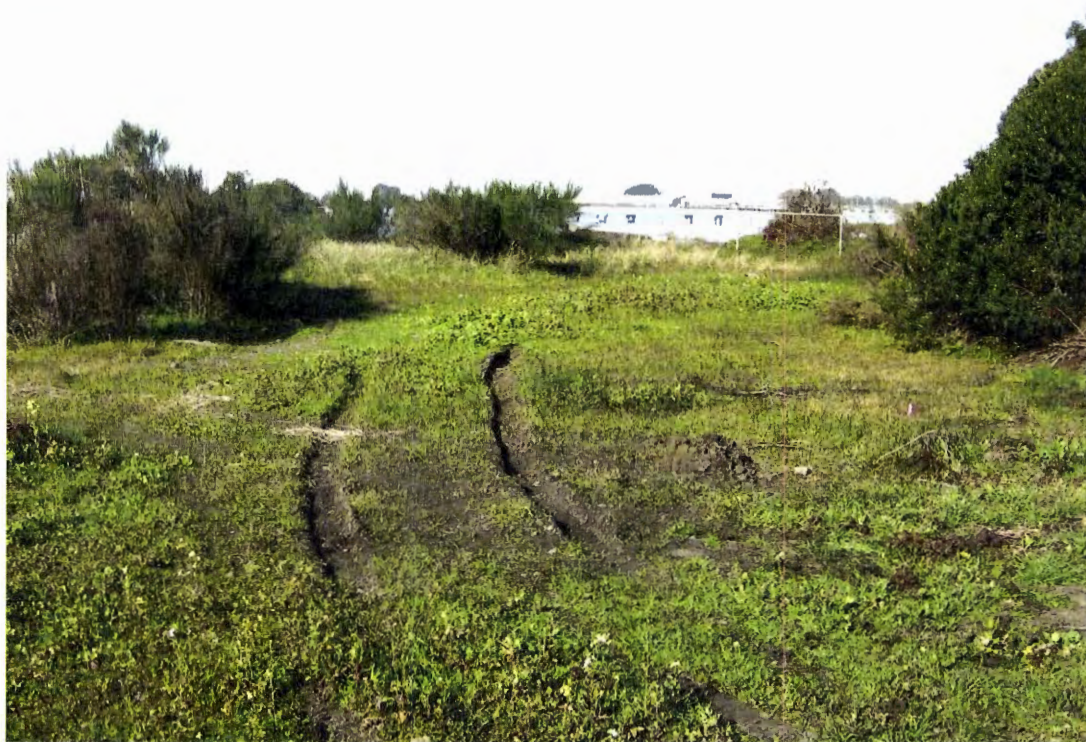
Photograph of broad-leaved wild radish, *Raphanus sativus*, on northern fill soil location with tire tracks through soft fill, looking northwest toward pipeline across mouth of Elk River. Notice tall Pacific wax myrtle on right and Scotch broom-covered berm on left. Photograph taken January 6, 2015.

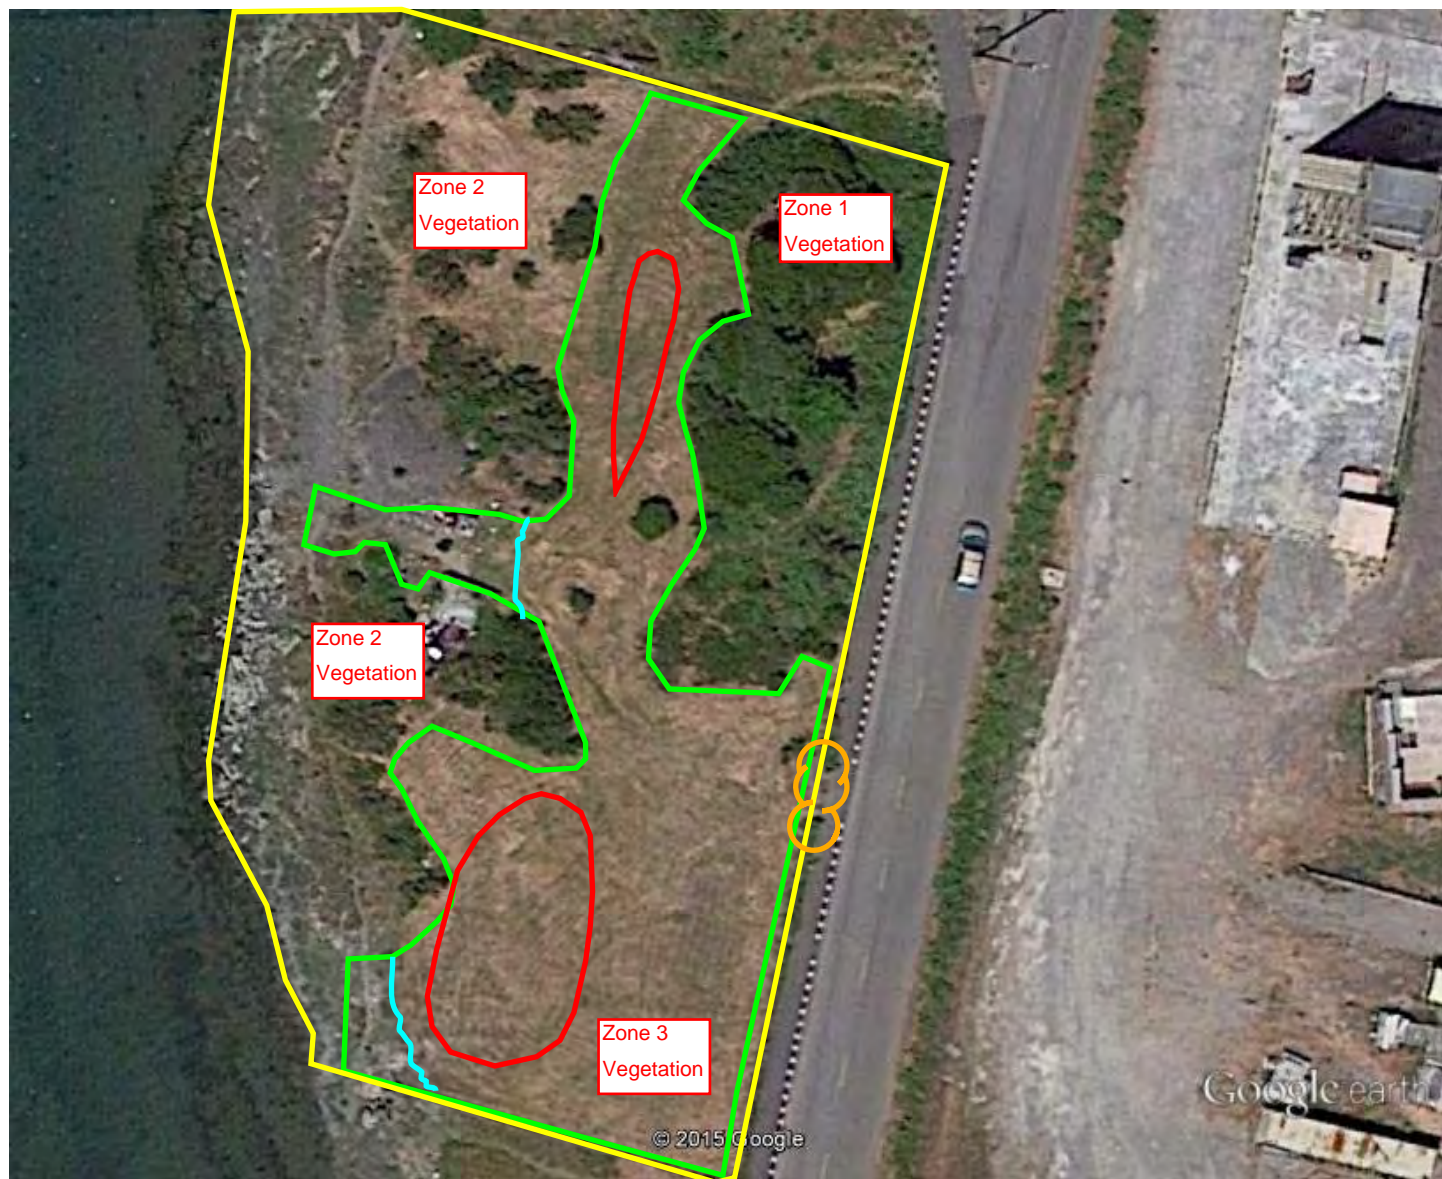
ATTACHMENT 3. RESTORATION PLAN AERIAL PHOTOGRAPH

Straw Wattle Sediment Control

To stabilize the soil and prevent erosion that could cause sedimentation of the adjoining Elk River during the removal of fill and the reestablishment of native vegetation, the permittee proposes to install straw wattles along the two low points between the river and the restoration site prior to fill removal, and apply jute netting over exposed soil immediately after fill removal. In addition, after the soil is removed, the permittee proposes to erect temporary fencing around the restoration area to prevent people from compacting or otherwise disturbing the soil or damaging emerging plants. The temporary fencing would be removed upon successful restoration of the fill removal area.

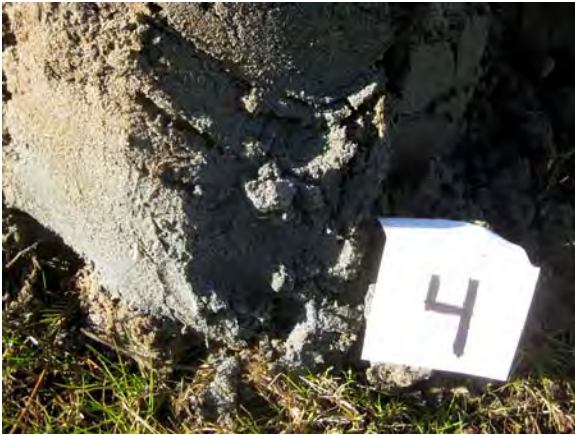
Photograph 1. Soil Pit #4 revealing nearly pure sand with stray pieces of scrap metal simulating redoximorphic features. Notice small piece of iron in upper left corner.

The soils found throughout the site are dominated by sand (Photo 1, Attachment 4). Annual rainfall at this site is approximately 39 inches or 99cm (WRCC 2013). The dominant geomorphic characteristic of the site is the gently sloping depression that runs north to south through the center of the parcel, opening to the bay at the central and southern ends (Photo 2, Attachment 4).

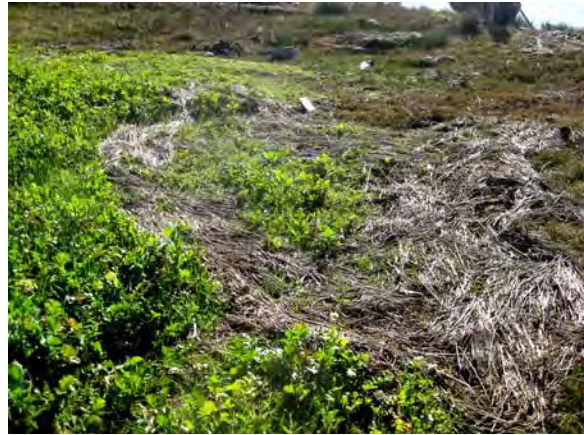
Photograph 2. Heavy drift deposit characteristic of the two jurisdictional wetland areas. Note also depressed topography and adjacent bay at upper right.

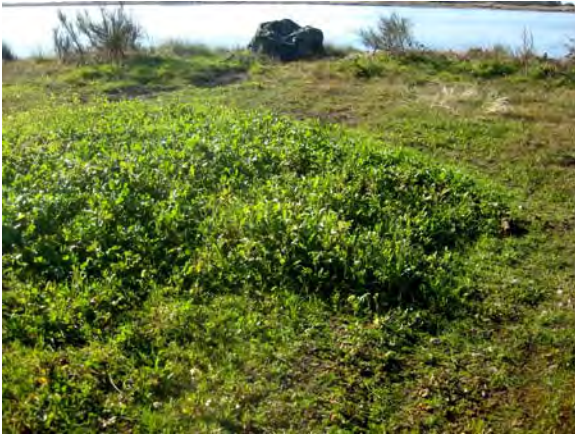
Photograph 3. Wild radish patch indicating filled area. Notice surrounding, short *Carex pansa*.

Approximately 3,000 ft² were covered with just over 8/10ths of a cubic yard of fill. Soil examination confirmed that both fill areas lie within the Coastal Zone wetland. The fill areas are easily located onsite by the presence of wild radish, *Raphanus raphanistrum* (Photo 3, Attachment 4). The fill consists of a dark (10YR2/1) loam topsoil. The soil was likely full of radish seeds, which prefer recent disturbance and loam soils. Table 1 outlines the types and amounts of recent fill found.

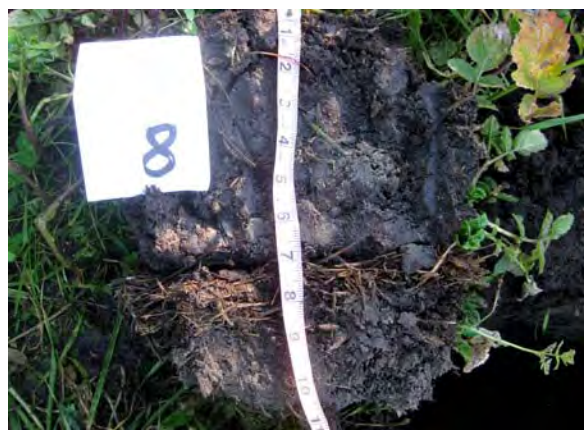
Photograph 4. Fill profile at Pit #8 showing 7 inches of loamy fill soil on top of decomposing surface vegetation, underlain by original sand.

At both fill areas it is very evident where the wetland/original soil surface exists below the fill due to what appears as a black peat layer where the original plant foliage is decomposing (Photo 4, Attachment 4). This line separates the loam topsoil from the sandy original soil. When a cross section is dug for examination, the profile breaks in half at this dividing line when removed from the spade. Additionally, the existing sandy soil contains significant quantities of broken asphalt pieces, which are lacking in the fill soil. Essentially no disturbance of the original topsoil could be detected underneath the fill, indicating the original rhizomes and roots are still intact.

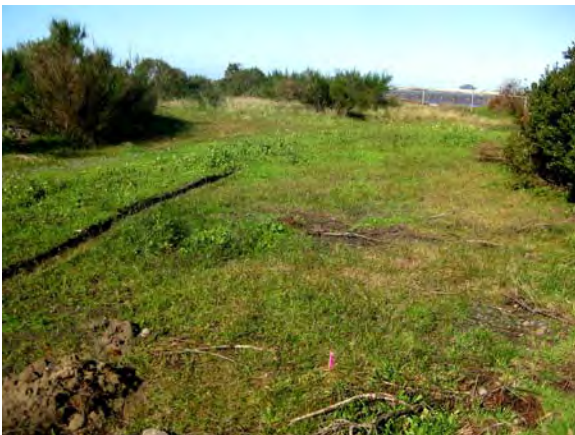
Photograph 5. Looking northwest toward Pit 9 from the Pit #2 flag. Notice the elevation increase and Scotch broom/Coyote Brush upland plant community. Bright green low-growing vegetation is wild radish on the northern fill area surrounding Pit #8.

The wetland ecosystem affected by fill on this site is a unique, short coastal prairie grassland dominated by *Carex pansa* and interspersed with sparse *Juncus lescurii* (Photo 5, Attachment 4). Periodic flooding during extremely high tides or intense precipitation events encourages the dominance of facultative or facultative-wet species (Photo 6, Attachment 4). The sandy soils over the high water table associated with the close proximity to the bay impede downward movement of soil water at around two feet deep, resulting in lateral water flow. This condition results in wetter than normal conditions for a sandy soil, resulting in the dominance of the two above-mentioned species, which prefer sandy soils that become periodically inundated. This type of wetland remains dry most of the season and can handle extreme drought conditions. These characteristics have discouraged the encroachment of invasive, non-native species.

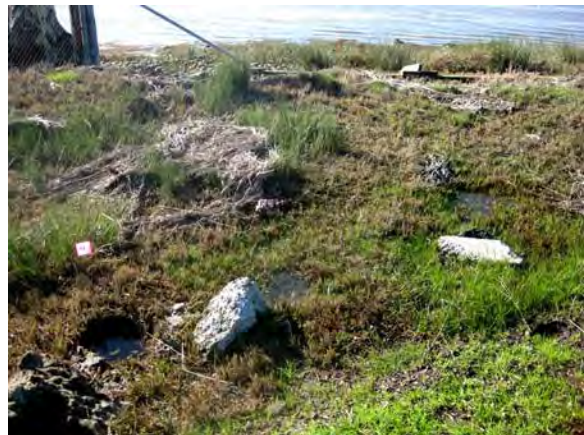
Photograph 6. Looking southwest at Pit#4. Notice heavy drift deposits, pit full of water and standing water in two depressions at center and right.
